Town Brook Realignment & Restoration Project: an Urban River Case Study

Heidi M. Davis Acting Section Chief, Wetlands Program MassDEP Northeast Regional Office

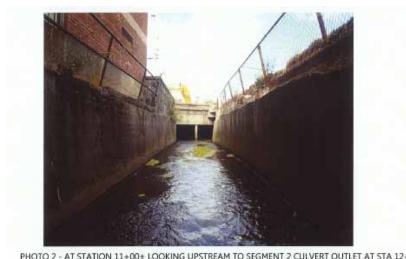
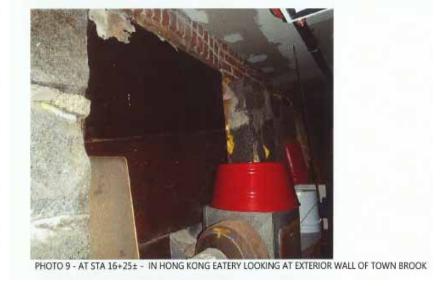
Extensive historic alteration of Town Brook placed the majority of the brook in culverts of varying materials & dimensions. This patchwork of culverts is intersected by various utilities & illegal sewer connections.

Left: Town Brook is flanked by an American Legion and extensive retaining walls.

Right: photo of a "window" looking from the basement of the Hong Kong Eatery into Town Brook.

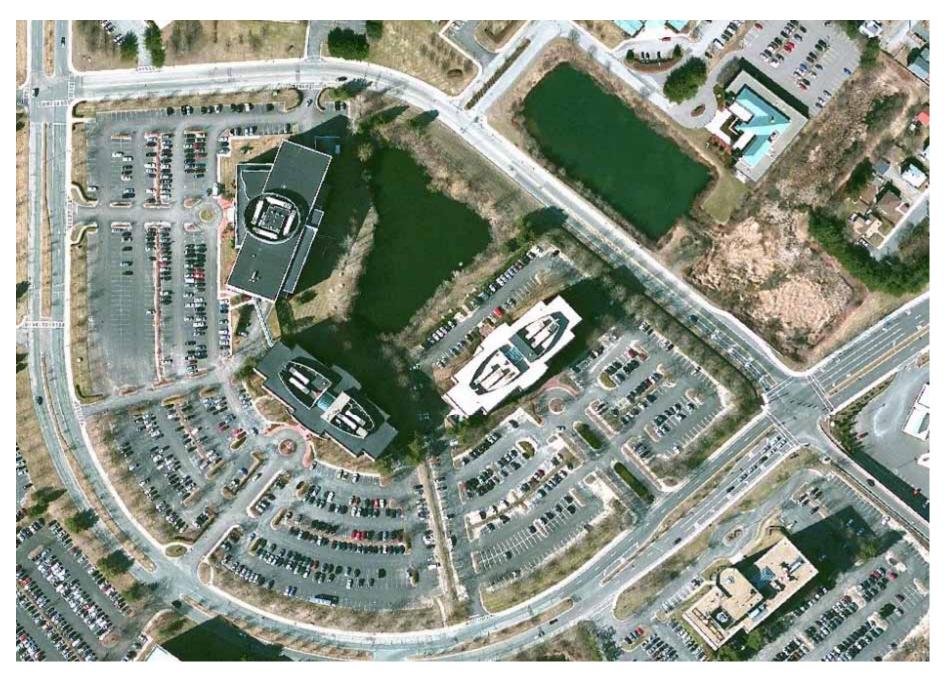
As part of the flow augmentation requirements of this project, flows from Crown Colony Development are now treated & directed into Town Brook.

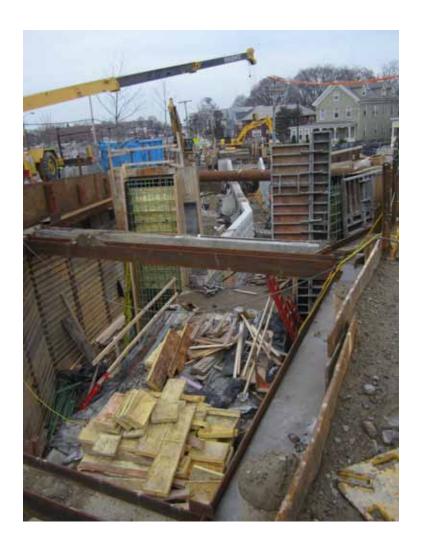
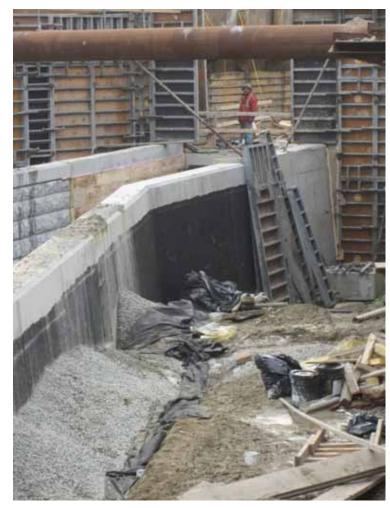
Left: looking from Hancock Street towards Mechanic Street. Right: open channel segment emerges from sub-surface tunnel.

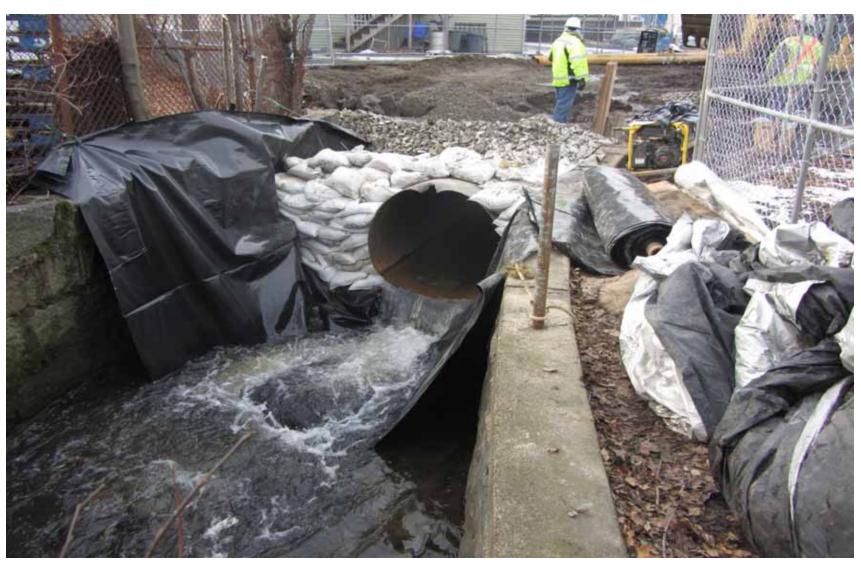
The existing Town Brook is temporarily placed in a culvert during construction. Note poly sheeting used for velocity dissipation at outlet.

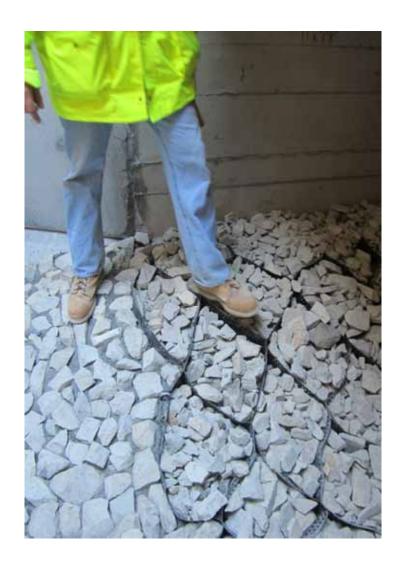
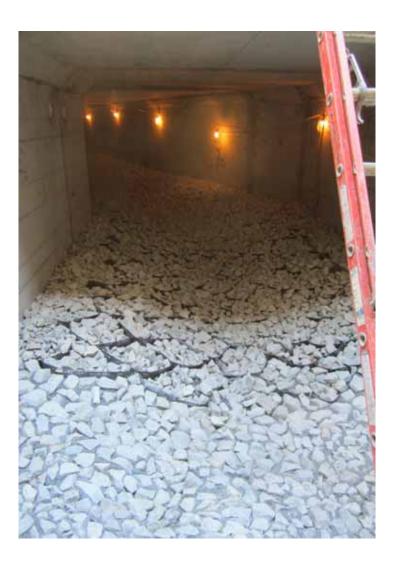
Geogrid matrix keeps stone in place. Size of stone was selected for suitability as spawning substrate.

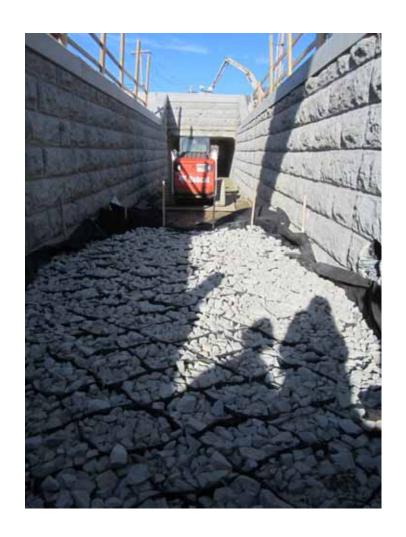
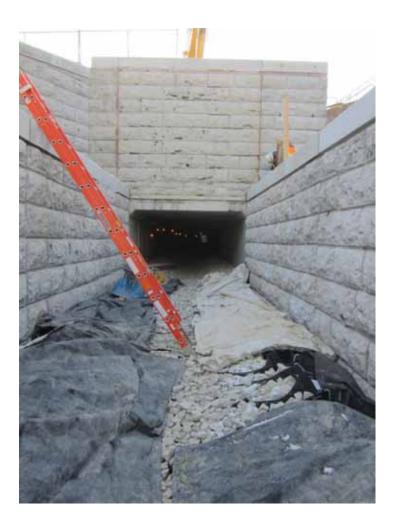
Town Brook is not a typical stream restoration project as it took place in an urban setting with severe space constraints (which is why the channel walls are vertical).

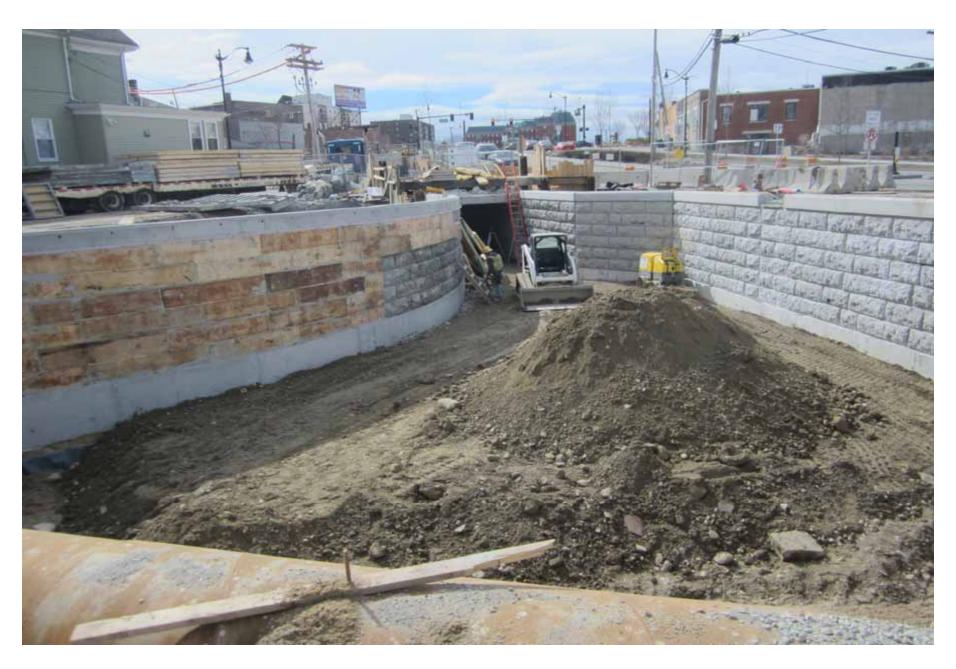
Formation of the BVW island by the bend in the stream.

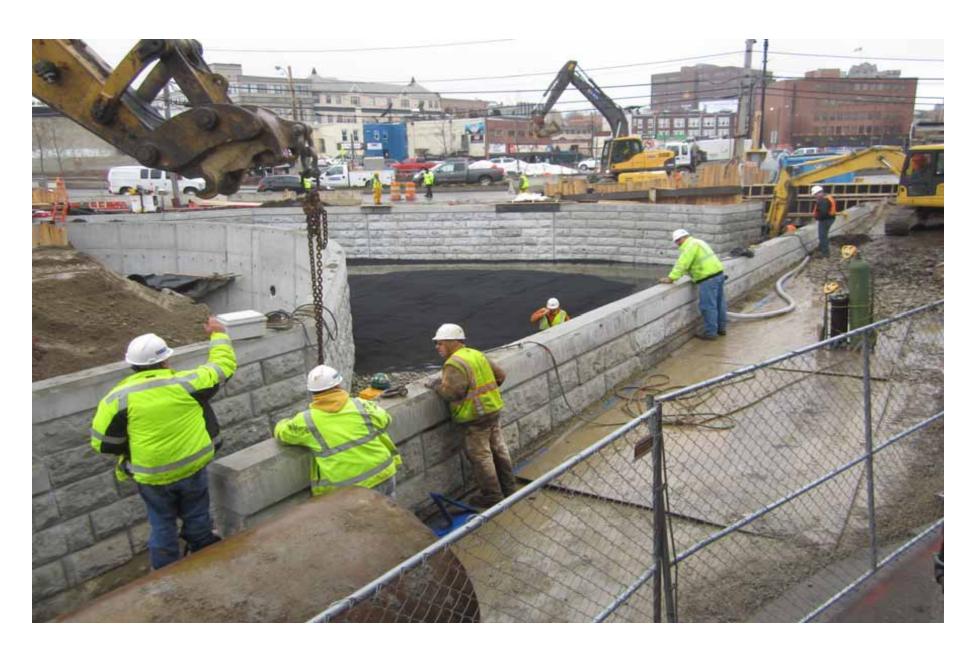
On March 6th, the culvert carrying Town Brook was pulled and water flowed through the new alignment for the first time.

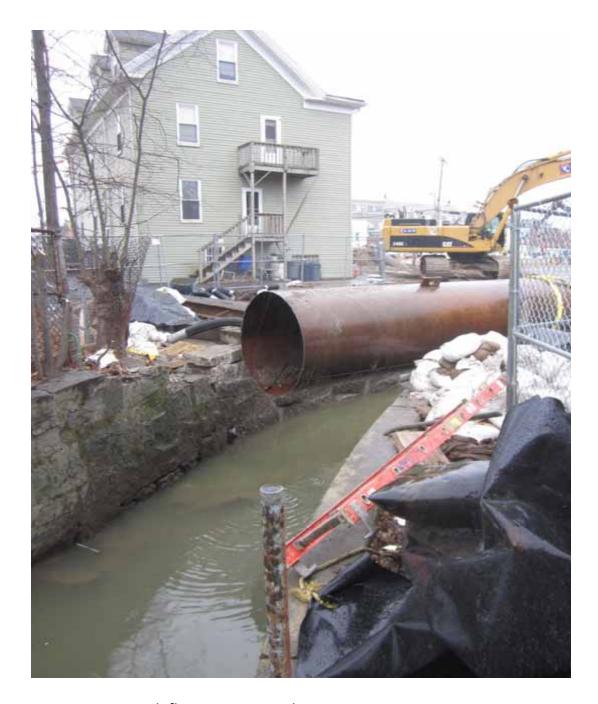
Culvert carrying Town Brook flows is removed.

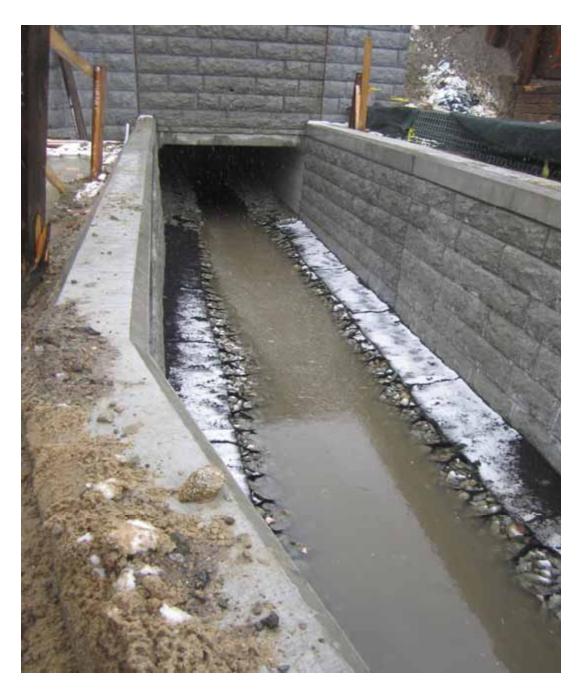
First flush as water flows through the new alignment for the 1st time.

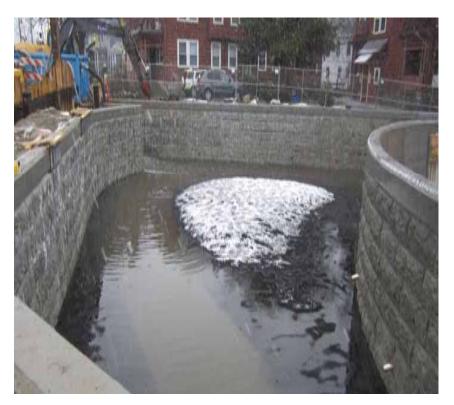
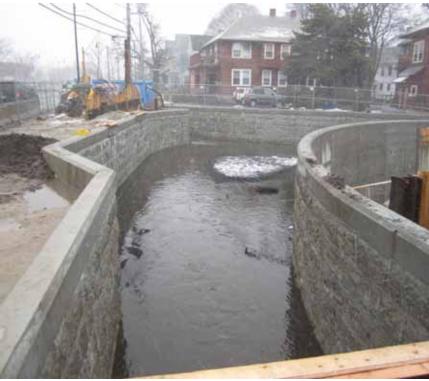
The BVW island is covered by filter fabric prior to planting. Planting could not occur until the Time-of-Year restriction for the smelt run was lifted (June 1st).

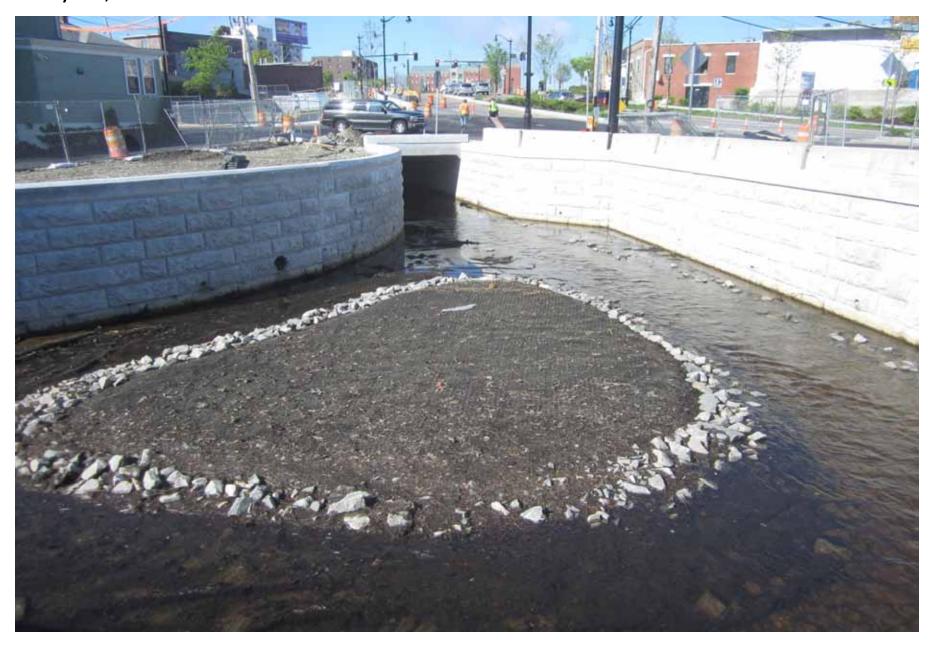
The toe of the BVW island was secured by stone as high flows were lifting the filter fabric.

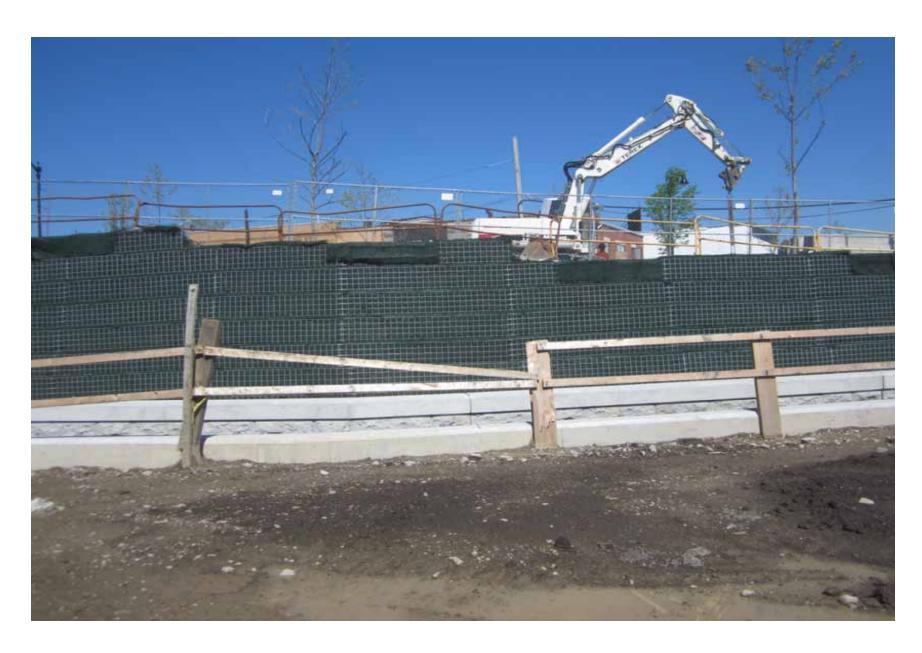
Construction of the vegetated retaining wall.

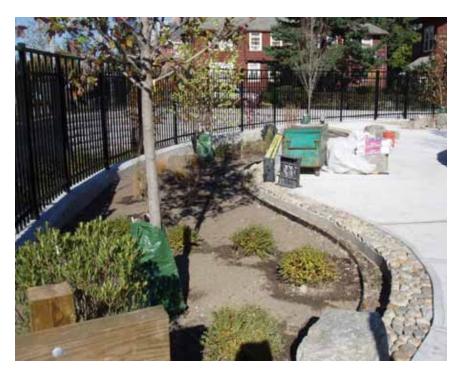
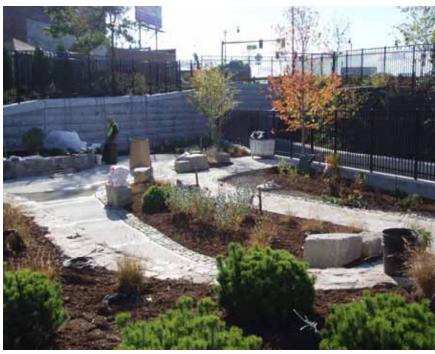
Planting of the pocket parks is in progress

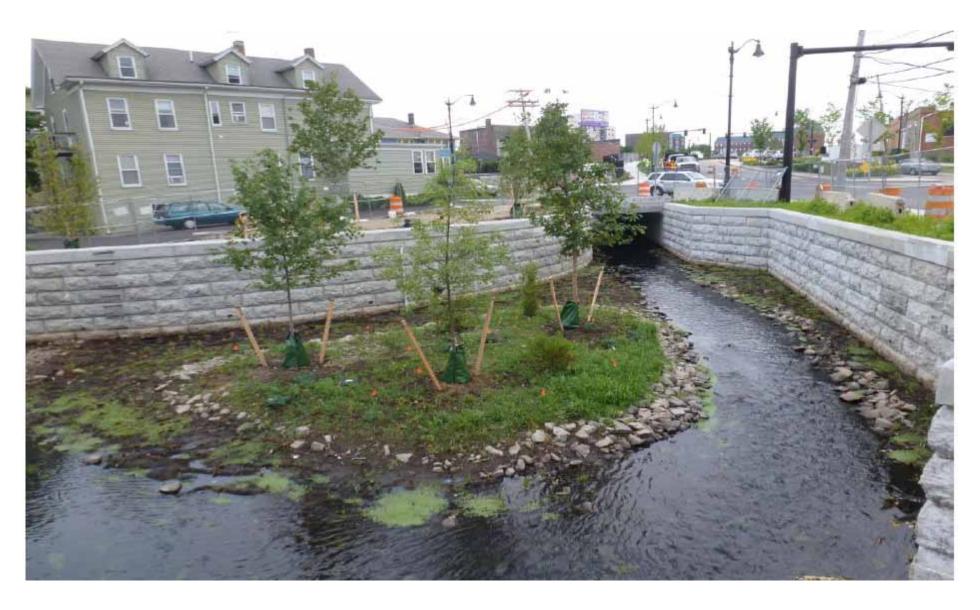
The BVW island has been planted and water is flowing in the new alignment.

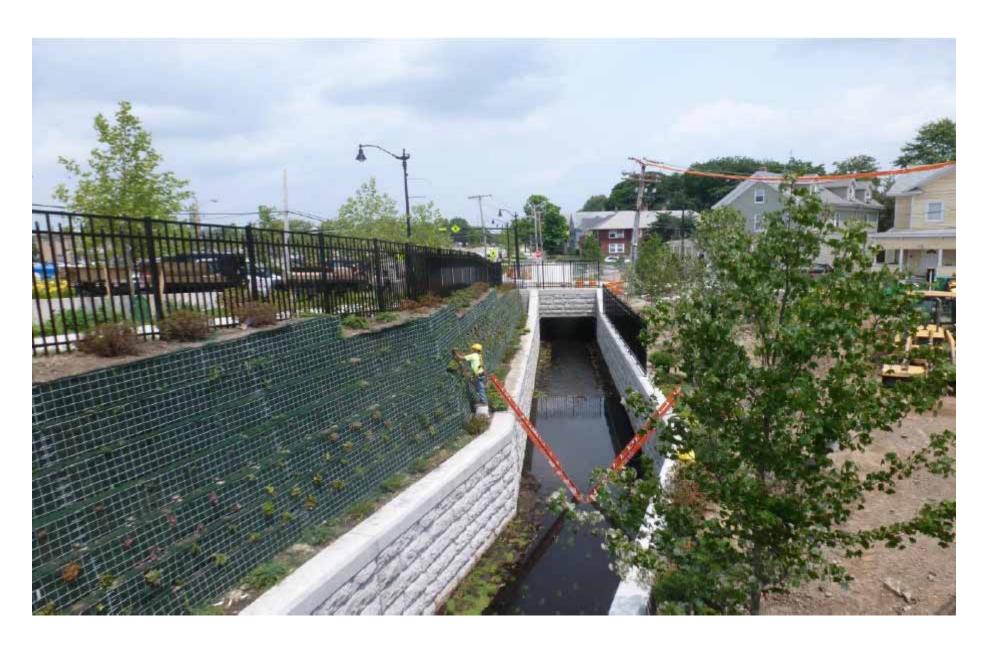
Planting of the vegetated wall.
