Patch Pond Dam Removal Feasibility Study Final Report

City of Worcester,
Massachusetts

June 2014

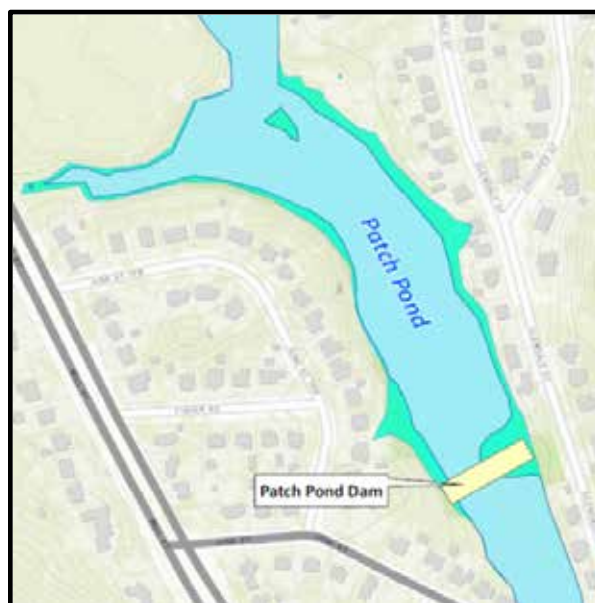
Patch Pond Dam Flood Analysis

The existing HEC-HMS model extends south from the Holden No. 1 and No. 2 Reservoirs to the Patch Pond Dam and extends to Coes Reservoir, which is downstream of the Patch Pond Dam. The analysis focused within the immediate vicinity of the Patch Pond Dam and focused on the average day flow and the 100 year storm event, although other larger storm events were considered in the model. The removal of the Patch Pond Dam would have little or no effect on the flood stage from the existing conditions outside the vicinity of the existing dam. However, in the area Patch Pond Dam, removal would and lower the peak flood stage.

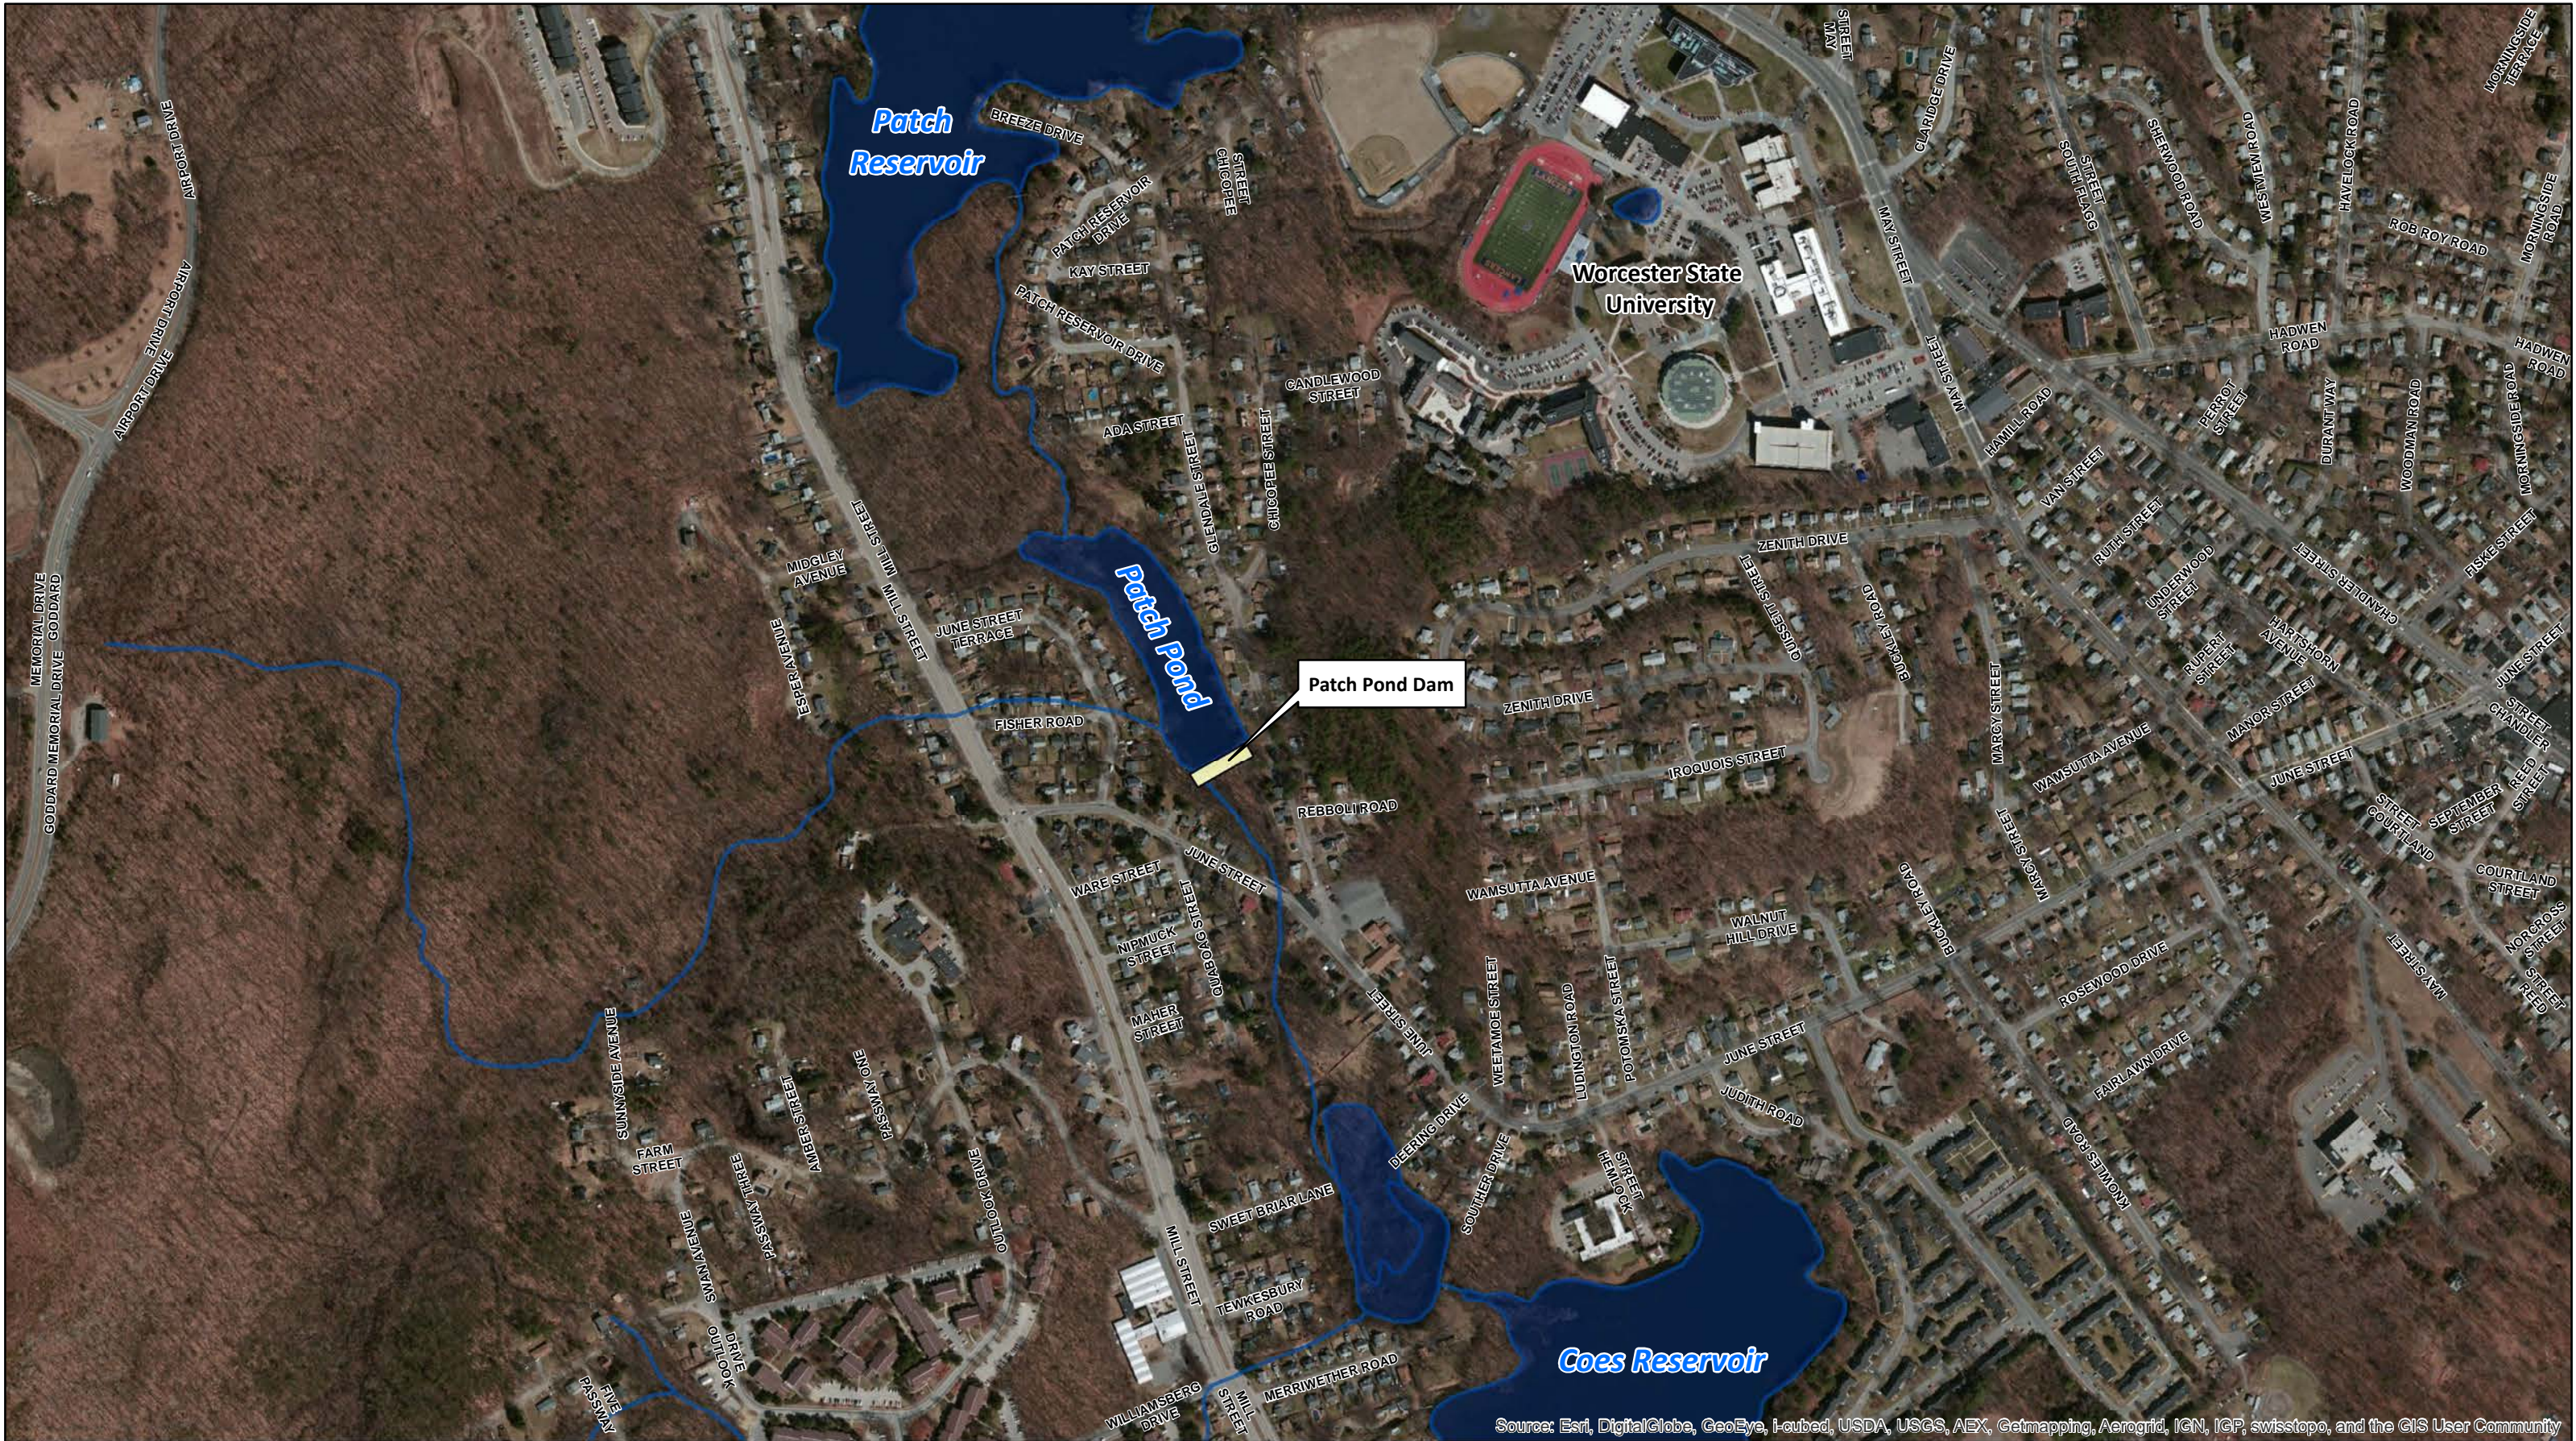
Figure 1-3
Existing Conditions

The PPD (State Dam ID No. 3-14-348-10, NID No. MA03341) is located on Tatnuck Brook and is tributary to Coes Reservoir. The size of the upstream impoundment area is approximately 4.82 acres at normal pool. It is located at 42.2637 N, 71.8483 W, approximately 3 miles west of downtown. Figure 1-2 shows the site of the dam and the adjacent area from Patch Reservoir to Coes Reservoir. The existing site conditions are shown on Figures 1-3, 1-4 and 1-5.

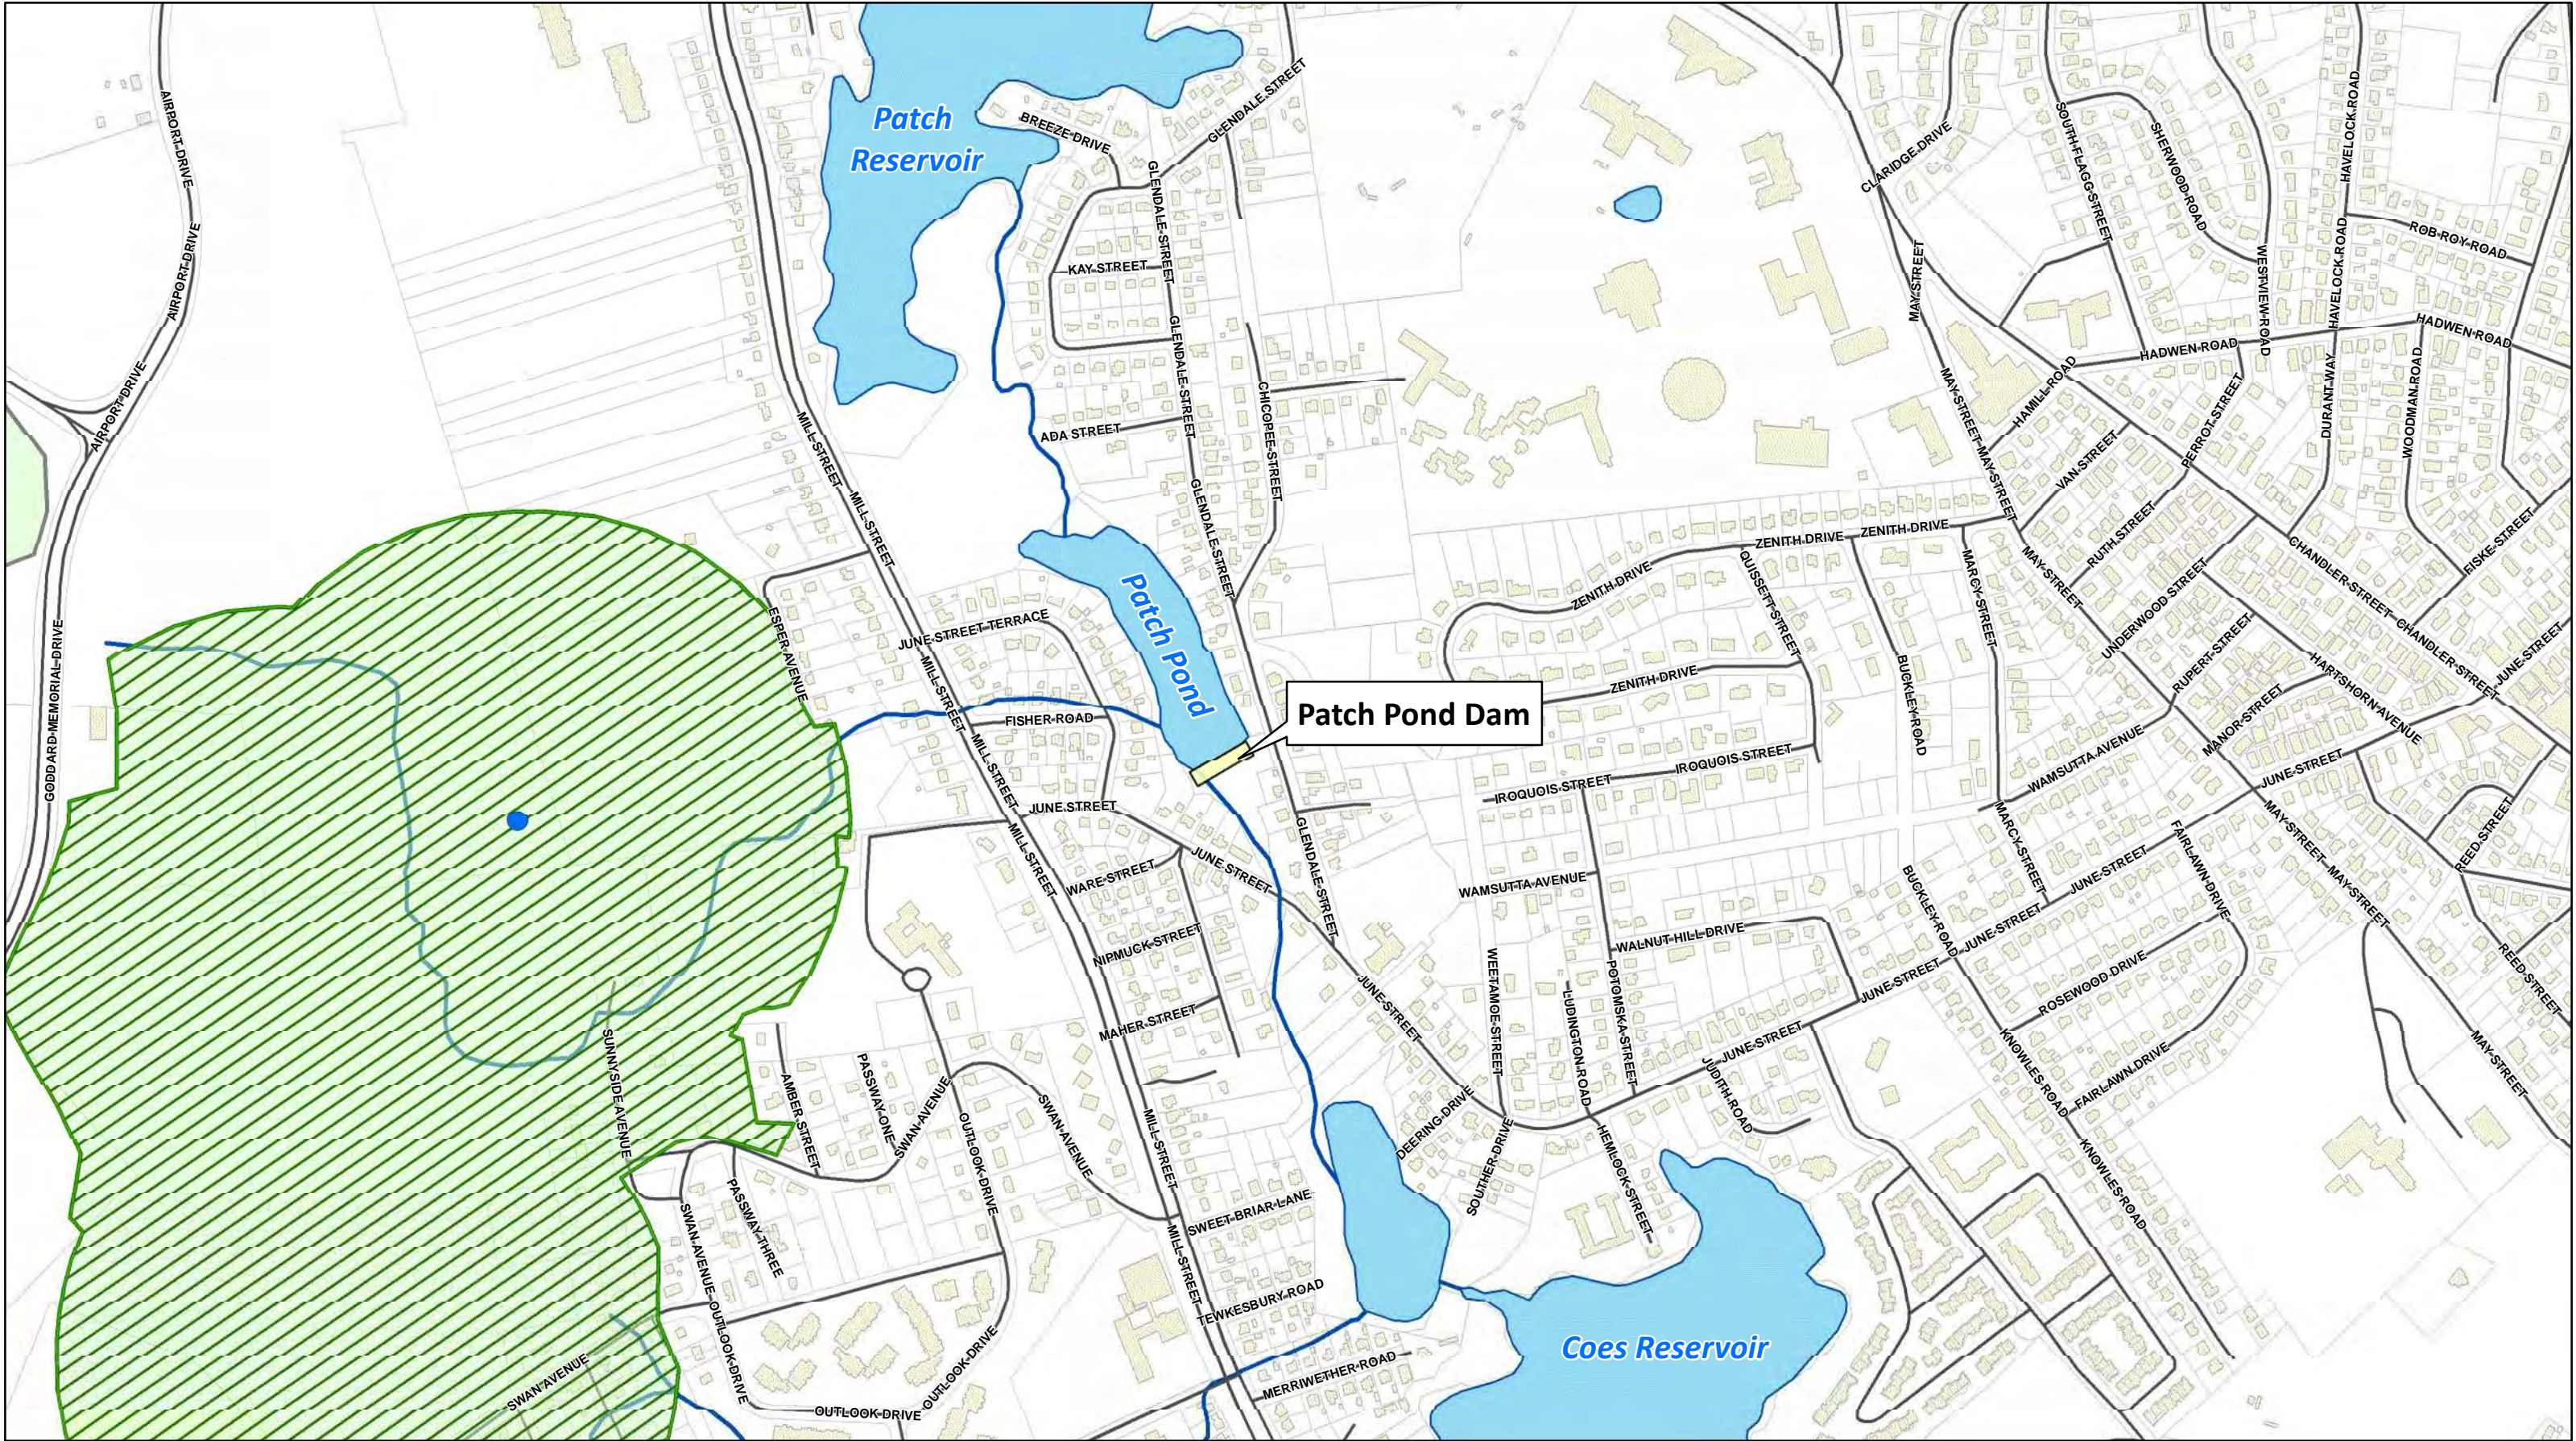
Figure 3-3
Wetland and Floodplains

FEMA Flood Insurance Rate Map of the area identifies the 100-year floodplain in the project area. The Patch Pond Dam and upstream impoundment is located within the 100-year floodplain (see Figure 3-3). The FEMA Map of the area (Panel ID: 25027C0613E) identifies the 100-year flood elevation at elevation 534 feet (NAVD 88) on the upstream side of the dam and at elevation 527 feet (NAVD 88) immediately downstream of the dam.

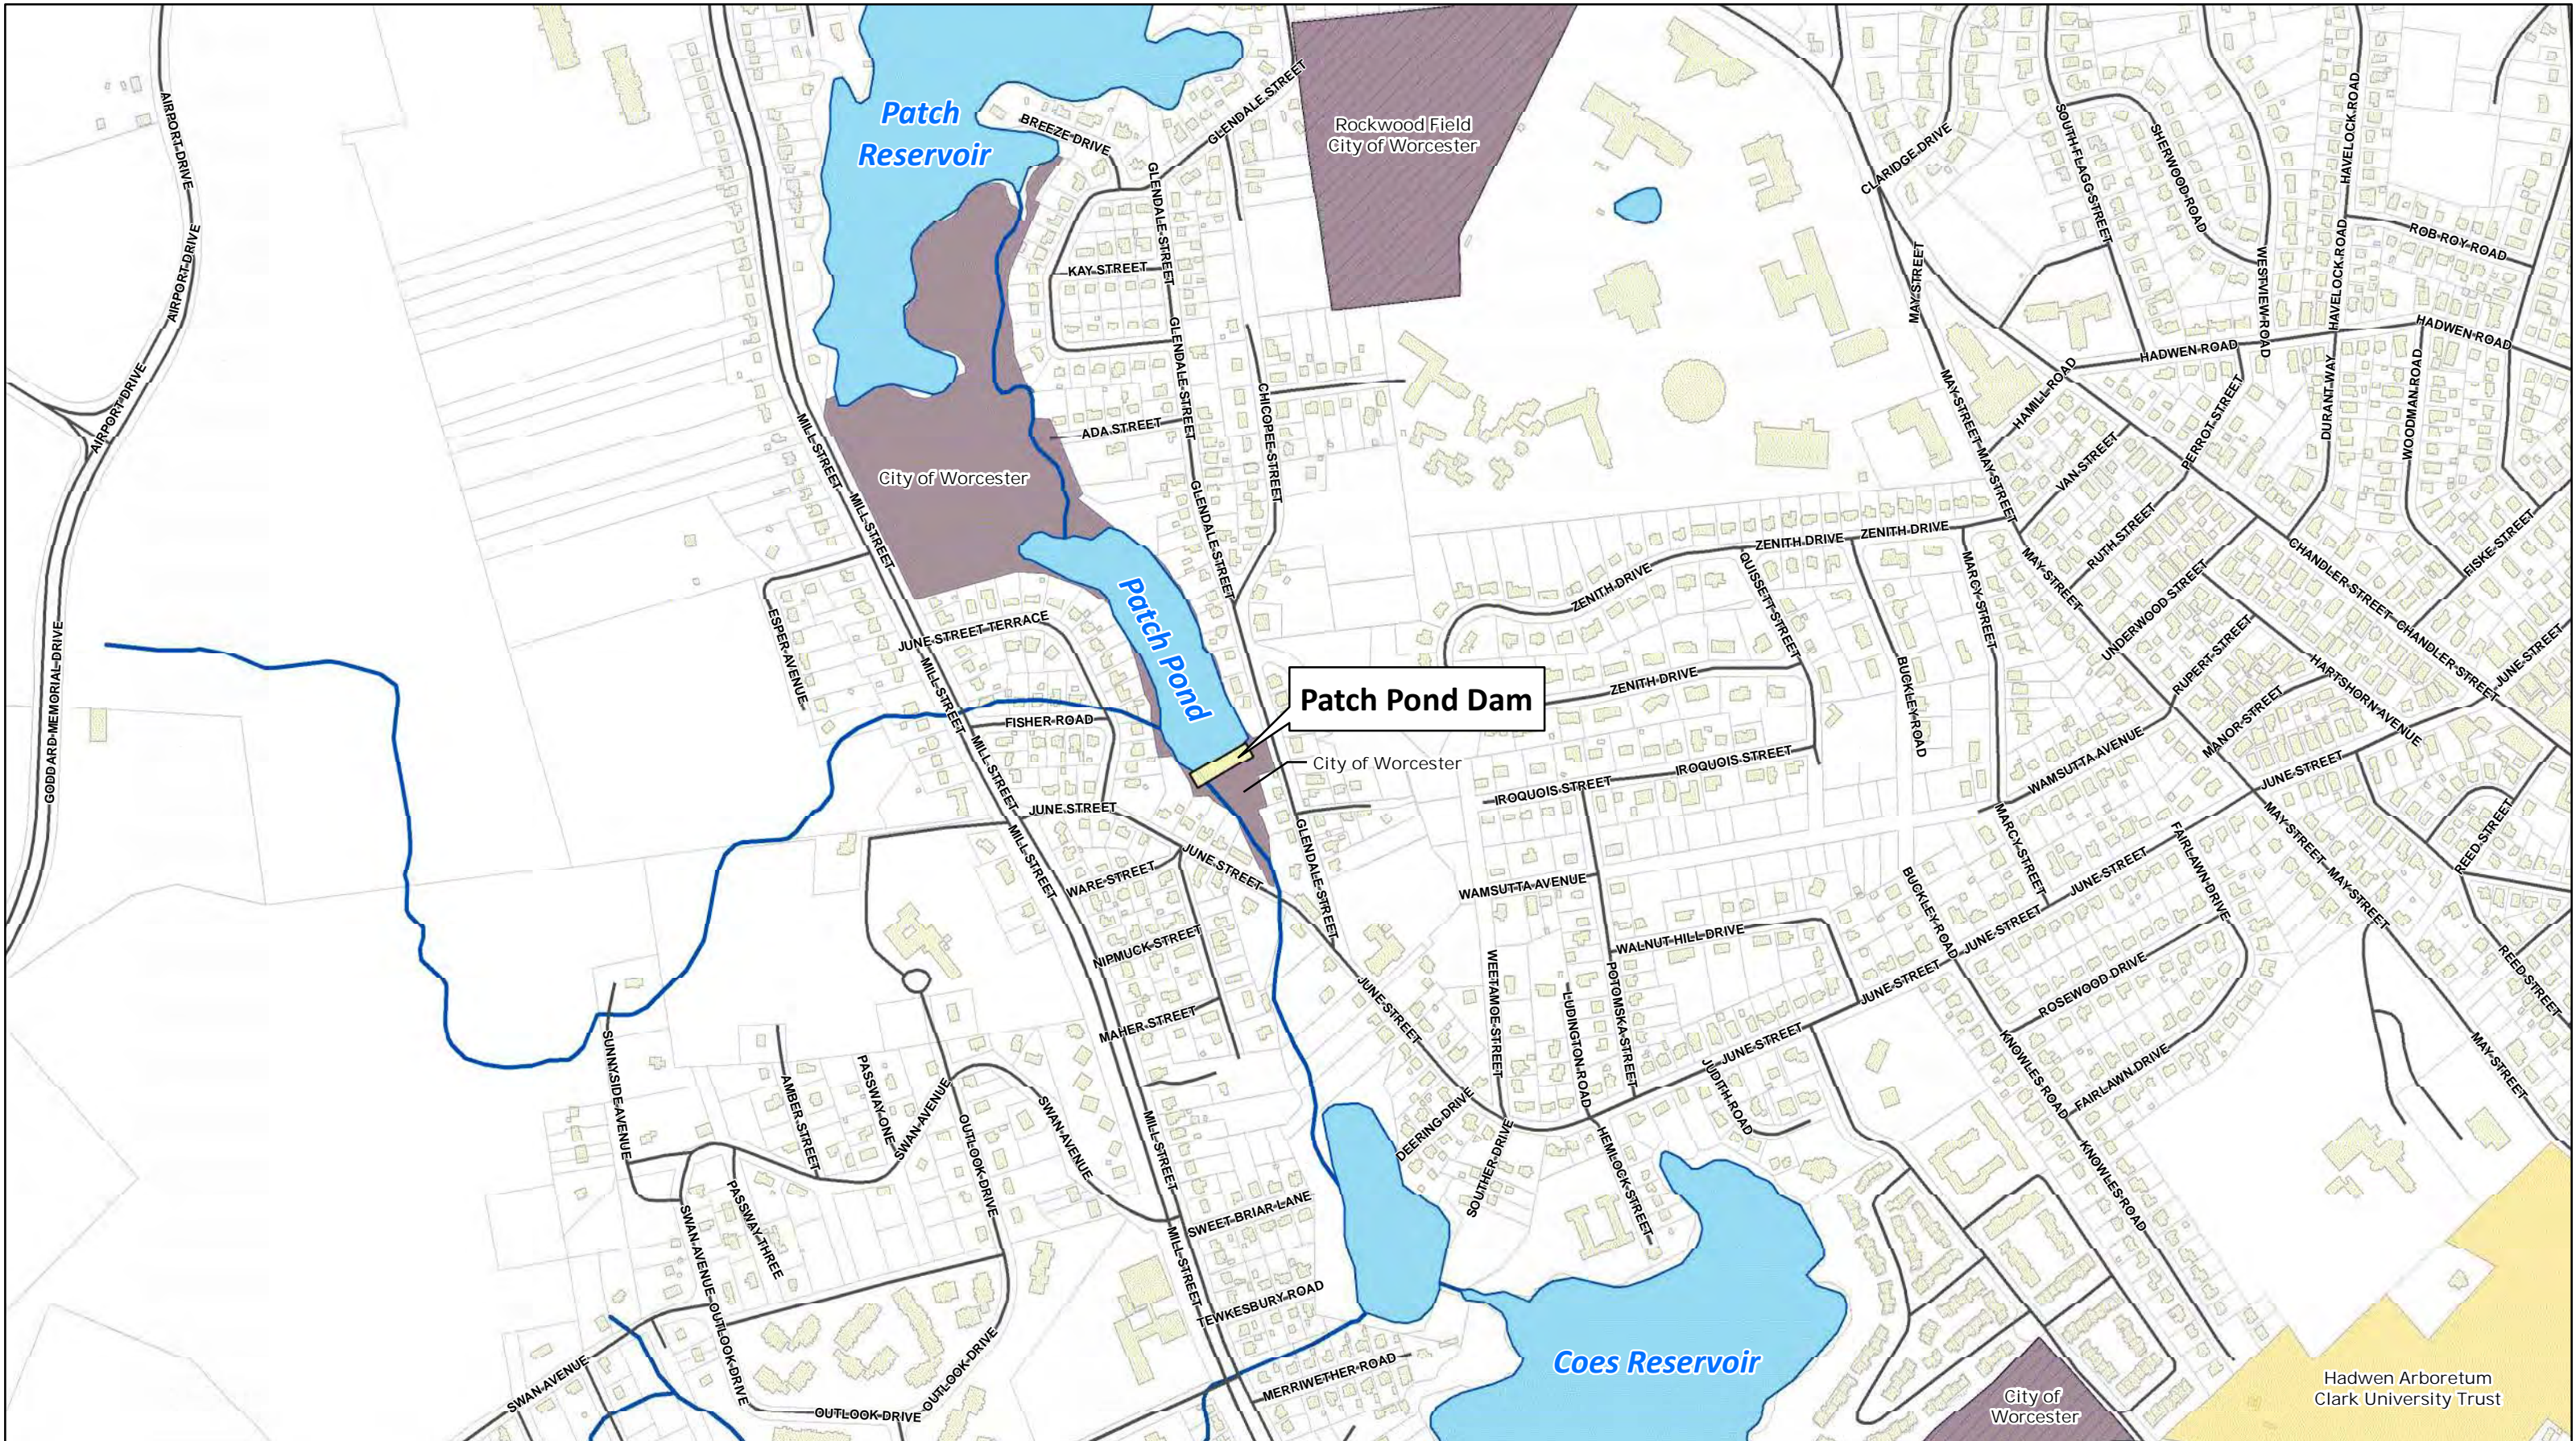
Figure 3-5
Conservation Lands and
City Owned Property

The PPD and upstream impoundment is located on a 6.45-acre parcel held by the Worcester Conservation Commission as conservation land (see Figure 3-5). The parcel includes Tatnuck Brook downstream of the PPD, north of June Street. The Worcester Conservation Commission owns about 43 properties throughout the City encompassing nearly 400 acres of land of which the PPD parcel is one of the smaller holdings. Article 97 (Mass. Const. Art. XCVII) protects land acquired for natural resources purposes. These lands and easements taken or acquired for natural resources purposes cannot be used for other purposes or otherwise disposed of except by laws enacted by a two thirds vote in the state legislature. Article 97 Approval is not anticipated to be required for the removal of the PPD since dam removal would not change the land use as it would remain as land held for environmental management purposes and as conservation land.

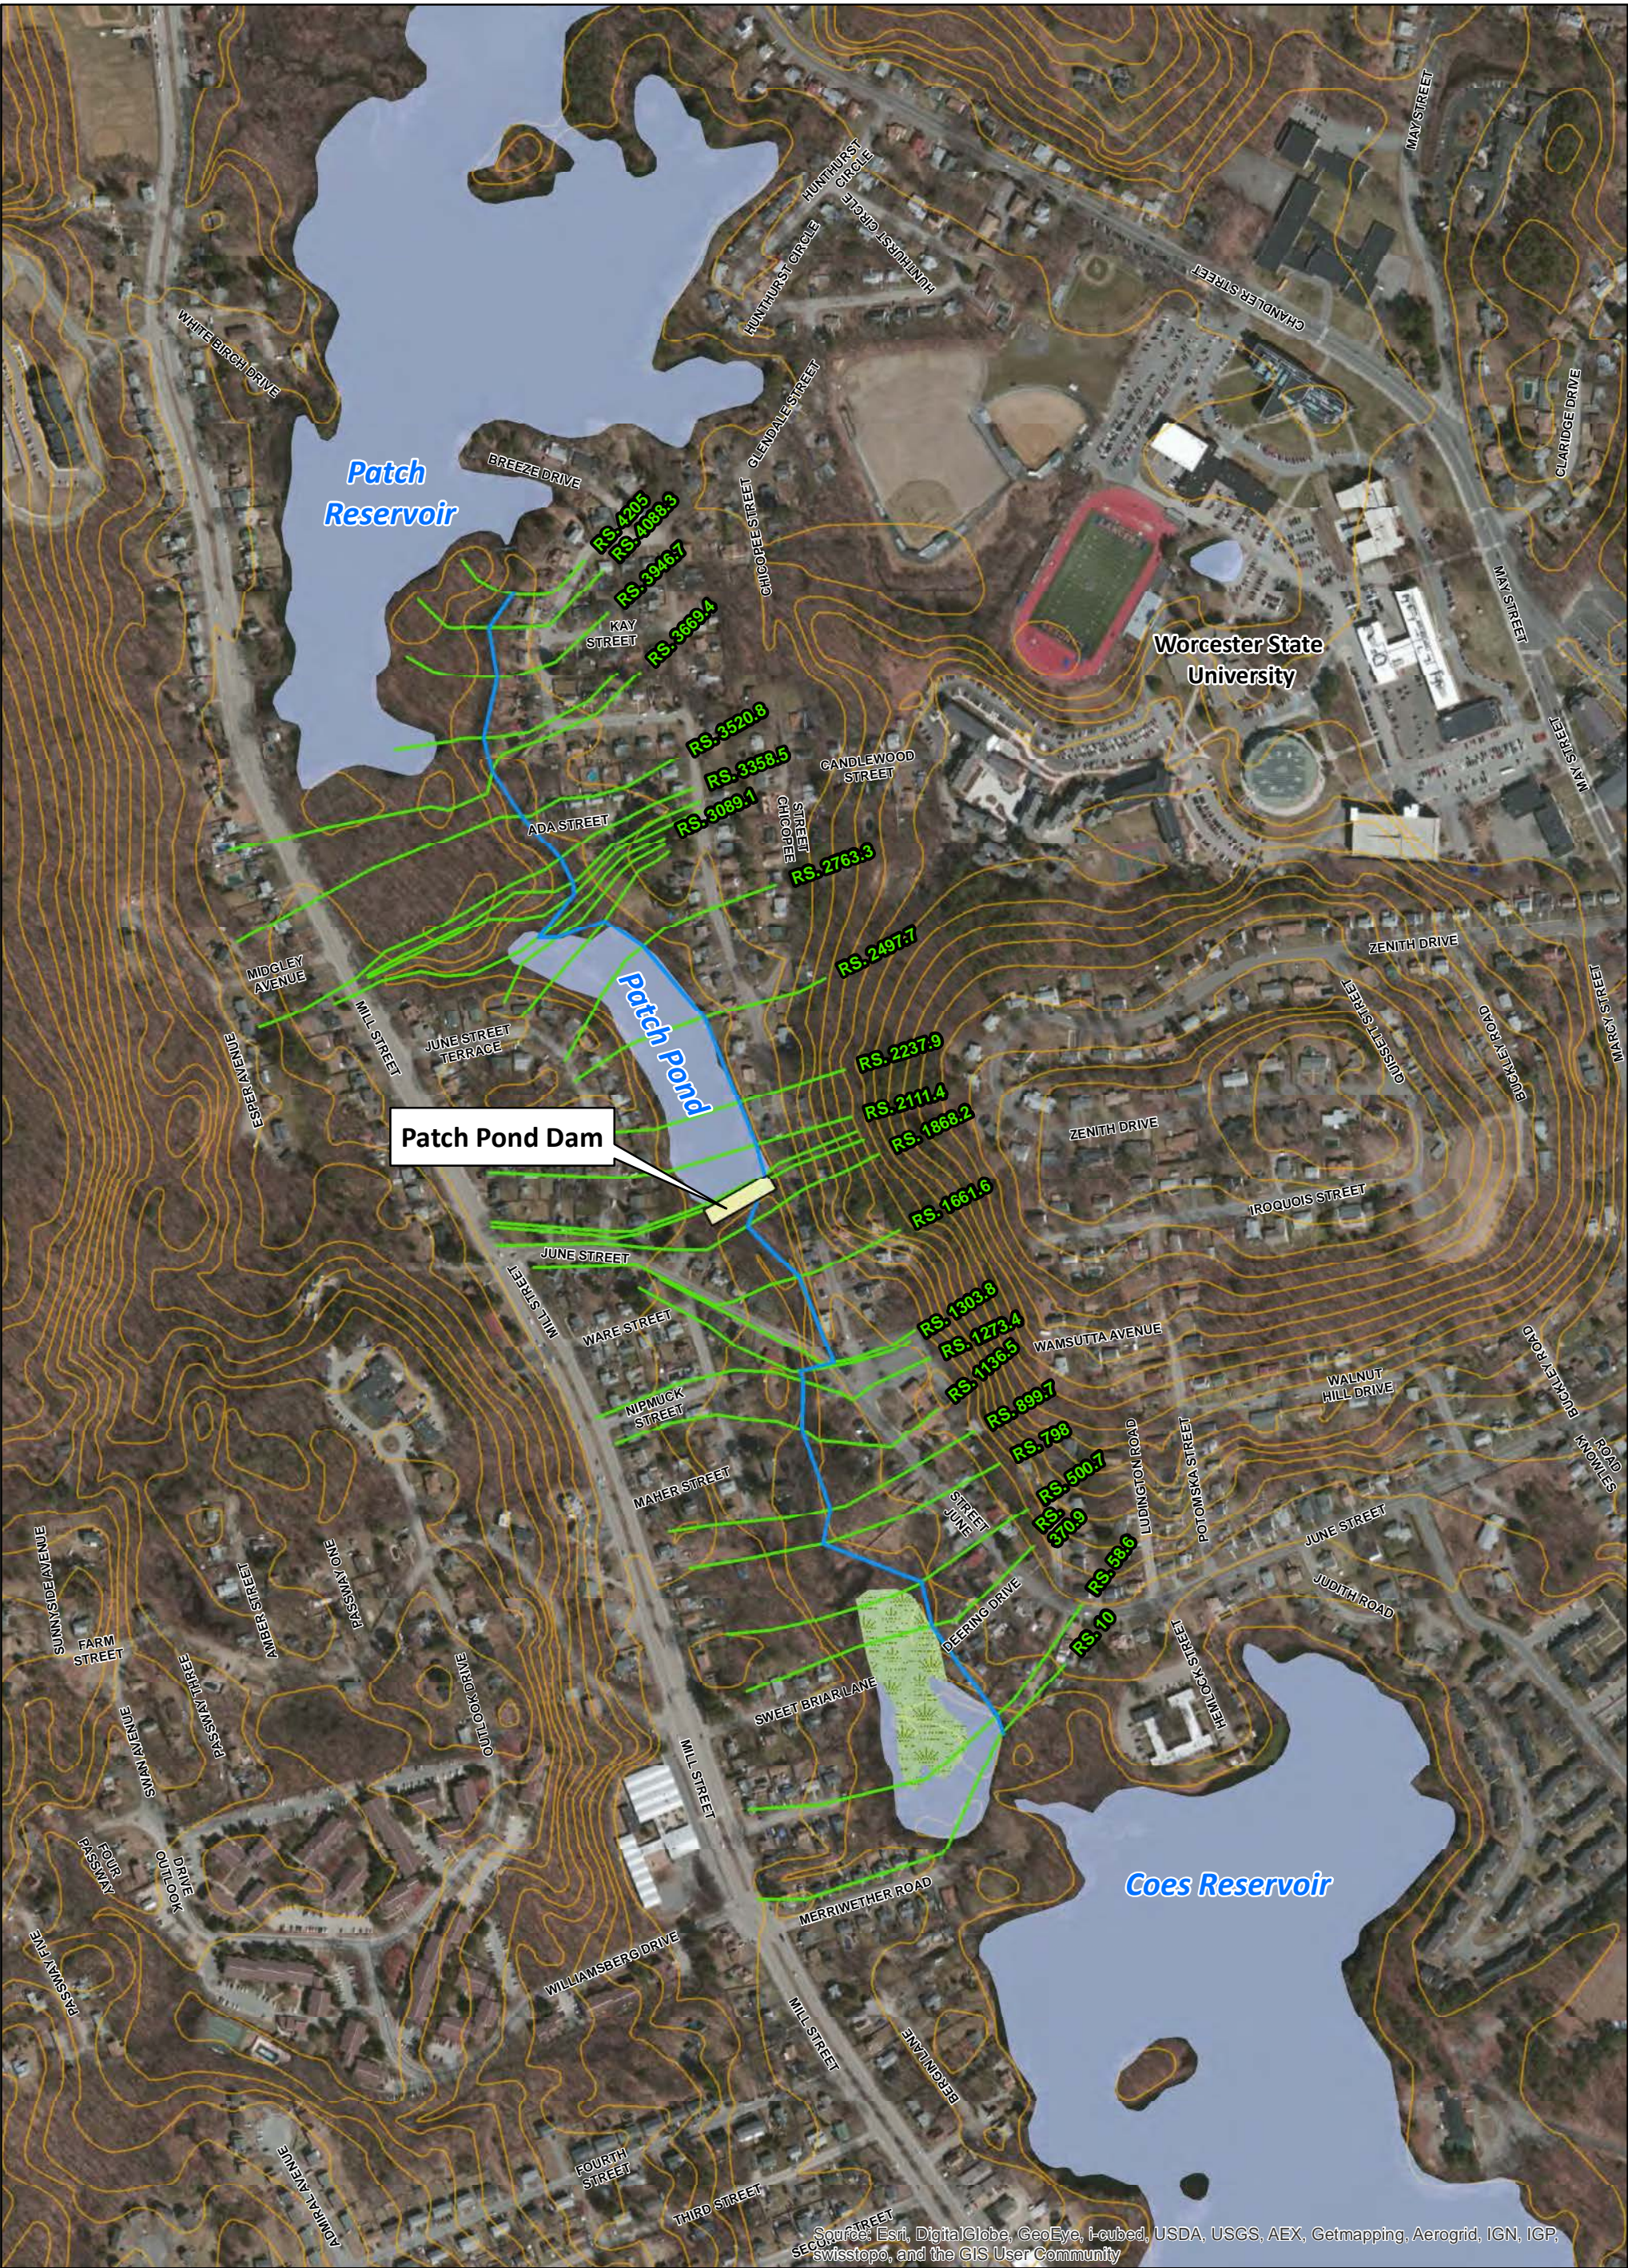
Manning's roughness was used for energy loss calculations. In each cross section, roughness coefficients were assigned to the main channel defined by the bank stations selected from cross section geometry and the left and right banks. Manning's roughness coefficient for the main channel is 0.065 based on the associated coefficients described FEMA's Flood Insurance Study (FIS) of the area. The overbank Manning's coefficients were set at $n = 0.1$.
