**Roxbury Trial Court
Roxbury, MA**

**HVAC SYSTEM
EVALUATIONS
COVID-19**

Office of Court Management

February 25, 2022

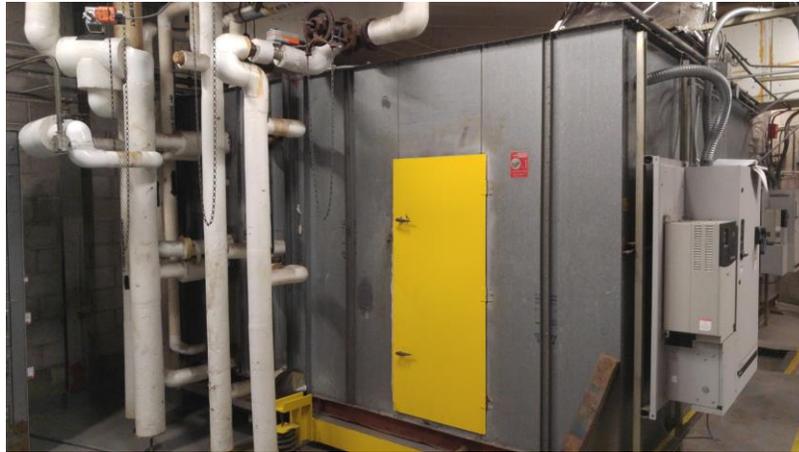
Photo 1 – Representative Air Handler

The four AHU's in the penthouse mechanical room each have a preheat hot water coil, chilled water coil, reheat hot water coil, and supply fan, as well as return and outside air dampers. Each AHU has an associated external return air fan and exhaust air damper. The AHU's are generally in poor condition. The return air fans are in fair condition. The AHU's are original to the building. In 1993, the preheat coils were added to the AHU and control improvements were made to convert the AHU's from constant volume to variable air volume (VAV) operation. On AHU's 2 and 3, the condensate drains have rusted through, which are an integral part of the metal enclosure. Fabricated trays have been set under the units to contain the condensate leakage, but do not address air leakage. The reheat coils are in very poor condition and appear to be original. The damper actuators are generally in good condition, and the dampers are in fair condition.

These air handlers are original to the building and have exceeded their expected service life. While the dampers and controls have been upgraded, the enclosures, coils, and fans have not. Consider replacing these units in the next three to five years.

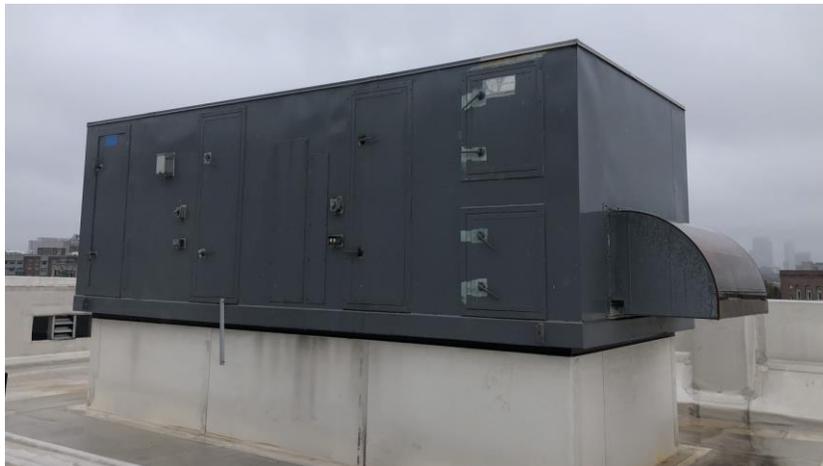
Photo 2 – Representative RTU

RTU-1 was installed in 1993 and was added to serve the lobby and other new areas along the northwest façade. The RTU has a preheat hot water coil, chilled water coil, supply fan, as well as return and outdoor air dampers. RTU-1 is in good condition and no issues were noted.

RTU-2 and RTU-3 were replaced in 2010 and serve the lockup areas on the third floor with 100% outdoor air. Each unit has a DX cooling coil, DX hot gas reheat coil, supply fan, and an indirect natural gas furnace. The units appear to be in very good condition.
