HISTORICAL DOCUMENTATION

**CARVER COTTON GIN COMPANY COMPLEX :
DAM AND RIVER RETAINING WALLS AND
BLACKSMITH SHOP AND HARDENING BUILDING**

East Bridgewater, Massachusetts

John J. Daly, Senior Industrial Historian
Michelle Johnstone, Assistant Architectural Historian
The Public Archaeology Laboratory, Inc. (PAL)
26 Main Street
Pawtucket, RI 02860
January 2018

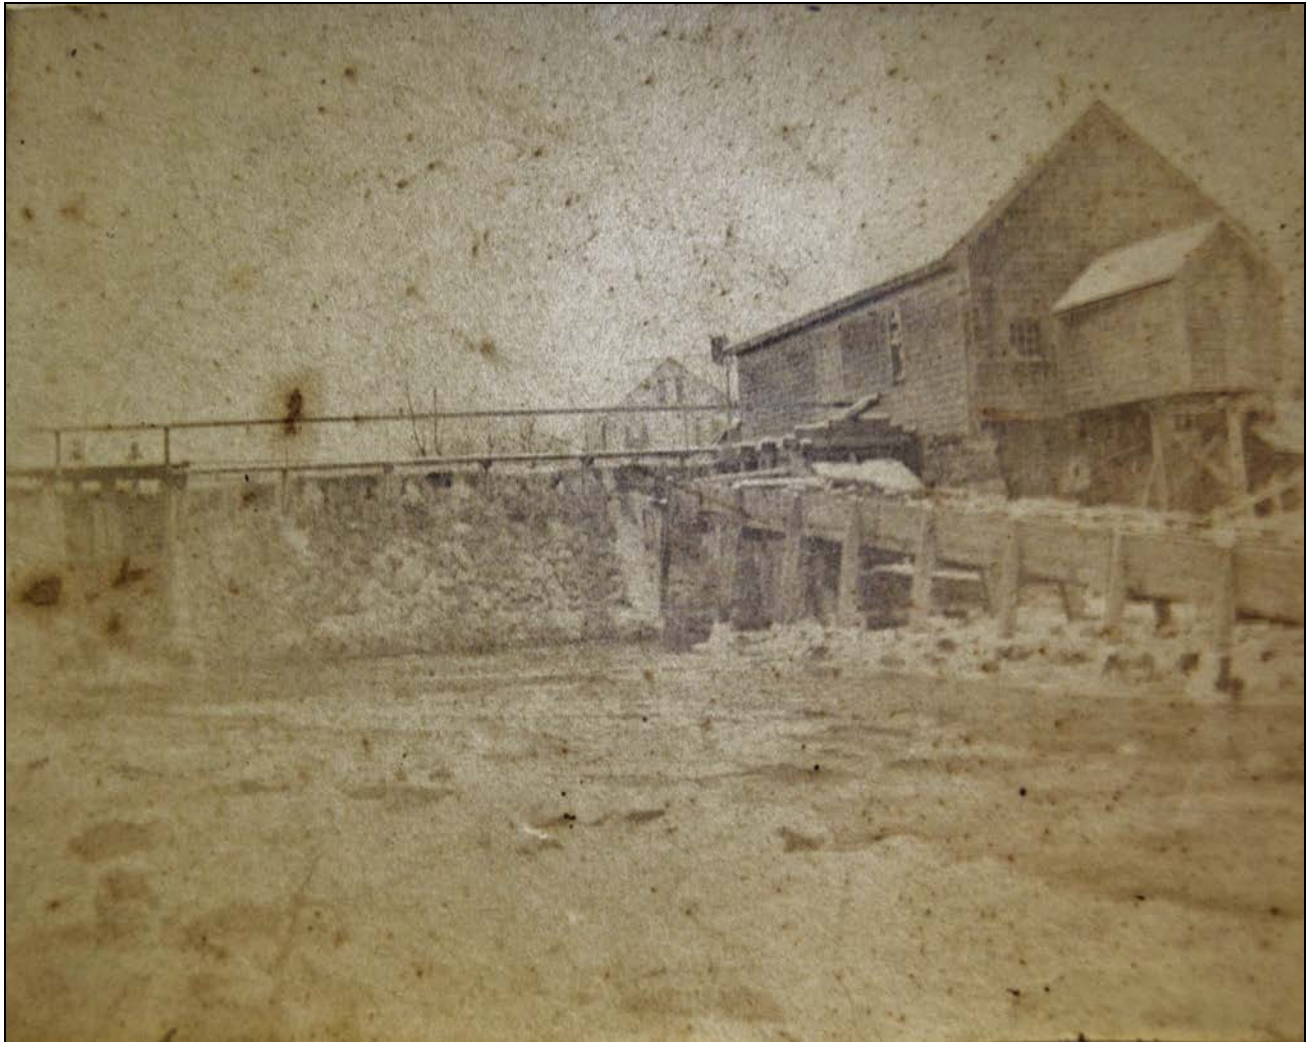
Pre-1890 photograph of the Carver Cotton Gin Company Dam, looking northeast (upstream) with shed or former sawmill and fish ladder at right (East Bridgewater Public Library collection).

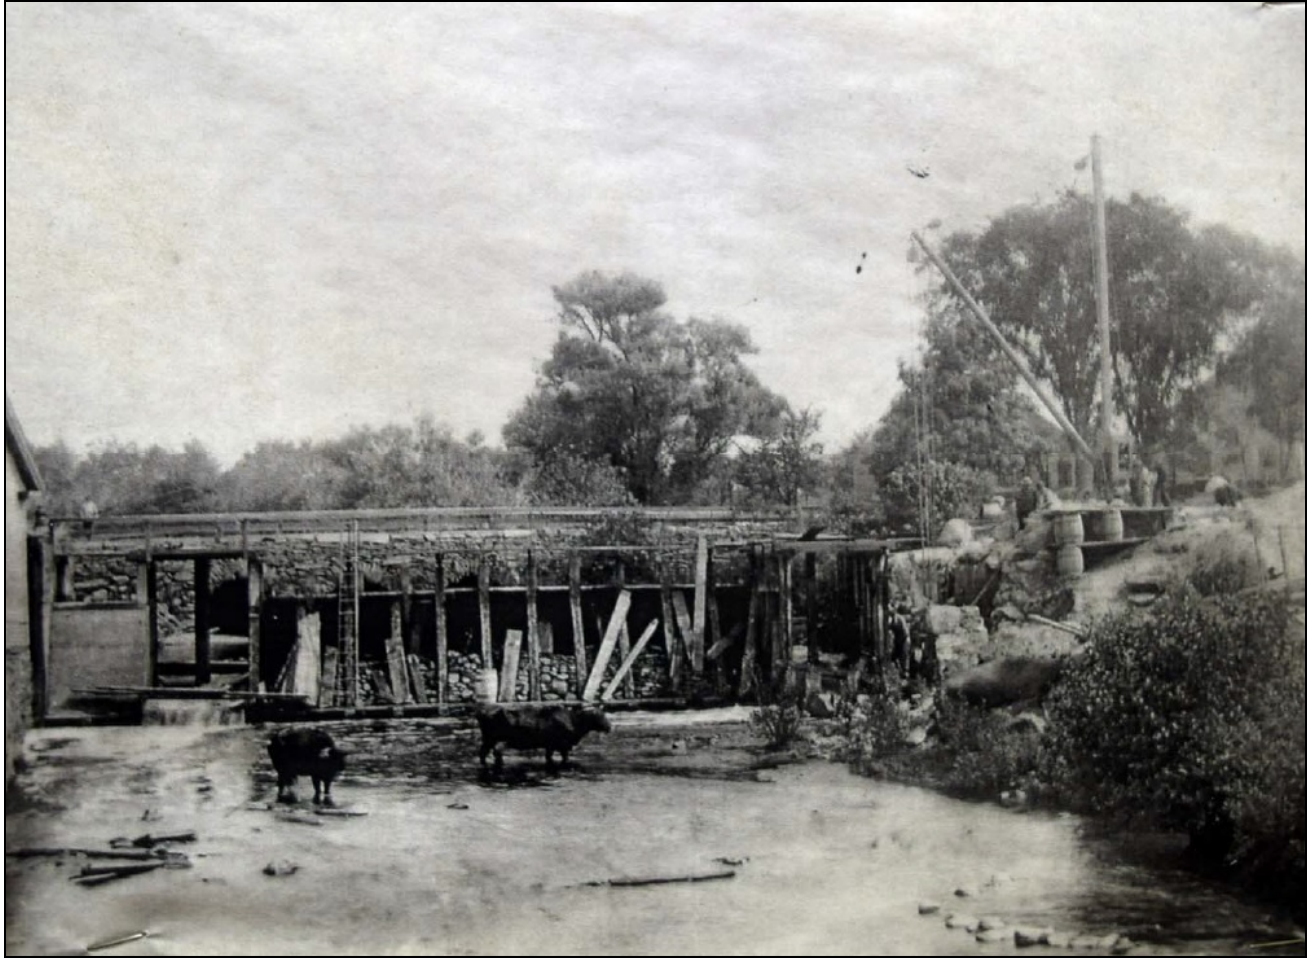
1890s photograph showing reconstruction of the Carver Cotton Gin Company Dam, looking northeast (upstream) (U-Store It company files).

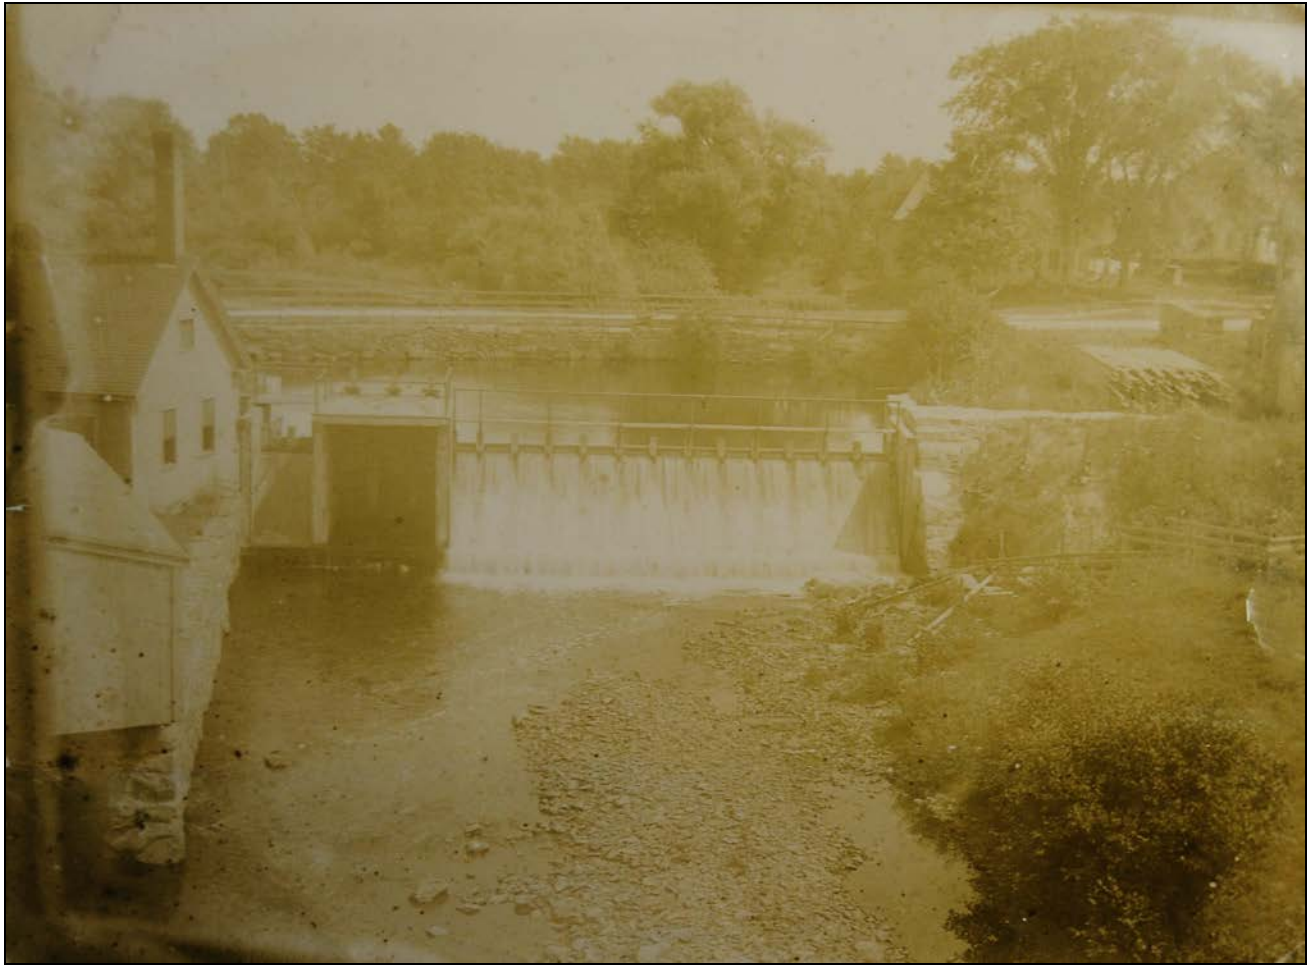
Photograph dating to between 1901 and 1906 showing Carver Cotton Gin Dam after rehabilitation, looking northeast (East Bridgewater Public Library collection).

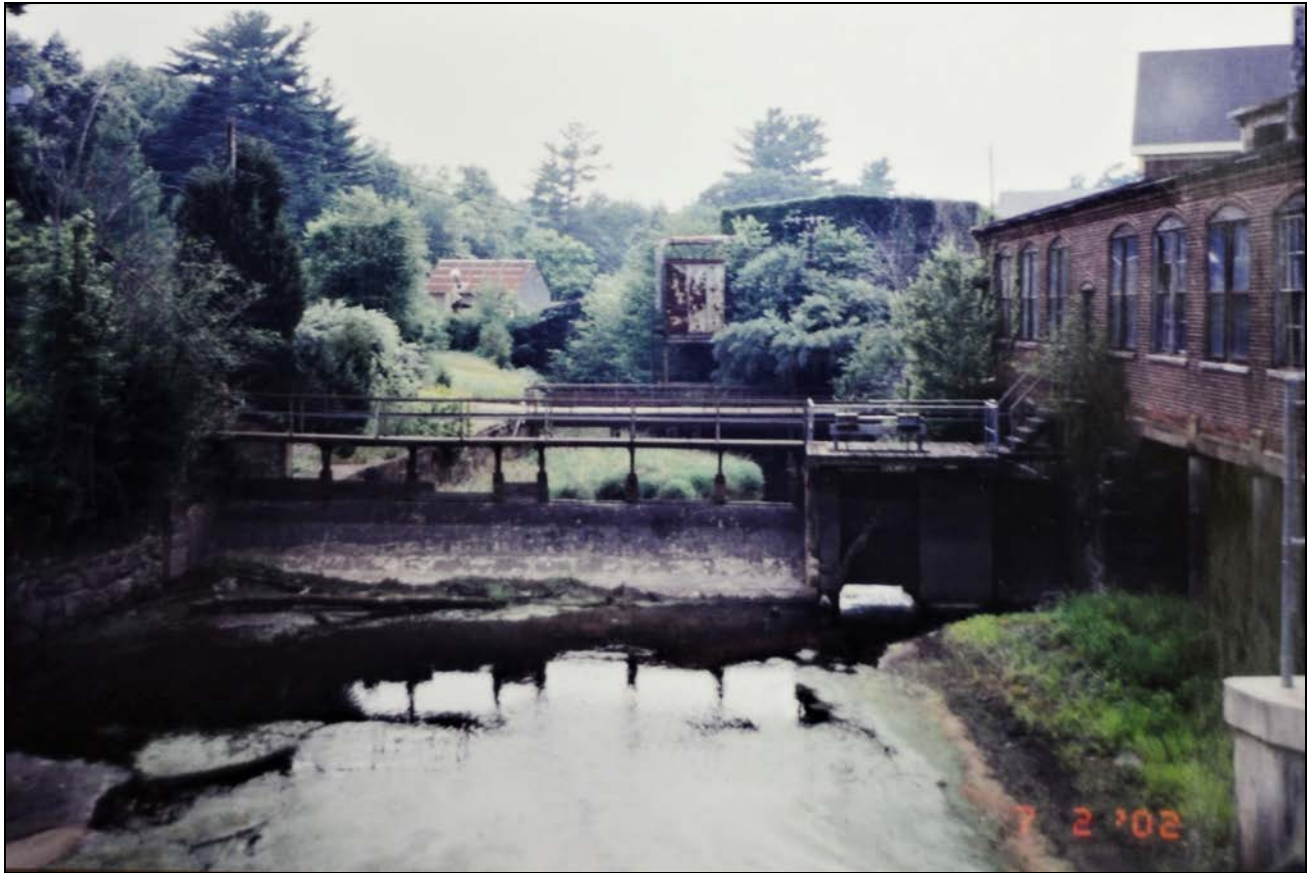
2002 photograph of the Carver Cotton Gin Dam, looking south (East Bridgewater Public Library collection).

A poured concrete sluiceway (built or rehabilitated in 1969) is set near the west end of the spillway and surmounted by a painted, rolled steel frame. The gate opening is 5.5 ft wide and 10 ft high and formerly housed two vertical-lift gate leaves. The gate leaves and operating mechanisms were removed in 2001; the gate stems remain in place. The year "1969" is inscribed into the concrete of the gate frame. A 12-inch iron water line (function unknown) runs through the foundation of the gate frame and extends into the river channel downstream of the Dam.

The spillway abutments are 6–12-inch-thick poured concrete walls integrated into the river training walls. The dam is in poor condition, and a portion of the spillway is collapsing.

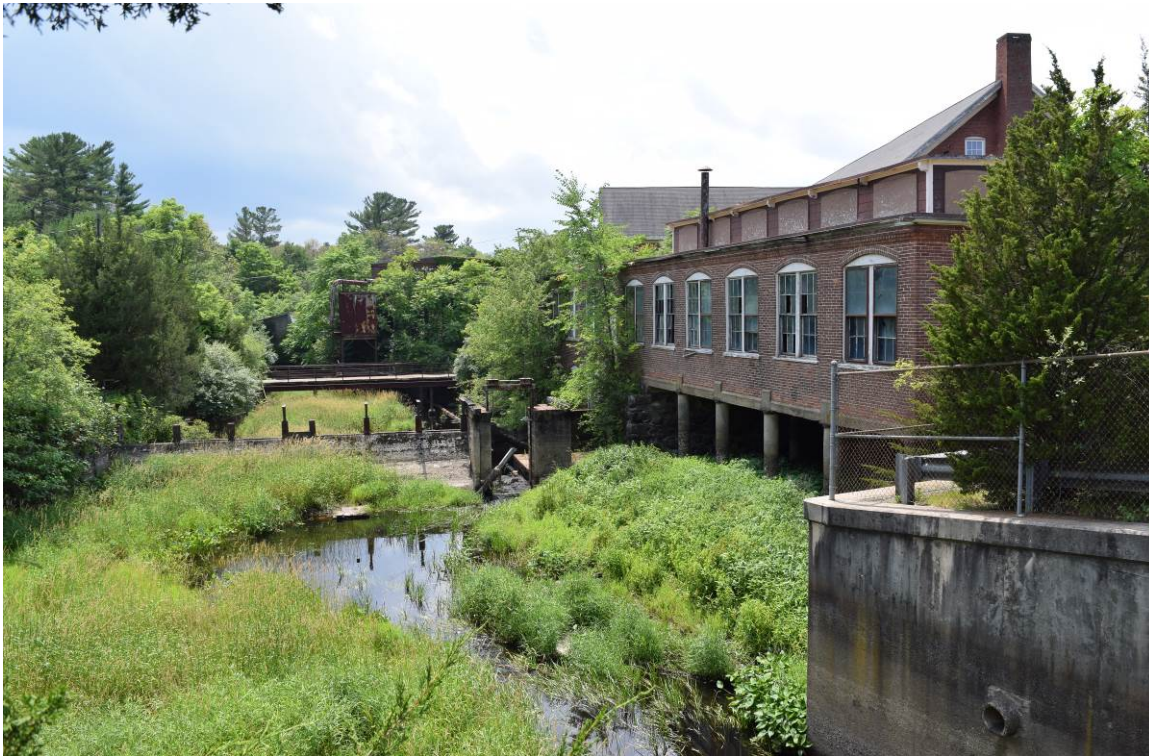
Photo 2. Carver Cotton Gin Co. Dam and Blacksmith Shop & Hardening Building, looking south.

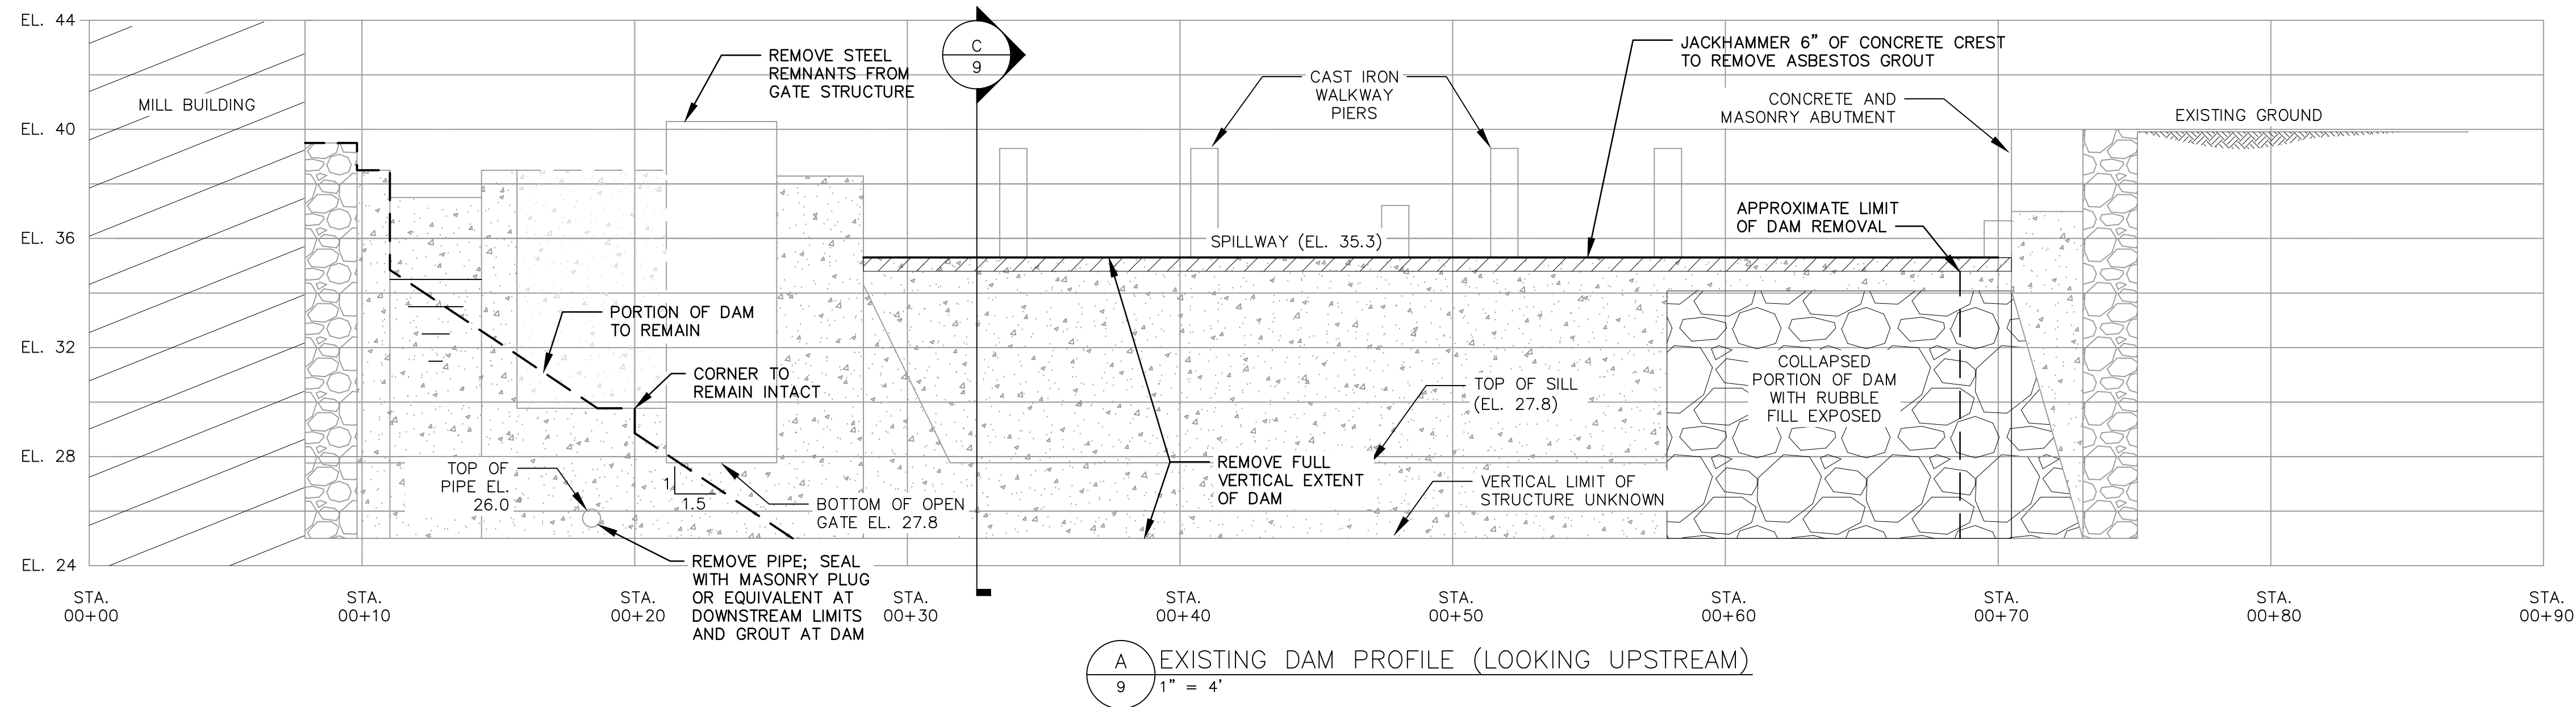
EXISTING DAM PROFILE AND ABUTMENT SECTIONS

- NOTES**
1. GEOMETRY AND EMBEDMENT DEPTHS OF STRUCTURES ARE BASED ON LIMITED INFORMATION AND ARE INTENDED TO BE SHOWN SCHEMATICALLY. THE CONTRACTOR SHALL CONFIRM ACTUAL DIMENSIONS IN THE FIELD.
 2. BASED ON GPR SURVEY OF THE DAM, TOP OF WEATHERED BEDROCK IS ANTICIPATED TO BE AT APPROX. EL. 17', AND TOP OF COMPETENT BEDROCK IS ANTICIPATED TO BE AT APPROX. EL. 11. REFER TO HAGER GEOSCIENCE, INC. AUGUST 13, 2015 REPORT FOR DETAILS.
 3. REMOVE EXISTING TIMBER FRAMING AND REPLACE WITH GROUT.
 4. GROUT IN THE VOID BETWEEN THE NON-OVERFLOW SECTION AND CONCRETE FACED ABUTMENT.

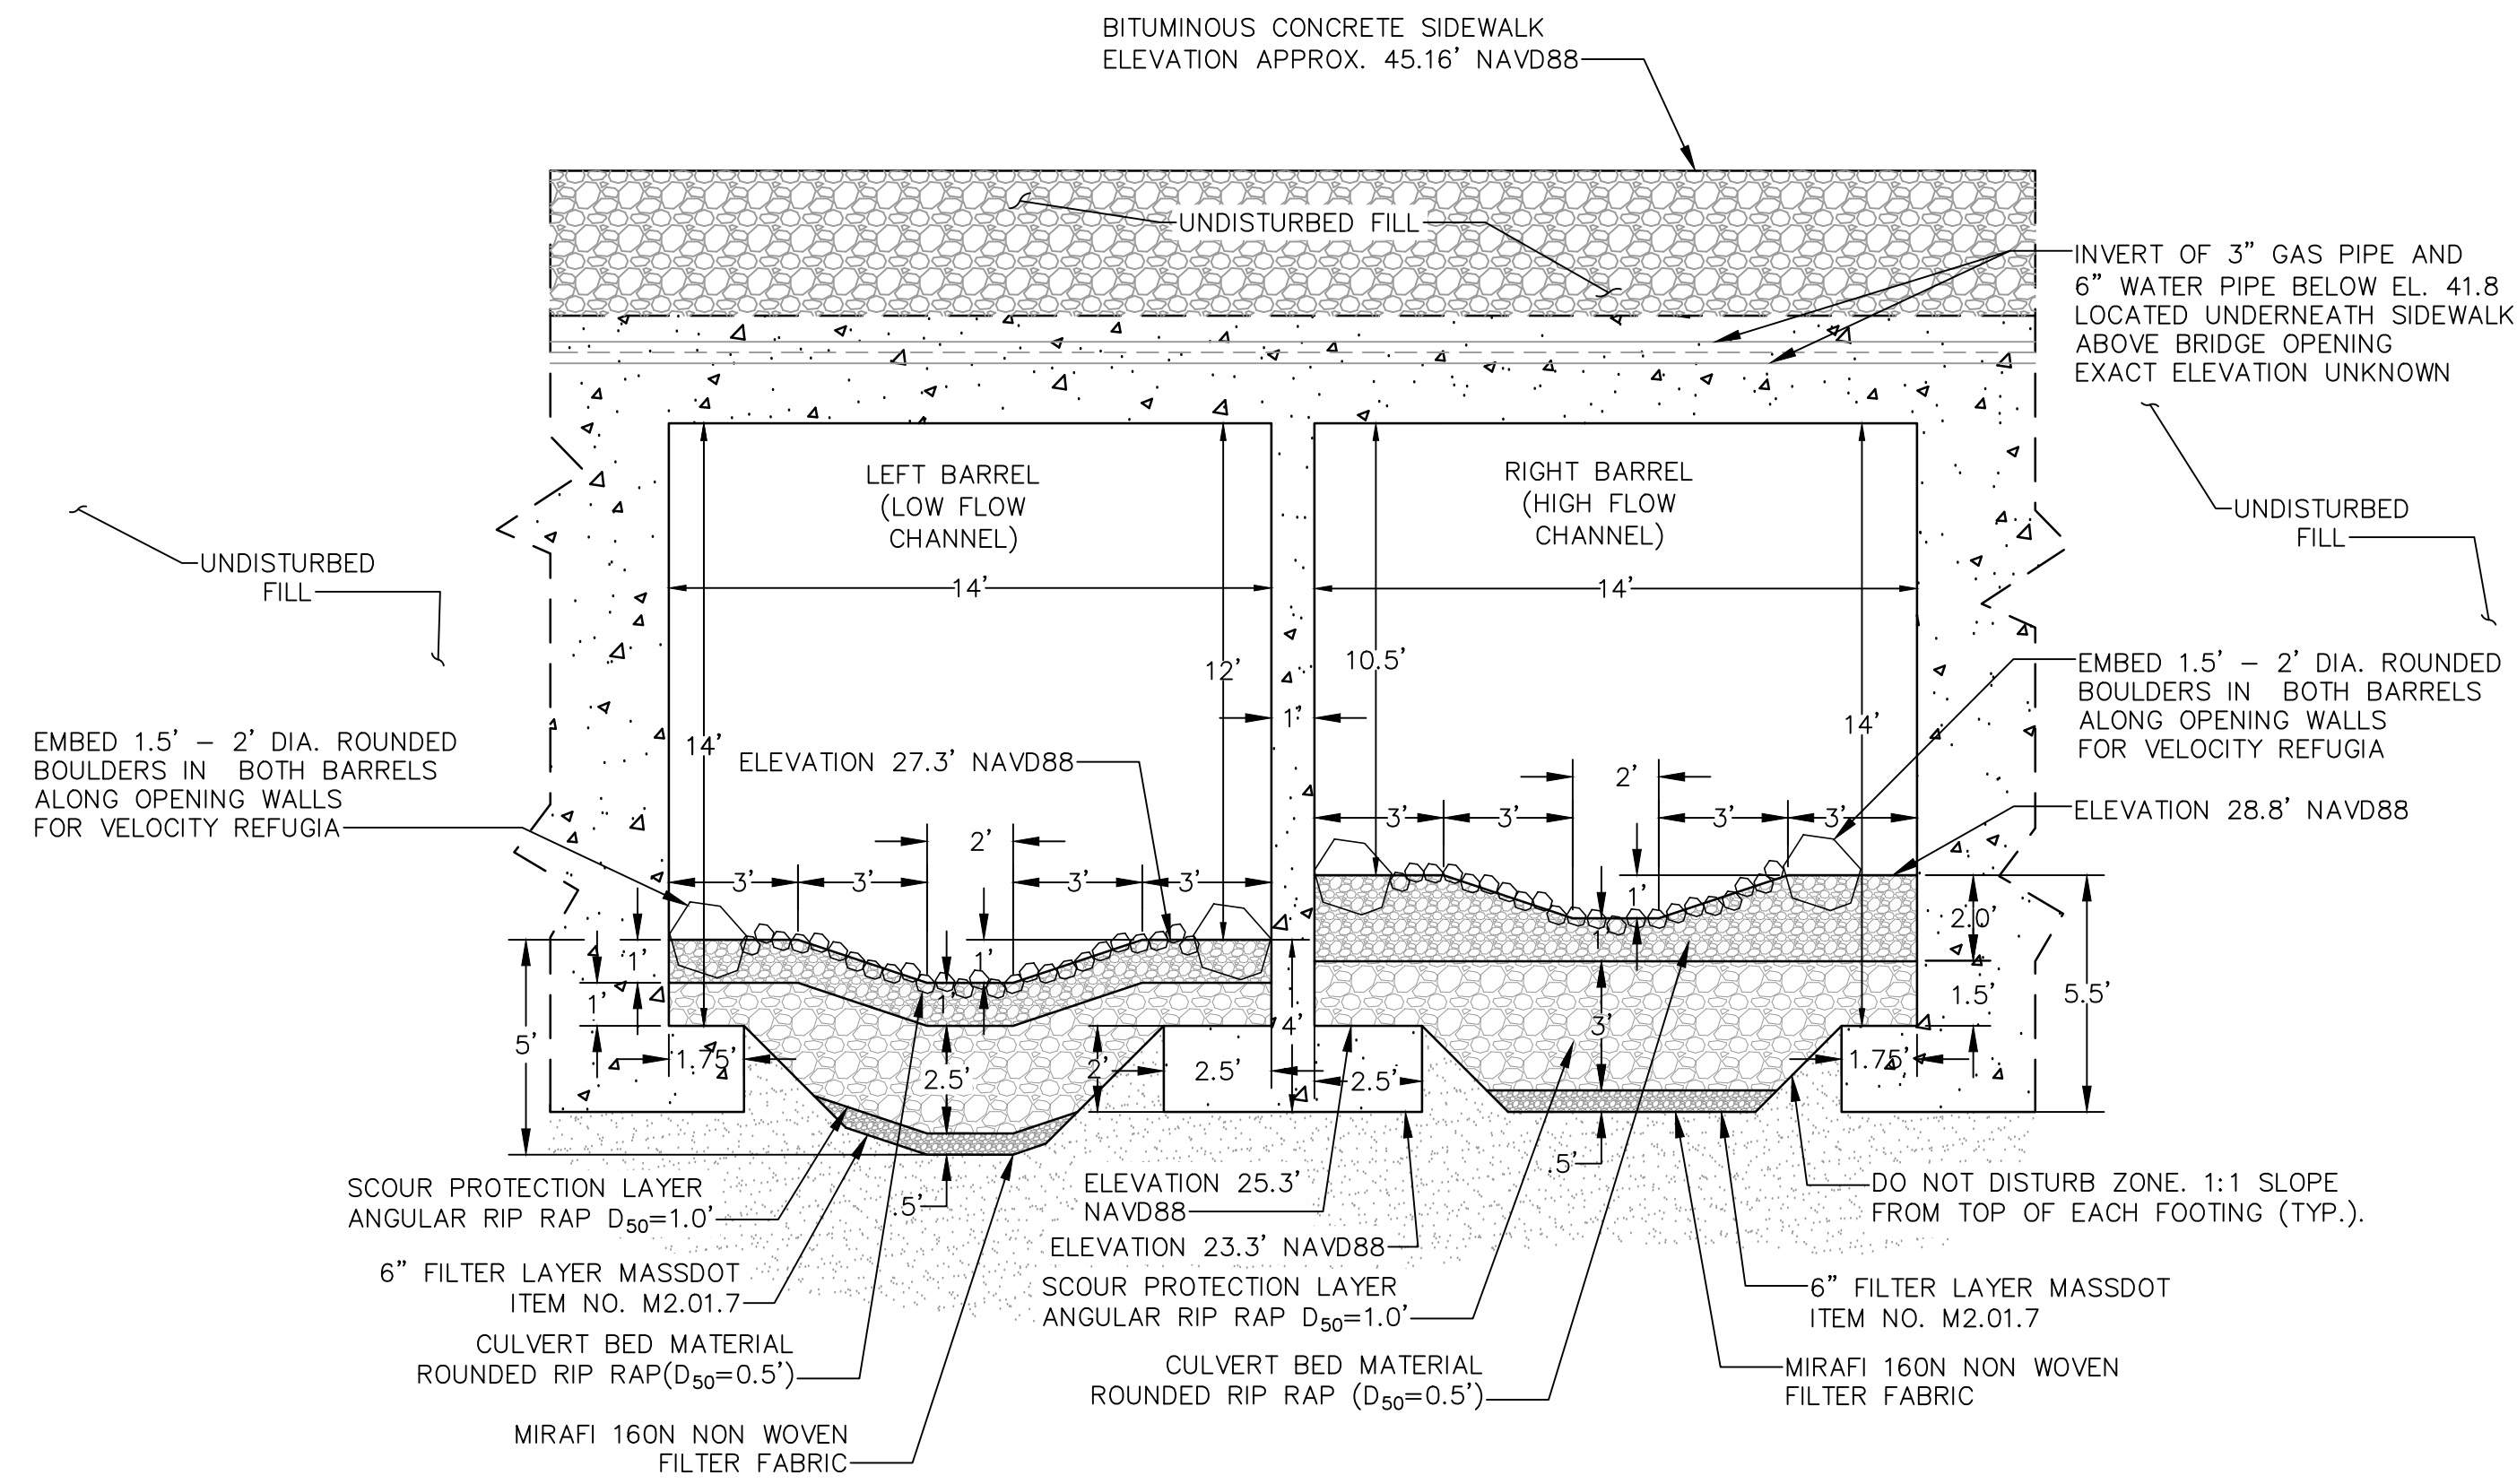
BRIDGE SECTION — LOOKING DOWNSTREAM

- DESIGN NOTES:
1. CULVERT BED MATERIAL IS SIZED BASED ON NEAR-BRIDGE SHEAR STRESSES AND THE ROSEN GRAIN SIZE VERSUS CRITICAL SHEAR STRESS FIGURES FOR THE 100-YEAR FLOW EVENT.
 2. THE COUNTERMEASURE WILL EXTEND 15 FEET UPSTREAM AND DOWNSTREAM OF THE BRIDGE.
