SHAWSHEEN RIVER WATERSHED 2000 WATER QUALITY ASSESSMENT REPORT

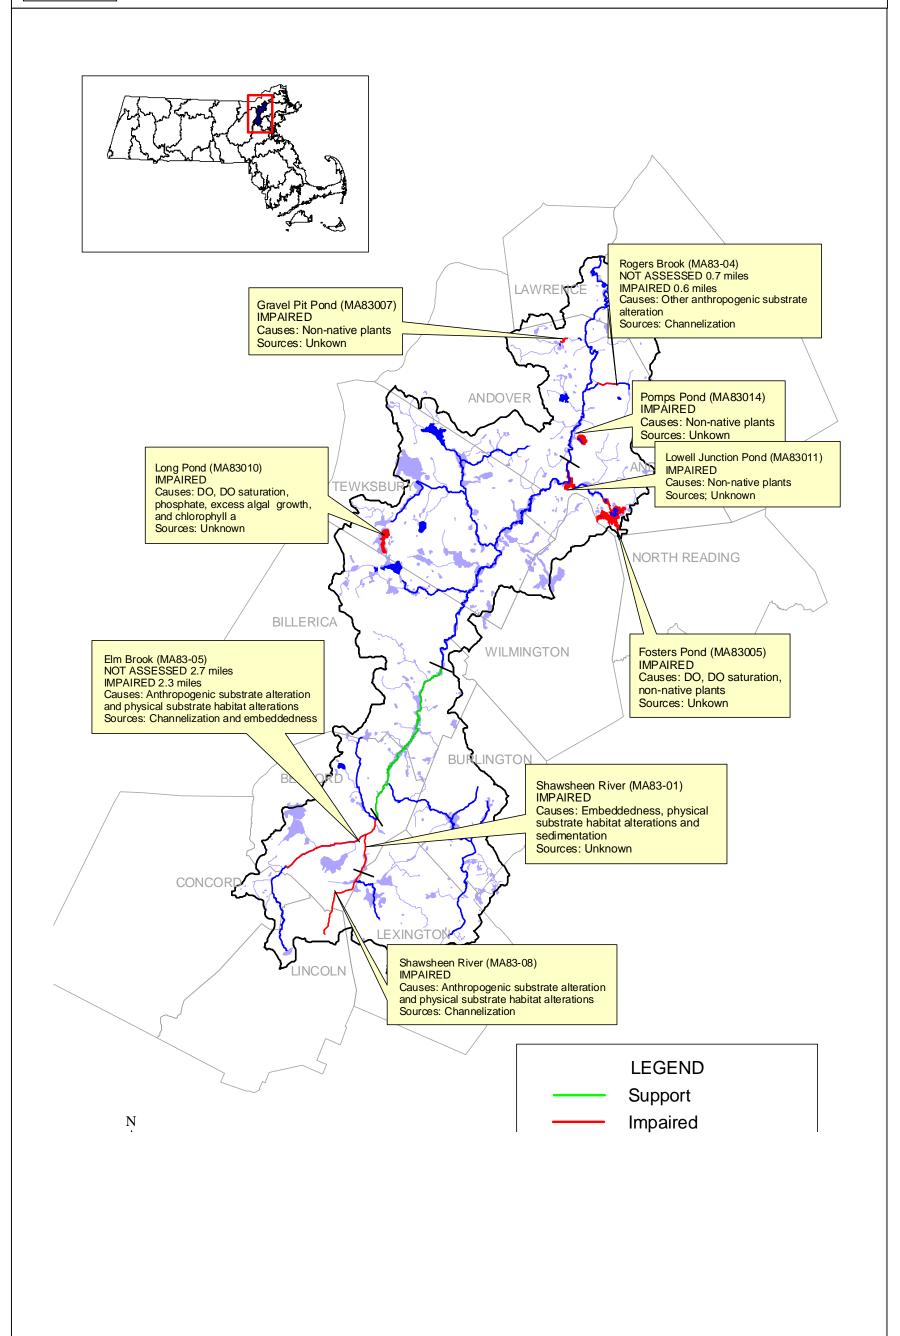
Figure 1. Shawsheen River Watershed Aquatic Life Use Assessment Summary – Rivers and Lakes.

SHAWSHEEN RIVER WATERSHED Aquatic Life Use Assessment Summary – Rivers and Lakes

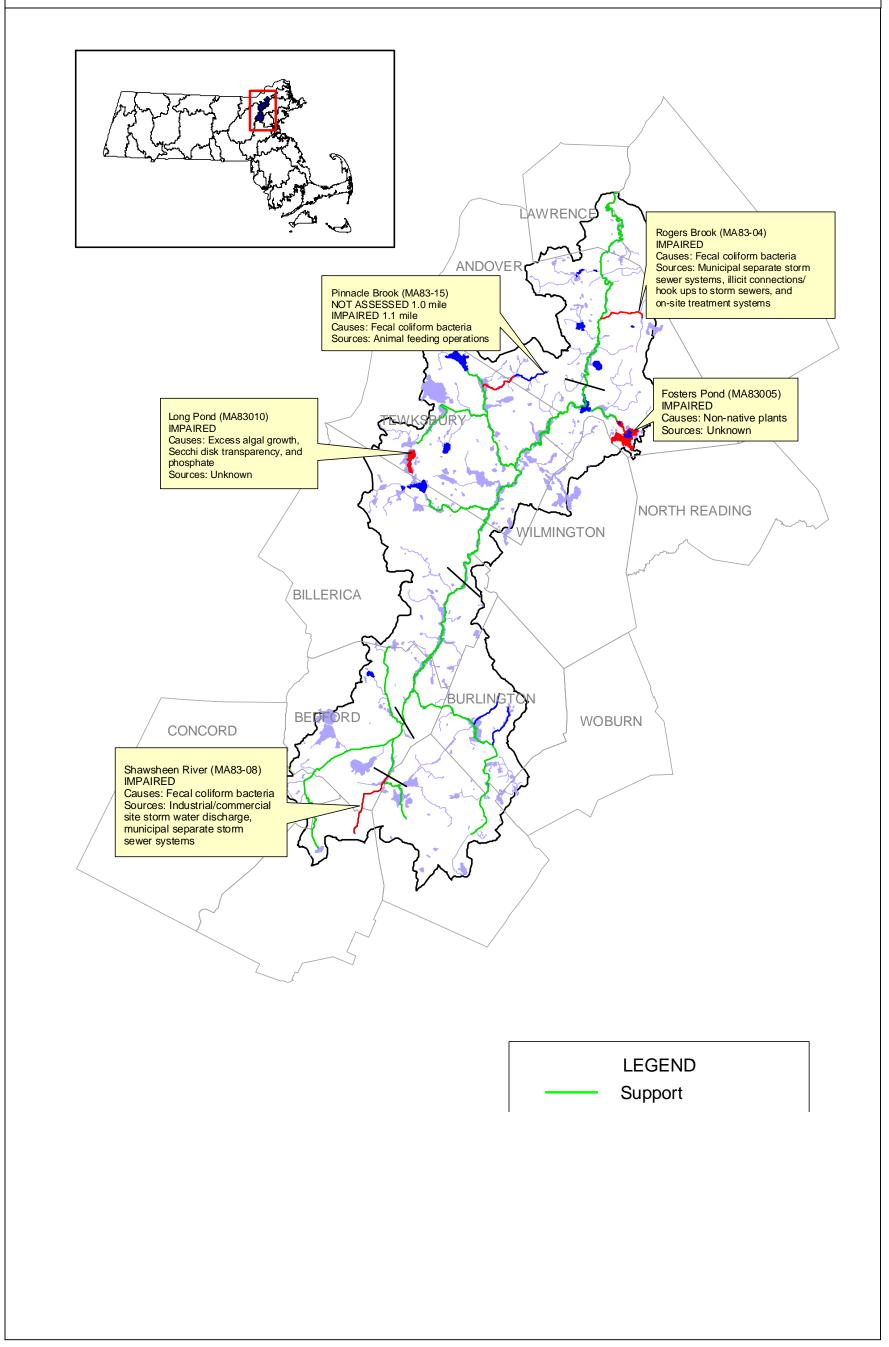
Figure 4. Shawsheen River Watershed Secondary Contact Recreational Use Assessment Summary – Rivers and Lakes.

Secondary Contact Recreational Use Assessment Summary – Rivers and Lakes

The majority of the river miles (86%) are assessed as support for the *Secondary Contact Recreational Use* (Figure 4). The lower 1.1 miles of Pinnacle Brook, all of Rogers Brook and the upper 2.1 miles of the Shawsheen River (headwaters in Bedford) are assessed as impaired. Sources of impairment were primarily caused by elevated levels of fecal coliform bacteria. A total of 3.5 miles are currently not assessed for the *Secondary Recreational Use*. Only 0.5 miles of Rogers Brook was assessed as support for this use. The majority of the river miles (99%) are not assessed for the *Aesthetics Use* (Figure 5).

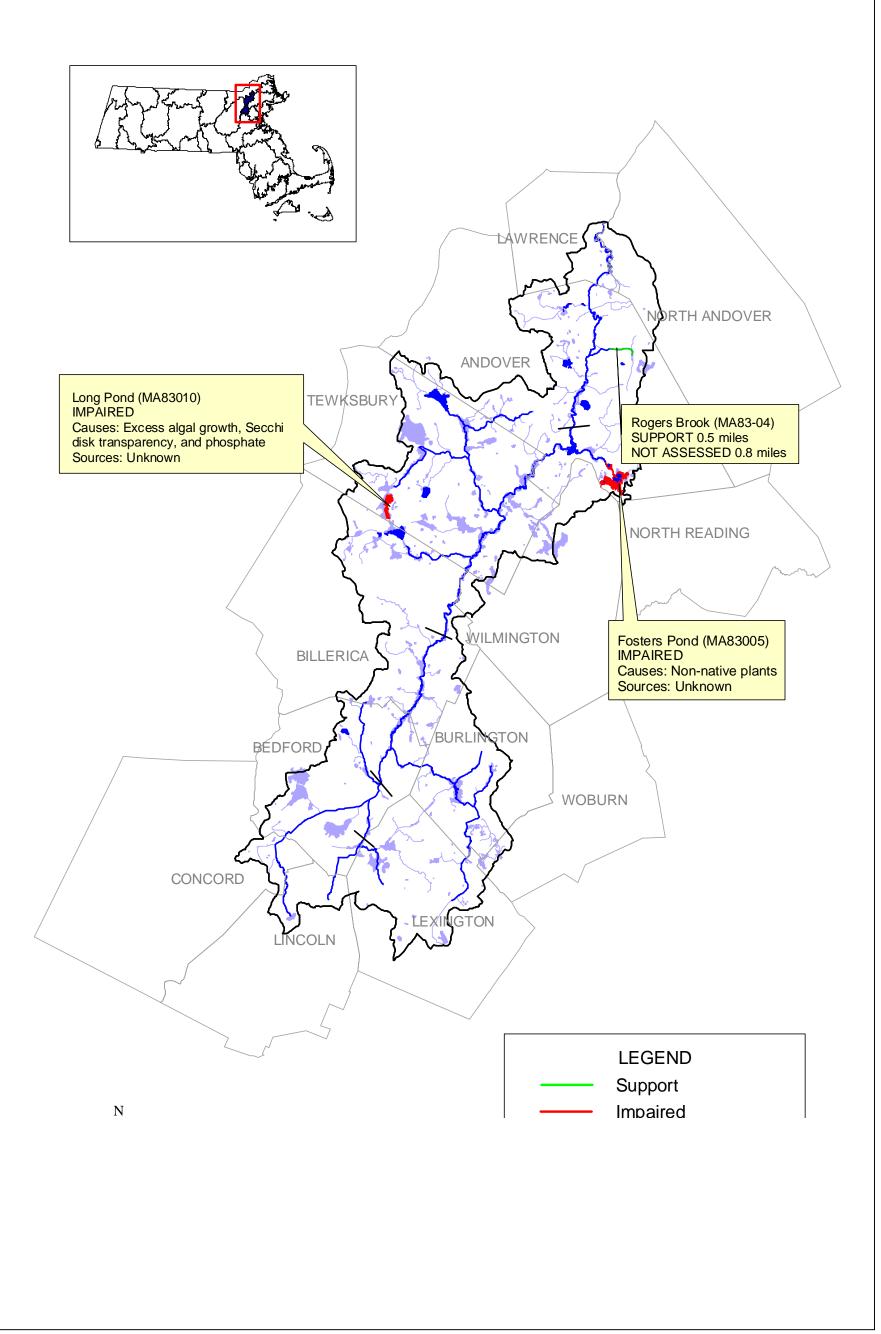
Figure 5. Shawsheen River Watershed Aesthetics Use Assessment Summary – Rivers and Lakes.

SHAWSHEEN RIVER WATERSHED Aesthetics Use Assessment Summary – Rivers and Lakes
