**Shelburne’s Community Compact – “Preparing For Success” Best Practice
August 17, 2017**

Name of Slum and Blight Area: Shelburne Falls

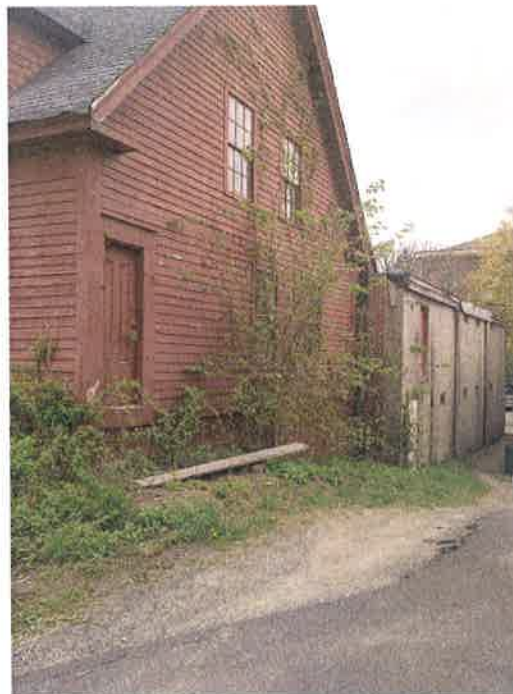
Address: 19-23 Bridge Street

<u>Component</u>	<u>Condition</u>
Roofing:	Asphalt shingles. 100% of the shingles are curling/broken and many are missing. 50% of flashing is falling off. POOR
Windows and Doors:	Windows are original. Most of the window trim is rotted. There are many broken windows with missing panes. Other windows are boarded up. POOR
Exterior Walls:	Some of the wood siding is split. There are is also asbestos siding which is peeling and crumbling. Over 50% of paint is peeling. POOR
Porch, Stairs, Deck:	Ramp to doorway is rotted. Cellar door is rotted. FAIR-POOR
Foundation:	Field stone, brick, and cinderblock foundation. The cinderblock is crumbling with loose bricks. FAIR
Storefront/Signage:	
Parking Lots:	
Other Conditions:	
Overall Property Rating:	POOR

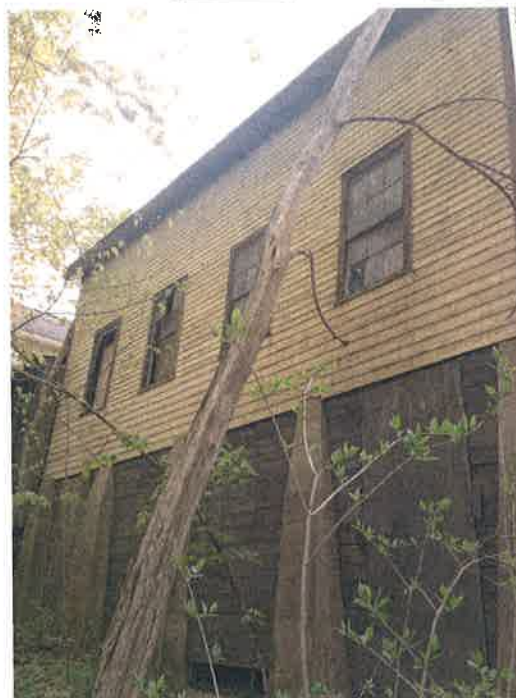
Roofing:	Slate roofing has 30% shingles that are cracked and loose. Fascia is rotting and in need of paint. FAIR-POOR
Windows and Doors:	Many broken windows (>50%). Garage doors are broken and rotted. Trim is rotting. POOR
Exterior Walls:	Bottom 25% of siding is rotted. Trim is missing in places. Paint is peeling and faded on 100% of walls. POOR
Porch, Stairs, Deck:	n/a
Foundation:	Concrete piers with wooding siding between. The wood is 75% rotted and falling down. FAIR-POOR
Storefront/Signage:	<input type="text"/>
Parking Lots:	<input type="text"/>
Other Conditions:	<input type="text"/>
Overall Property Rating:	<input type="text" value="POOR"/>

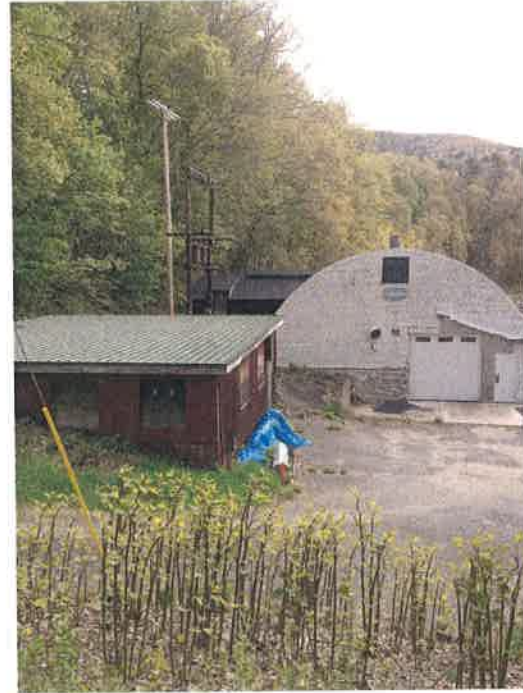
<u>Component</u>	<u>Condition</u>
Roofing:	Metal drip edge is rusty and curled. Asphalt tar paper is torn in places. FAIR-POOR
Windows and Doors:	All windows on one building are boarded up. FAIR
Exterior Walls:	Steel siding is rusting and and severely lifting away from exterior. Wood building has 100 paint peeling and at least 50% is rotting. POOR
Porch, Stairs, Deck:	n/a
Foundation:	Steel building is eroding on the river side. POOR
Storefront/Signage:	Faded and barely visible. POOR
Parking Lots:	50% of parking lot is cracked. POOR
Other Conditions:	
Overall Property Rating:	POOR
