**Somerville District Court
Somerville, MA**

**HVAC SYSTEM
EVALUATIONS
COVID-19**

Office of Court Management

October 7, 2021

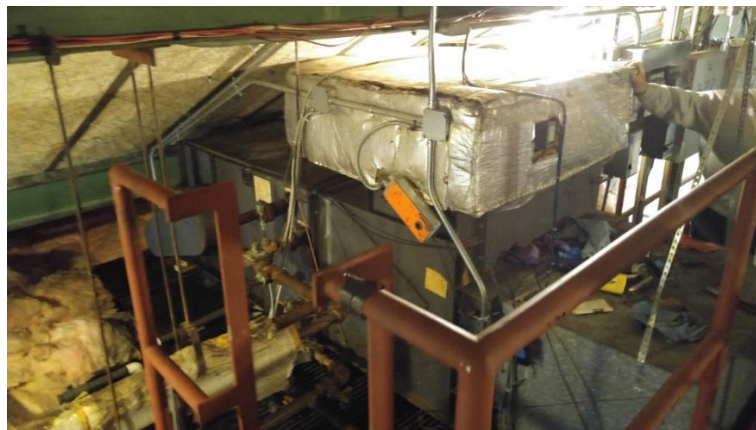
Photo 3: Representative Air Handler (AHU's 3 & 4).

AHU's 3 and 4 have a hot water coil, a chilled water coil, supply fan, return and outside air dampers, and a single exhaust fan and exhaust damper serving both units. These units each serve roughly half of the first floor, with the courtroom split between the two units. On AHU-3, the damper linkages appeared to be in working condition, but the setscrews were loose on the shafts, preventing the damper from operating.

Several AHU heating coils were found to be dirty. In some units it was noted that there was a small gap in the filter tray around the air filters, which causes increased dirt buildup on the coils. The cooling coils were not visible, but they should also be inspected, and cleaned if needed.

Replace dampers and actuators that are not functioning. In AHU's 1,2, and 3 damper issues were noted. Test all dampers and actuators for proper operation. Adjust, repair, or replace dampers as necessary.

Several air handlers showed signs of buildup on the coils. The hot water coils were visibly dirty. The cooling coils were not observed, but likely are also dirty. The coils should be cleaned to ensure the airflow and heating/cooling capacity can be maintained.

2.7.4 Replace AHU-3 and AHU-4

While still operational, these AHU's are approximately 50 years old and beyond their useful life. While the attic location makes replacement difficult, consider replacing these units and the associated exhaust fan in within the next three to five years. As part of this replacement project, consider using return fans instead of exhaust fans. Staff noted that pressurization and air balance is difficult with the current configuration, as the exhaust fan is not effective in returning air from the spaces. Consider the use of energy recovery and/or demand-controlled ventilation with any new system.

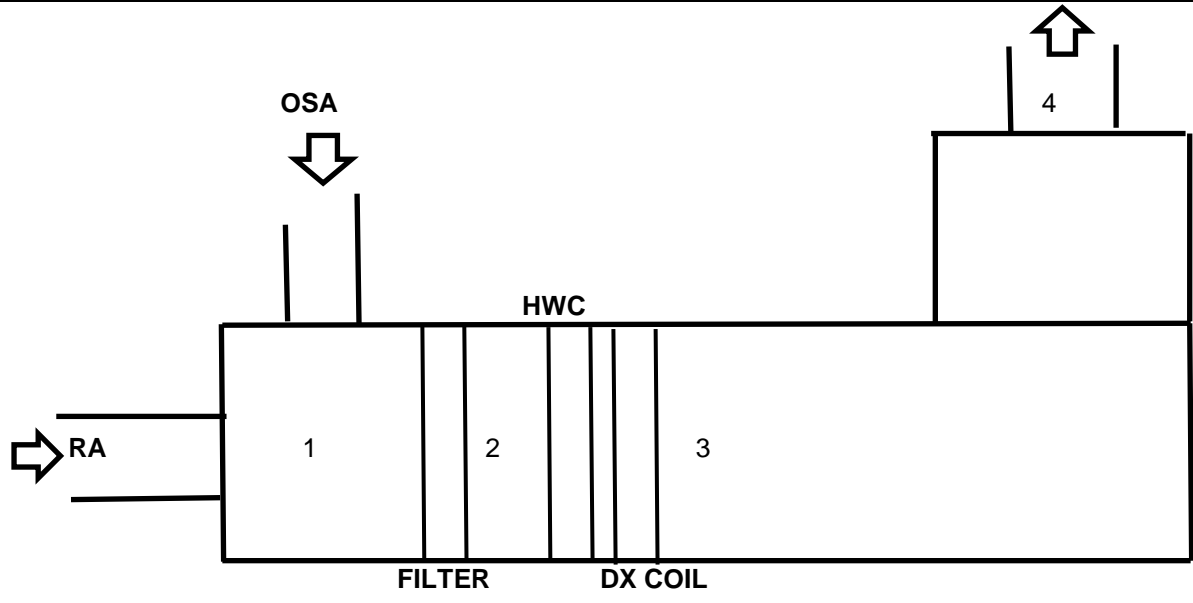
AHU-2 STATIC PROFILE

LOCATION	STATIC
1	-0.61
2	-0.8
3	-1.65
4	0.67
