## WATERSHED-BASED PLAN

### Southwest Branch Housatonic River and Richmond Pond

May 10, 2024

Berkshire Regional Planning Commission

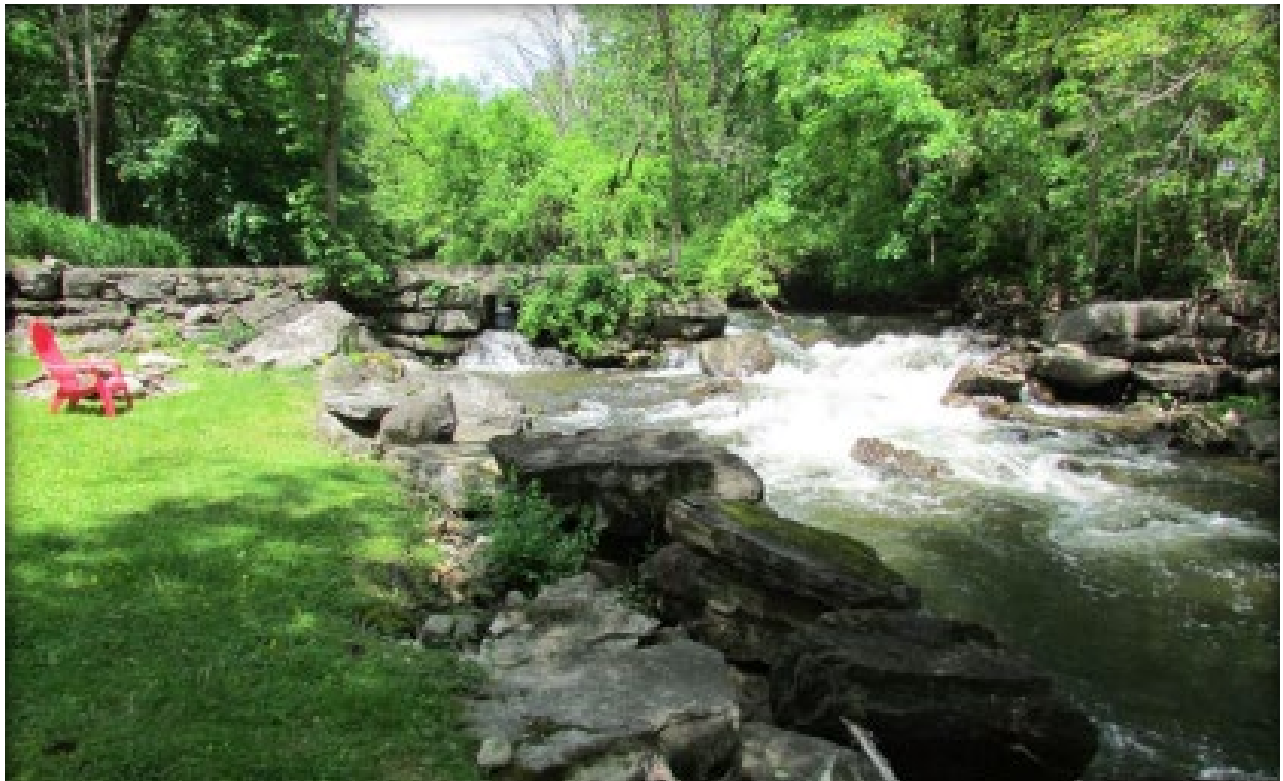
**Photo A-3: Breached dam on the SW Branch upstream of Rte. 20 Bridge near Hungerford Avenue (Photo by Diane Wetzel for HVA)**

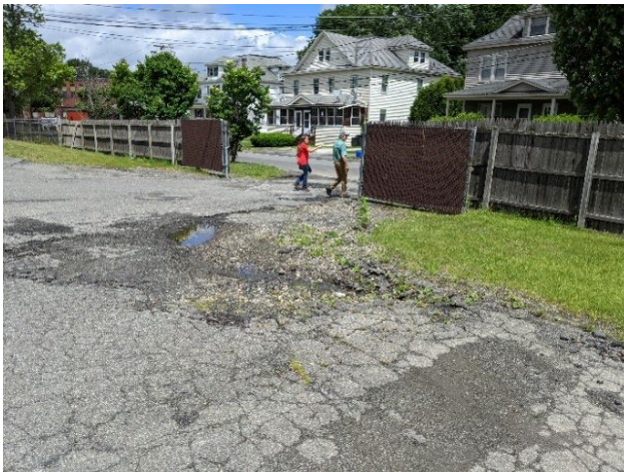
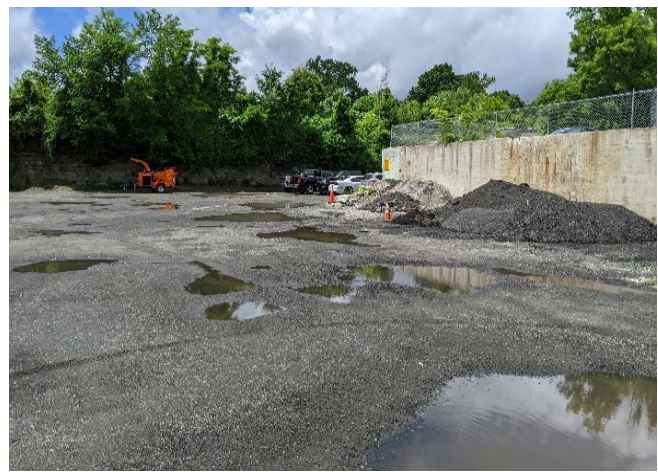
**Photos C-1: DPW site, West Housatonic Street, Pittsfield.** Upper photo shows the front parking lot where existing stormwater infrastructure could not be located. Bottom photo of parking lot entrance where asphalt is eroding and spalling.

In 2023, the city of Pittsfield received \$637,500 Long Island Futures Fund (LISFF) implementation funding to support this and another project. Completion of the final design and permitting is expected by May 2024 with construction expected to occur between August 2024 and October 2025. The City of Pittsfield will be responsible for ongoing maintenance of the installed BMPs.

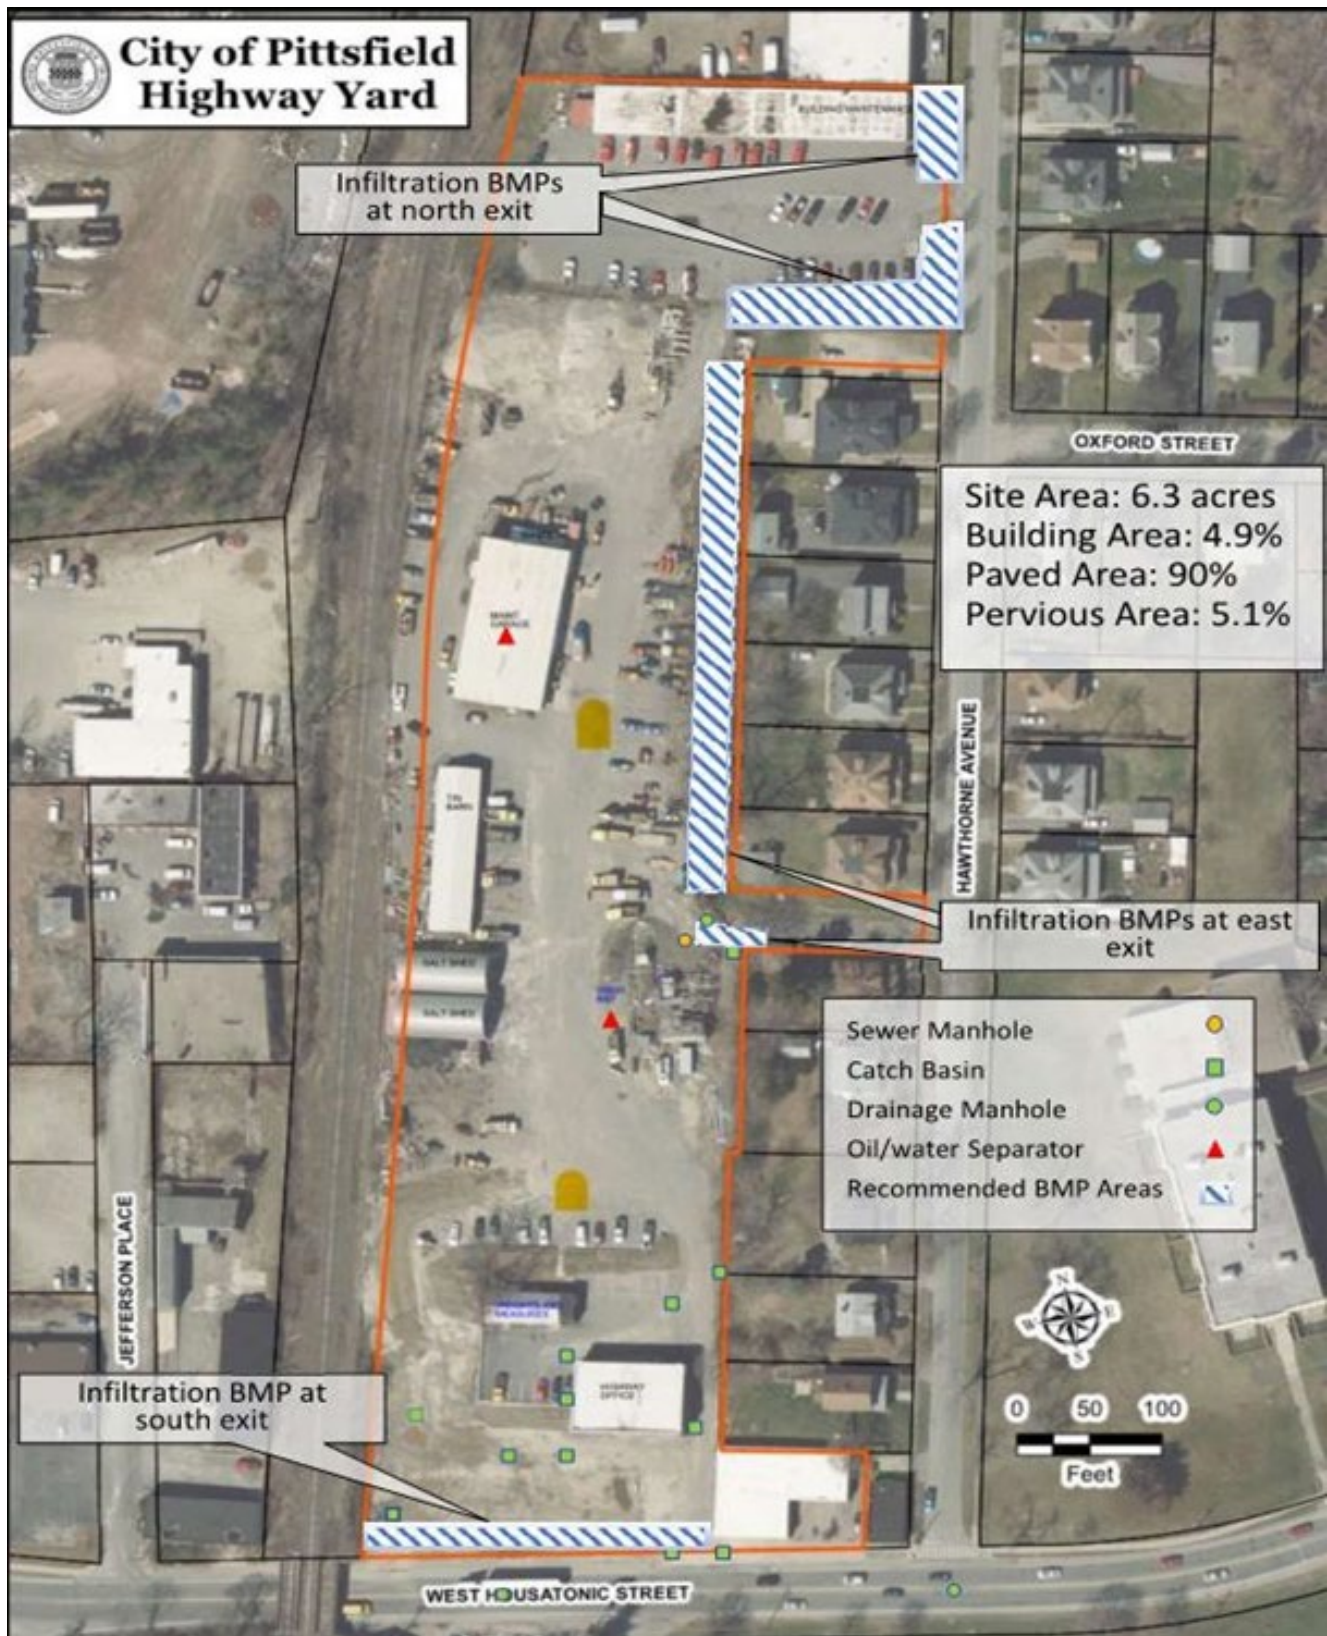
Figure C-2: City of Pittsfield, DPW site, 232 West Housatonic Street

- Total Suspended Solids: 0.94 tons/year
- Total Phosphorous 8.89 lbs/year
- Total Nitrogen 77.2 lbs/year

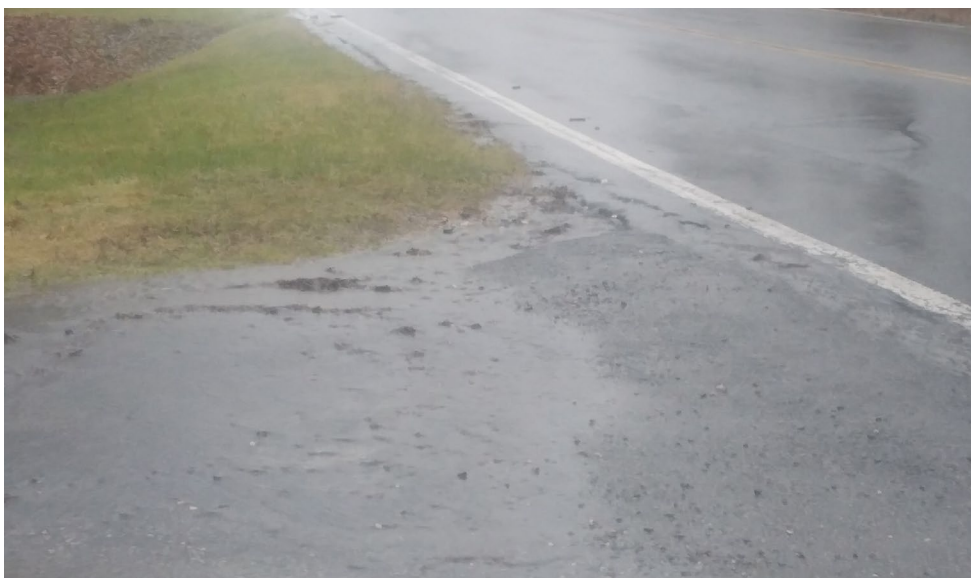
**Photo C-7: Driveway of 1161 West Street during recent storm**

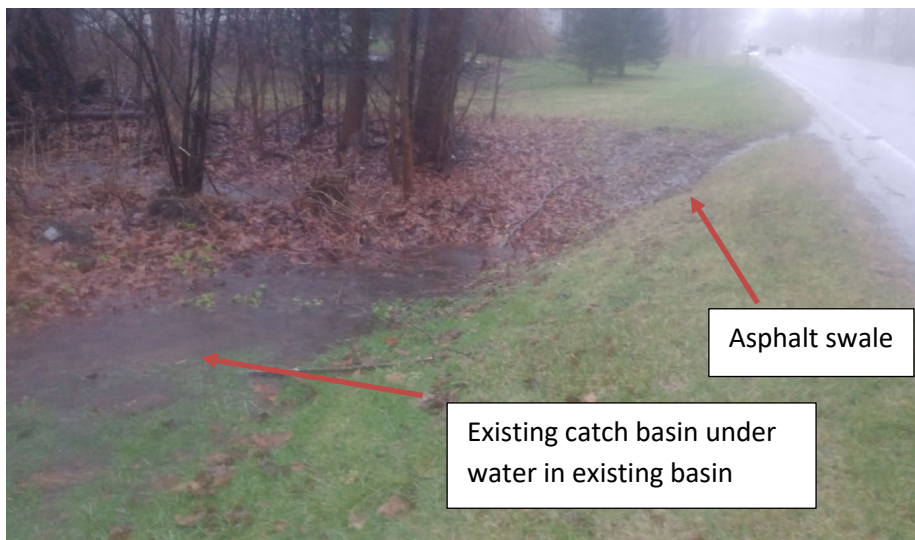
**Photos C-8: Looking west along West Street shows existing basin (left) and eroded drainage channel which has formed off flowing off the driveway next to outfall pipe on property of 1161 West Street**

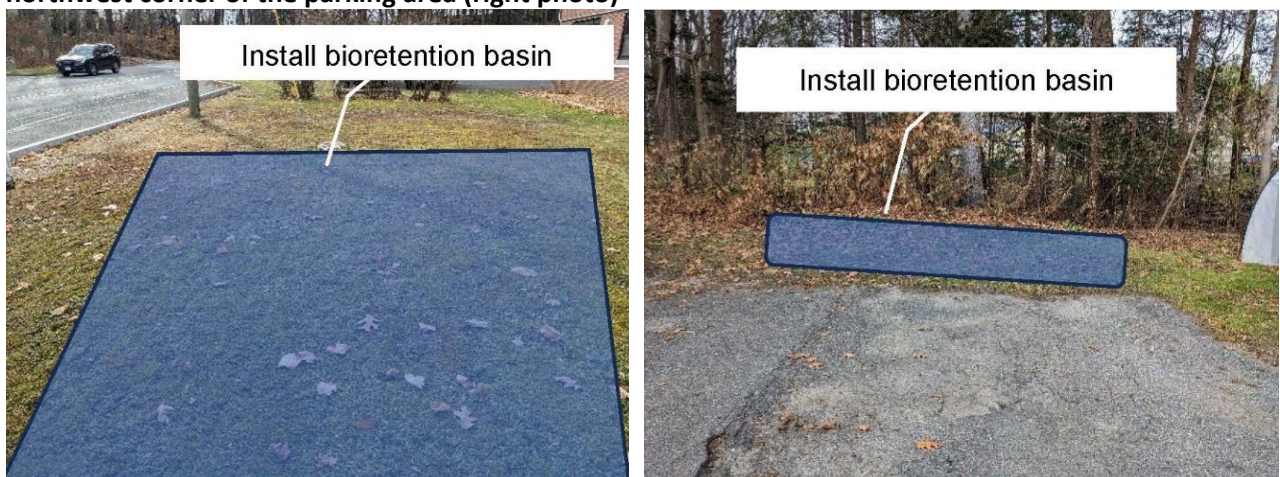
**Photos C-7: Pittsfield Fire Dept, BMP visuals: Bioretention basin along Barker Road (left photo) and the northwest corner of the parking area (right photo)**

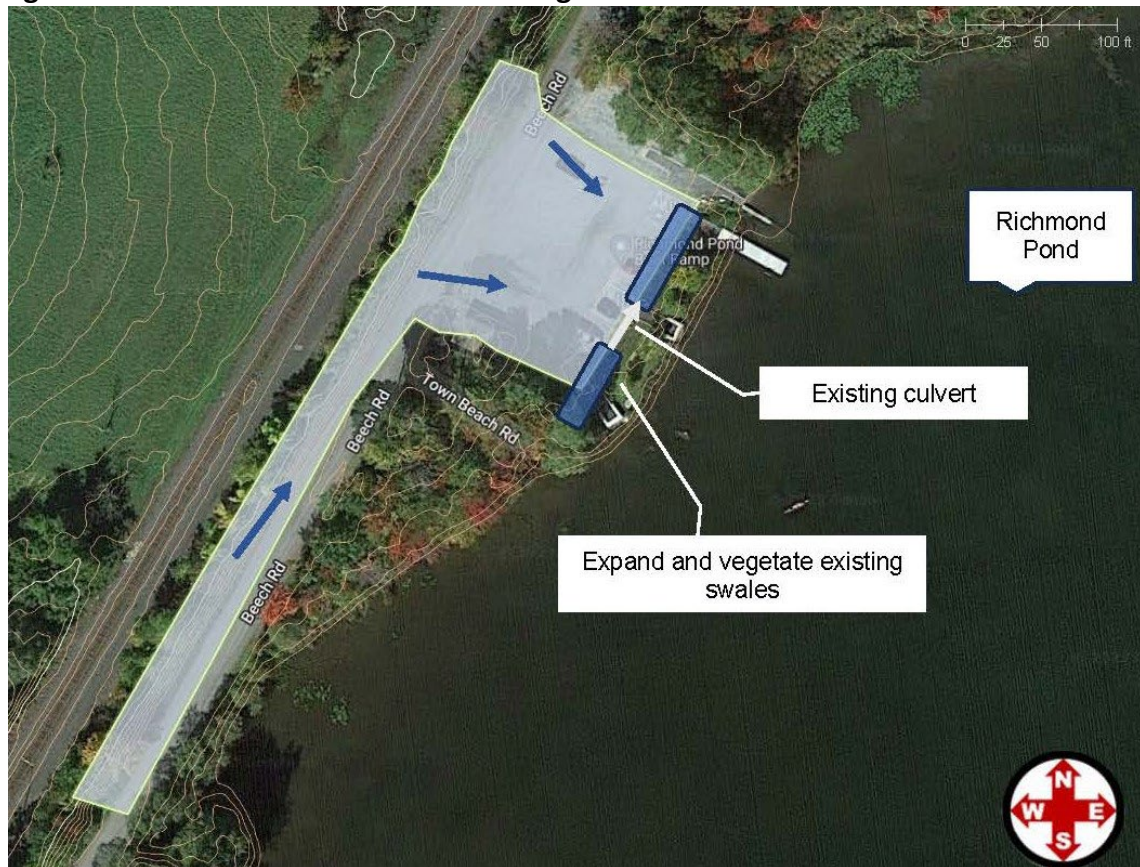
**Figure C-10: Richmond Boat Access Parking area BMP locations**

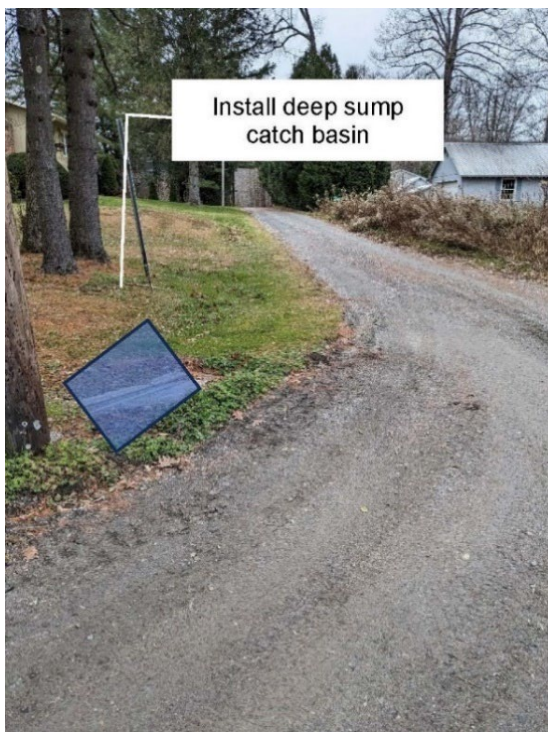
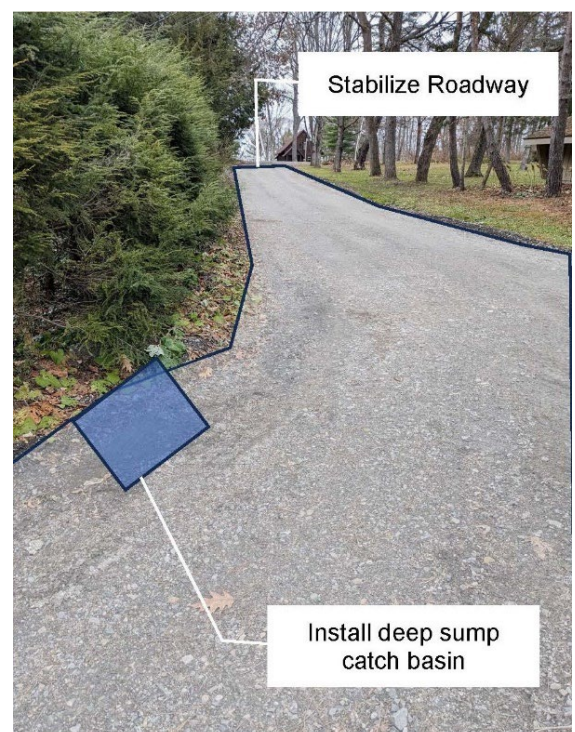
**Photos C-11: Spruce Road BMPs: deep sump catch basin location at the intersection of Bridge Street (left photo) and catch basin location at corner of Spruce and Hemlock Streets (right photo)**

These BMPs focused on Spruce Road are designed to reduce road erosion and reduce the sediment and pollutant load entering Richmond Pond. Improvements that stabilize the gravel roads to prevent washouts and flooding needs to be considered for all of the Richmond Shores roads. Alternative options could also be considered such as repaving all of the roads with permeable or impermeable asphalt and adding additional drainage structures that support reduction in pollutant loads and improve the climate resilience of this community.

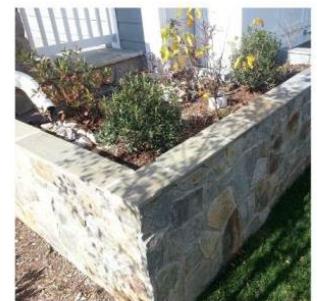
### Infiltration Trench

If you need to filter a lot of stormwater, build an infiltration trench along your driveway filled with sand, gravel and rock.

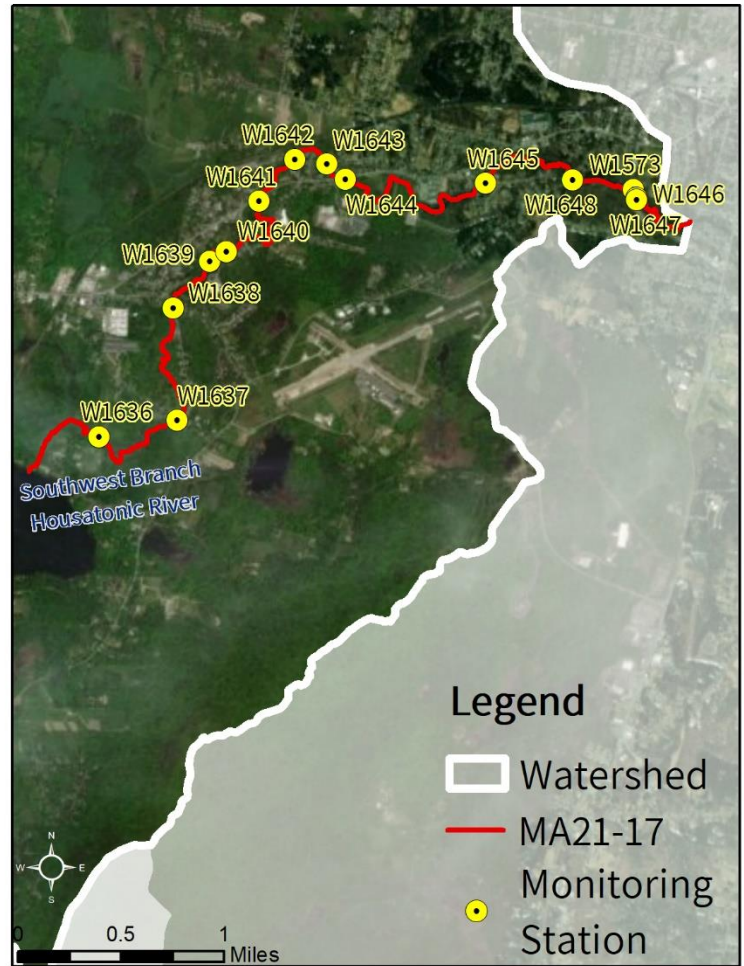
**Figure 5-2.** Location of monitoring station(s) along the impaired river segment.
