**Springfield Juvenile and Family Court
Springfield, MA**

**HVAC SYSTEM
EVALUATIONS
COVID-19**

Office of Court Management

November 8, 2021

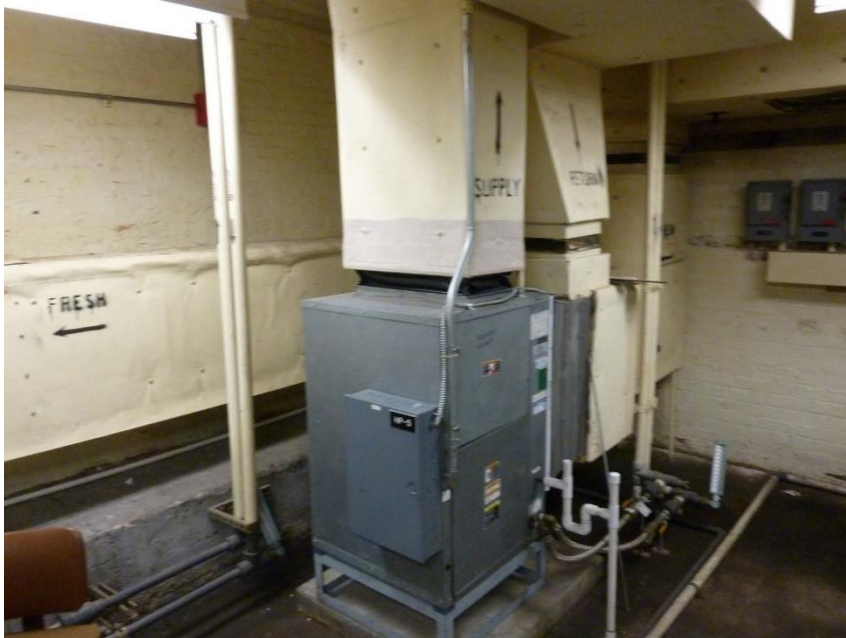
Photo 1 – Representative Heat Pump

All air handling units (Photo 1), rooftop units, and fan coils appear to be from the renovation in 2005 and are in fair condition. The outdoor air damper actuators are in good condition however, the outdoor air dampers are rusted (Photo 2). Facilities personnel report that the heating and cooling coils are cleaned twice a year for preventative maintenance (PM), and they appear to be in good condition.

ASHRAE lists the life expectancy for small indoor air handling units as 25-35 years, and 19 years for water-source heat pumps (WSHPs). The air handlers are approximately 45 years old and are in fair condition. Consider replacing these units in the next 2-4 years. This recommendation is an energy saving measure and may not increase the indoor air quality of the building. WSHPs are available with much higher efficiencies and features such as electronically commutated (EC) fan motors, multi-stage or variable-speed compressors, and advanced controls. These features can reduce energy use and noise levels while increasing reliability and thermal comfort.
