**Massachusetts Division of Marine Fisheries  
Technical Report TR-56**

**The Acushnet River Restoration  
Project: Restoring Diadromous  
Populations to a Superfund Site in  
Southeastern Massachusetts**

March 2014

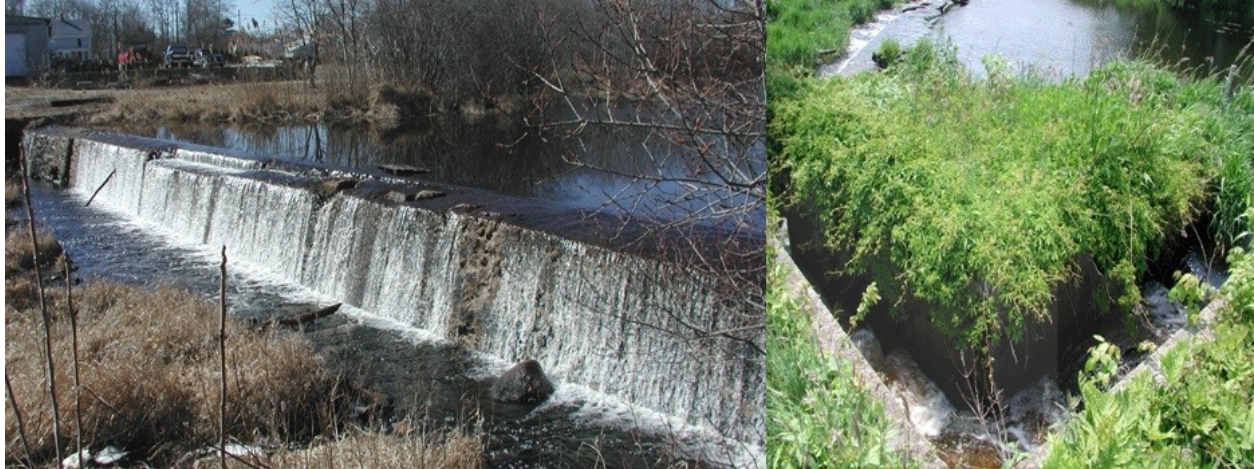
Figure 2: The Acushnet Sawmill Dam (left) and original weir-pool fish ladder (right) prior to construction in 2007.

The Acushnet Sawmill Dam, at river mile 4.4 (Figure 2), was originally constructed in 1746 and used to power the sawmill there. Prior to this project, the earthen dam was unused and had a concrete spillway 118 feet in length and approximately 4.6 feet in height with heavy siltation both above (approximately 30 ft upstream) the dam and below in the tailrace. A 6.5

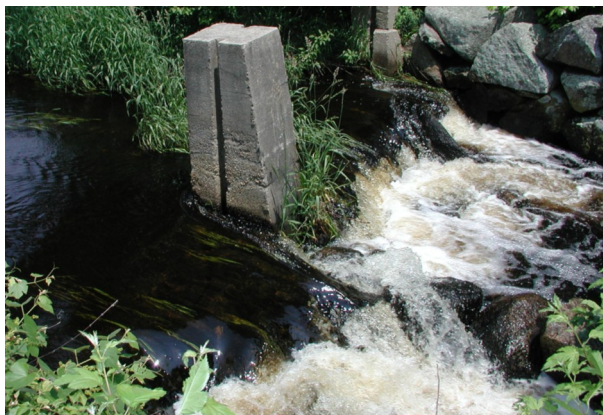
Figure 3: The Hamlin Street Dam prior to construction in 2007.

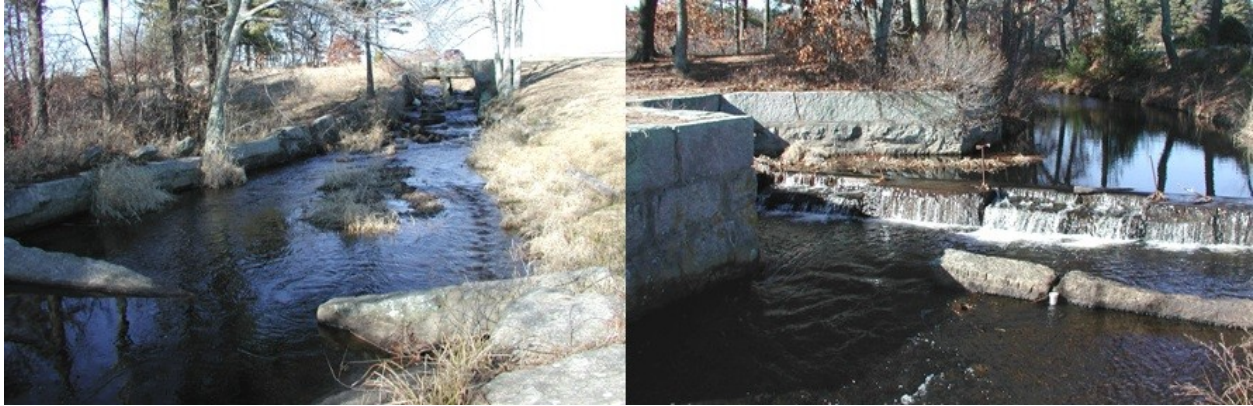
Figure 4: Downstream (left) and upper (right) sections of the New Bedford Reservoir Dam prior to construction in 2007.

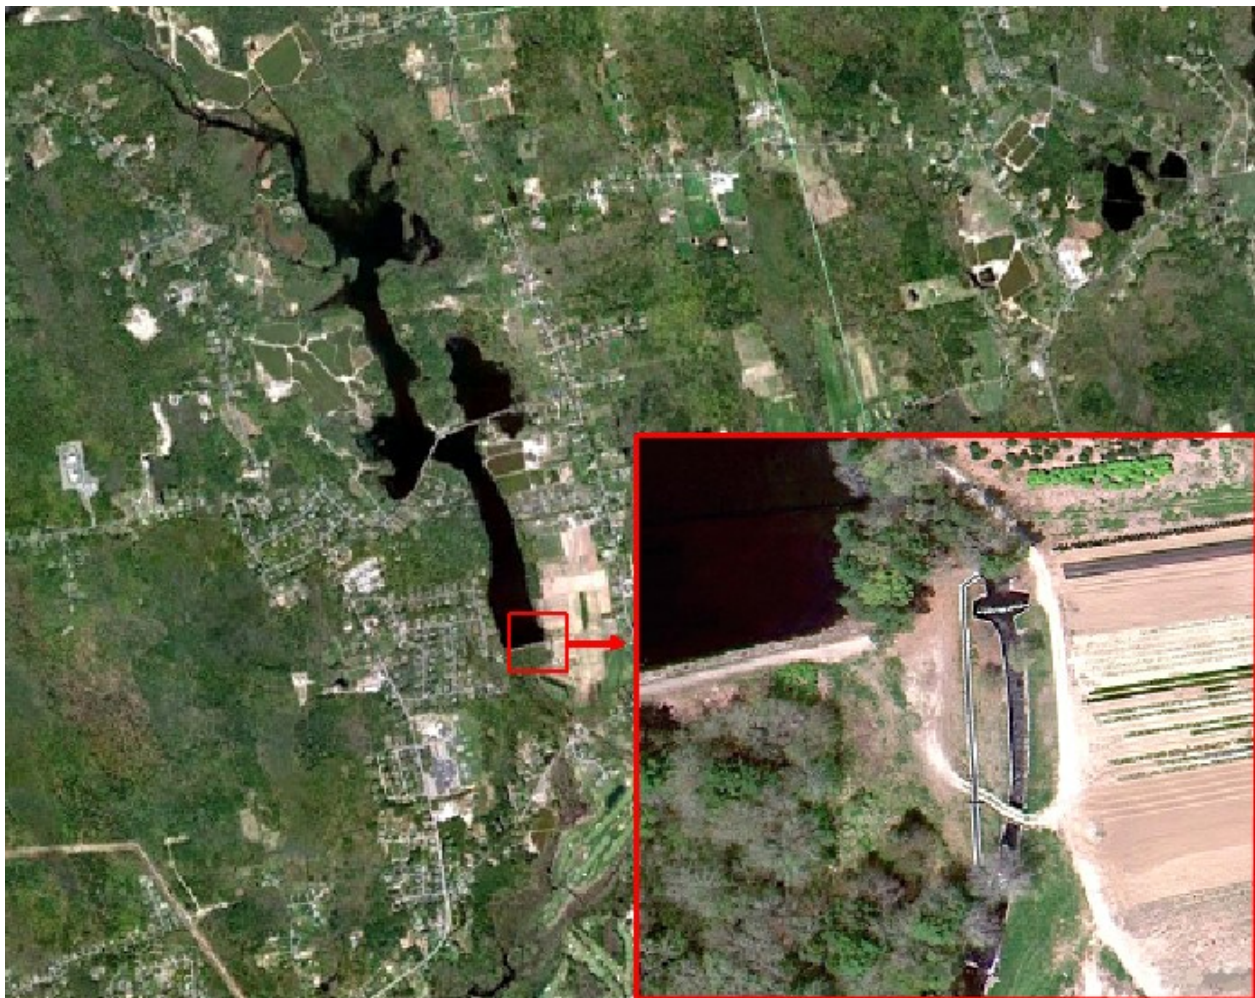
Figure 5: Upper Acushnet River watershed and New Bedford Reservoir with focus on the project area (*insert*).

Following the completion of the permitting process (Appendix C, Table C1), the fishway was built at the New Bedford Reservoir Dam and is located on the western edge of the river channel adjacent to the spillway (Figure 5). In accordance with design criteria, the fishway exit is located approximately 25 feet upstream of the centerline of the spillway structure and continues for approximately 240 feet along the bank of the stone lined channel. The entrance is located approximately 60 feet downstream of an existing channel crossing. The channel to the entrance was placed in a backwater pool created by an existing grade control structure. An

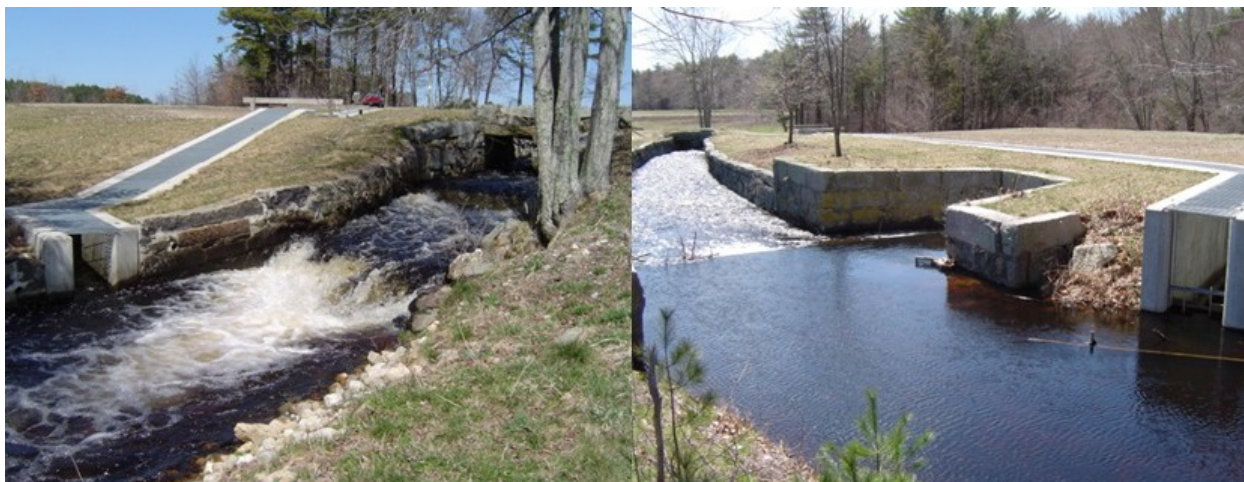
Figure 6: Downstream section of the New Bedford Reservoir showing the location of the Denil ladder entrance (left) and exit upstream (right).

existing partial barrier, consisting of boulders, was enhanced to act as a barrier dam guiding upstream migrants into the fishway entrance. After migrants enter the fishway, they must negotiate two Denil baffle sections (a maximum lift of approximately 5 feet) and three level sections before exiting the fishway above the upper spillway. Design plans can be found in Appendix C (Figure C2).

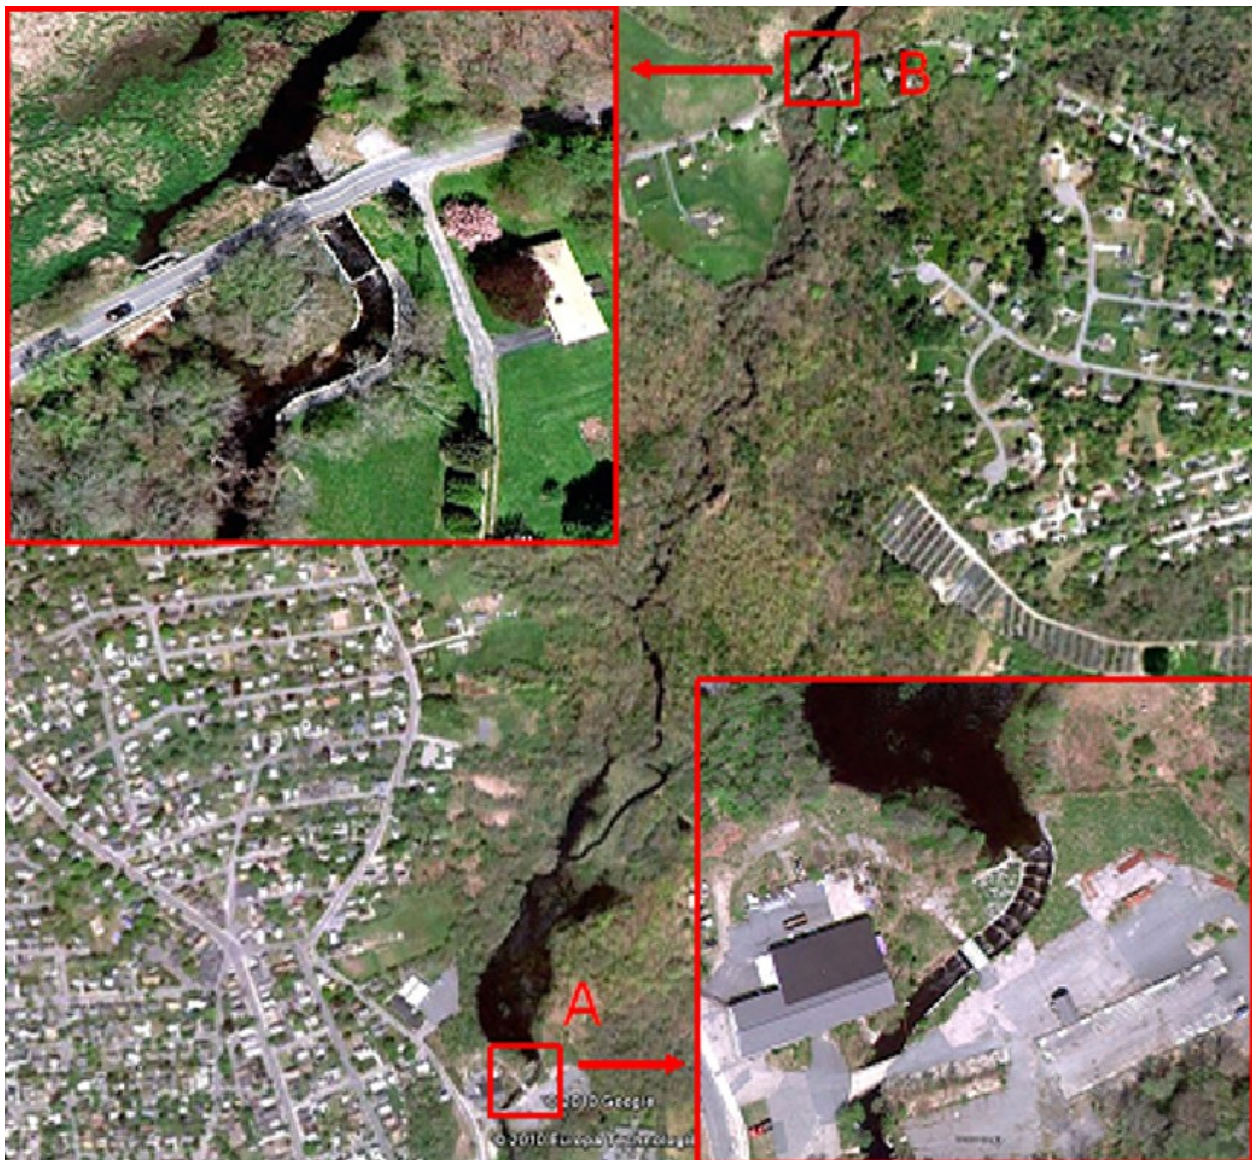
Figure 7: (A) Acushnet Sawmill and (B) the Hamlin Street dams and fishways on the lower Acushnet River.

Restoration efforts then focused on improvements to fish passage along the 3.8-mile stretch of the Acushnet River from the head of tide to the reservoir (Figure 7). Various alternatives, including conventional fishway installation as well as full and partial dam removals, were examined to determine the most appropriate fish passage designs. These scenarios were considered due to the poor condition of the dam structures, the potential need for future road improvements at the Hamlin Street site, and the willingness of the dam owners to consider removal. The first task was to consider the various feasible alternatives that would enhance fish passage at the Sawmill and Hamlin Street Dams while meeting the following criteria:

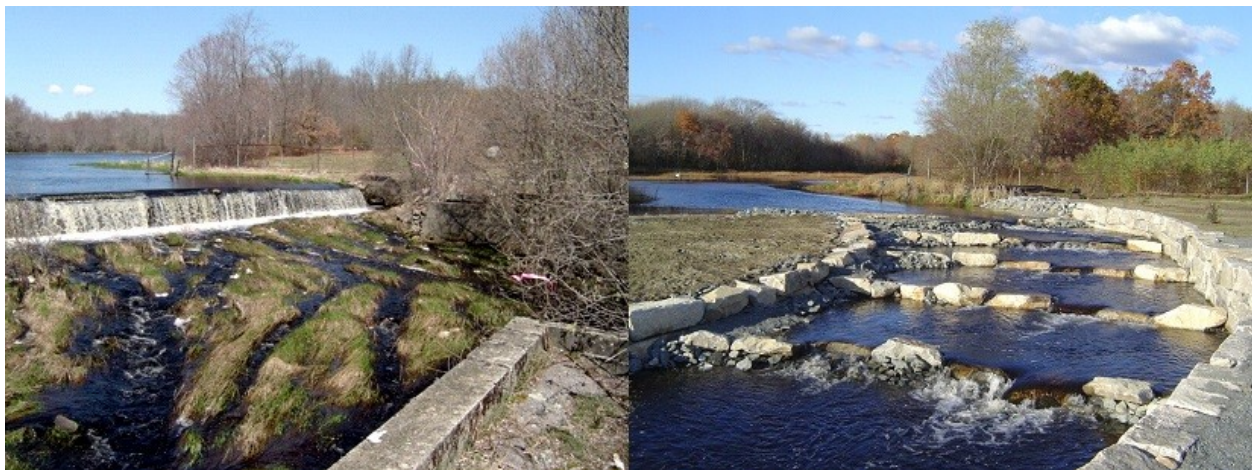
Figure 8: The Acushnet Sawmill dam and fishway prior to (April 2007, *left*), and after (July 2007, *right*) construction.

Work at the Sawmill site involved the construction of a flow constrictor-step pool structure that extends from the top of the Sawmill Dam spillway for a distance of approximately 200 ft downstream. Details of the technical design are summarized in Appendix D. Construction commenced in July 2007, outside of the critical migration period of adult spawning river herring and elvers (March 15 through June 30), after the required permits were obtained (Appendix D, Table D1). This was also a time of low flow periods, allowing for the effective diversion of river flows from construction areas through the existing sluiceway. This, in turn, allowed the construction site to be de-watered (impacting approximately 4,400 ft<sup>2</sup> of wetland resource areas) and work was conducted in dry conditions while safe passage for any outmigrating diadromous species was still provided. Fishway replacement (Appendix D, Figure D2a) involved breaching the dam through removal of a portion of the spillway in which the length of the

dam was reduced (approximately 60 feet). The dam was further modified by demolishing a portion of the spillway in which the height of the dam was lowered about three feet and notched at the eastern end. This was done to facilitate passage upstream as the modified dam served as the final weir in the ladder.

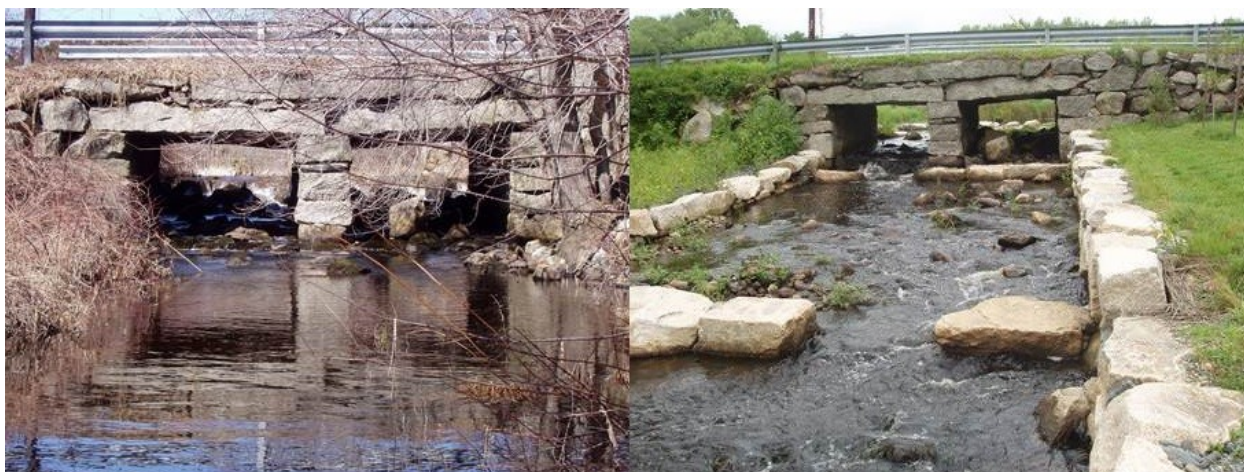
Figure 9: Completed construction (October 2007) of the rock weirs downstream of Hamilton Street.

Results from feasibility studies and the subsequent ENF (Milone & MacBroom 2000, 2003b, 2003c; EAEST 2006b) recommended the removal of the eastern sill of the Hamlin Street Dam and the construction of a graduated stone step-weir system. Details of the technical design are summarized in Appendix E. Construction commenced in August 2007, after the required permits were obtained (Appendix E, Table E1) and included the partial demolition of the existing concrete spillway and three associated concrete piers upstream of the eastern bridge under Hamlin Street. In addition, a 50 ft channel upstream of the removed spillway was stabilized by replacing the fine substrate with cobble.

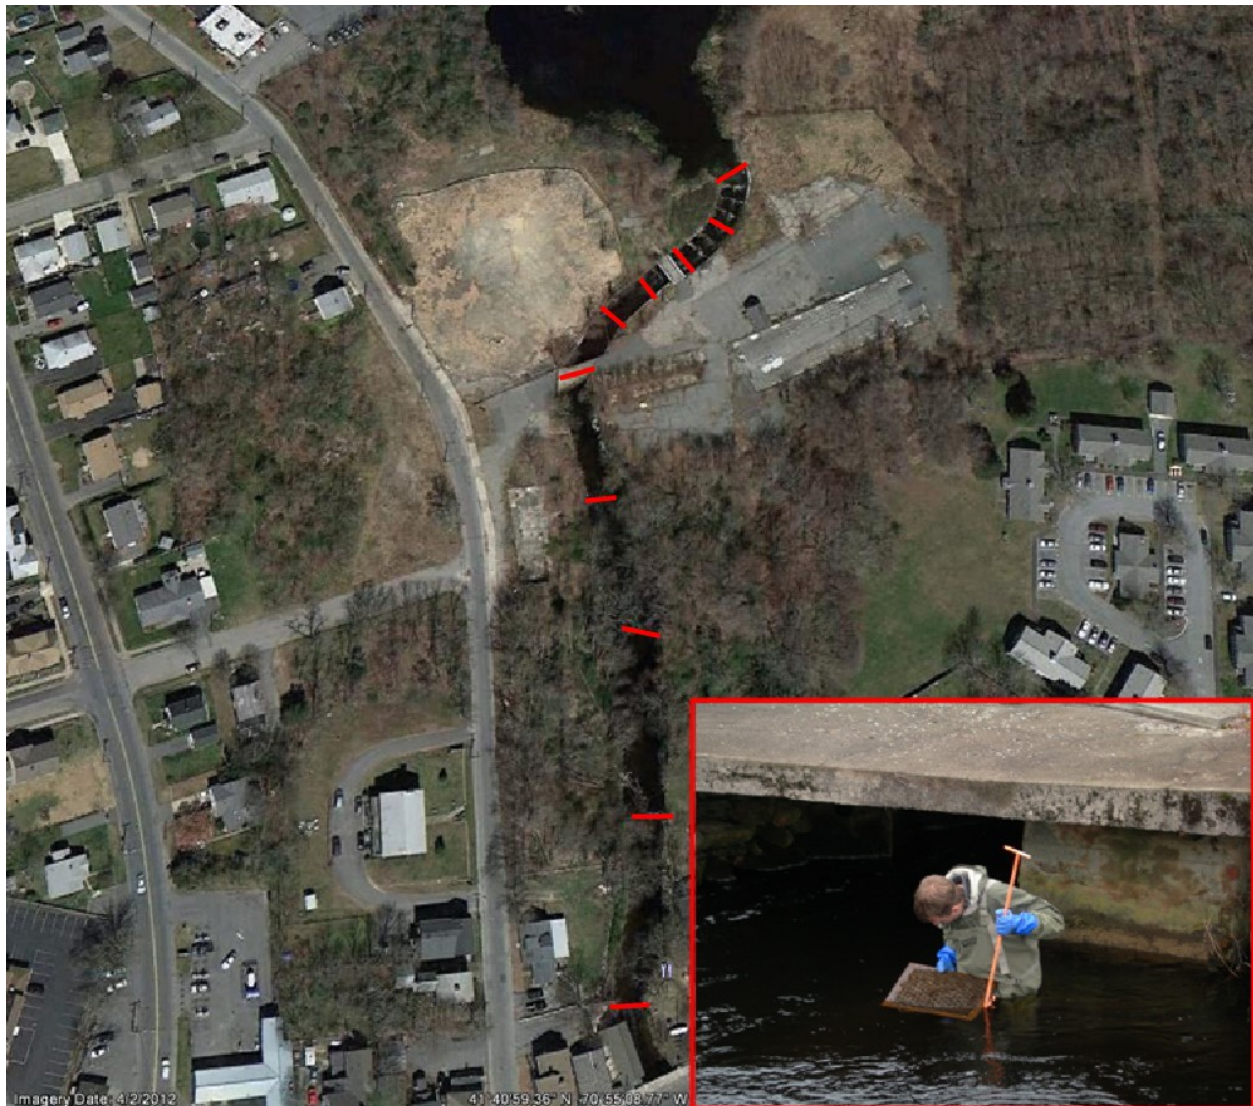
Figure 11: Transect locations (red) for monitoring smelt egg deposition in the lower Acushnet River.

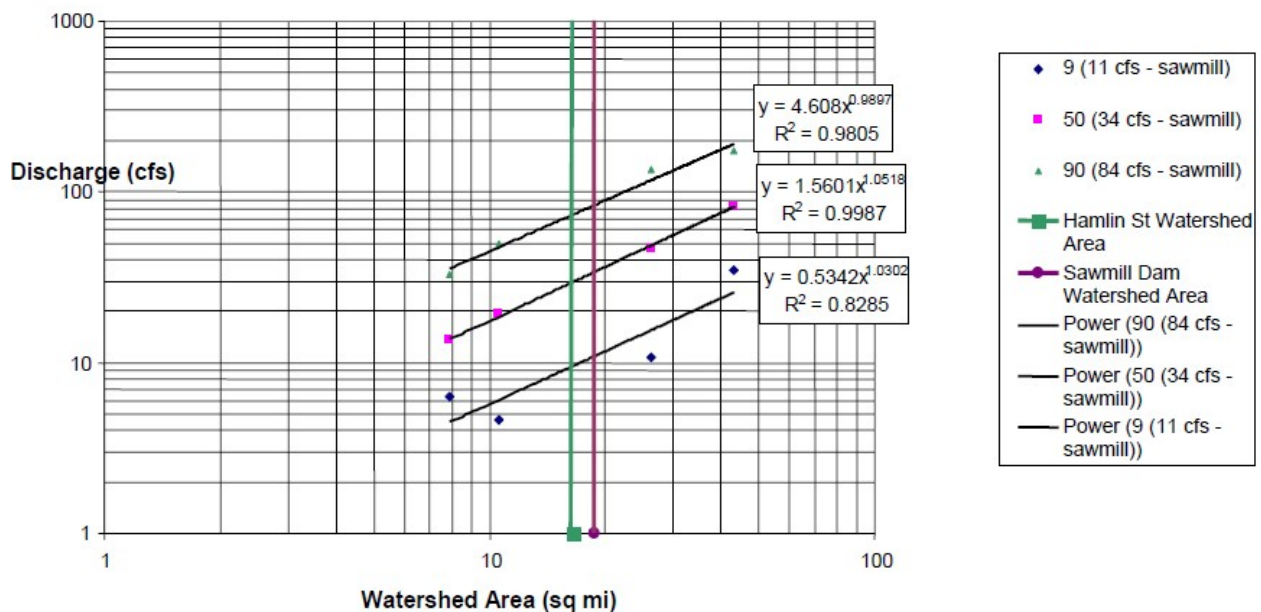
Figure D1. Non-exceedance curves for discharge based on watershed area for March-June at three gauging stations (source: EAEST 2007).

The 9, 50, and 90 percent baseflow values were then plotted against the watershed area. Regression lines were drawn through the values to generate linear equations and associated  $r^2$  values. These equations along with those generated during the 50% Basis of Design (EA/KCI 2005) were then used with the known watershed area of the Sawmill Dam to find the expected 9, 50, and 90 percent exceedance flows for this watershed. Estimated maximum design flows for the Sawmill fishway is shown in Figure

D1. Results indicated maximum flows for 9, 50, and 90 percent exceedance flows are 11 cfs, 34 cfs, and 84 cfs, respectively.
