# Campus Wide Safety Improvements Speed Humps – Commonwealth Ave, Amherst, MA

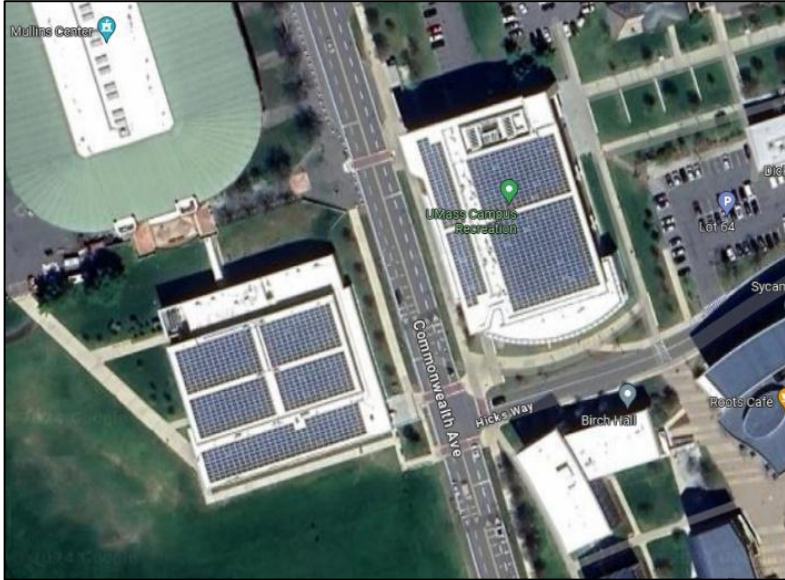
Commonwealth Avenue in Amherst, MA serves as a collector/local roadway and a part of the “campus loop” within the University of Massachusetts Amherst campus. This corridor serves multiple modes of transportation, including pedestrians, bicyclists, and an average annual daily traffic volume of 5100 vehicles per day. The corridor adheres to the same speed limit across campus at 25mph.

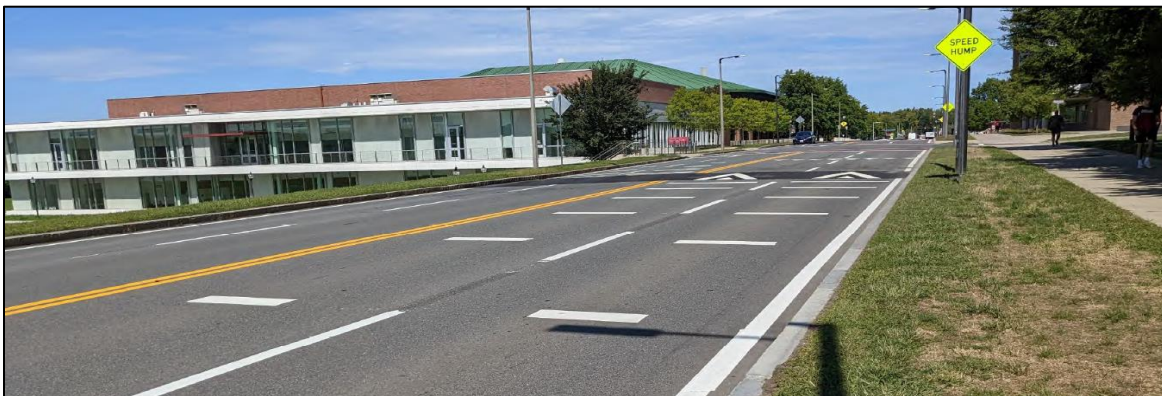
In early 2022, there was a crash resulting in a pedestrian fatality on the UMass Amherst campus. Less than a month later, there was another crash leading to a pedestrian being seriously injured in a crosswalk. Given these incidents, the campus initiated a campus-wide pedestrian safety audit, evaluating every roadway, intersection, and pedestrian crossing on campus. As a result, several initiatives were taken to enhance the safety of pedestrian crossings, including the implementation of speed humps on Commonwealth Avenue.

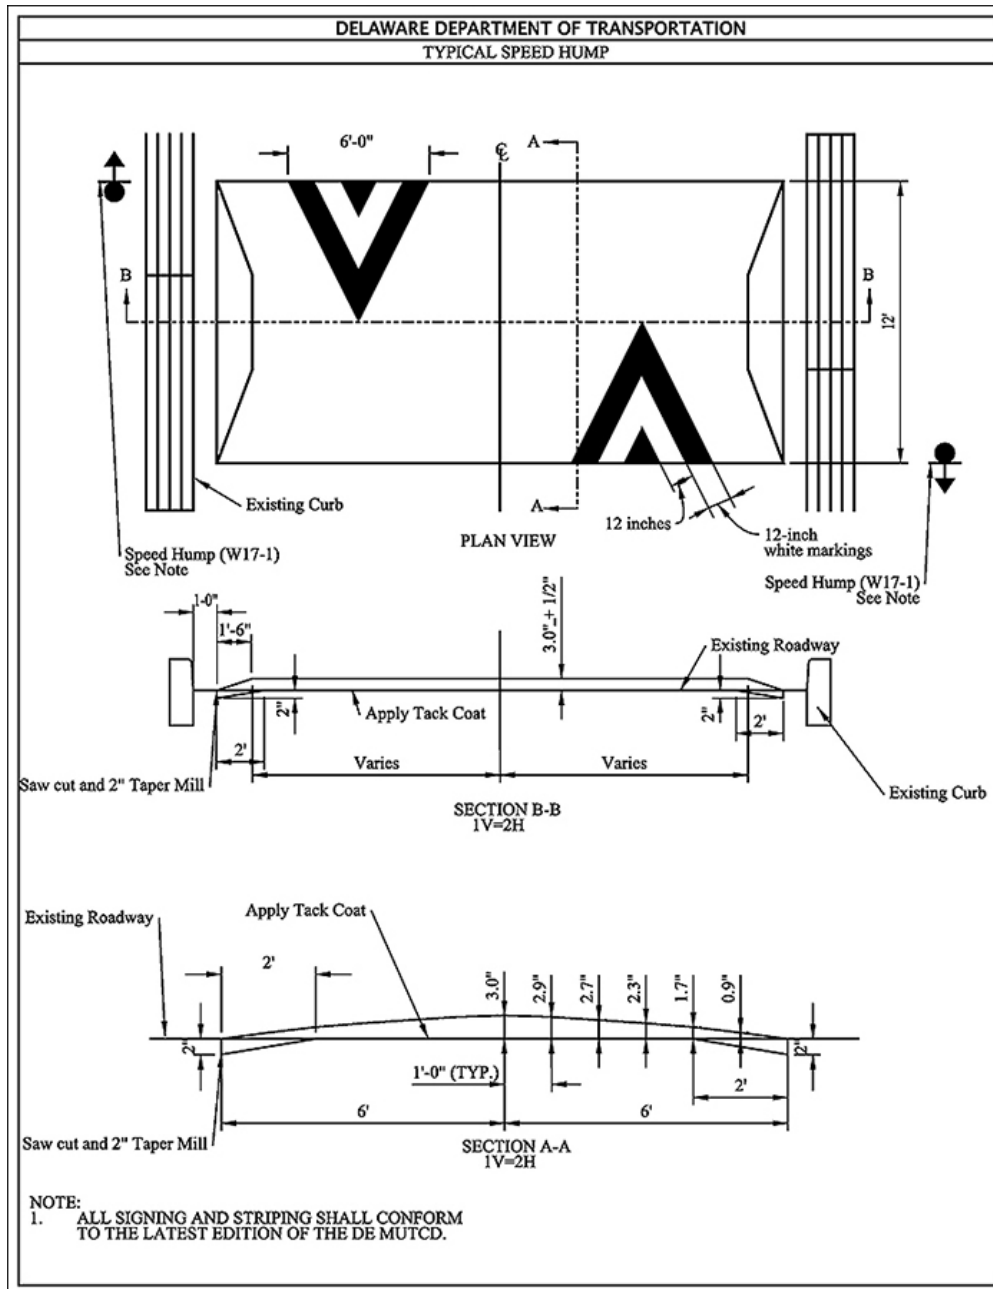
## Appendix – Speed Hump Design Specification

Initially a set of speed humps were installed along Commonwealth Avenue on the northern section of the corridor near the Mullins Center. It was important to begin here, as several pedestrian collisions had occurred on this segment over the last decade. The speed humps were designed to follow the Delaware DOT design spec that has been shared through the [FHWA Traffic Calming measures toolbox](#). Campus officials designed each of these with a total rise of 3 inches; however, the depth of the speed humps varied. Depending on the location, the speed humps varied from 12 to 15-feet in depth along the corridor. Regardless, the speed humps were estimated to cost roughly \$3000 per installation along the corridor.
