# INDOOR AIR QUALITY ASSESSMENT

**Uxbridge High School**  
**300 Quaker Highway**  
**Uxbridge, Massachusetts**  
August 2026

Prepared by:  
Massachusetts Department of Public Health  
Bureau of Climate and Environmental Health  
Division of Environmental Health Regulations and Standards

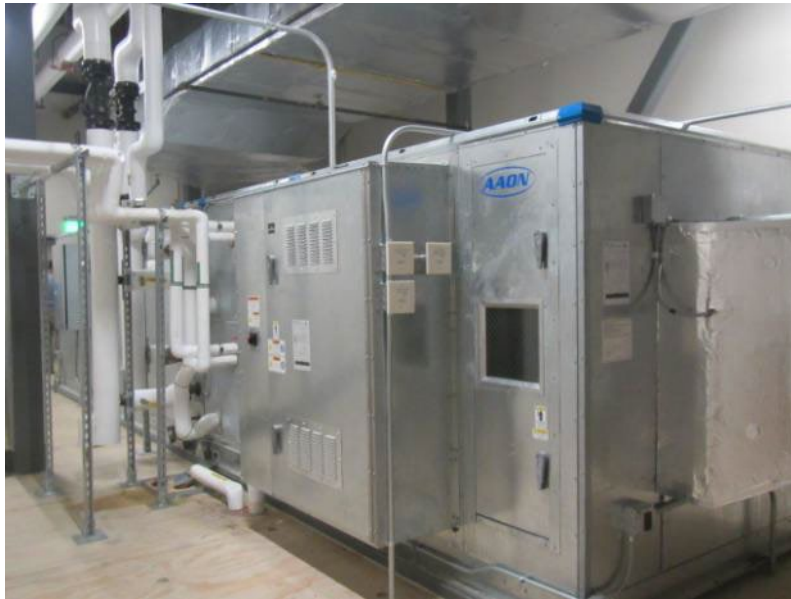
Picture 1

UHS has mechanical ventilation supplied by multiple large individual air handling units (AHU), most of which are located in mechanical areas above the second floor (Picture 1), and some of which are on flat parts of the roof (Picture 2). These units draw fresh air in from vents to the outside, filter it, and heat it as necessary, before distributing the air to classrooms, offices, and other areas through ceiling-mounted supply vents (Picture 3). Only one of the AHU supplies cooling/air conditioning. This unit supplies the main offices, the auditorium, the library, and several other rooms nearby.

Air handling unit in a mechanical area above the second floor

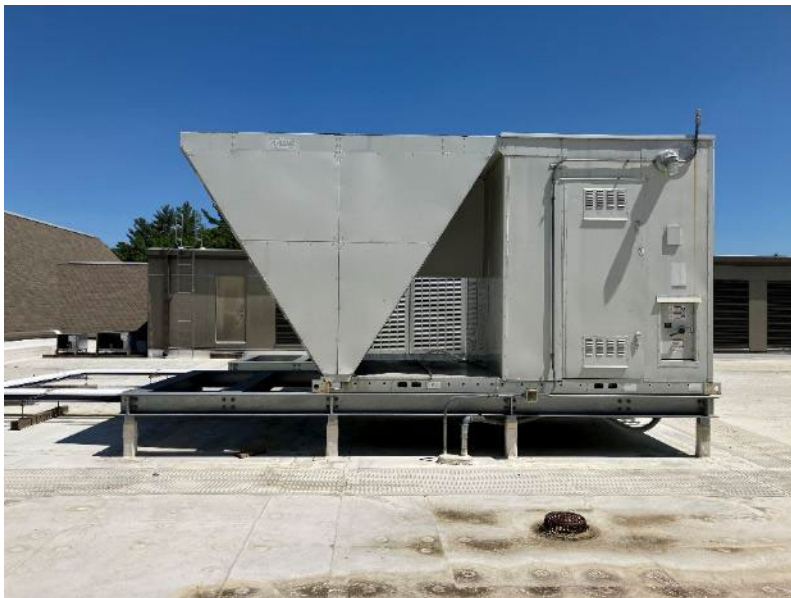
Picture 2

Air handling unit on a flat part of the roof

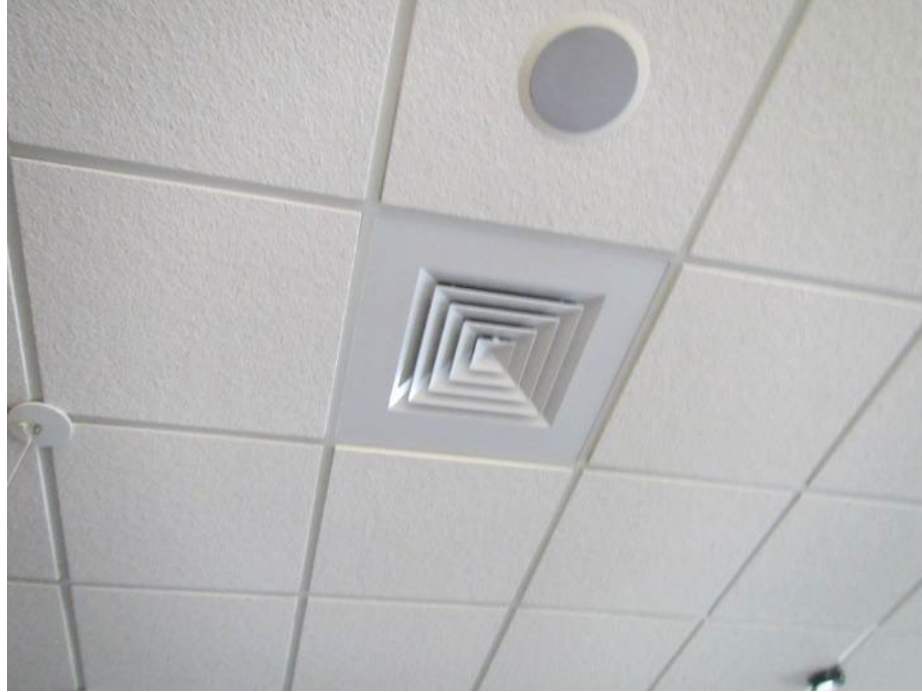
Picture 3

Typical supply vent in a classroom

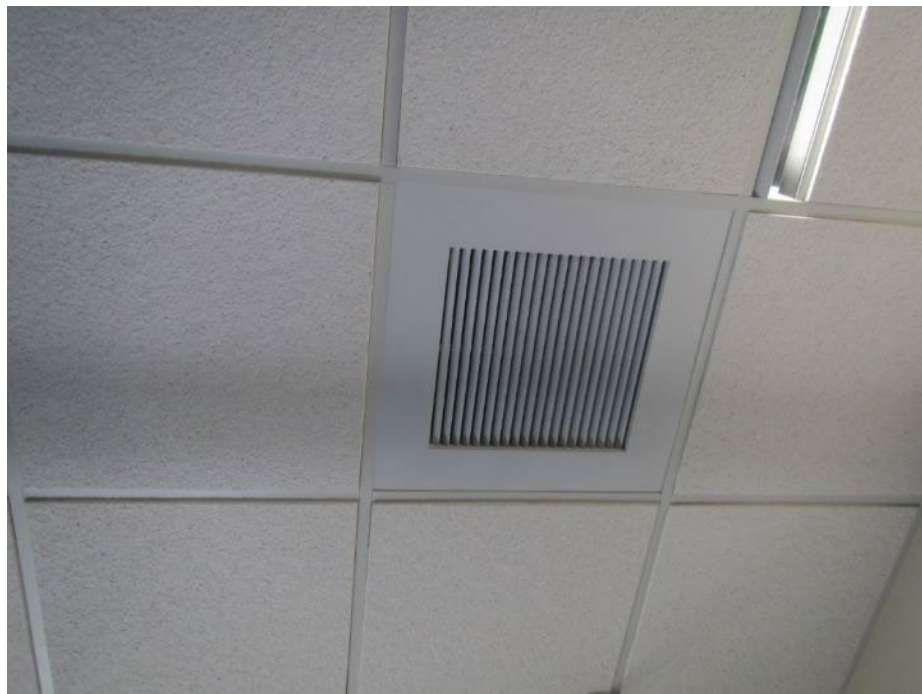
Picture 4

Air is returned to each AHU or exhausted from the building through ceiling-mounted return/exhaust vents (Picture 4). Exhaust vents from locations that produce odors or moisture (e.g., bathrooms) should be directly vented to the outside of the building. It was not determined if all classroom/office exhausts were directly vented outside, or if some were partly recirculated through an AHU.

Typical ceiling-mounted exhaust or return vent

| Description | | Helpful links |
|---|---|---|
| 4. | Check the function of all exhaust vents now, and periodically during the school year. Repair any vent fans or louvers that are not operating correctly. | |

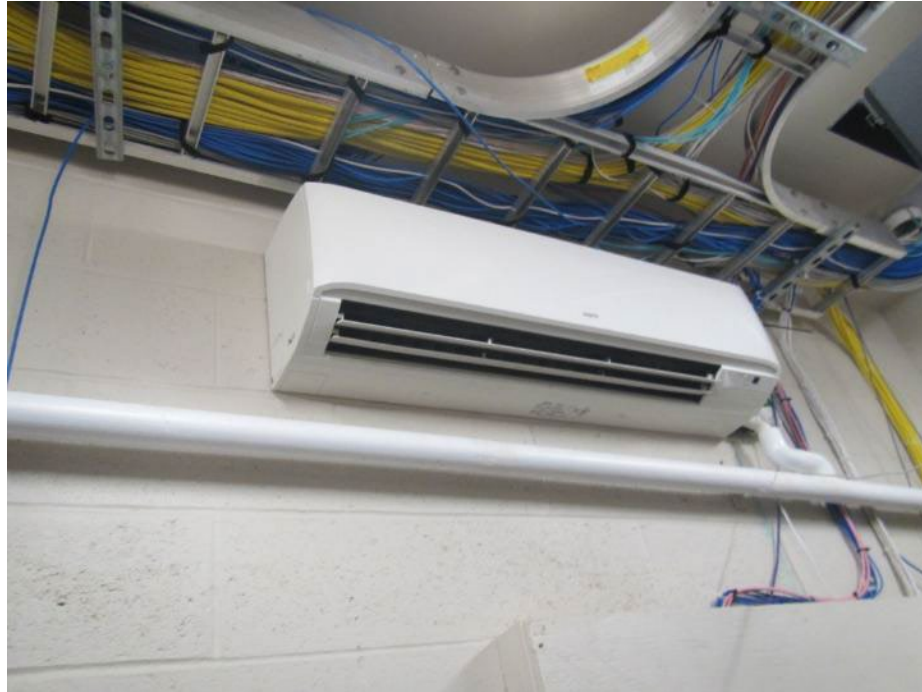
Picture 5

Ductless air conditioning units, also known as “mini-splits,” provide heating and/or cooling, but do not have a fresh air supply. Several of these units were found in utility spaces such as the IT closet and a computer room (Picture 5). When used in cooling mode, ductless air conditioners produce condensation that needs to be drained with a hose and sometimes a pump. These components should be checked periodically for issues such as blockages when in use and cleaned/repaired, as needed.

Ductless air conditioner, also known as a mini-split, note condensation drain (white pipes)

| Description | | Helpful links |
|---|---|---|
| 8. | Maintain and clean ductless air conditioning units per manufacturers' instructions. Ensure condensation can drain properly to prevent leaks. | |

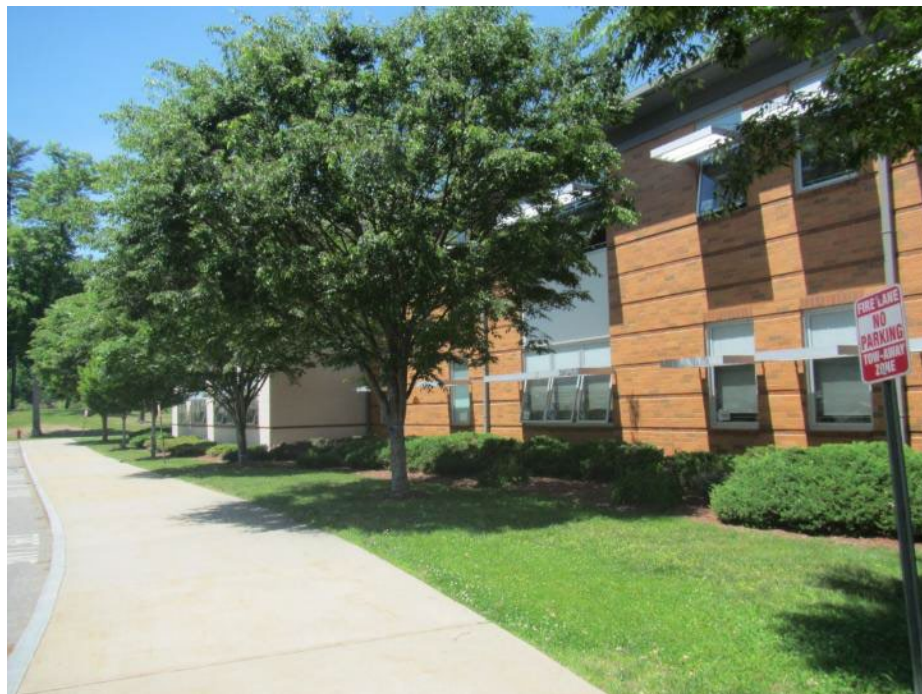
Picture 6

Most rooms in the building are equipped with openable windows (Picture 6; Table 1). These windows were in good condition, and many were open during the assessment. Opening windows during temperate weather can supplement other HVAC components and help with temperature/comfort during hot weather in areas without air conditioning. Windows should not be opened during heavy rain, very cold or hot weather, and when outdoor air quality is poor due to outside activities such as lawn maintenance, pollen, or wildfire smoke.

Open windows, note trees and bushes next to the building and under windows

| Description | | Helpful links |
|---|---|---|
| 1. | Use openable windows for additional fresh air during temperate weather. However, care should be taken to <i>avoid opening windows when air conditioning is in use</i> to prevent condensation and mold growth, and during extreme cold to prevent freezing of pipes. | <a href="https://www.airnow.gov">https://www.airnow.gov</a> |

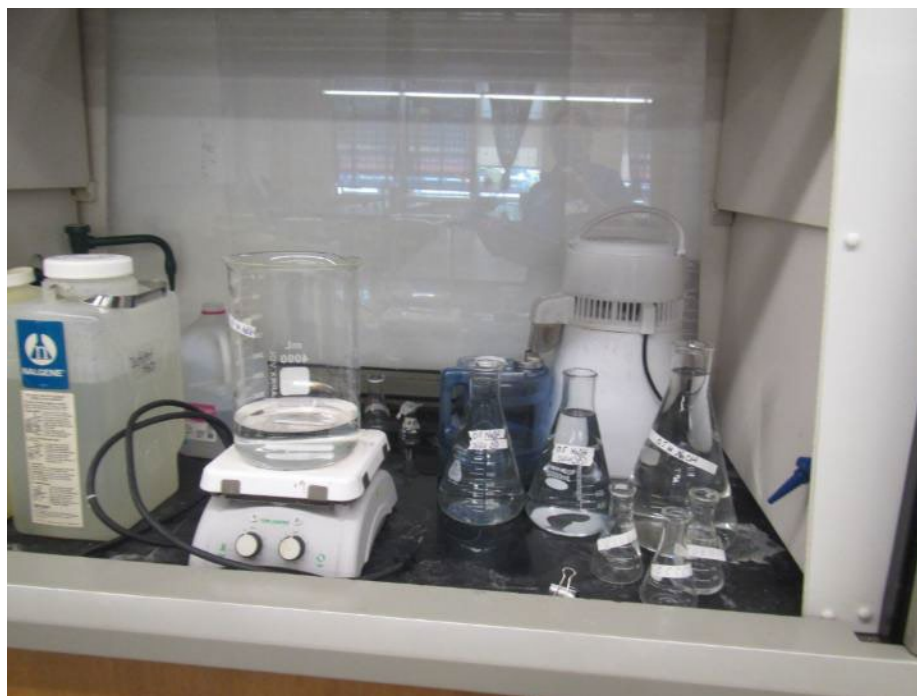
Picture 8

Various task or equipment-based exhaust ventilation units were found in the school. Fume hoods were noted in several science labs. Fume hoods need to be calibrated annually to ensure they work properly and calibration stickers were noted next to most of the fume hoods (Picture 7). One was reported to be out of order and had been blocked from use. In addition, chemicals were stored in a fume hood, which should not occur unless they are currently being used in the science lab (Picture 8).

Bottles in a fume hood

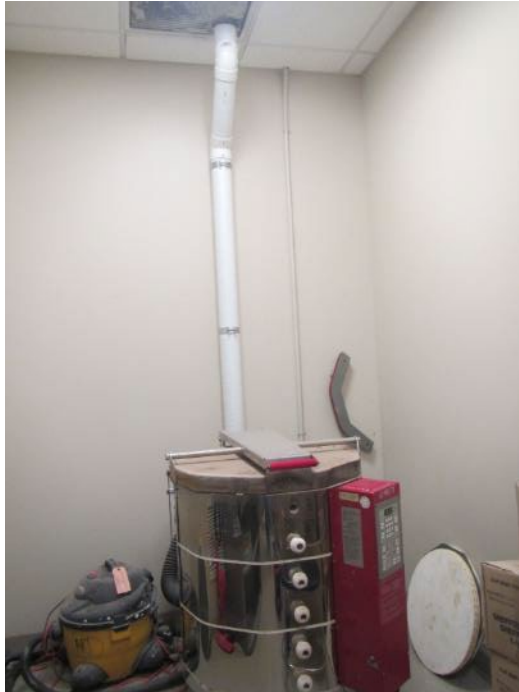
Picture 9

Other task-based exhausts included an exhaust vent for the kiln in the art room (Picture 9). The shop area is equipped with dust extractors (Picture 10), which remove the wood shavings/dust to a collection vessel outside the building. The dust extraction system was activated during the visit and appeared to be operating. Laser cutters were also equipped with an exhaust vent (Picture 11). All of these types of equipment need to be kept in good repair and used every time the accompanying equipment is activated.

- The kiln is an electric model and is equipped with an exhaust vent which is used whenever the kiln is in use. Items should not be left near the kiln when it is in operation. Students should not be in the room when the kiln is operating. It was also noted that the exhaust vent in the room with the kiln was dusty and may also be corroded. This should be cleaned periodically and replaced if necessary.

Dedicated kiln vent

| Description | | Helpful links |
|---|---|---|
| 10. | Task-based exhaust systems for art and shop equipment should be kept in good repair and operated every time the associated equipment is used. | |

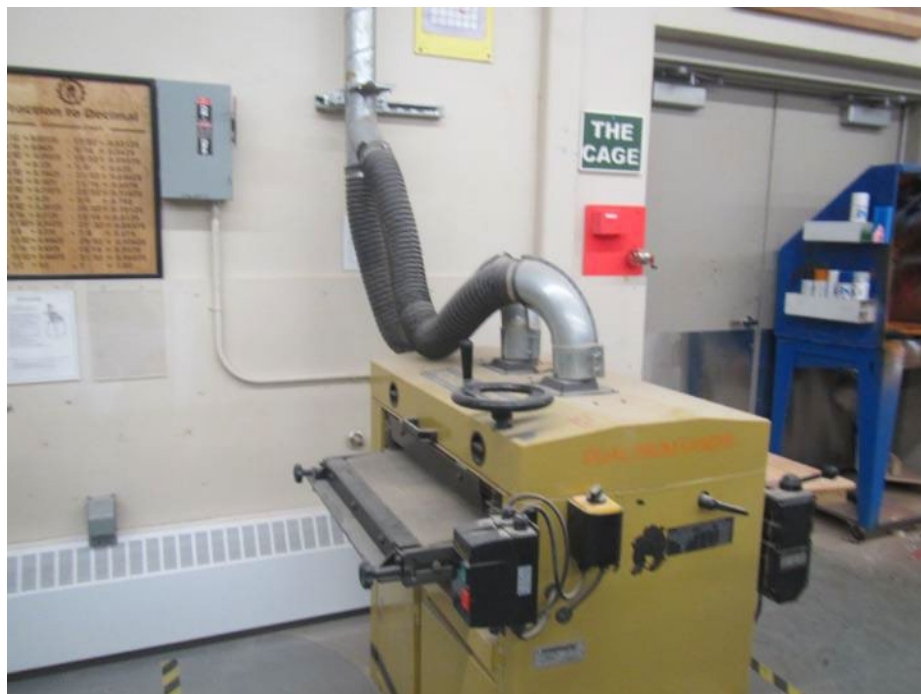
Picture 10

Example of a dust extractor in the wood shop

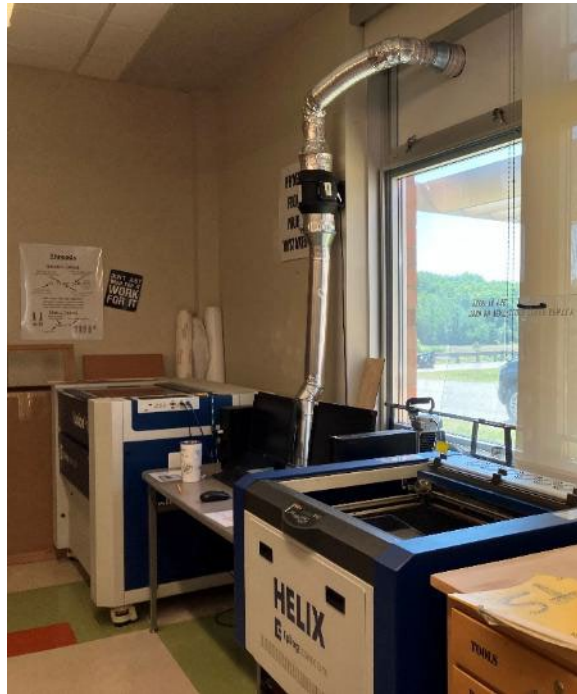
Picture 11

Exhaust vent for a laser cutter

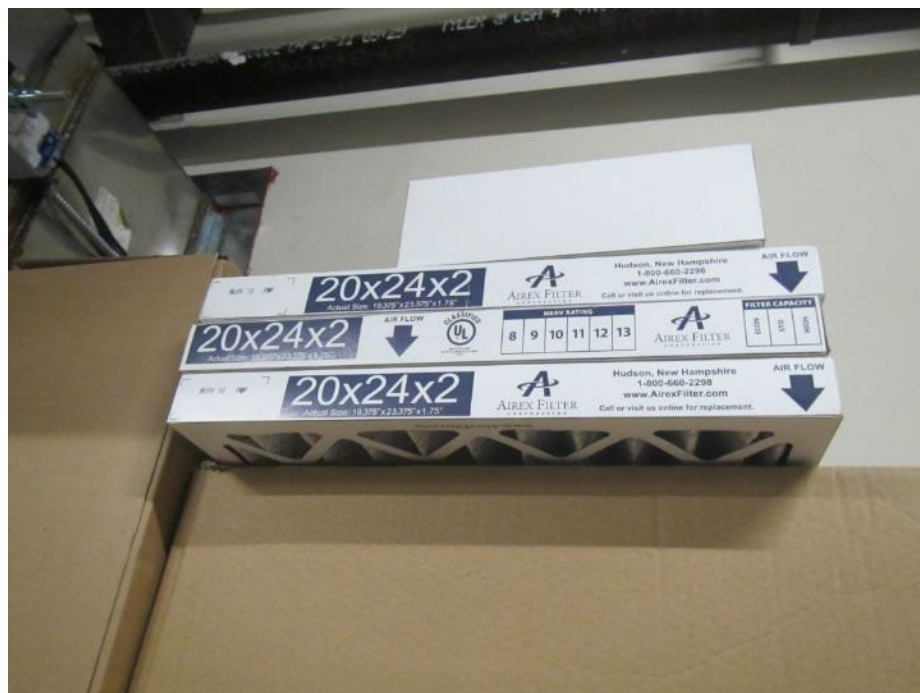
Picture 12

Replacement MERV 10 air filters in an AHU room; filters should be stored in an enclosed space

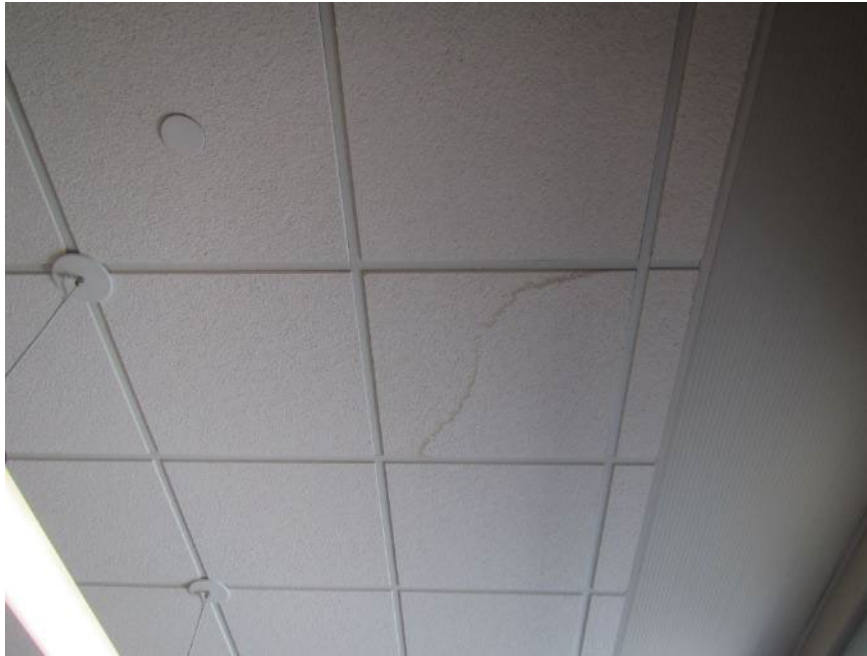
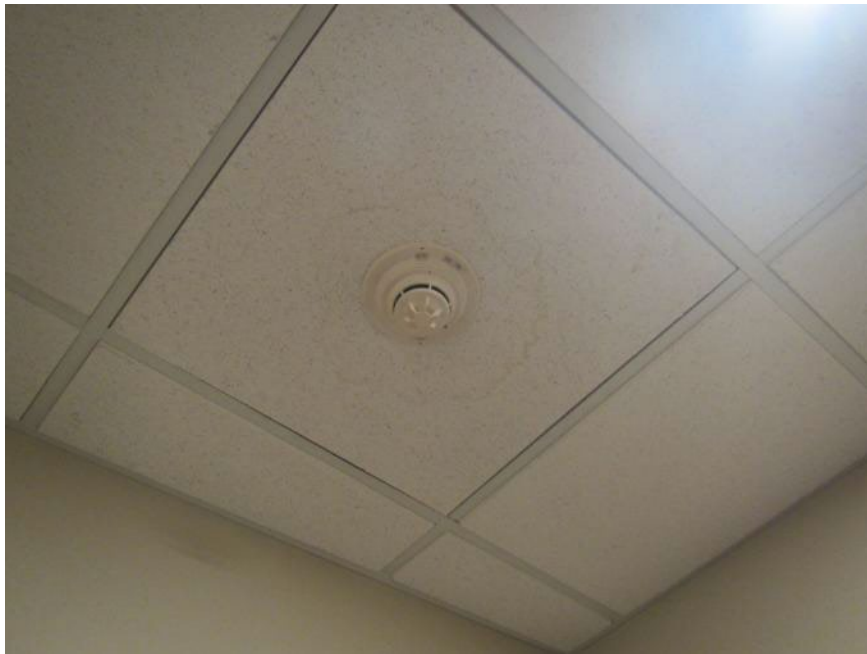
- **Water-damaged ceiling tiles were noted in a few areas** (Table 1; Pictures 13 and 14).
  - Some of these are likely caused by roof leaks and leaks through the building envelope during wind-driven rain or due to ice dams. In one area, paint also appeared to be water-damaged (Picture 15).

**Water-damaged ceiling tile**

- No characteristic dark or fuzzy staining that indicates mold growth on any materials was found, nor were any musty or moldy odors detected.
  - Water-damaged ceiling tiles should be replaced, and water-damaged paint should be repaired. During replacement of ceiling tiles, the area above should be examined for additional signs of water damage.

| Description | | Helpful links |
|---|---|---|
| 13. | Replace water-damaged ceiling tiles and repair water-damaged paint. During replacement, check above the ceiling tile grid for additional water-damaged materials or water sources. If any ceiling tiles appear moldy, use the EPA guidance “Mold Remediation in Schools and Commercial Buildings” to address the mold. | <a href="http://www.epa.gov/mold/mold-remediation-schools-and-commercial-buildings-guide">http://www.epa.gov/mold/mold-remediation-schools-and-commercial-buildings-guide</a> |

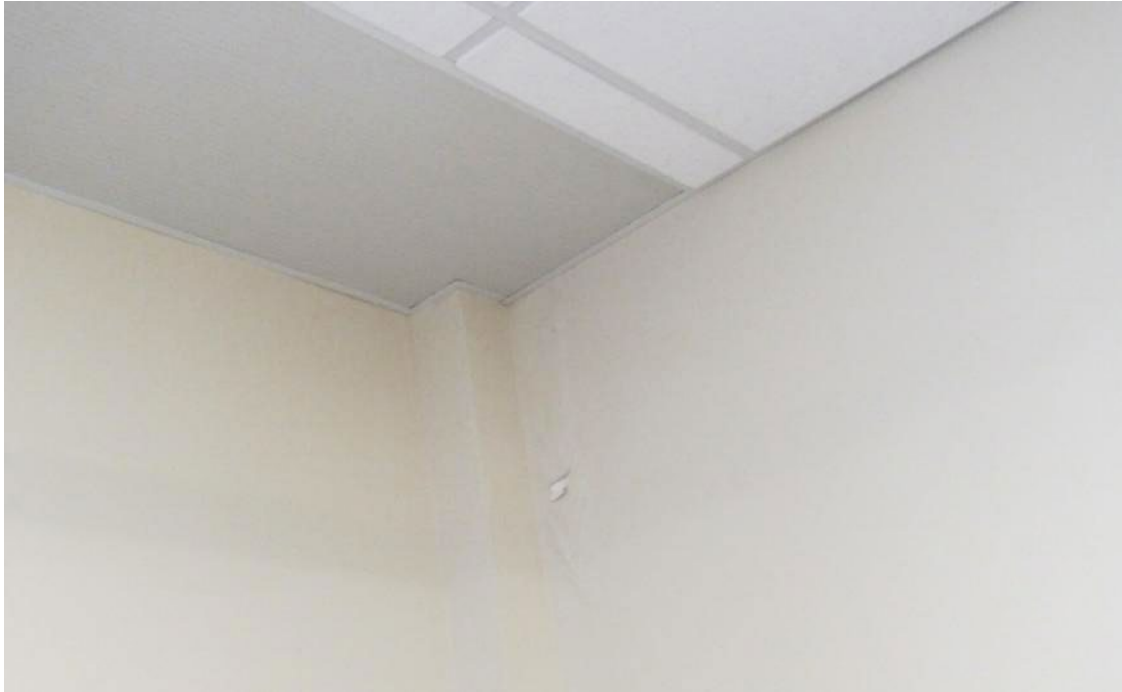
Picture 15

Peeling paint that appears to be due to water damage

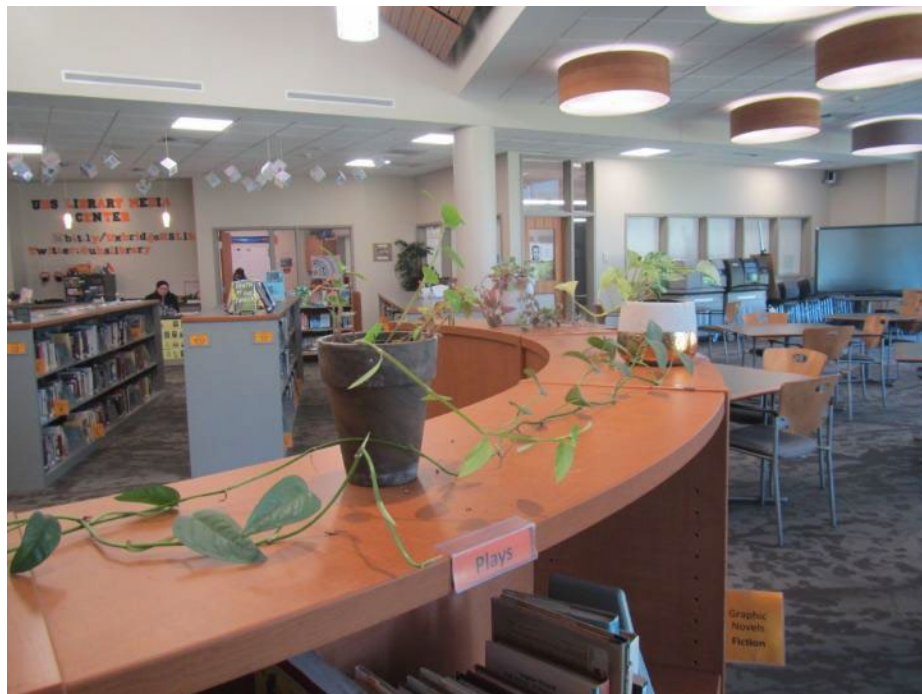
Picture 16

- **Plants were noted in a few classrooms, offices, and the library** (Table 1; Picture 16). Plants, soil, and drip pans can serve as sources of mold/bacterial growth. Plants should be properly maintained, over-watering of plants should be avoided, and non-porous drip pans should be used. Some plants were on cardboard or had no drip pans to protect building materials (Picture 17). Plants and drip pans should be inspected periodically for mold growth and cleaned/replaced as needed. Plants should also not be placed near HVAC components or fans as this distributes dust, odors, or pollen throughout the room.

Plants in the library

| Description | | Helpful links |
|---|---|---|
| 14. | Maintain plants in good condition, avoid overwatering, and use waterproof drip pans underneath that are cleaned regularly. | |

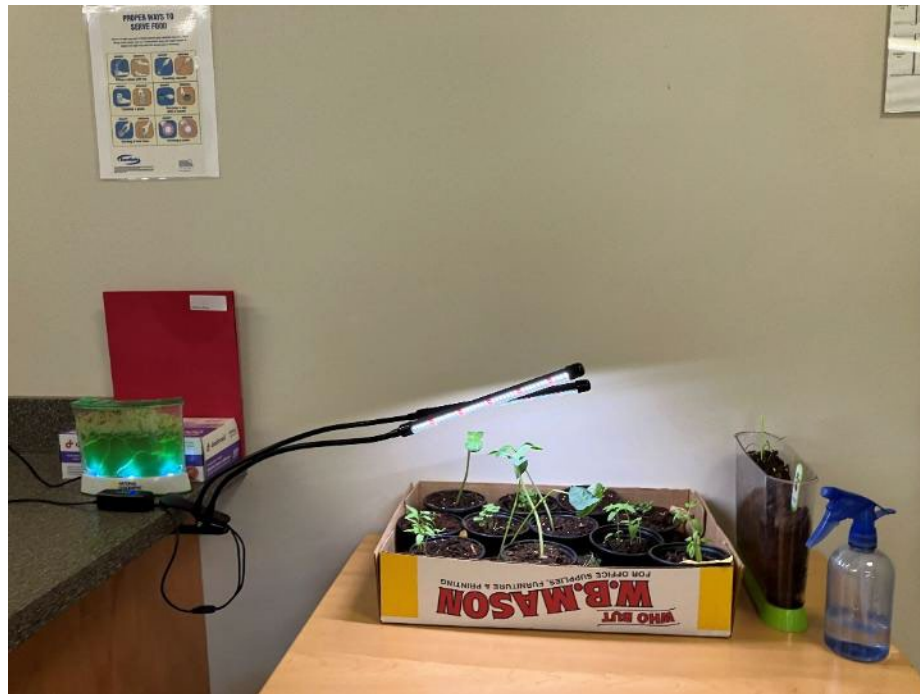
Picture 17

Plants in a cardboard box in a classroom

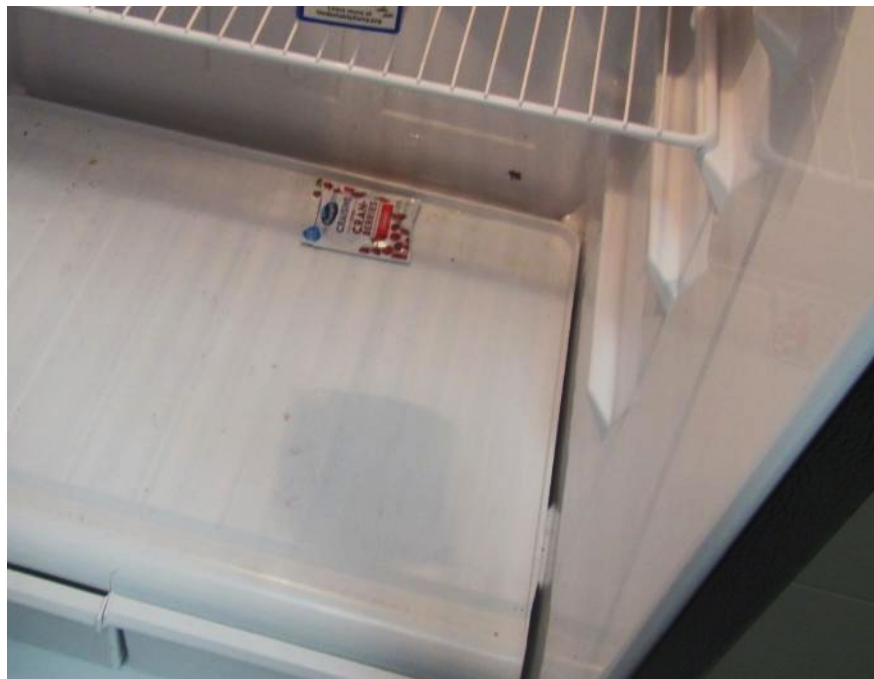
Picture 18

- **There were several full-sized and smaller refrigerators in the building. Food/liquid stains were observed in one** (Picture 18). Spills in a refrigerator can be a source of odors and mold growth.

Debris/residue inside a refrigerator

| Description | | Helpful links |
|---|---|---|
| 15. | Routinely clean food/liquid stains from refrigerators and ensure they are cleaned out regularly. Consider adding a thermometer to every fridge to ensure correct temperatures. | <a href="https://www.fda.gov/media/164194/download">https://www.fda.gov/media/164194/download</a> |

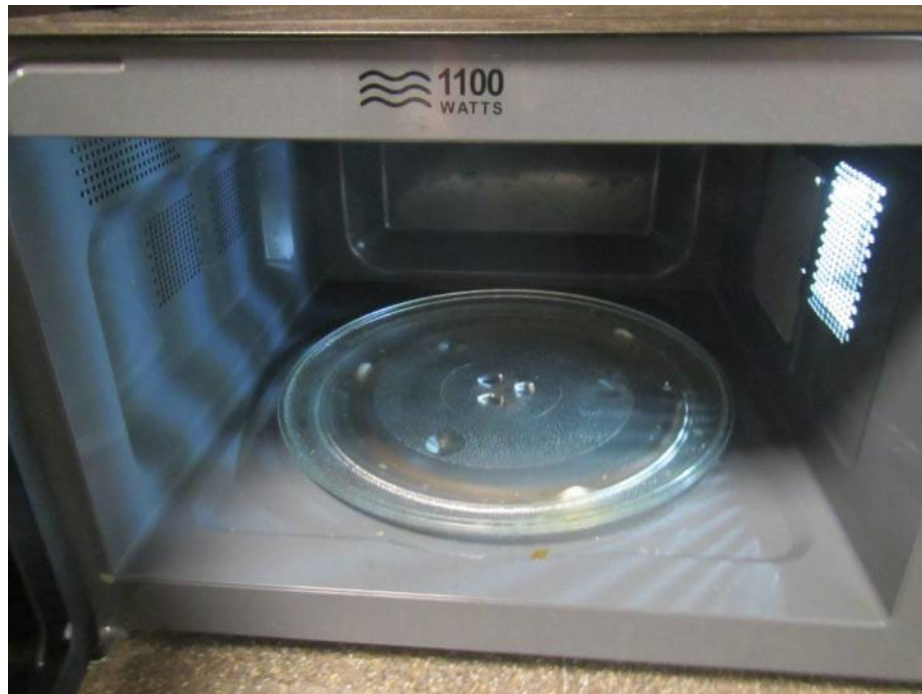
Picture 19

- **Food and food preparation equipment was noted in some classrooms and offices** (Table 1). **Some of the equipment was dirty** (Picture 19). To reduce the potential for pest activity, all food and food items should be stored in closed, pest-proof containers at all times other than active use. Food waste and crumbs should be cleaned up promptly.

Microwave in need of cleaning

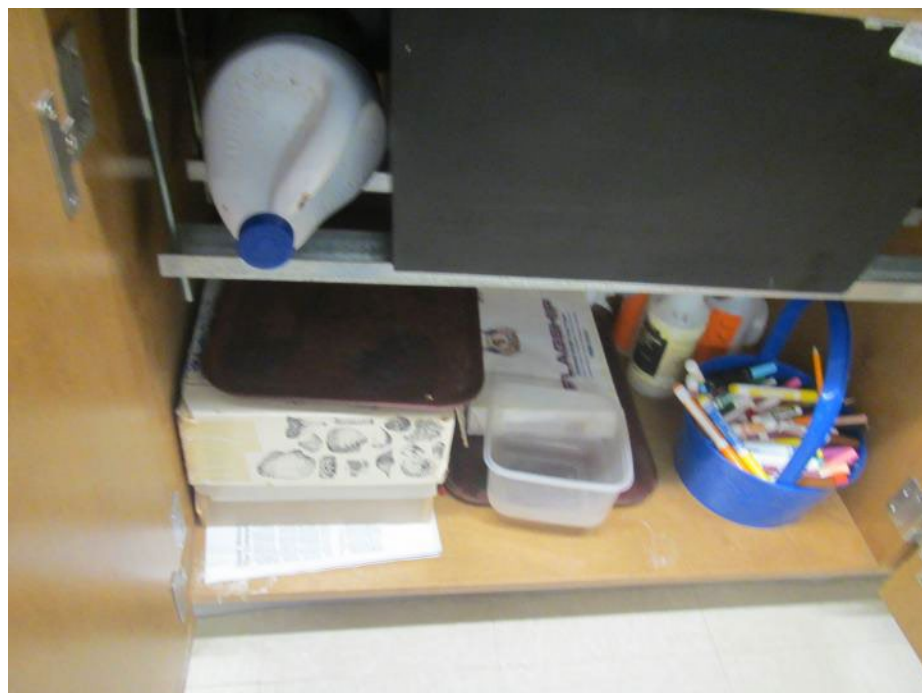
Picture 20

Items stored under a sink, including porous items and potential bleach bottle

| Description | | Helpful links |
|---|---|---|
| 18. | Avoid storing porous items or large amounts of items under sinks. Clean the sink cabinets regularly to remove dirt and debris that can be moistened by condensation or sink leaks. | |

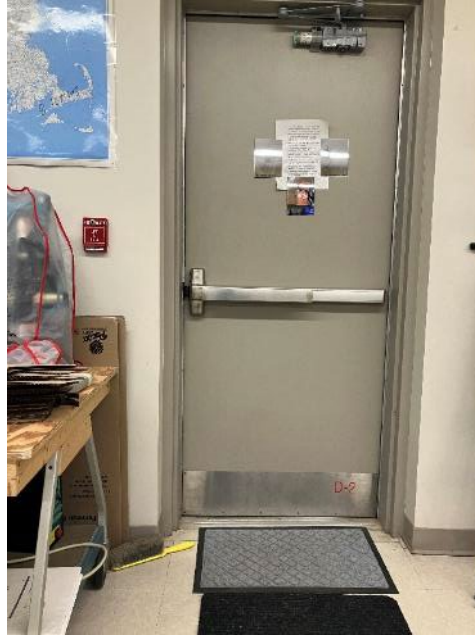
Picture 21

- **Light was noted penetrating through the spaces around a few exterior doors (Picture 21),** which can provide a pathway for odors, fumes, uncontrolled drafts, moisture, and pests into the building.
- **A few trees and shrubs were noted against exterior walls (Picture 6).** The presence of trees prevents the exterior of the building from drying and may clog gutters/roof drains with leaves and other debris. In addition, trees and shrubs next to the building can be a source of pollen and odors to open windows and may provide pest harborage.

Gap beneath exterior door

| Description | | Helpful links |
|---|---|---|
| 23. | Make sure all doors to the exterior are tight-fitting using weatherstripping to prevent water, moisture, odor, fumes, exhaust, drafts, and pest access. | |

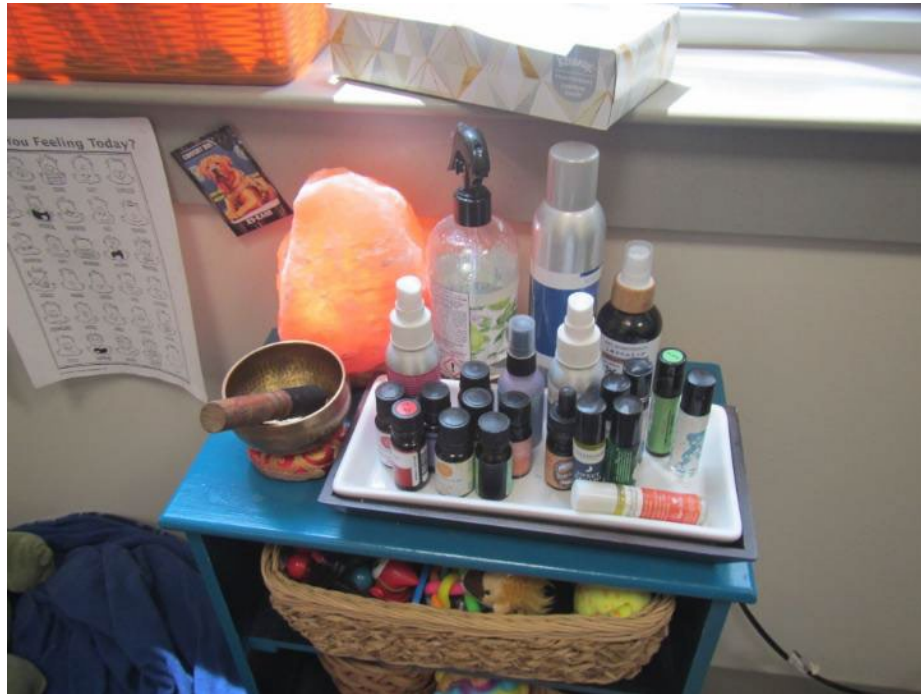
Picture 23

Essential oils in a guidance-area office

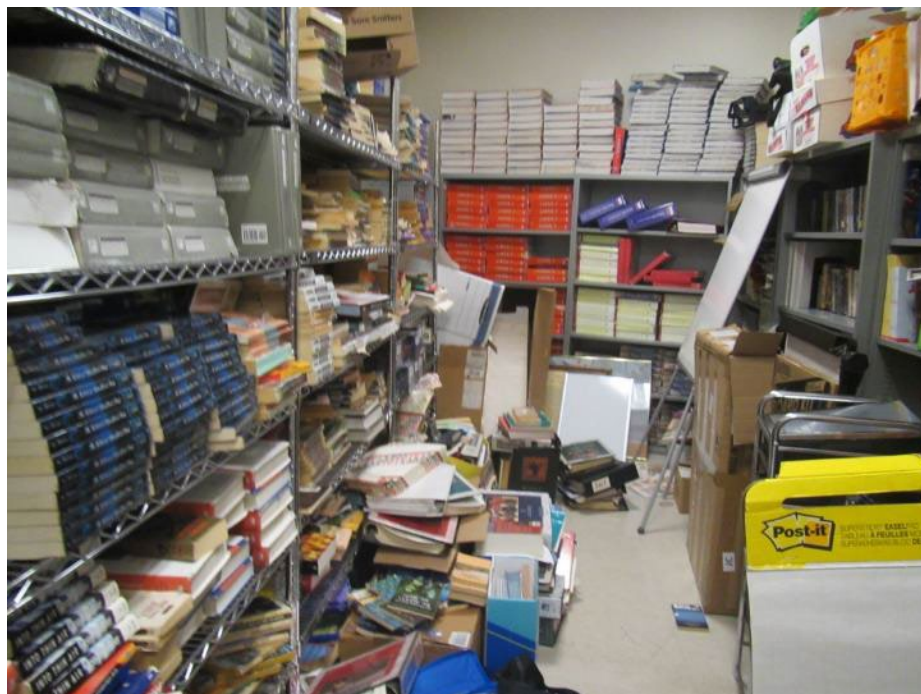
Picture 24

Returned books and other items on the floor of a storage area

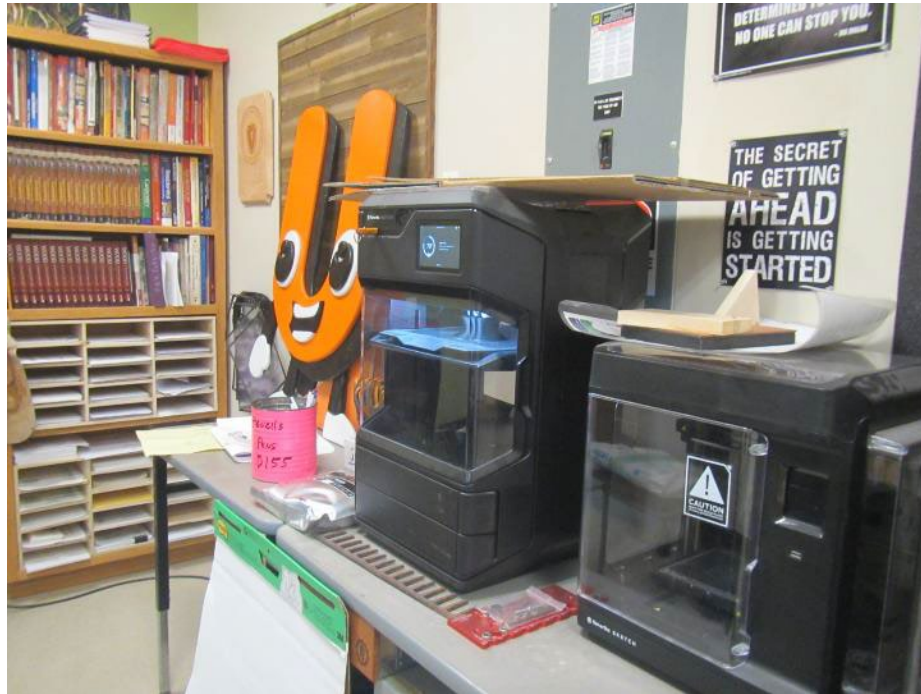
Picture 25

- Only lead-free glazes and other materials should be used. Bottles of glaze material found in the pottery room were labeled as lead-free.
- **3D printers were found in several classrooms** (Picture 25; Table 1). These appliances can produce fumes, particulates, and odors in use, with toxicity depending on temperature and the types of materials used in the printer (UL, 2026).

Two 3D printers in a side room of the fabrication/wood shop area

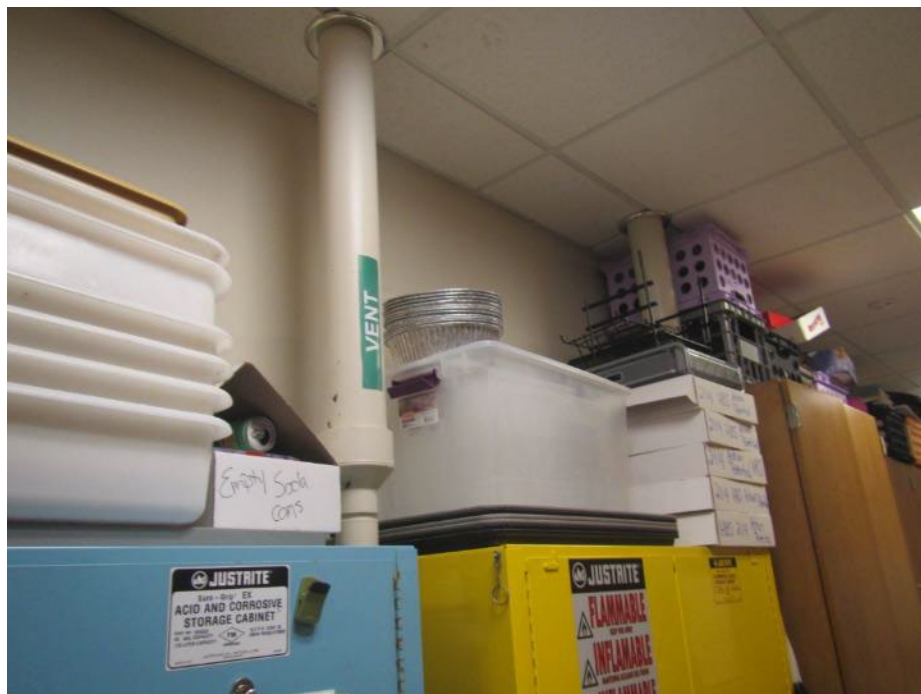
Picture 26

- **As noted above, there are science labs in the building and chemistry storage areas. The following was noted:**
  - Flammable and acid cabinets were present in at least two prep rooms. All had venting which should go directly outside the building (Picture 26). Flammable and acid cabinets were tightly closed and locked.

Flammable and acid cabinets with vents

| Description | | Helpful links |
|---|---|---|
| 29. | Evaluate chemical storage and safe use procedures in school science labs. Laboratory chemicals should be stored properly, with flammable materials in closed, properly designed and labeled, cabinets. Ensure old and expired products are regularly removed for proper disposal. | <a href="https://www.mass.gov/info-details/improper-chemical-storage-or-usage">https://www.mass.gov/info-details/improper-chemical-storage-or-usage</a> |

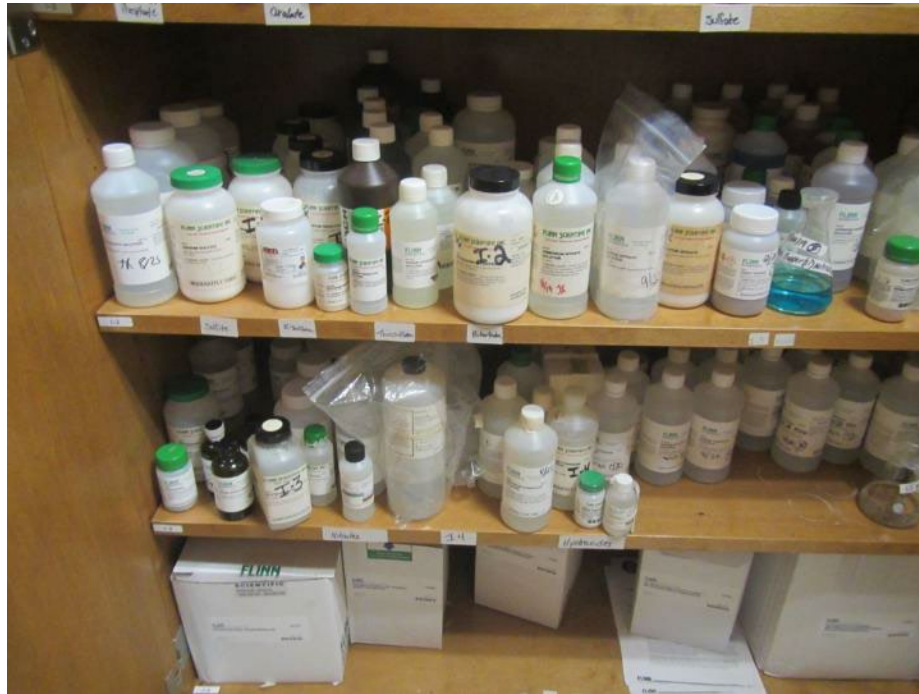
### Picture 27

Chemicals in a science prep area cabinet, note flask on right of upper shelf with inappropriate cover

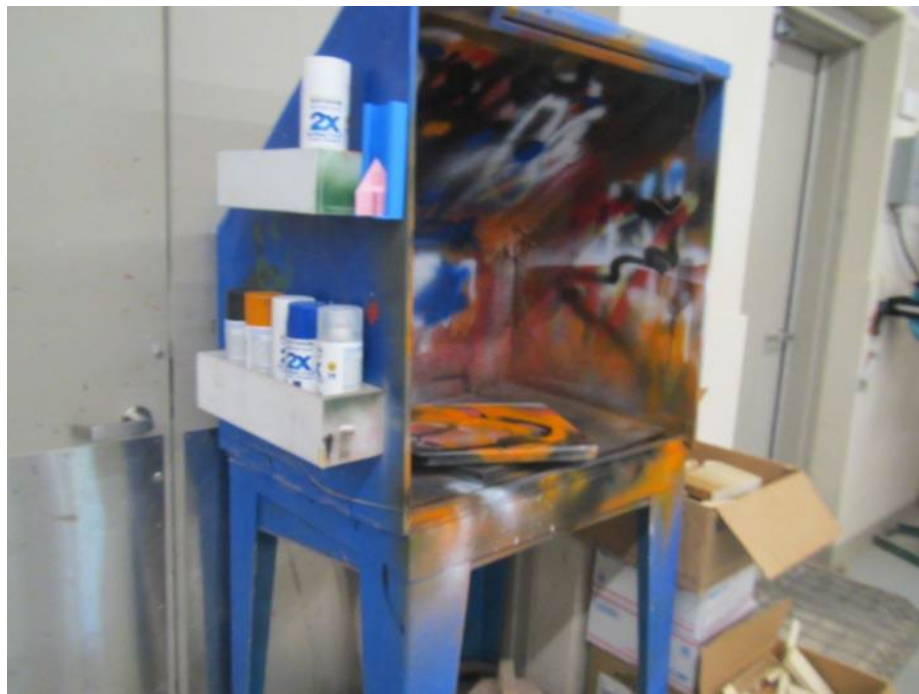
### Picture 28

Painting spray booth in the wood shop, also note the exterior door

| Description | | Helpful links |
|---|---|---|
| 30. | Take steps to keep the wood shop organized and clean of debris to prevent excess wood dust in the air and physical hazards. | |

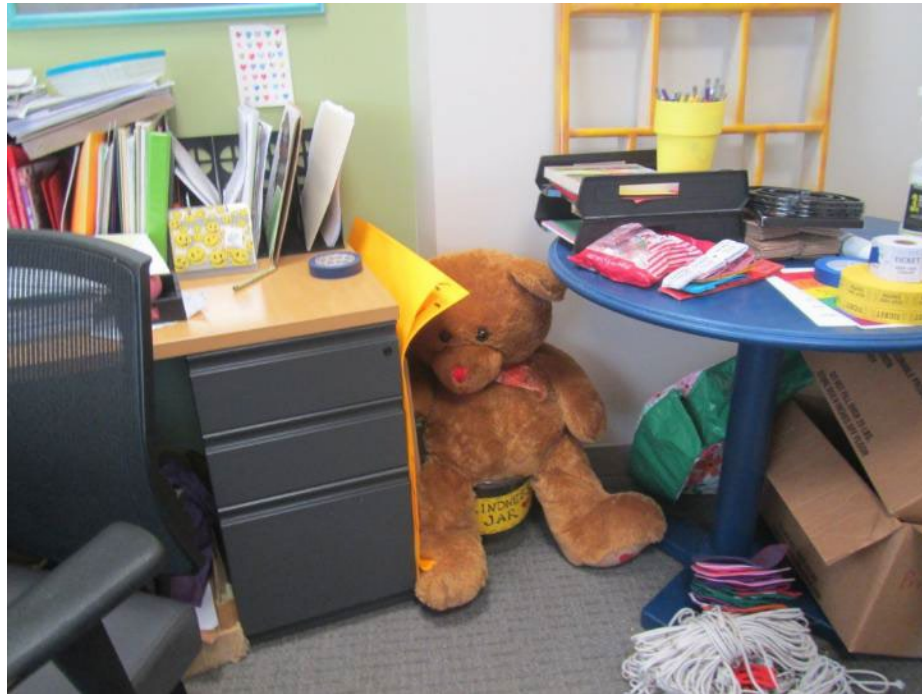
Picture 29

- **Plush items (Picture 29) and upholstered furniture were found in some areas of the school.** These items need to be cleaned regularly to remove accumulated dust.

Plush item in an office
