MassDOT Quarter 2 Submittal (September 8 – December 7, 2010)

NPDES MS4 General Permit Compliance Water Quality Impaired Waters Assessment and Mitigation Plan

December 8, 2010

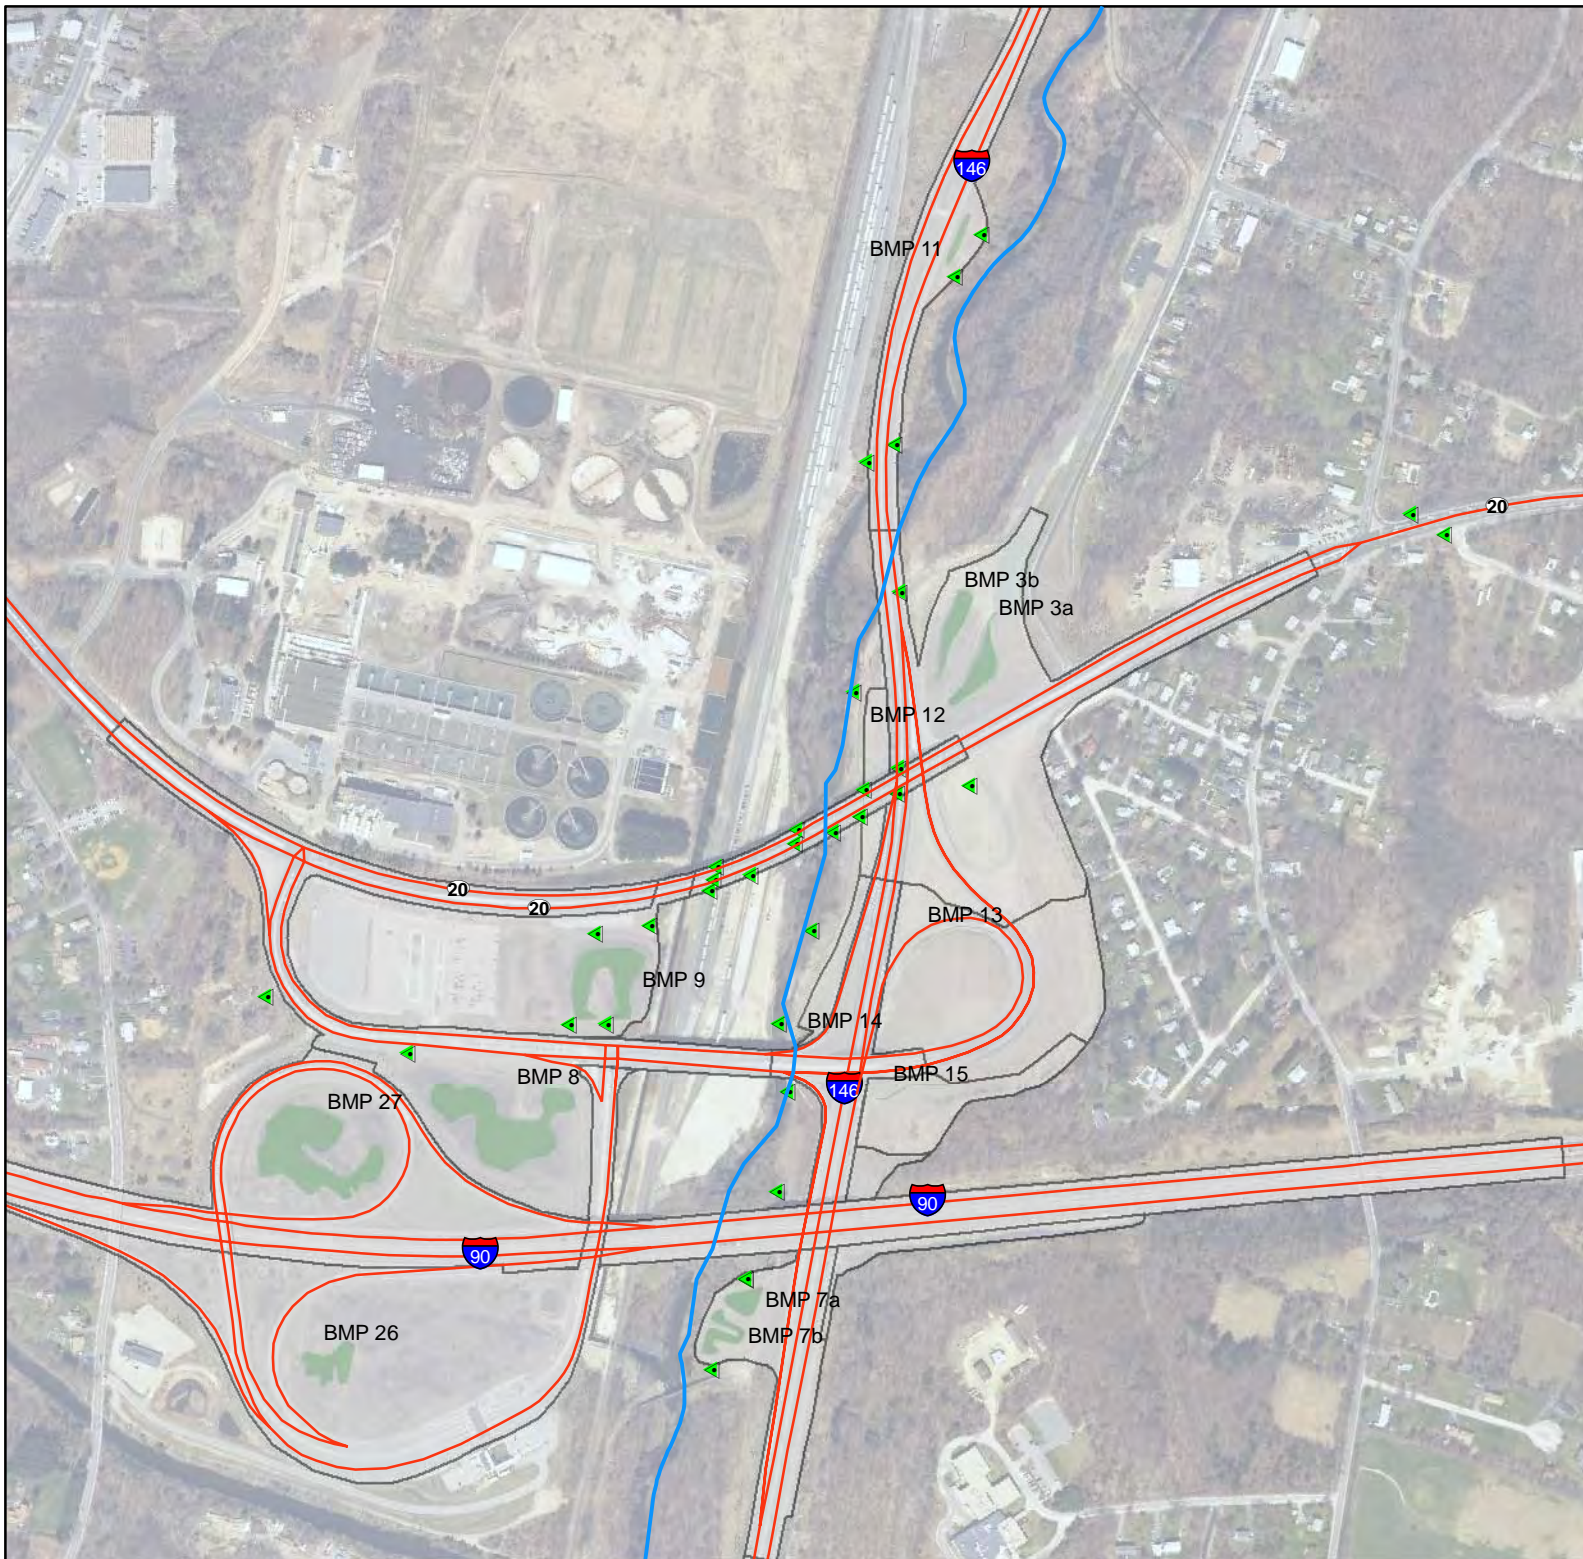
Figure 2a
Blackstone River
Directly Contributing
Watershed
MA51-03
 December 2010

Storm water from approximately 116 acres of MassDOT roads discharges directly to this segment of the Blackstone River. Approximately 94% of that area flows through storm water structural BMPs prior to discharging to the river. The storm water systems are comprised of a combination of piped collection systems, surface swales, and detention and infiltration systems with well-established vegetation. Several systems include BMPs in series, providing additional treatment of storm water prior to discharge. These BMPs are generally sized to store/treat approximately one inch or more runoff over their contributing impervious watersheds and many have additional storage and outlets

The existing BMPs that mitigate potential storm water quality impacts prior to discharge to Blackstone River Segment MA51-03 include infiltration basins, dry ponds (extended detention), and grass swales. These BMPs receive credit for removing the effect of IC depending on their type, size relative to the IC that they process, and the local soil conditions. The areas associated with the existing BMPs are general hydrologic group B (sand and loam) and group C (silt, loam, and clay) soils or urban fill. Urban fill was conservatively assumed to have drainage properties similar to those of a group C soil.

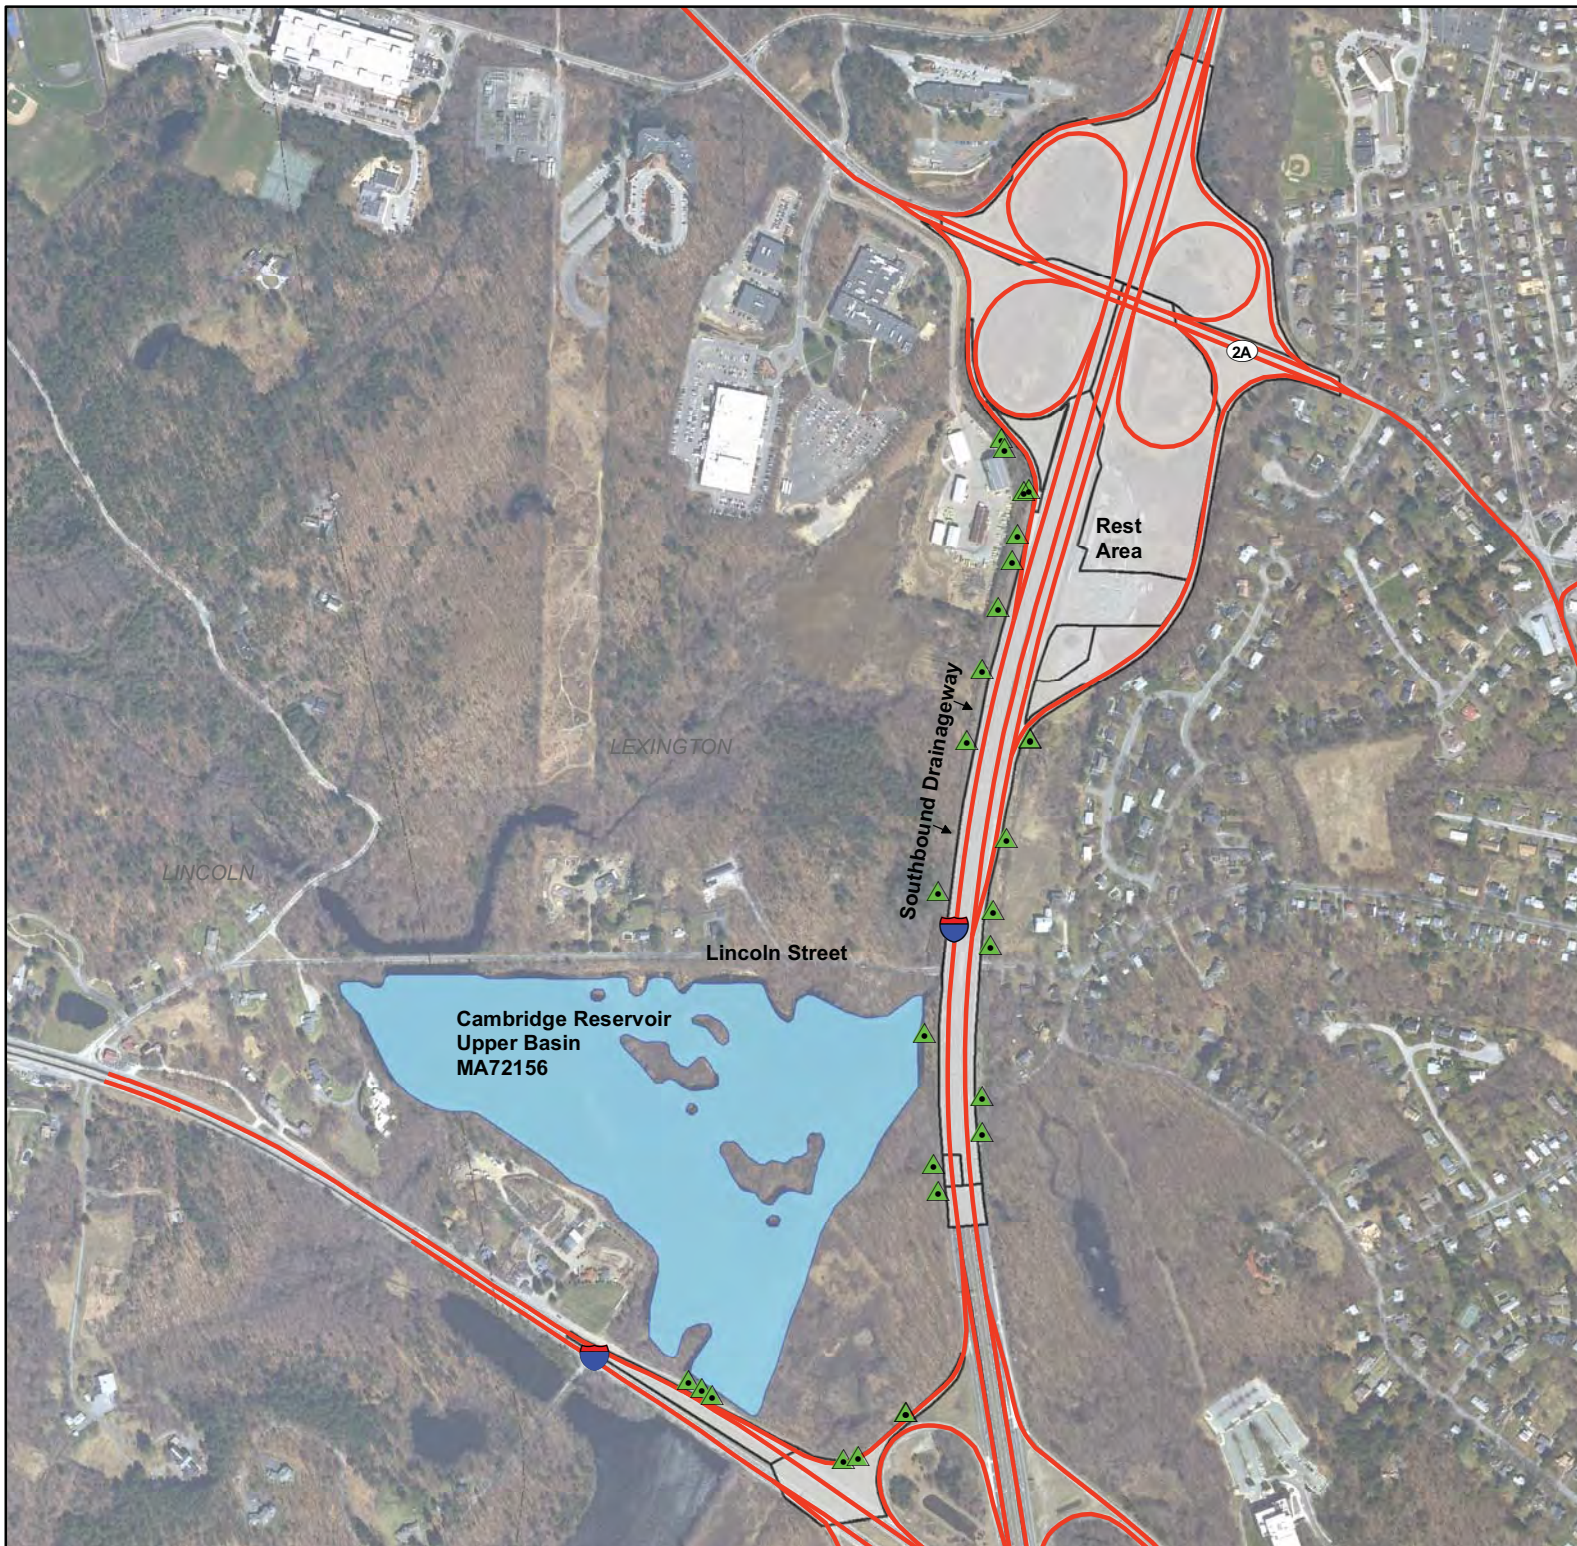
Figure 1
Cambridge Reservoir
Upper Basin
Watershed
MA72156

MassDOT property in the watershed includes portions of Route 2A, Route 95 from north of Route 2A to Route 2, and Route 2 which traverses the southern boundary of the reservoir (Figure 1). In addition there are interchanges at both Route 2A and Route 2, and a rest area on the northbound side of Route 95 just south of Route 2A. MassDOT owns at least 24 outfalls that discharge to the reservoir directly or to a reach of a small drainageway that then discharges to the Cambridge Reservoir Upper Basin (Figure 2). The drainageway, which runs from Route 2A to the reservoir, has been channelized and culverted along the southbound side of Route 95. For purposes of this assessment, discharges to this drainageway are functionally considered direct discharges to the Cambridge Reservoir Upper Basin. An overview and details of the direct drainage watersheds and outfalls are presented in greater detail below.
