MassDOT Quarter 3 Submittal

NPDES MS4 General Permit Compliance Water Quality Impaired Waters Assessment and Mitigation Plan

Impaired Waters Assessment for Lowes Pond (MA 42034)

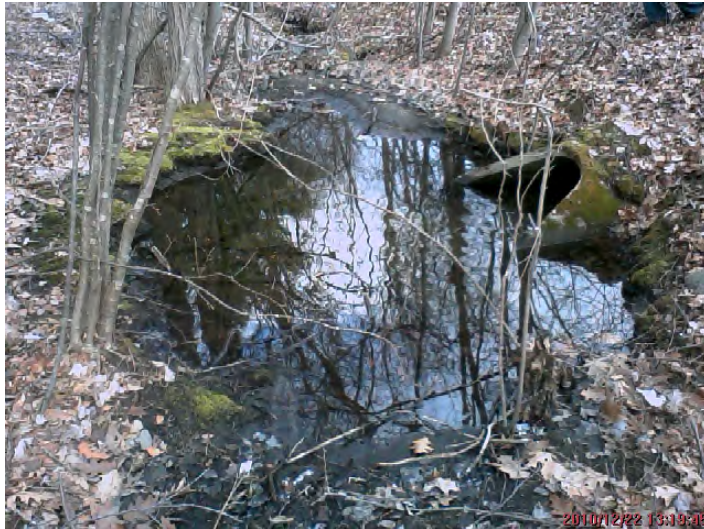
BMP 1 - Outfall 10390

Outfall 10390 is an 18 inch concrete outlet receiving storm water from approximately 5 acres of roadway. It discharges to the shoulder along the southbound side of I-395. Storm water has eroded a small pool where MassDOT observed standing water under dry-weather conditions (shown in the photograph below). It appears that under storm conditions, runoff entering this pool flows into an adjacent 36 inch culvert that flows into the median and then to the opposite side of the highway. MassDOT proposes to install an infiltration basin at this outfall. MassDOT will direct overflow from the infiltration basin into the adjacent culvert during high flow conditions. Refer to Figure 2 for the exact location of this culvert.

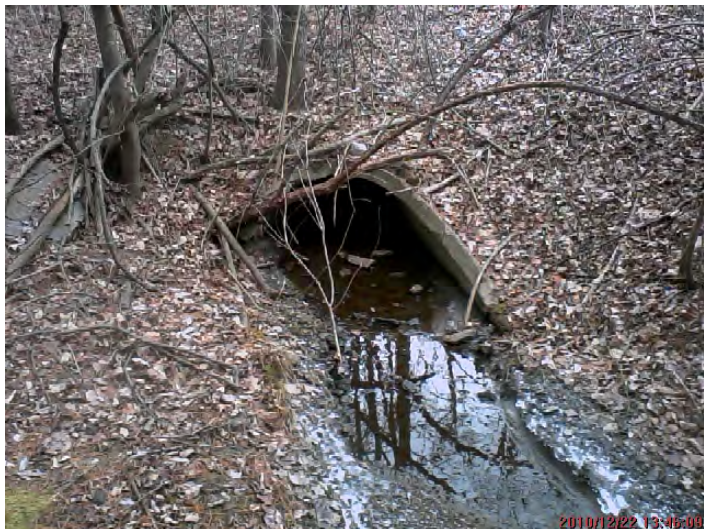
BMP 2 - Outfall 10391

Outfall 10391 is a 24 inch concrete outlet and receives storm water from approximately 3 acres of MassDOT property, mostly roadway. It discharges to the shoulder along the northbound side of I-395 into a heavily-eroded ditch through which MassDOT observed some dry-weather flow, as shown in the photograph below. This dry-weather flow appeared clean and is likely due to groundwater inflow. MassDOT proposes to install an infiltration basin to capture and infiltrate flow from this outlet. MassDOT also proposes to armor the existing ditch with erosion control fabric or riprap stone and utilize it for overflow from the infiltration basin during high flow conditions.

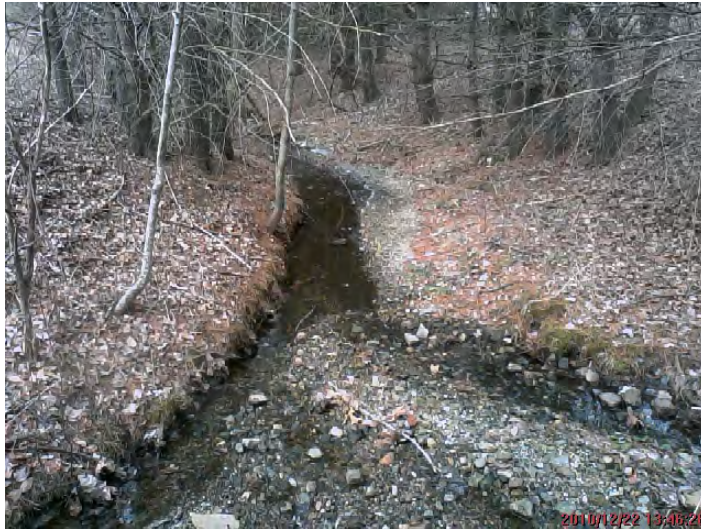
BMP 3 - Outfalls 10392 and 10392.1

Outfall 10392 is a 12 inch concrete outlet and receives storm water from approximately 0.5 acre of roadway. Outfall 10392.1 is the outlet from a 36 inch concrete culvert directing storm water from approximately 1.5 acres in the median to the northbound shoulder. MassDOT proposes to install an infiltration basin to infiltrate storm water discharges from these two outlets.

Additionally, flow from these two outlets currently discharges into a heavily eroded ditch as shown in the photograph below. MassDOT proposes to armor the existing ditch with erosion control fabric or riprap stone and utilize it for overflow from the infiltration basin during high flow conditions.

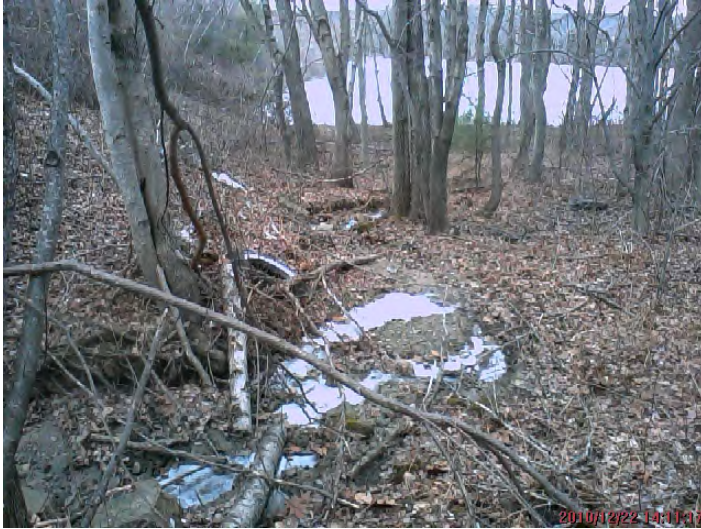
BMP 6 - Outfall 13633.4

Outfall 13633.4 is a 12 inch concrete outlet receiving storm water from approximately one acre of roadway. It discharges to a heavily eroded ditch flowing directly to Lowes Pond as shown in the photograph below. MassDOT proposes to install an infiltration basin at this outlet to capture and infiltrate storm water. MassDOT will also armor the existing ditch with erosion control fabric or riprap stone and utilize it for overflow from the infiltration basin during high flow conditions.

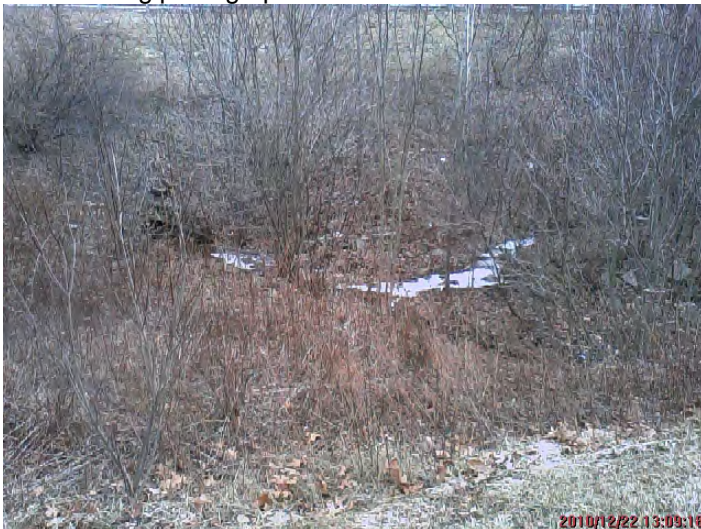
BMP 7 - Outfalls 10393 and 10513

Outlet 10393 is a 12 inch concrete outlet receiving storm water from approximately 0.35 acres of roadway. Outlet 10513 is a 24 inch concrete outlet receiving storm water runoff from approximately 3.65 acres of both roadway and median drainage. The outlets currently discharge to the median area and flow overland into a 30 inch culvert which directs the storm water to the northbound shoulder. MassDOT proposes to install a water quality swale to collect discharge from these two outlets and direct the storm water into an infiltration basin in the median. The overflow from the infiltration basin will be directed into the existing 30 inch culvert and flow to the northbound shoulder.

The following photograph shows the current condition of the median.

Construction of a water quality swale and infiltration basin here may require the removal of some light brush and other vegetation.

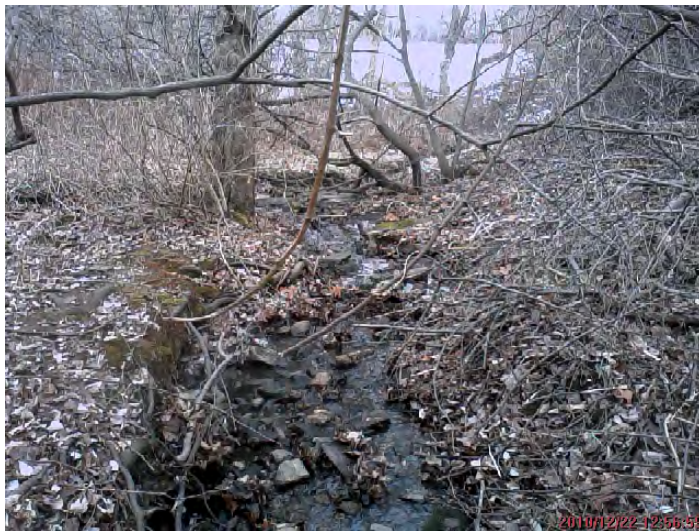
BMP 10 - Outfall 13579

Outfall 13579 is a 12 inch concrete outlet receiving storm water from approximately 2 acres of roadway. The outfall discharges to a heavily eroded ditch approximately 50 to 75 feet from Lowes Pond. As shown in the photograph below, the ditch flows directly towards the water body. MassDOT proposes to construct an infiltration basin to capture and infiltrate storm water from this outlet. In addition, MassDOT proposes to armor the existing ditch with erosion control fabric or riprap stone and utilize it for overflow from the infiltration basin during high flow conditions.

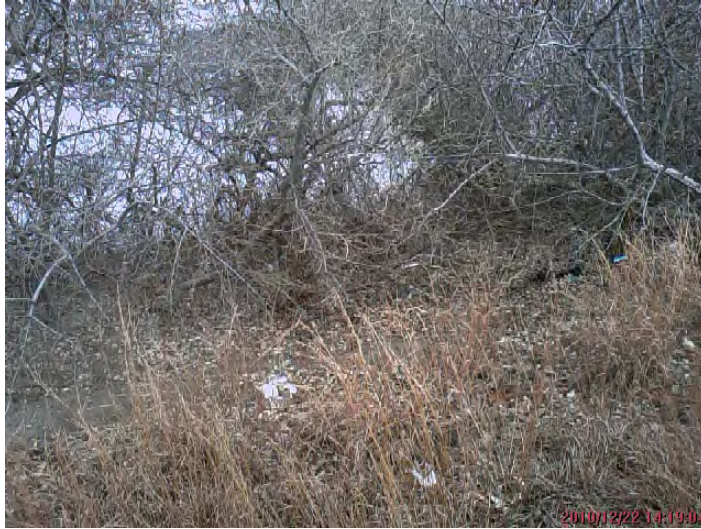
BMP 11 - Outfall 13582

Outfall 13582 is a 12 inch concrete outlet receiving flow from two catch basins that collect storm water from approximately 0.3 acres of roadway. The outfall discharges directly to Lowes Pond along the northbound shoulder of I-395 approximately 100 feet south of the pond's culvert. The shoulder of the road in this location slopes down towards the pond at approximately two horizontal to one vertical. As shown in the photograph below, there is not adequate space here for the construction of a water quality BMP. MassDOT instead proposes to reroute this outfall to discharge to the median.

Original construction plans for this portion of I-395 from 1972 show that the median directly across from this outlet has been mildly graded to channel approximately 2.7 acres of storm water northward towards Lowes Pond. In addition, the median in this location is relatively vegetation-free. MassDOT will construct a vegetated filter strip in the median by reestablishing vegetation to slow runoff velocities and promote infiltration of storm water from the median and from the rerouted outlet before entering Lowes Pond.

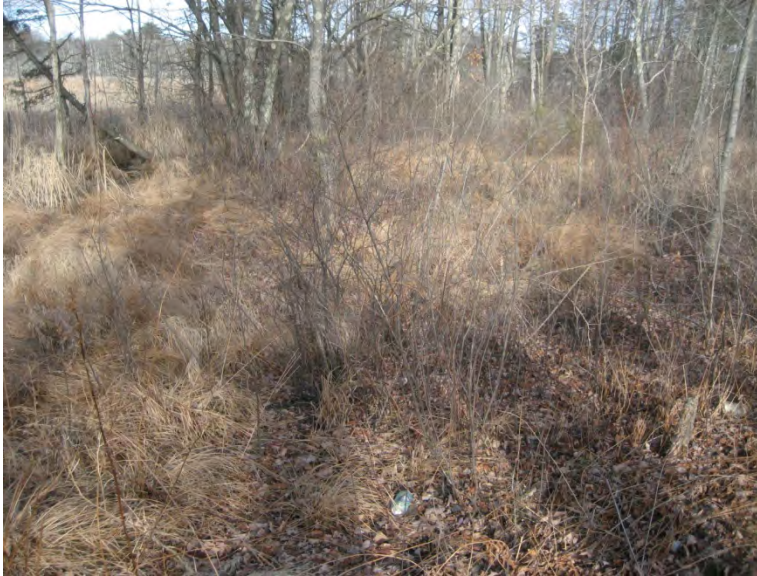
show that the outfall was designed to discharge into a 4 foot wide ditch graded towards Lowes Pond.

MassDOT observed that this ditch was partially filled and overgrown with vegetation, as shown in the photograph below. MassDOT proposes to convert this ditch into a water quality swale to provide treatment before storm water from this outlet enters Lowes Pond. This will be achieved by removing accumulated sediment and debris, reestablishing grass cover, and adding stone check dams to provide some detention of storm water flows.

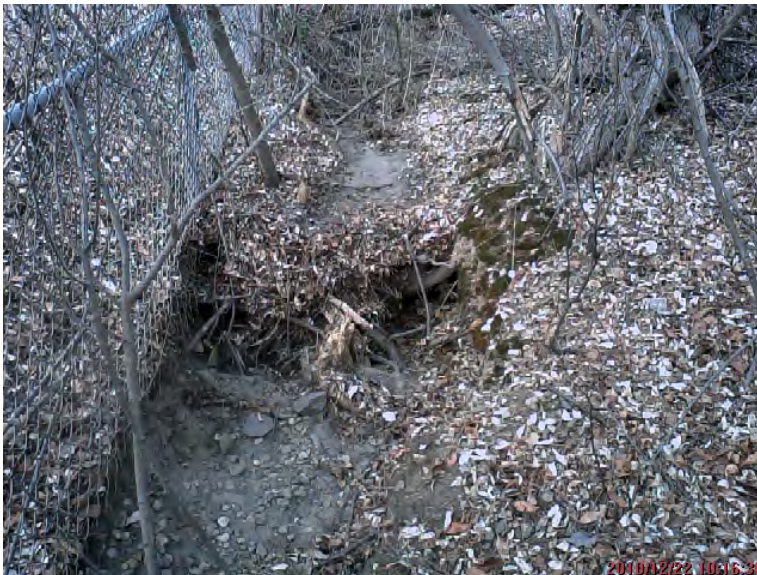
BMP 15 - Outfall13631.4

Outfall 13631.4 is a 12" corrugated metal outlet discharging to a heavily eroded ditch that flows into a small finger along the northwestern edge of Lowes Pond. The outfall receives storm water runoff from approximately 0.3 acres of roadway. MassDOT proposes to convert the heavily eroded ditch into a water quality swale to provide treatment before discharge from this outlet enters the water body upstream of Lowes Pond.

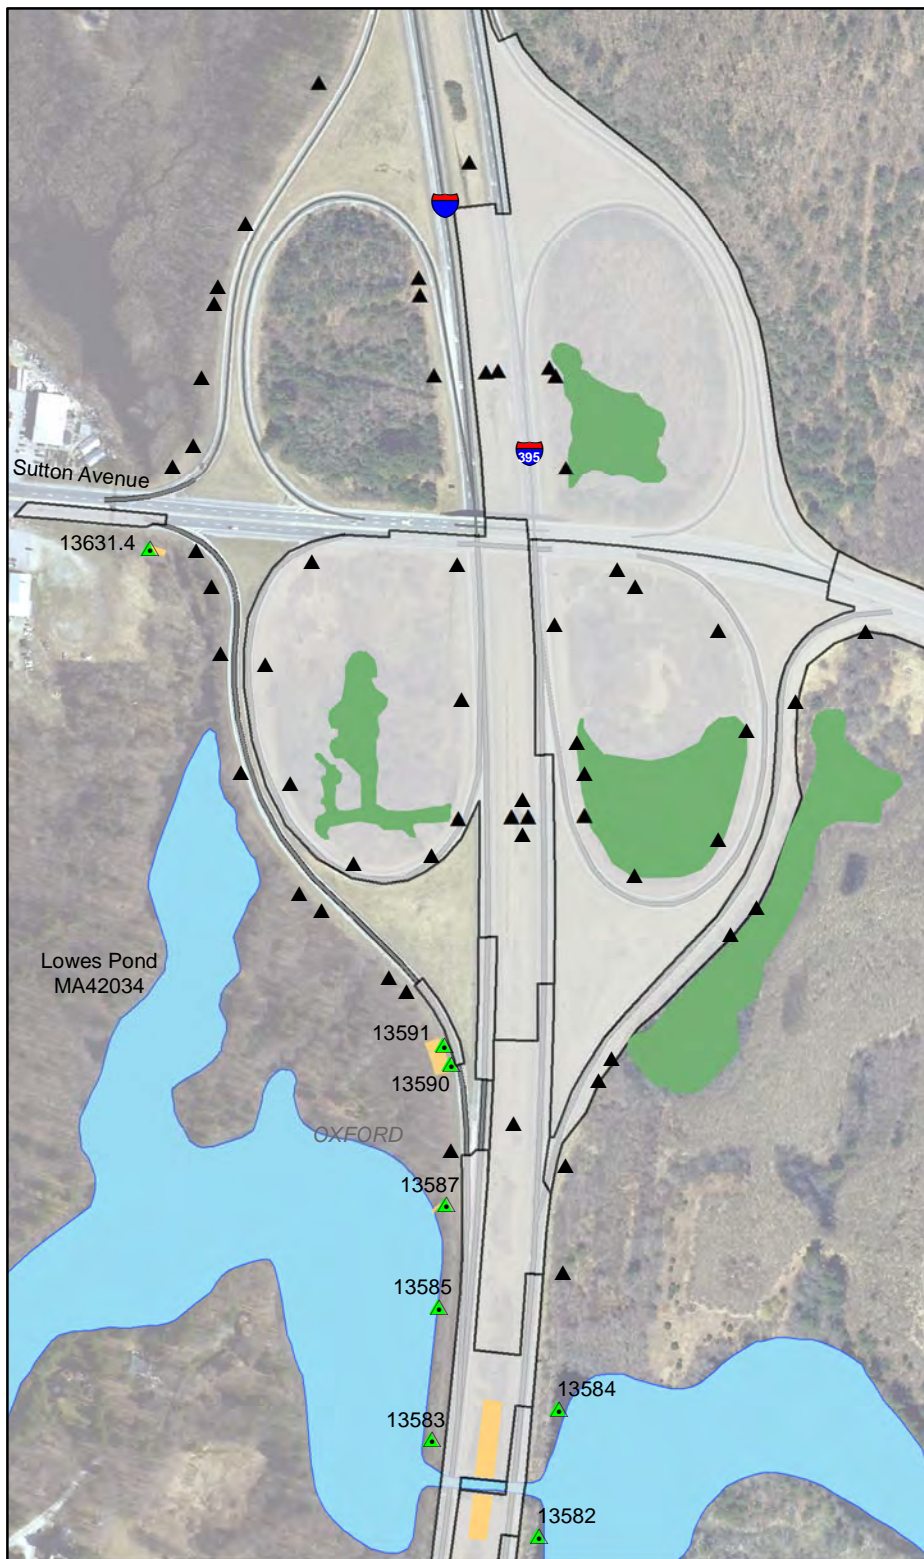
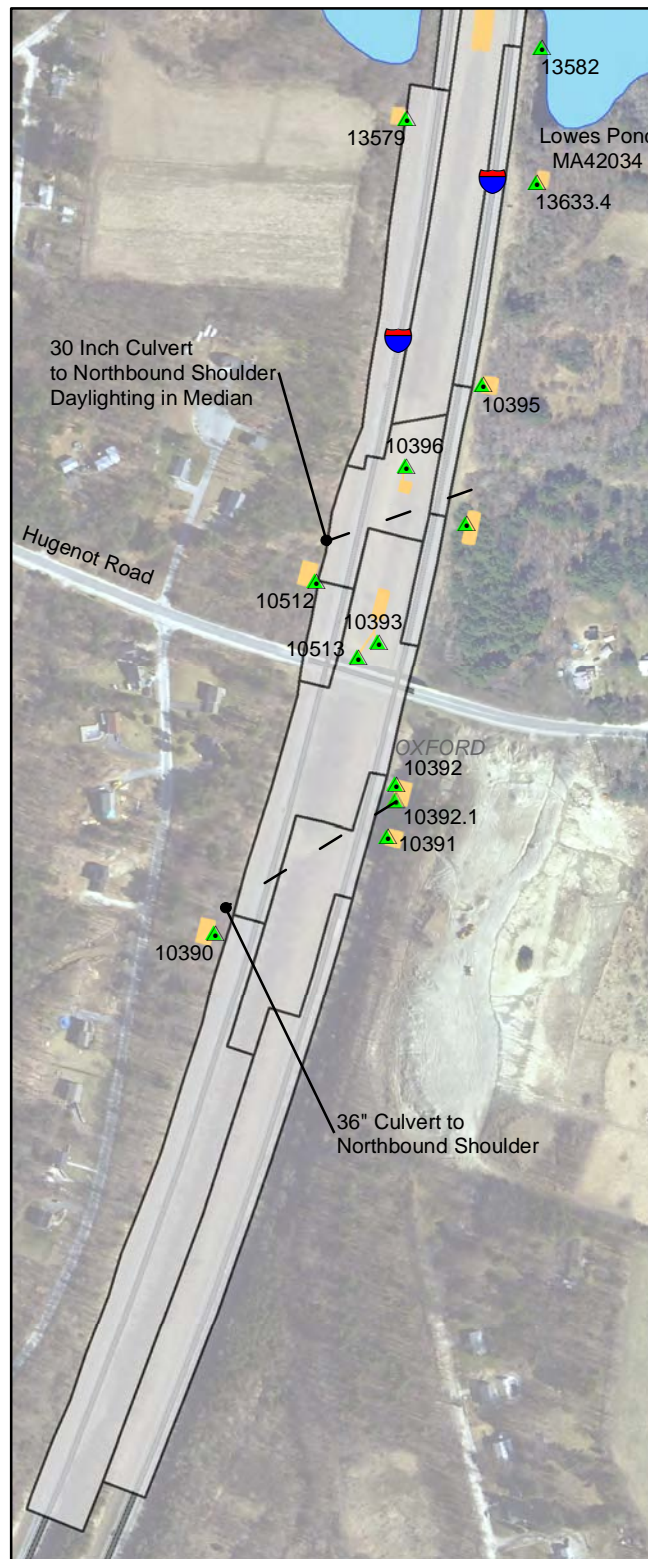
Figure 2
Lowes Pond

- Town Boundaries
- ▲ MassDOT Outfalls
- ▲ Proposed BMP Outfalls
- ~ Impaired Stream Segments
- ~ Impaired Water Bodies
- ~ Existing Stormwater Wetlands
- ~ Proposed BMPs
- ~ BMP Watersheds
- MA DOT Roads in Urban Areas
- MA DOT Roads

The recommended BMPs provide 77% removal of TP from MassDOT's directly contributing urban property, meeting the 77% reduction required by the TMDL. Refer to Figure 2 for exact locations of the recommended BMPs.

The following sections describe the recommended BMPs in further detail. Refer to Figure 2 for exact location of storm water outfalls and recommended BMPs.
