WATERSHED-BASED PLAN

Lake Mansfield
Great Barrington, MA

December 5, 2018

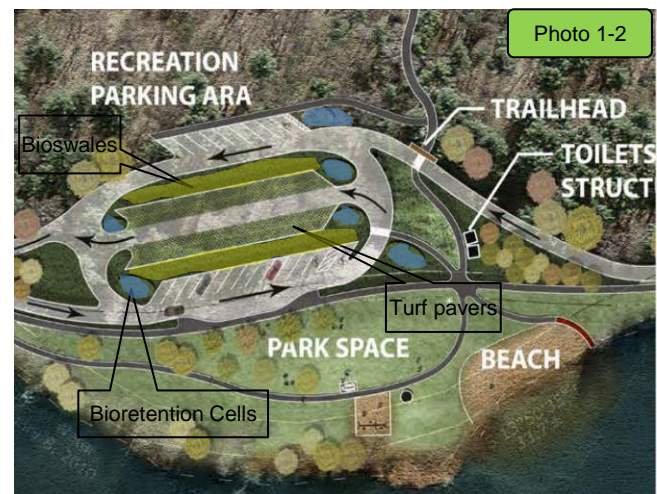
Proposed Improvement: As part of the “Town of Great Barrington Lake Mansfield Recreation Area Improvements” (KZLA, 2016), a conceptual level design was presented for proposed updates to the recreation parking area. Photo 1-2 depicts the concept illustration from the report with some added callouts. The recommended parking plan moves the parking north of its existing location with a total of 50 paved parking spaces. The proposed stormwater management system includes turf pavers for the “overflow” parking spaces, two bioswales and six “small detention basins”. As an update to KZLA’s report, it is recommended that the proposed “small detention basins” be replaced with bioretention cells to allow for greater pollutant removal efficiency.

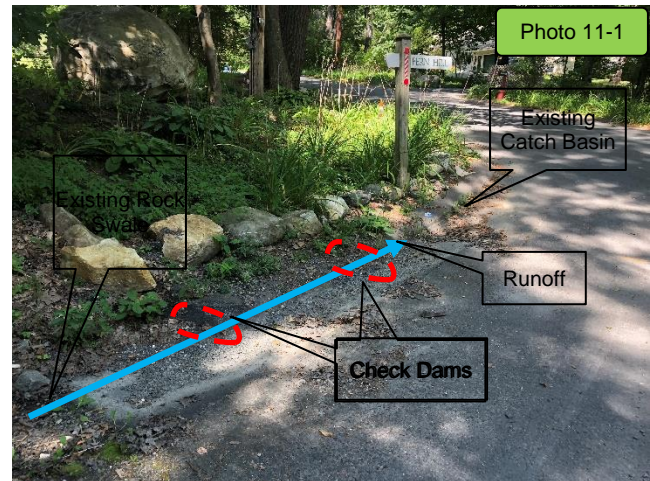
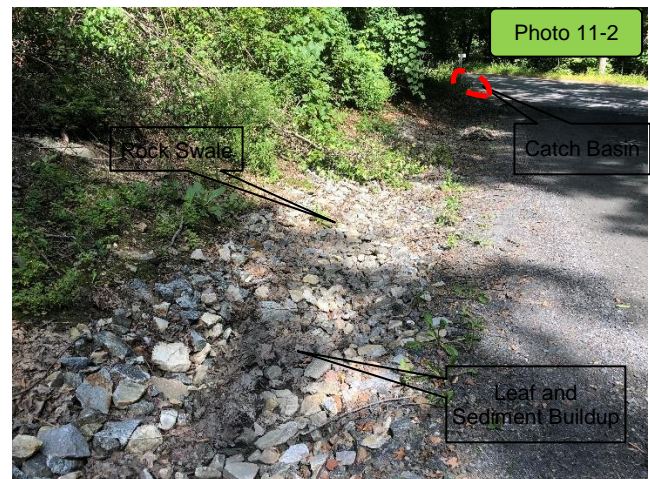
BMP Type: Rock Swale Maintenance and Check Dams
