**Westborough District Court
Westborough, MA**

**HVAC SYSTEM
EVALUATIONS
COVID-19**

Office of Court Management

March 15, 2022

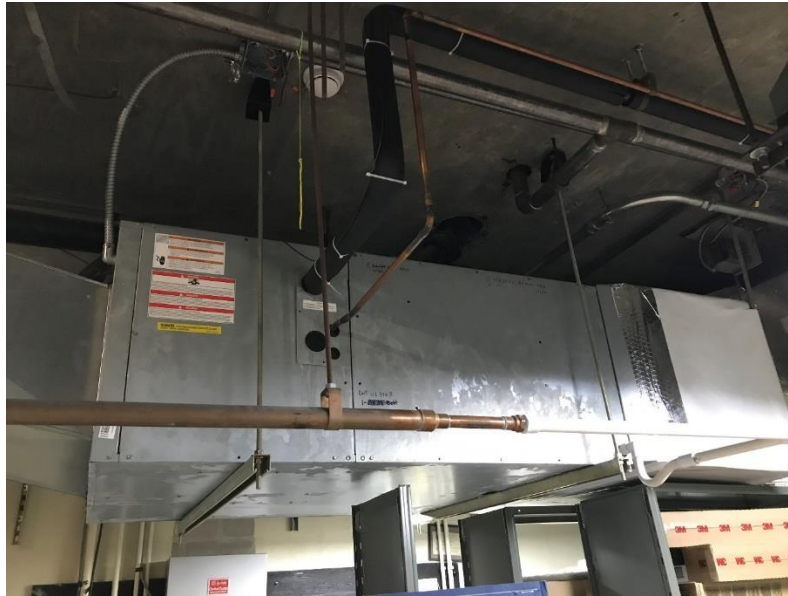
Photo 1 – Typical Air Handler

AHU-1 serves the lobby area on the upper floor and is located above the ceiling in the public men's room. This unit has a 1" thick MERV-13 inlet filter, direct expansion (DX) cooling coil, and a supply air fan. Two electric resistance heating coils, with 13-kW and 10-kW capacity, are located in the supply ductwork. AHU-1 is paired with a 4-ton outdoor air-cooled condensing unit (CU-1), mounted on the low roof. Both AHU-1 and CU-1 are original to the building and are in poor condition. Facility personnel indicated that this unit is scheduled for replacement in the near future.

AHU-2 is located in the basement mechanical equipment room and serves the main courtroom on the upper floor. This unit has 2" thick MERV-13 inlet filters, a direct expansion (DX) cooling coil, and a supply air fan. AHU-2 is original to the building and is in fair condition. This air handler is paired with a 7.5-ton outdoor air-cooled condensing unit (CU-2) pad-mounted on grade. CU-2 appears to have been replaced recently, and the original unit is abandoned in place on the roof.

AHU-3 is a heating-only 100% outdoor air makeup unit located in the basement mechanical equipment room and serves the holding cells in the lockup area. This unit has 2" thick MERV-13 inlet filters and a supply air fan. AHU-3 is original to the building and is in fair condition. The unit is sandwiched by a 17-kW electric resistance preheat coil and a 2-kW reheat coil. An inline exhaust fan, rated for 600 cfm, draws air from high-mounted sidewall grilles in each of the holding cells. These units were not operating at the time of our visit.

We strongly recommend replacing AHU-1 immediately, and the other units in 3-5 years. Small indoor air handling units have a life expectancy of 25-30 years. The units in the Westborough District Court are approximately 50 years old and are in fair to poor condition. The air-cooled condensing units should be replaced along with the AHUs. CU-1 is well beyond its expected service lives of 15 years, and it uses R-22 refrigerant which is no longer manufactured. This will limit repair options and increase costs should a failure occur. The replacement systems should use heat pump technology, which will generate energy and operational savings by minimizing the use of electric resistance heat. This will also provide AHU-3 and the holding cells with air conditioning and dehumidification in summer.

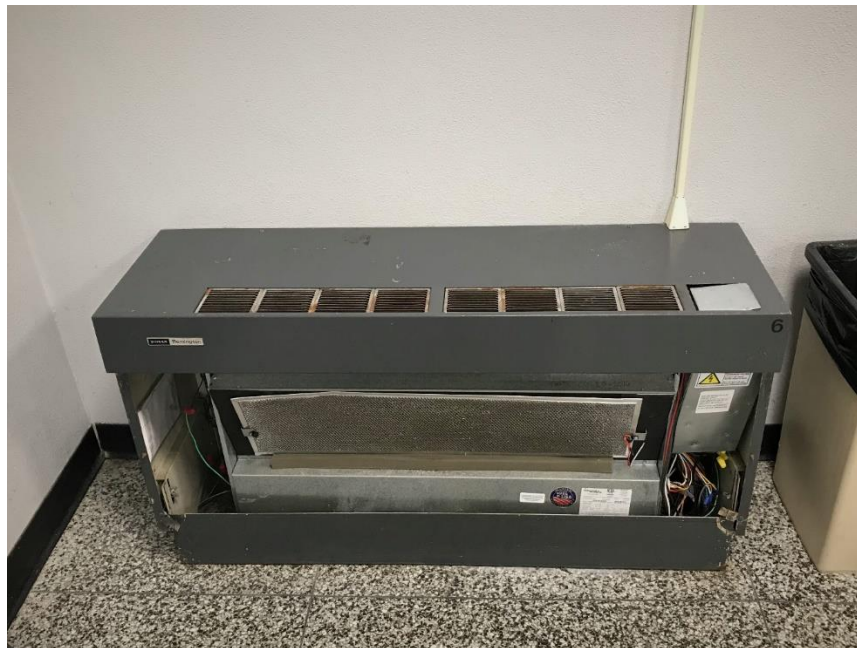
Photo 2 – Original Unit Ventilator

There are 18 heating-only unit ventilators serving areas around the building perimeter. These units each have a 36-kW electric resistance heating coil, a two-speed supply air fan, OA intake louver and control damper. The filters are washable expanded metal type, and do not have a MERV rating. We were unable to verify operation of the outdoor air dampers, and none of the intake louvers were observed to have any airflow. The condition of these units varies, as some are original to the building, and some are recent replacements.

We recommend replacing the unit ventilators. The average life of a unit ventilator is approximately 35 years. The units that appear to be original are approximately 50 years old, exceeding their expected useful life. The replacement units should be specified with MERV-13 filters, code-compliant OA volumes, and packaged terminal heat pump (PTHP) technology to minimize the electric resistance heating load. This will also provide these areas with air conditioning and dehumidification in summer. Units can be selected with less fan noise for sensitive areas.

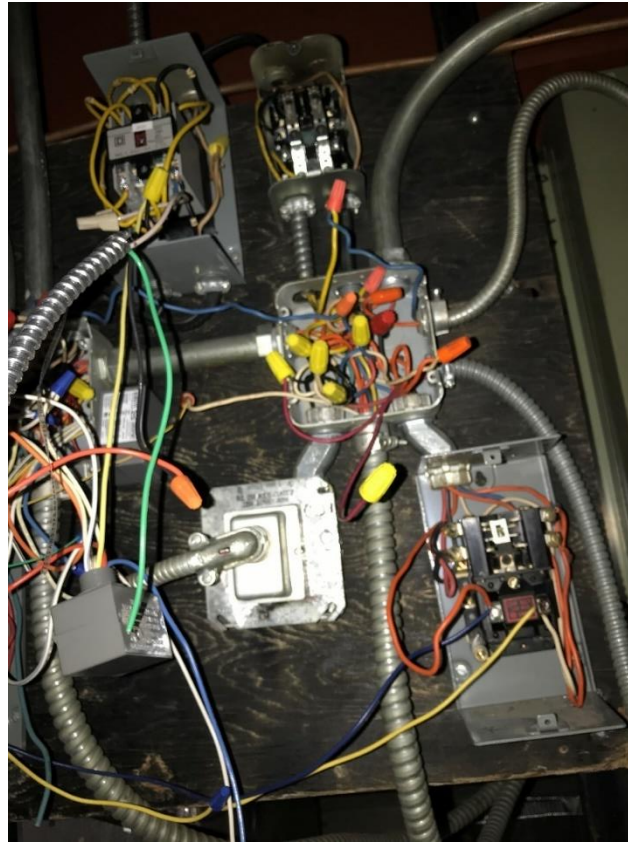
Photo 3 – Original Controls for AHU-1

AHU-1 serves the lobby area on the upper floor and has the original controls.

When the air handling units are replaced, we recommend adding a BMS to control and monitor equipment. The existing controls are antiquated and do not offer the same benefits as a BMS.

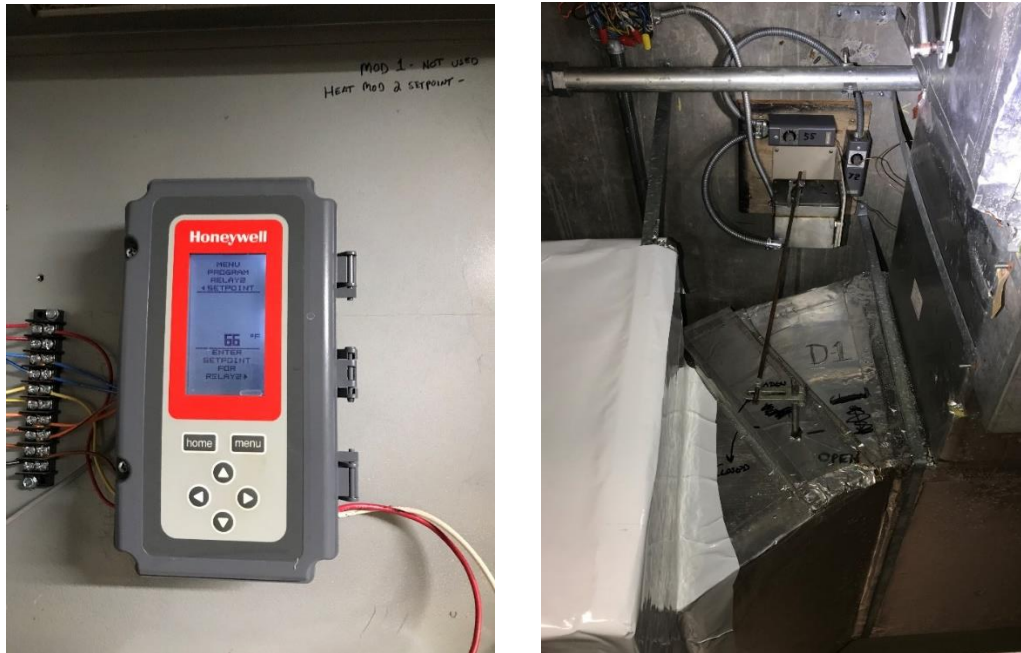
Photos 4 and 5 – Programmable Controller and Outdoor Air Damper Controls for AHU-2

AHU-2 serves the main courtroom and has a programmable controller for scheduling and temperature control. Some system components still the original controls, such as the outdoor air damper that appears to be using thermostats for upper and lower temperature limits.

It should also be noted that the programmable controller does not run the supply fan continuously during occupied hours and does not seem to control EF-1. The original design had AHU-1 and EF-1 under timeclock control. Facilities personnel indicated that EF-1 has been serviced to verify that it is operational, but they do not know how it is controlled.

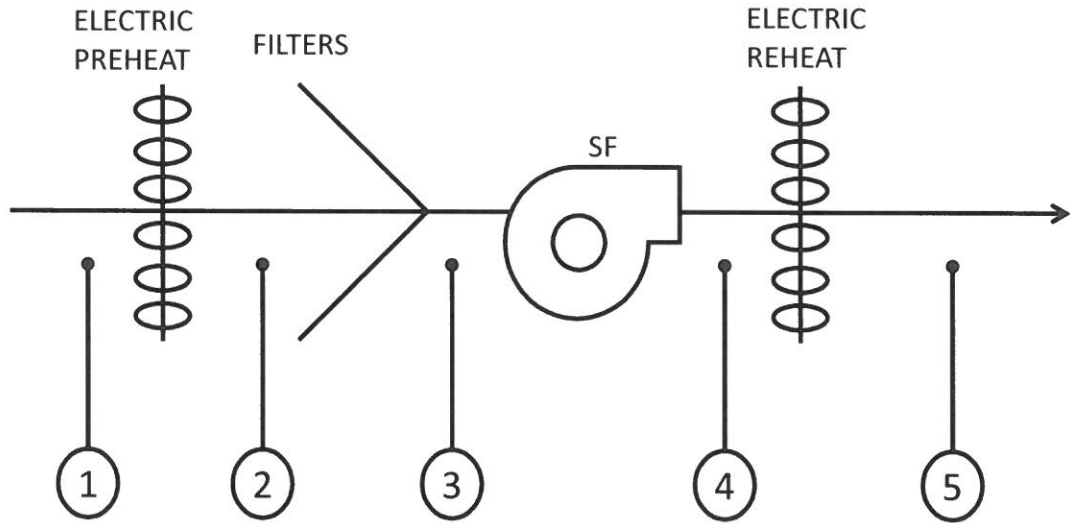
SYSTEM STATIC PRESSURE PROFILE

PROJECT:	Westborough District Court	DATE:	2/2/22
SYSTEM/AREA:	AHU-3	TECH:	BS

STATIC PRESSURE READINGS "wc

POS. (+) / NEG.(-)	1	2	3	4	5	6	7	8	NOTES
AHU-3	-0.04"	-0.05"	-0.26"	+0.54"	+0.52"

8. The supply fan for AHU-3 is providing more than double the design airflow rate for this unit. While this unit does have adequate heating and cooling capacities to handle the additional outdoor air, it would be significantly over-pressurizing the lockup area causing air to leak into the adjacent spaces. We recommend rebalancing AHU-3 to provide balanced ventilation with EF-12 (the exhaust fan serving this area) in order to maintain neutral pressurization in the lockup area.
