**APPENDIX H**  
**Quality Assurance Project Plan for Wetland Monitoring and**  
**Assessment Demonstration Project: Assessment of Wetland**  
**Mitigation Success**

### Revision to Quality Assurance Project Plan for Wetlands Monitoring and Assessment Demonstration Project: Assessment of Wetlands Mitigation Success (EPA RFA # EPA-REG1\_WPDG-2011; 2011-2013)

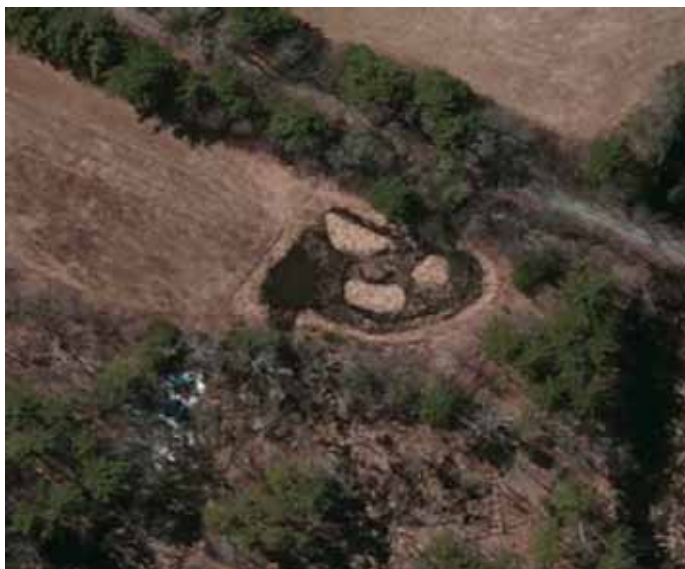
Figure 2: Aerial Image 1

After reviewing the plan we can then review the most recent aerial imagery (MassGIS 2011 Digital Globe imagery) and view the exact area (Figure 2).

Figure 2 depicts a feature that approximates the size, shape, and grading of the Groton replacement area and is in the location where the wetland replacement area is supposed to be built. Thus we can reasonably conclude that the wetland replacement area has been built. By measuring the photo we can confirm the approximate size of the replacement area. As an additional check that this is the wetland replacement area on the plan, we can then review earlier imagery (2005 or 2008 MassGIS orthophotography) to determine if the feature was constructed after the date of the permit. Figure 3 confirms that the wetland replacement area was built after the date of the permit (i.e. between 2004 and 2008) since it shows the feature has not been built.

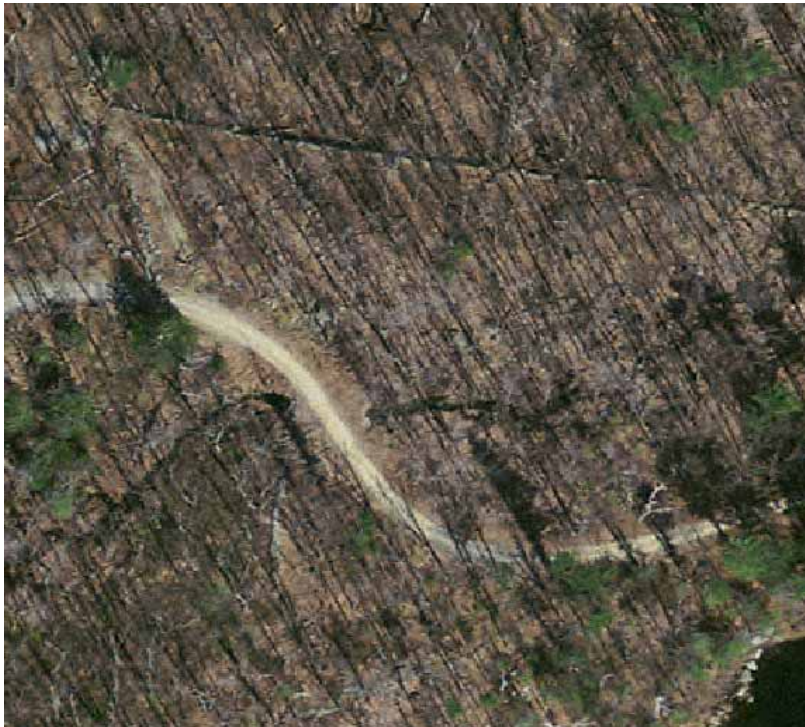
Figure 5: Aerial Image B

Figure 5 below shows recent 2011 aerial imagery that is inconclusive regarding whether or not the site was constructed.

An on-site investigation in the Summer of 2012, however confirmed that the wetland replacement area was in fact constructed. In the course of constructing it, all mature red maples (*Acer rubrum*) were preserved, the amount of excavation needed was minimal (approximately 1 foot in depth) to intercept ground water, and the edges were gradually sloped as opposed to abruptly sloped. The area was then planted with both wetlands shrubs and an herbaceous layer. The net effect of these careful and well implemented replacement area construction practices was to make this successful wetland replacement area effectively un-photointerpretable.
