**Attachment 4:**

**No Discharges from MassDOT Outfalls Assessments**

## List of Impaired Waterbodies

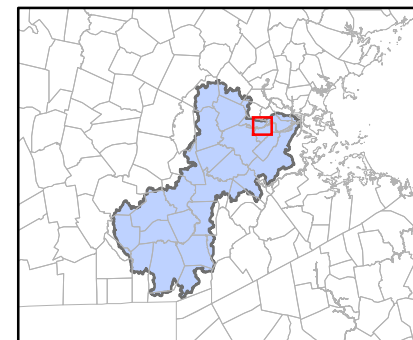
MassDOT property does not discharge directly to Sawins Brook. The nearest MassDOT property is a small portion of Arsenal Street and the bridge carrying Arsenal Street over the Charles River, was recently transmitted to MassDOT from DCR (see attached Figure).

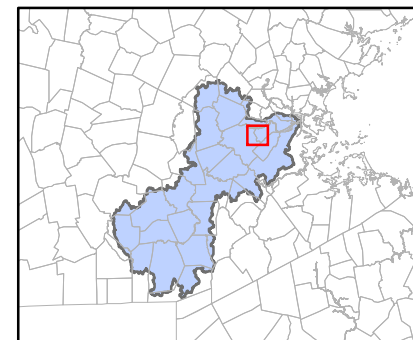
MassDOT property does not discharge directly to Chandler Pond (see attached figure). The nearest up-gradient MassDOT property is a segment of Interstate 90 approximately 0.75 miles north of the Pond. Stormwater runoff from this section of I-90 discharges to the Charles River. Route 9 is approximately 1.4 miles south of the Pond. Neither of these MassDOT roadways discharge directly to the Pond.
