Impaired Waters Assessments – Final Reports (IC/TMDL)

List of Impaired Water Bodies

Impaired Waters Assessment for Alden Pond (MA36003)

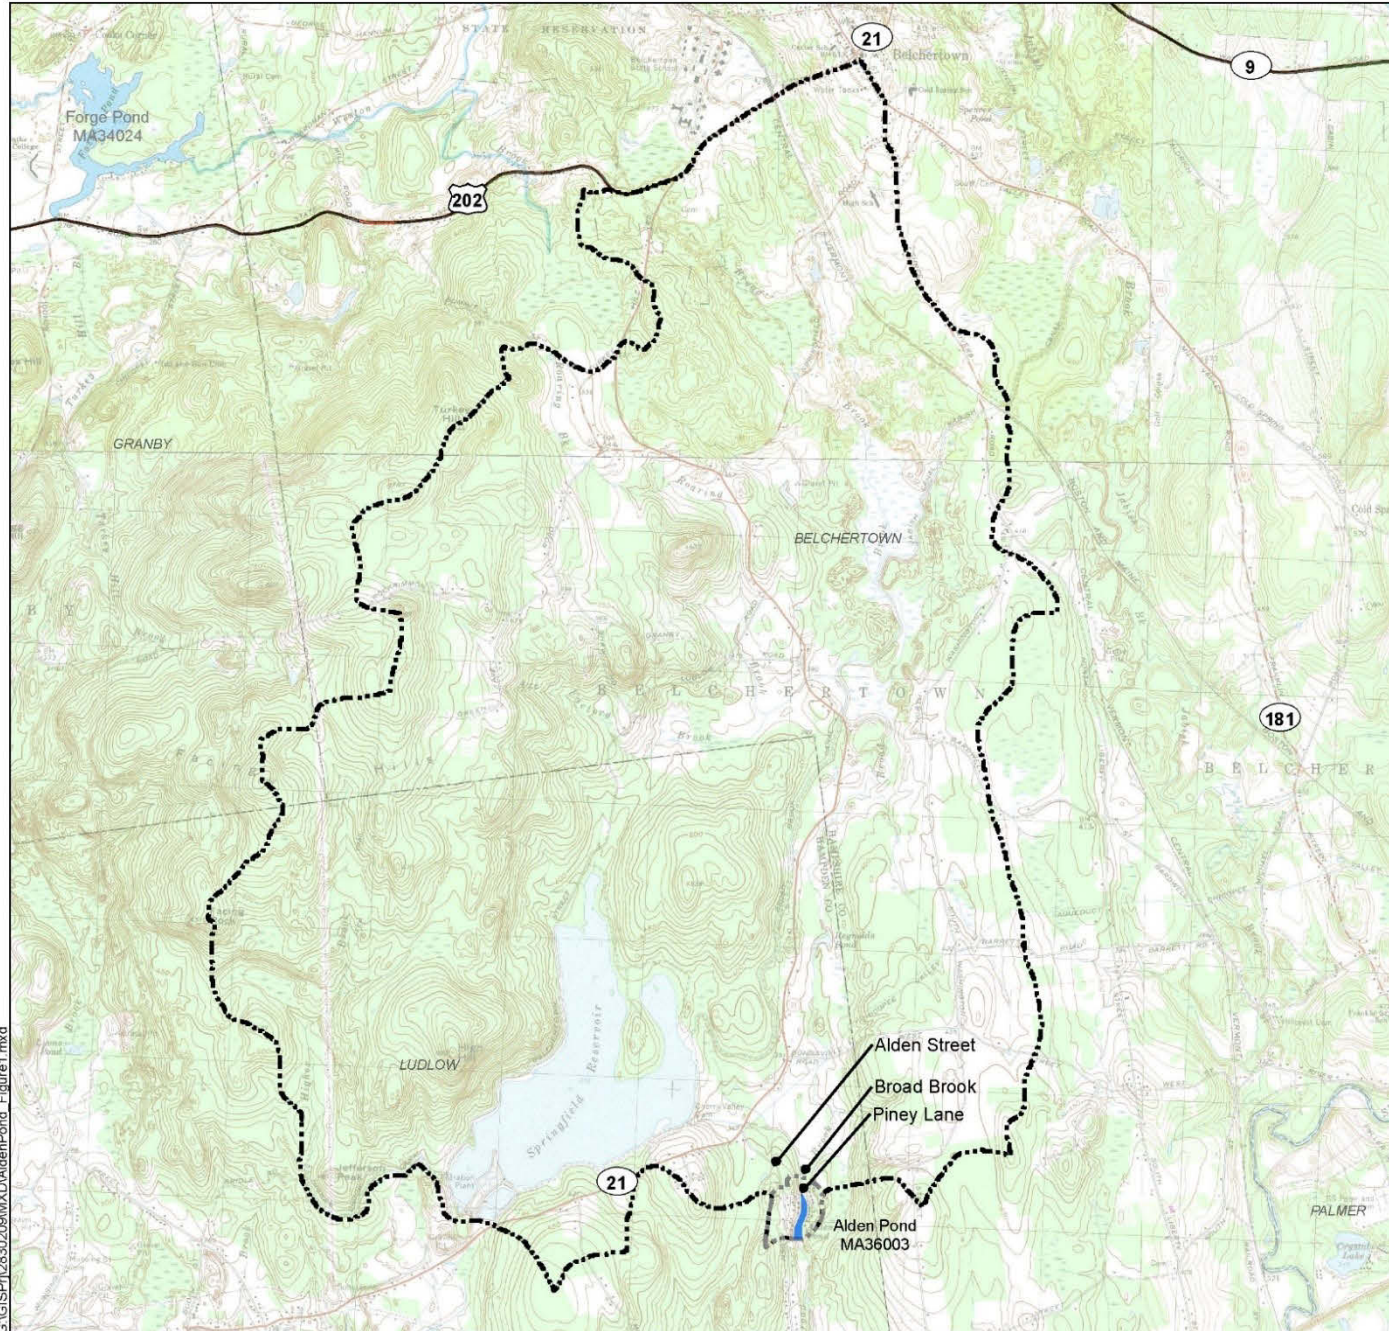
G:\GIS\PI\2830209\MXD\AldenPond_Figure1.mxd

2.7 miles to the west and 1.0 miles to the east (**Figure 1**). MassDEP's Water Quality Assessment Report³ for this receiving water states that the trophic state is eutrophic.

Alden Pond's subwatershed is 40 acres and is shown in **Figure 1**. The surrounding land use is generally residential. Alden Pond is fed from the north by Springfield Reservoir and Broad Brook through three arch culverts and outlets to the south into the continuation of Broad Brook and the Chicopee River. The section of Piney Lane that crosses over the three culverts at the northern end of Alden Pond is the only MassDOT owned roadway within the Alden Pond subwatershed (**Figure 2**).

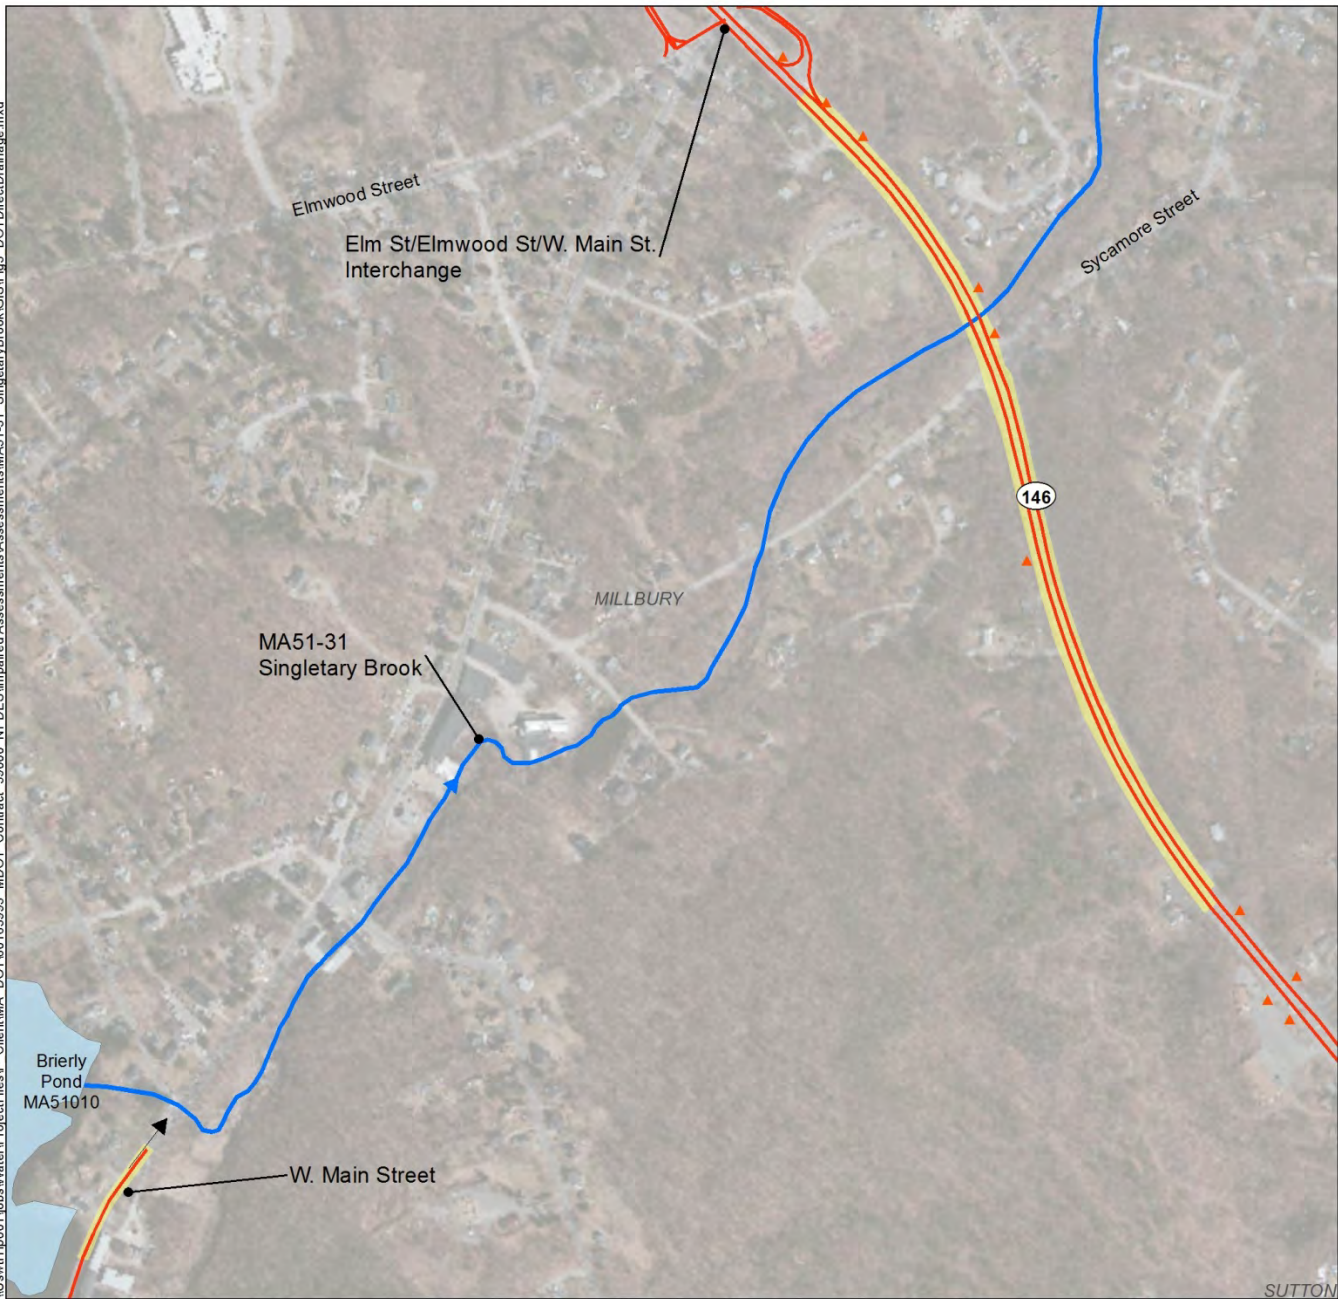
Figure 3
Singletary Brook (MA51-31)
Directly Contributing
MassDOT Watershed
June 2014

- Assessed Segment
- MassDOT Outfalls
- MassDOT Roadways in Urban Area
- MassDOT Roadways
- Impaired Streams
- Impaired Lakes
- MassDOT Directly Discharging Area

West Main Street contributes stormwater runoff to the portion of Singletary Brook that is downstream of Brierly Pond. West Main Street is adjacent to Brierly Pond; however, as shown in Figure 3 a portion of the roadway directs flow to a catch basin located to the northeast. This catch basin discharges stormwater to the portion of Singletary Brook, downstream of Brierly Pond, where it flows under the roadway. Stormwater runoff from other portions of W. Main Street south of the portion directly discharging to Singletary Brook is shown to discharge to Brierly Pond, as indicated in the Brierly Pond (MA51010) assessment, or to a non impaired stream segment east of the roadway.

Stormwater runoff from portions of Route 146, both northbound and southbound, also directly discharges to Singletary Brook (Figure 3). Route 146 is a two lane state road with a jersey barrier median. Singletary Brook flows beneath Route 146 north of Sycamore Street. From a high point to the south of the Brook, stormwater from Route 146 is directed to catch basins located on the shoulders of the roadway and in the median. These drainage systems discharge flow to Singletary Brook.

From the interchange of Route 146 with Elm St/Elmwood St/West Main St, stormwater runoff is discharged to a roadside ditch adjacent to the north bound lanes. This ditch conveys flow to Singletary Brook and is therefore considered direct discharge to the water body (Figure 3).

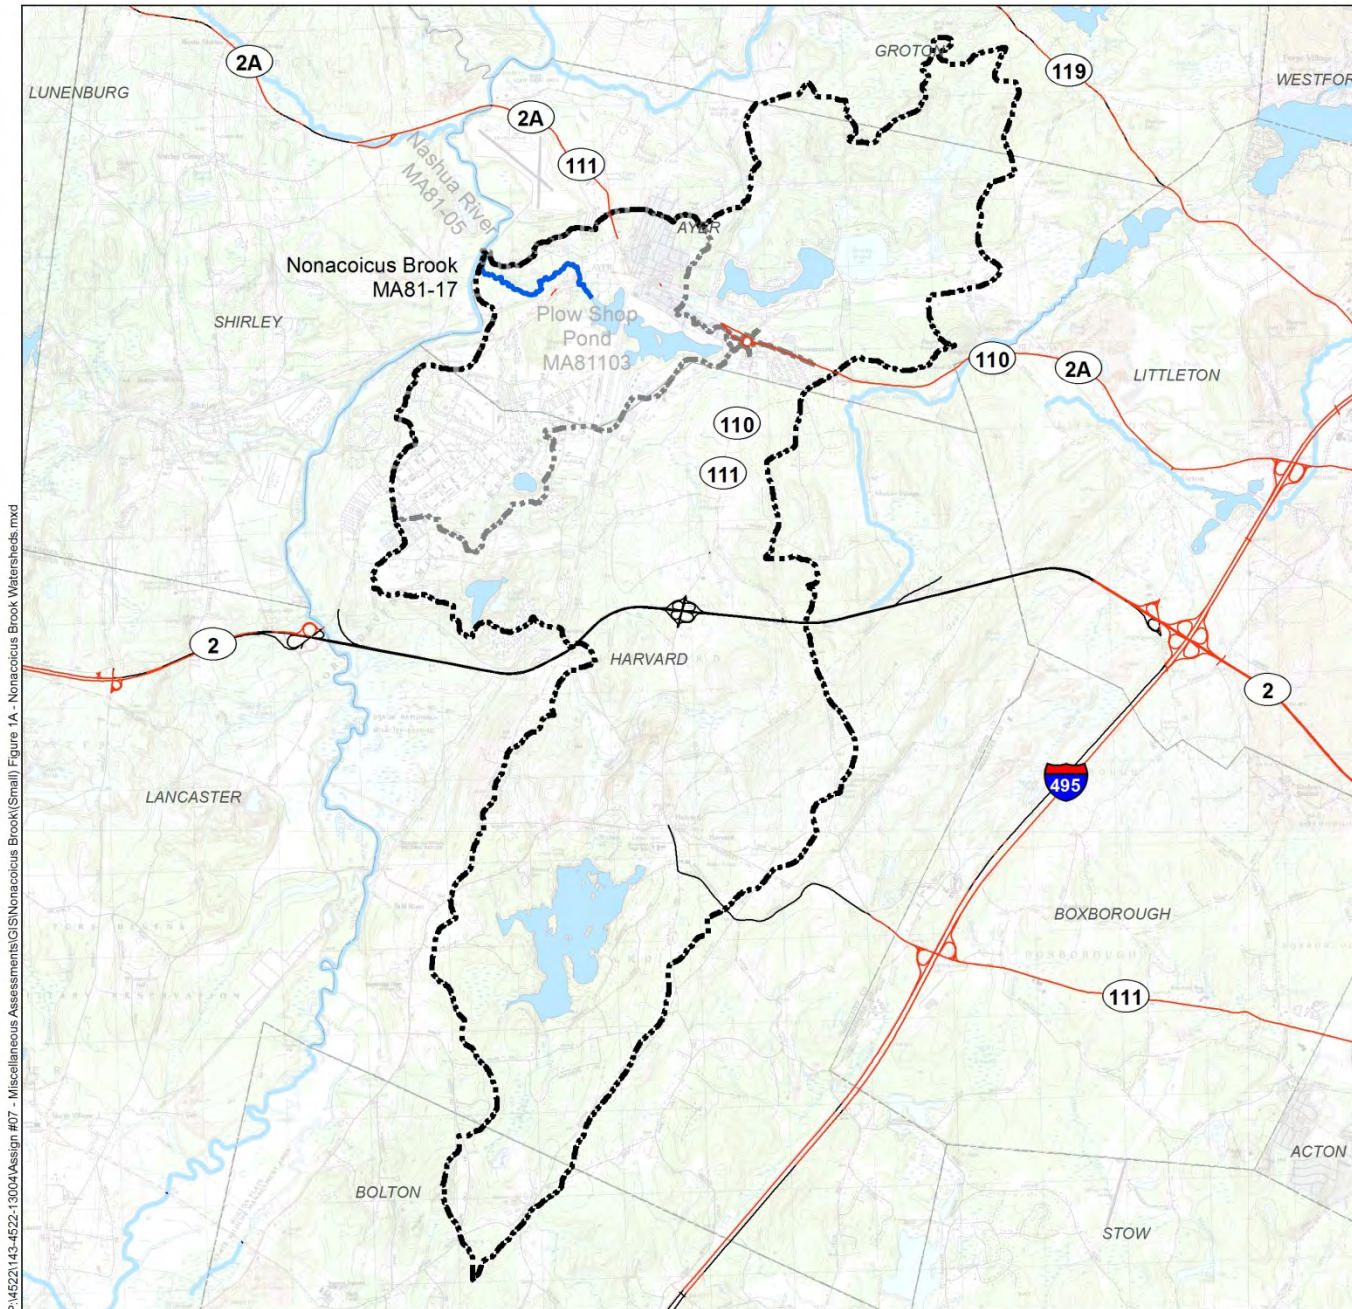
Figure 1A
Nonacoicus Brook (MA81-17)
Watersheds
June 2014

- MassDOT Roadways in Urban Area
- MassDOT Roads
- Total Watershed
- Subwatershed
- Assesed Segment
- Impaired Lakes
- Impaired Streams

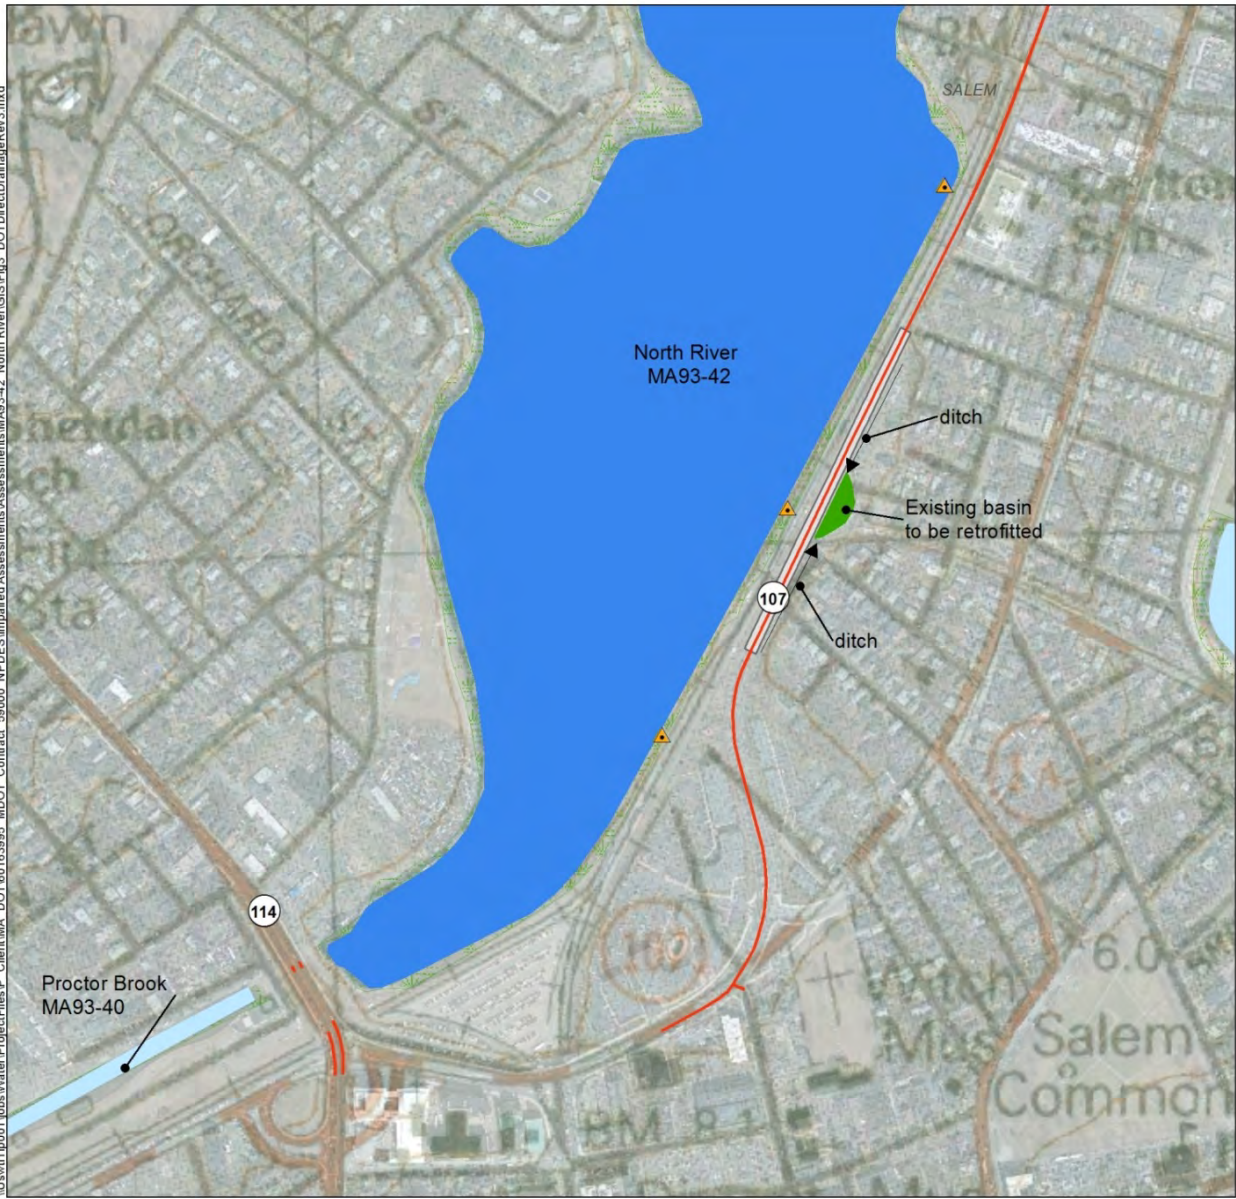
Figure 3
North River (MA93-42)
Proposed/Existing BMPs
June 2014

- MassDOT Roadways in Urban Area
- ▲ Stormwater Outfalls
- Assessed Segment
- Proposed BMP Watersheds
- Proposed/Existing BMPs
- DEP Wetlands

Drainage from an approximately 0.6 mile stretch of Route 107 (Salem bypass/SJA Memorial Drive) flows to catch basins and is directed to two of three outfalls discharging to the North River (Figure 3). A portion of this roadway discharges to existing basins before discharging to North River via outfalls. The basins are described further below.

Drainage from approximately 1,100 feet of Route 107 is piped to a basin/depression adjacent to the roadway (shown in Figure 3 as the proposed BMP watershed). MassDOT Plan set 5402, sheet 56 indicates that the area is a detention basin; however, the basin was not observed to include any overflow/spillway areas, control structure for flow, or other characteristics that would indicate that the water is being treated before discharging to the North River. Drainage from Route 107 is directed through drainage ditches or directly from catch basins within the roadway to the basin. In addition, drainage from residential streets is also directed to the basin. The outlet structure consists of a headwall and an 18 inch-pipe that extends from the basin to the North River by extending beneath Route 107 and the railroad. This area/basin has the potential to be used for a BMP, as displayed in **Photos 1 and 2** but is not considered a BMP in its current state. The photos show the well vegetated basin and the outlet structure.

MassDOT has identified that additional control measures are needed to reduce its effective IC within the directly contributing watershed to achieve the targeted reduction and that appropriate locations are potentially available for control measures (Figure 3). MassDOT will now work with its design consultants to identify locations suitable for construction of additional BMPs to treat directly contributing IC as part of MassDOT's Impaired Waters Retrofit Initiative. The project designer will gather additional information in this phase, such as soil data, wetland delineations, and site survey, to further refine the proposed BMPs. The design consultants will develop construction plans for BMPs that will aim to provide the target IC reduction to the maximum extent practical.
