**Attachment 3:**

**No Discharges from MassDOT Outfalls Assessments**

## Impaired Waters Assessment for Lake Warner (MA34098)

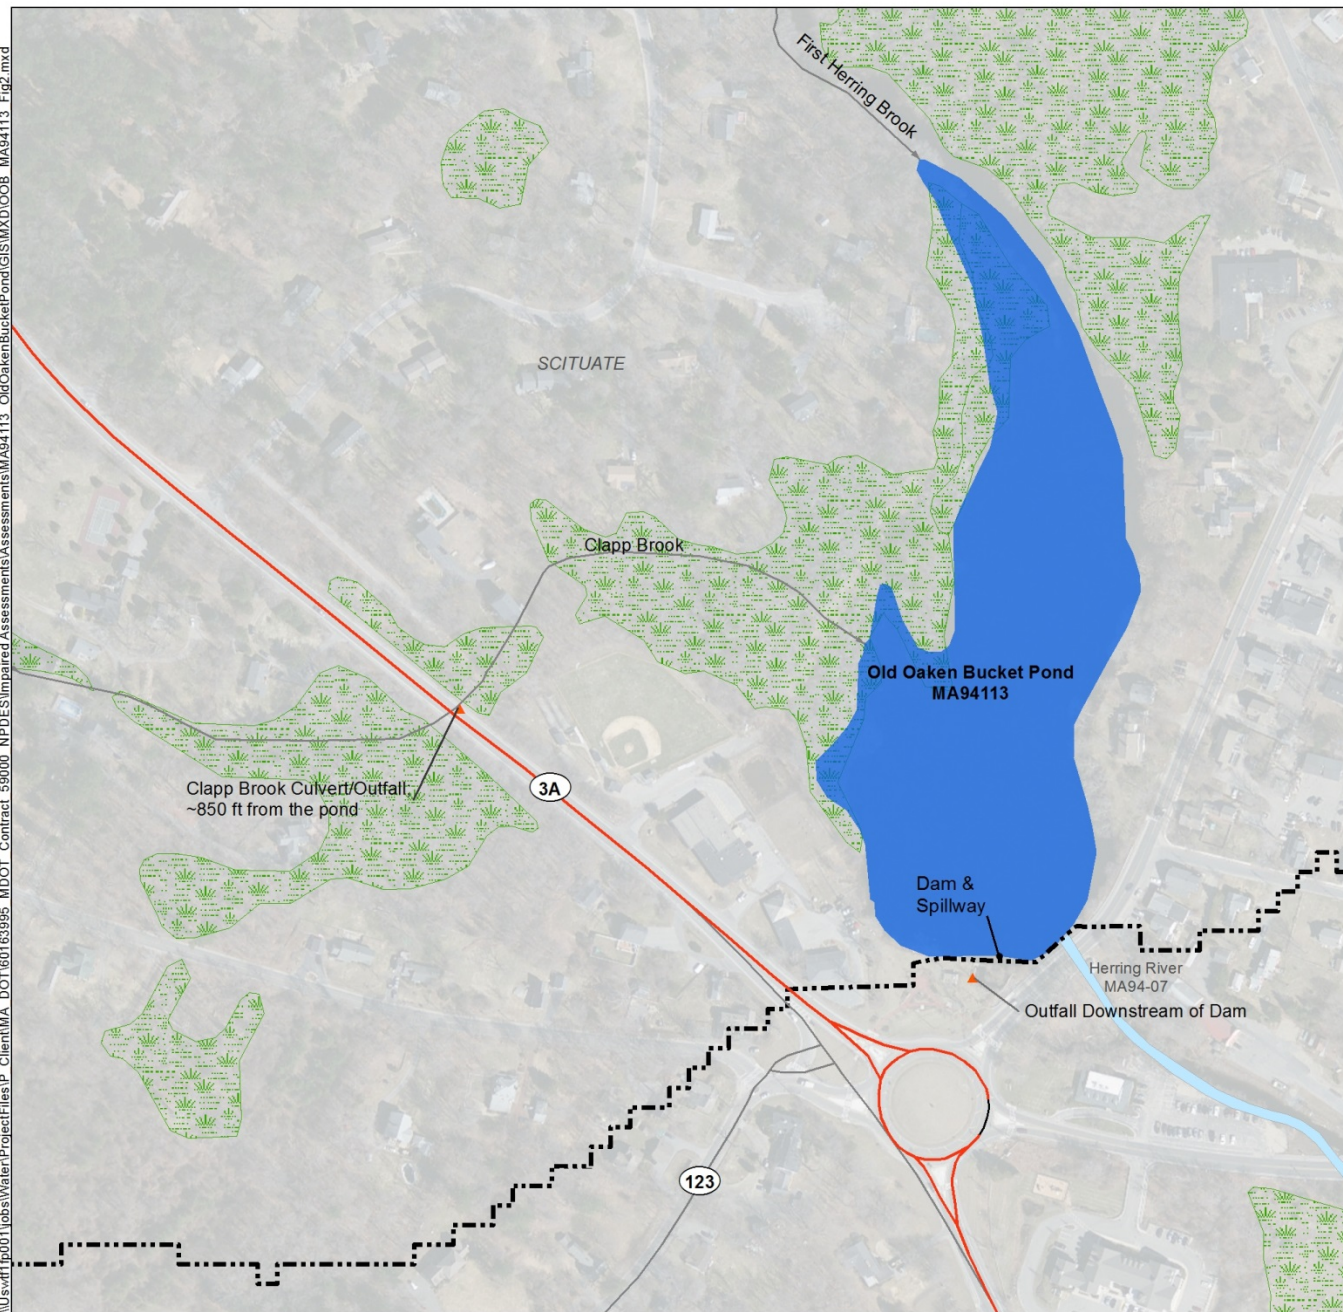
**Figure 2**  
**Old Oaken Bucket Pond**  
**(MA94113) Watershed**

After review, it was determined that the MassDOT property does not discharge to Old Oaken Bucket Pond. The review consisted of geographic and literature sources and a site visit conducted on August 18, 2014. Route 3A is the nearest MassDOT-owned property. Figure 2 shows a small, non-impaired stream that is a tributary to the Pond, Clapp Brook, crossing in a culvert under Route 3A. The site visit to this area found that this brook drains approximately 1,500 linear feet of the roadway via storm drain connections at the culvert. Clapp Brook, a non-impaired brook, flows from an outfall on the east side of Route 3A for approximately 850 feet before entering Old Oaken Bucket Pond. Approximately 700 feet of Clapp Brook's path from the outfall is through wetlands. This distance of flow over land and through wetlands eliminates this discharge point as a contribution to the impairment of the Pond.
