Attachment 4:

No Discharges from MassDOT Outfalls Assessments

Attachment 4 includes 36 assessments of water bodies where desktop review or field review of the subwatershed found that MassDOT-owned roads in the urban area do not drain to the receiving water in question and therefore, according to BMP 7U and 7R, no further assessment is necessary.

Impaired Waters Assessment for Pequot Pond (MA32055)

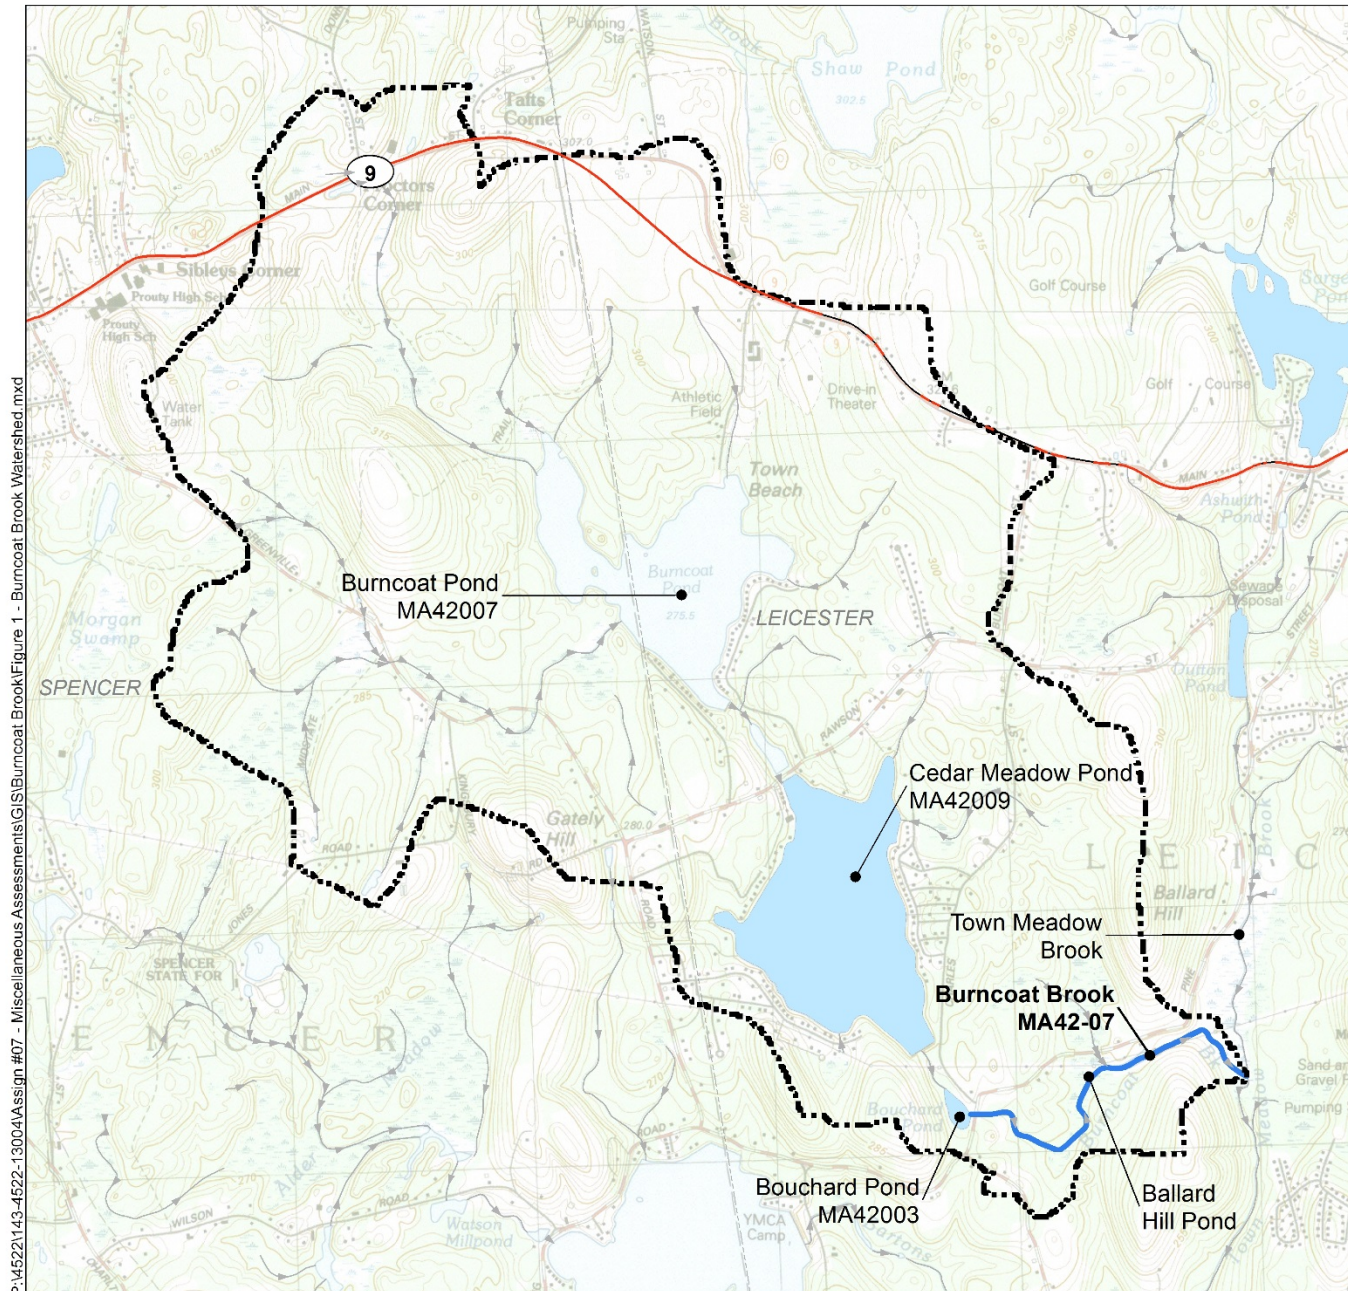
Figure 1
Burncoat Brook
(MA42-07) Watershed

Figure 1 shows the total and subwatershed of Burncoat Brook, which are the same, totaling approximately 4.5 square miles and are located in the towns of Leicester and Spencer, Massachusetts. The watershed to Burncoat Brook is comprised of low density residential areas, pastures, cropland and wetlands with the majority of the watershed consisting of forested land.

Burncoat Brook (MA42-07) originates at the outlet of Bouchard Pond (MA42003) and flows east for approximately 1.0 mile through former pond segment Ballard Hill Pond to its confluence with Town Meadow Brook in Leicester, Massachusetts (Figure 1).

After review, it was determined that MassDOT property does not discharge to Burncoat Brook. This determination was based on a review of aerials, hydrographic data and watershed mapping. The nearest MassDOT-owned properties to Burncoat Brook are Route 9 (1.4 miles north) and Interstate 90 (3.0 miles south). The section of Route 9 in Leicester and Spencer runs through the northern portion of the watershed. The runoff from this portion of Route 9 discharges to upland areas, wetland systems or other stream segments. Flows are then conveyed through Burncoat Pond (MA42007), Cedar Meadow Pond (MA42009) and Bouchard Pond (MA42003) before reaching Burncoat Brook.
