Attachment 7:

Phosphorus Groundwater Assessments

Impaired Waters Assessment for Parker Mills Pond (MA95115)

Impaired Waters Assessment for Crystal Lake (MA96050)

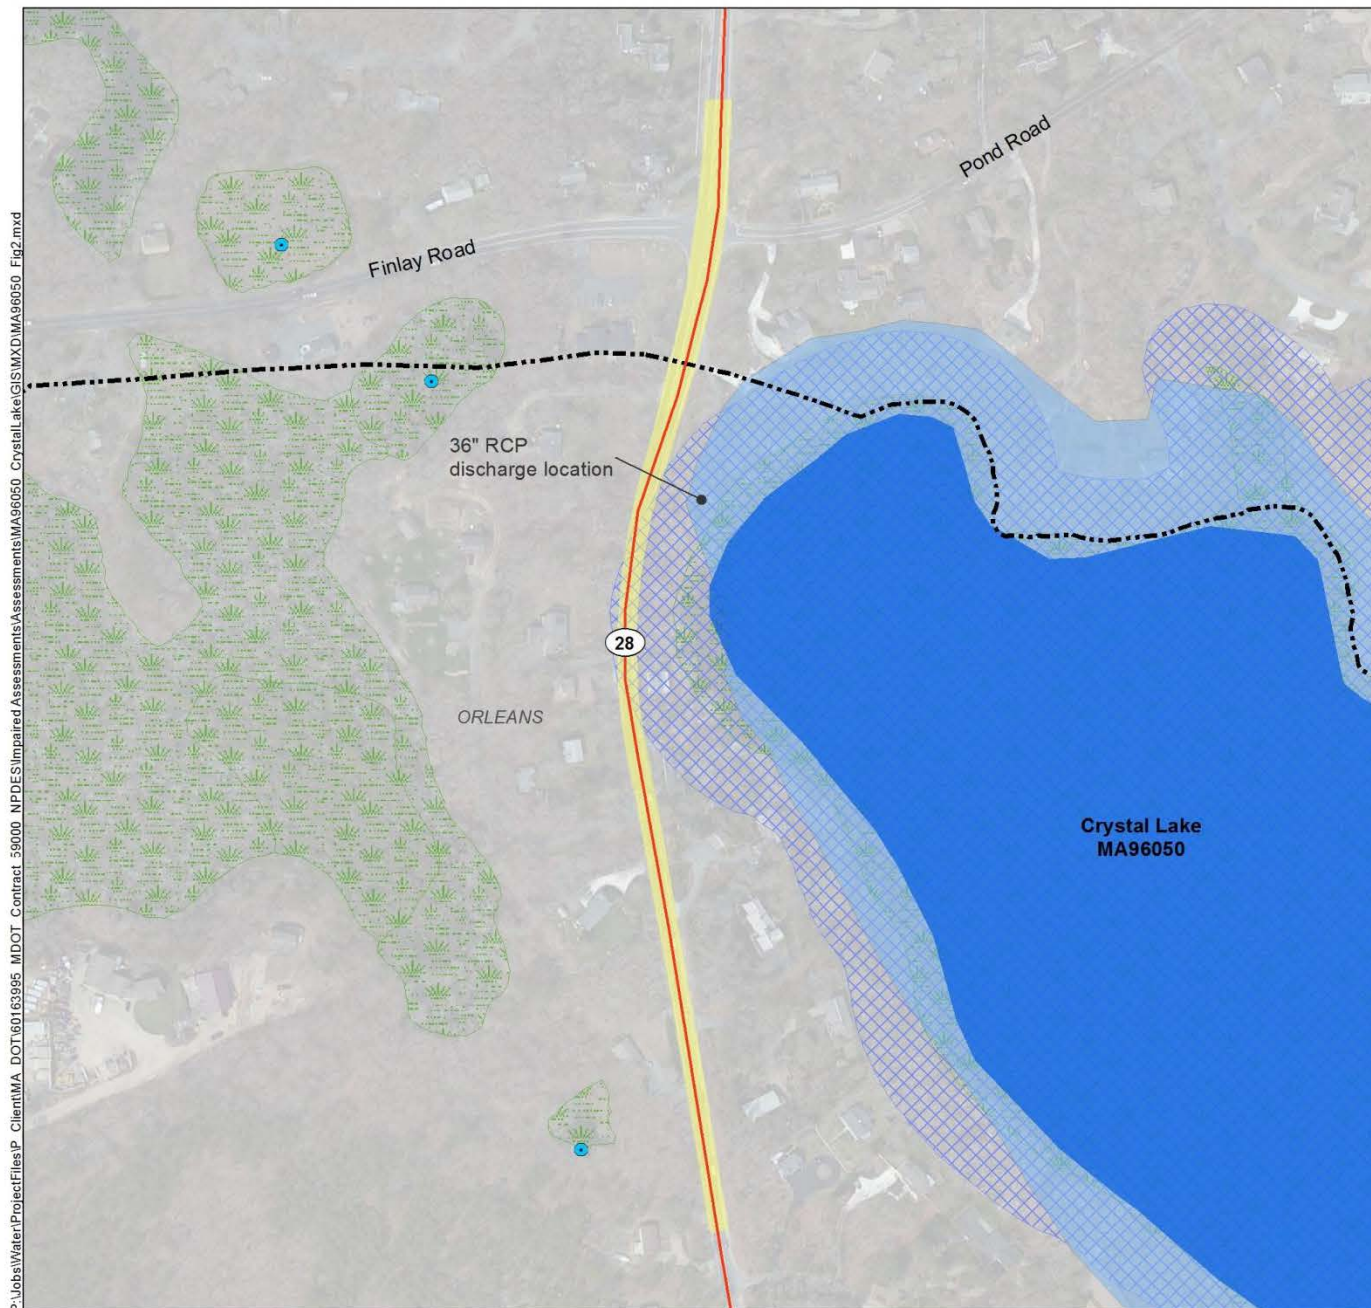
Figure 2
Crystal Lake (MA96050)
Directly Contributing
MassDOT Watershed

Crystal Lake and bordering land areas are mapped as an Outstanding Resource Water and part of the Pleasant Bay Area of Environmental Concern (ACEC; Figure 2). Wetlands with certified vernal pools are located west of Route 28 on the opposite side of the road from Crystal Lake. Although there are no wetlands mapped on the eastern border of Route 28, the existing outfall discharging MassDOT runoff to Crystal Lake is mapped as being within the ACEC and very close to mapped wetlands.

Route 28 is a MassDOT-owned two-lane roadway traversing the groundwater watershed in the north-south direction. Based on field observations, runoff from a portion of Route 28 is collected in a drainage system that discharges directly to Crystal Lake via a 36 inch reinforced concrete pipe. The MassDOT directly discharging property, as shown on Figure 2, extends approximately 1,830 feet. The area of impervious cover directly discharging to Crystal Lake is approximately 2.5 acres. A portion of this impervious cover is located outside of the groundwater watershed boundary. Starting approximately 200 feet north of the intersection of Route 28 with Finlay Road and Pond Road and extending to the groundwater watershed boundary, stormwater runoff is collected in a closed drainage system that discharges directly to Crystal Lake.
