**Massachusetts Division of Marine Fisheries  
Technical Report TR-37**

## **Eelgrass Restoration Used As Construction Impact Mitigation in Boston Harbor, Massachusetts**

A. S. Leschen, R. K. Kessler, and B. T. Estrella

December 2009

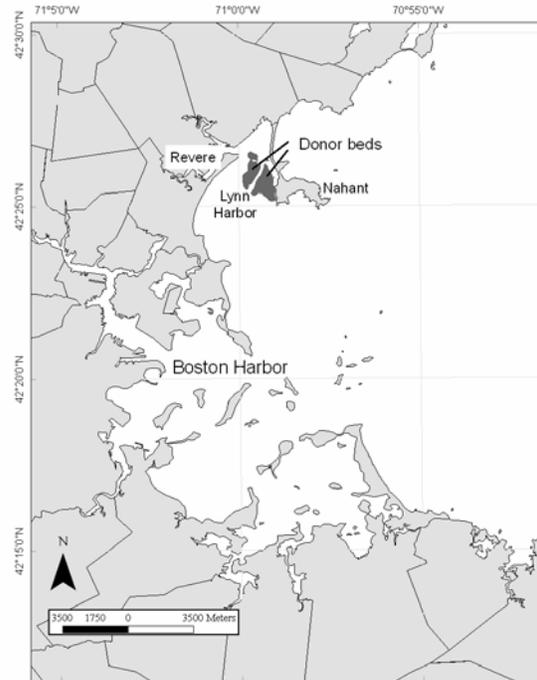
**Figure 2.** Donor beds in Revere and Nahant.

north of Boston Harbor, in Lynn Harbor, Nahant, was adopted as the primary donor site after investigation confirmed it was extensive and dense (Figure 2). (A bed across the channel in Revere was examined, but eliminated as a donor site since it was not as dense as the Nahant bed).

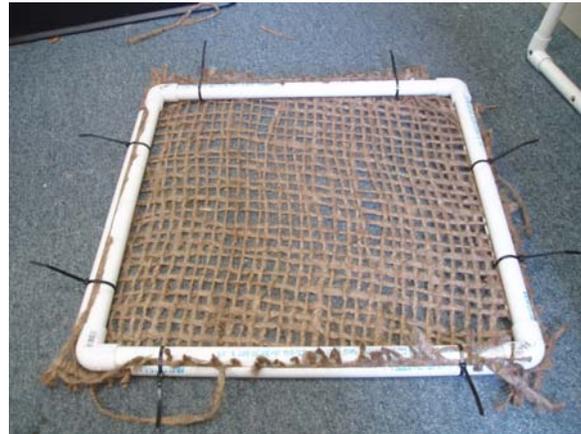
**Figure 4.** A PVC frame/jute mesh structure was constructed as a lighter-weight alternative to TERFs™.

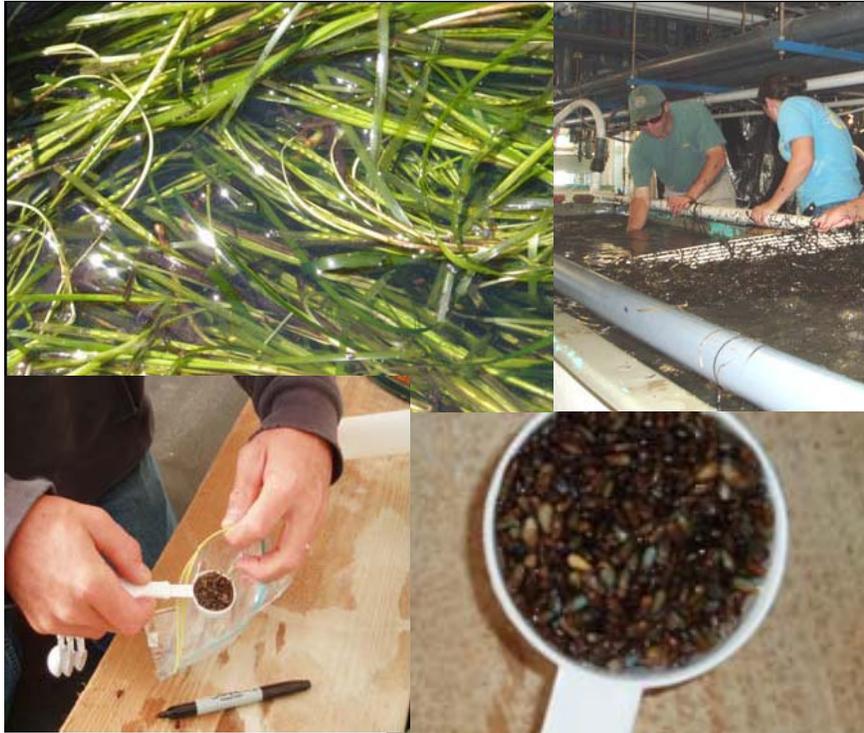
**Figure 6.** Clockwise from upper left: flowering shoots containing immature seeds; removing vegetation once seeds have dropped out; close-up of mature seeds; measuring seeds into bags for deployment.

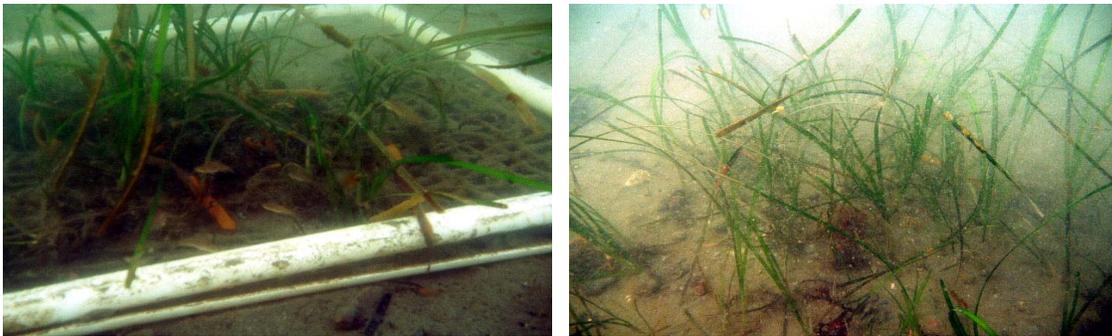
**Figure 14.** Photos of PVC frame in situ (left) and after frame has been removed (right). Note that jute is silted over.

*String frames.* PVC string frames (Leschen et al. 2006) planted in fall 2005 were left in place during the following winter. Those planted in spring 2006 were retrieved at the end of the summer after eelgrass shoots had rooted. The string frames proved easy with which to work, deploy, and retrieve and their spiked anchoring system effectively prevented frame-shifting (Figure 14).
