Historic eelgrass trends in Salem Sound, Massachusetts
Final Report

Massachusetts Division of Marine Fisheries

Massachusetts Bays National Estuary Program

June 29, 2017

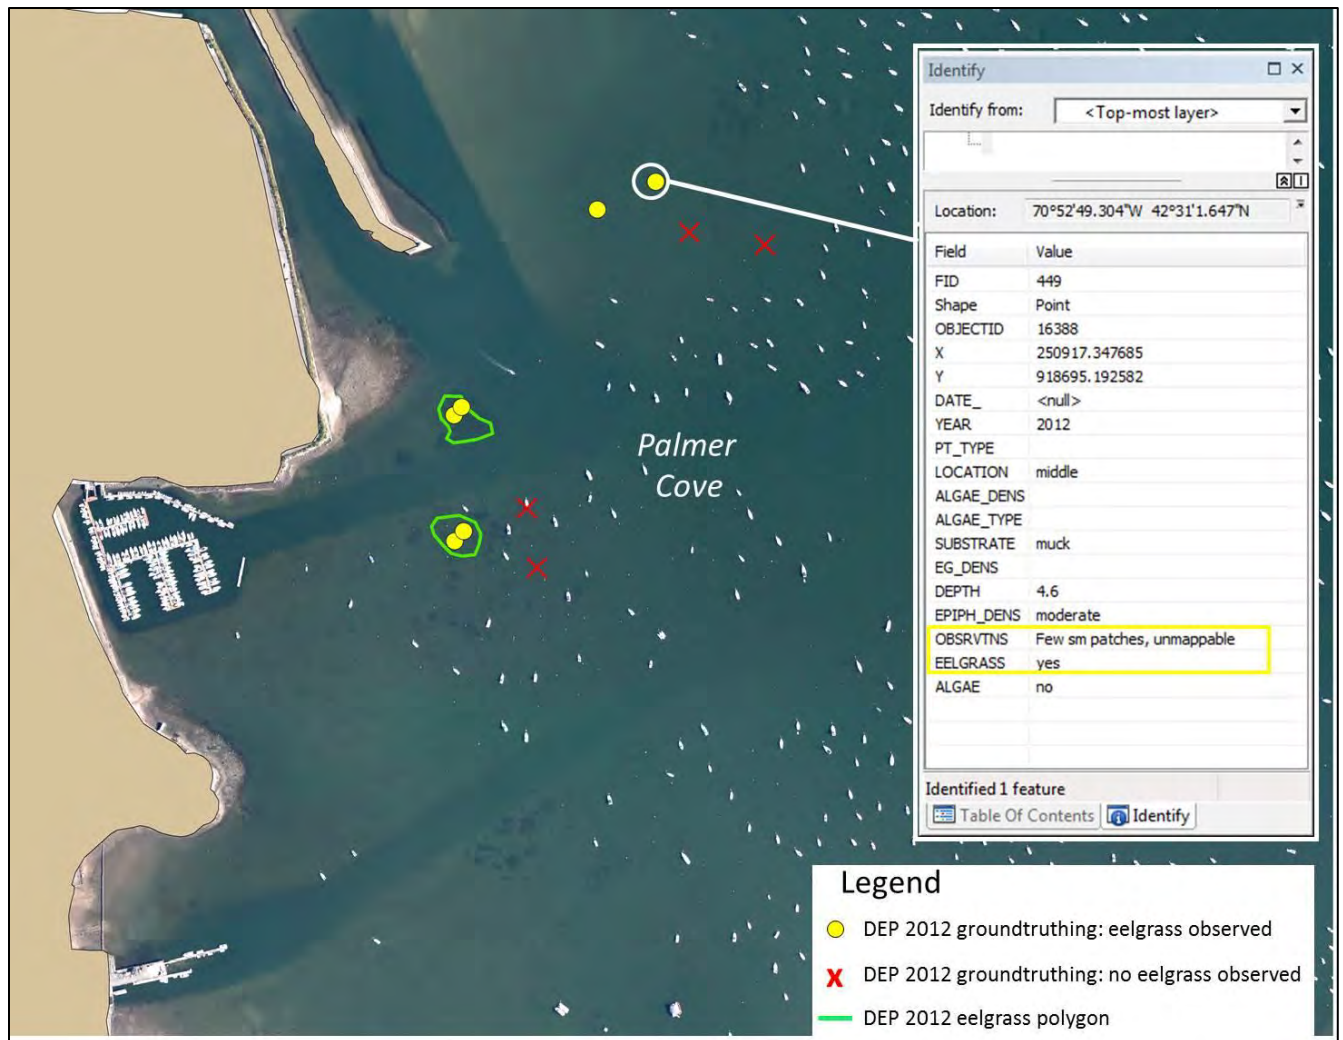
Figure 4. 2012 DEP aerial photograph of Palmer Cove, Salem with 2012 DEP field verification points. The attribute data for the circled point shows that sparse eelgrass (“few sm patches”) is present but was not included in the 2012 DEP polygon.

Originally we intended to re-delineate the eelgrass meadows at each time step. However, after some experimentation we were reluctant to revise DEP's eelgrass polygons since we were unable to groundtruth our photo-interpretation of each time step and the potential to mischaracterize areas was high. For example, areas that appeared heavily vegetated were actually comprised of algae or rocks based on DEP groundtruth data, and conversely some areas that appeared bare were vegetated with very short or very sparse grass (Fig 4). DEP's groundtruthing point-data were a critical component of drawing the polygons.

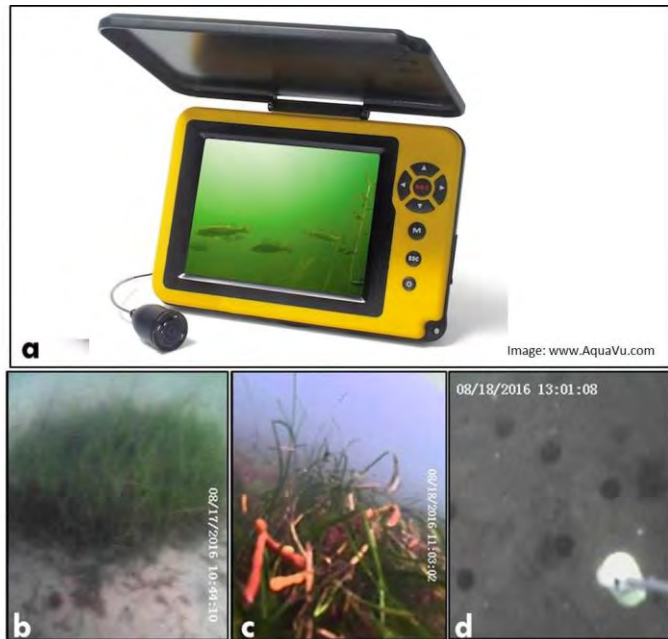
Figure 7. A) Aqua-Vu camera, B, C) imagery captured in vegetated areas, D) imagery captured in an un-vegetated area. Imagery from Salem Sound, MA.

Groundtruthing was done after the acoustic survey using an Aqua-Vu reeled towable live-feed underwater camera (Fig 7a). Sites targeted for groundtruthing were selected based on DEP eelgrass maps and real-time observations of the Humminbird display. The submersible camera allowed confirmation of eelgrass presence or absence (Fig 7b-d). In shallow or clear locations, eelgrass was observed by looking over the side of the survey vessel to confirm eelgrass presence (e.g. inner Marblehead and Manchester Harbors).

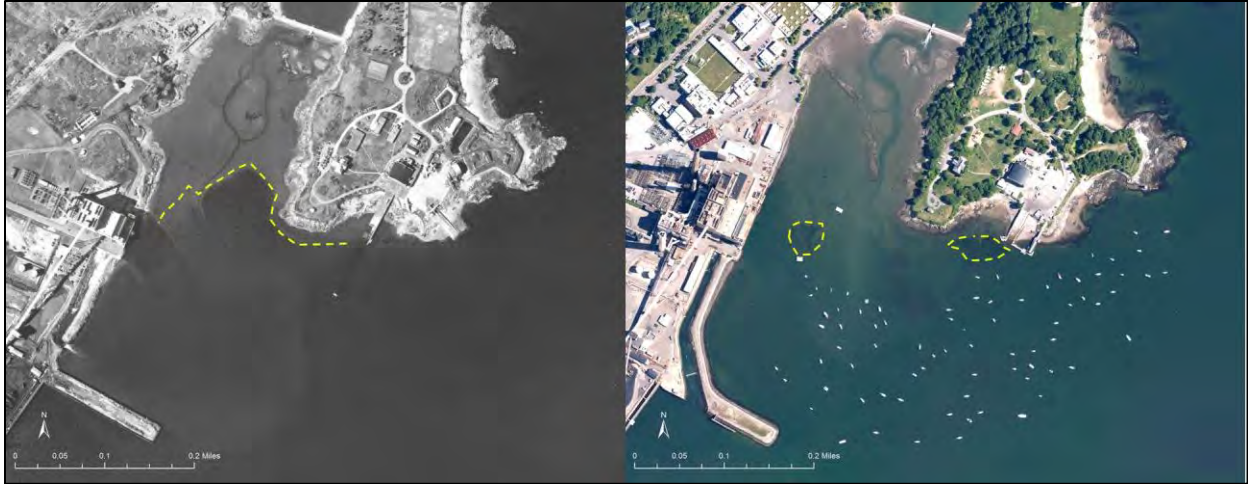
Figure 13. Aerial imagery of Cat Cove, Salem Harbor from 1954 (DOT) and 2012 (DEP) showing approximate eelgrass edge (yellow).

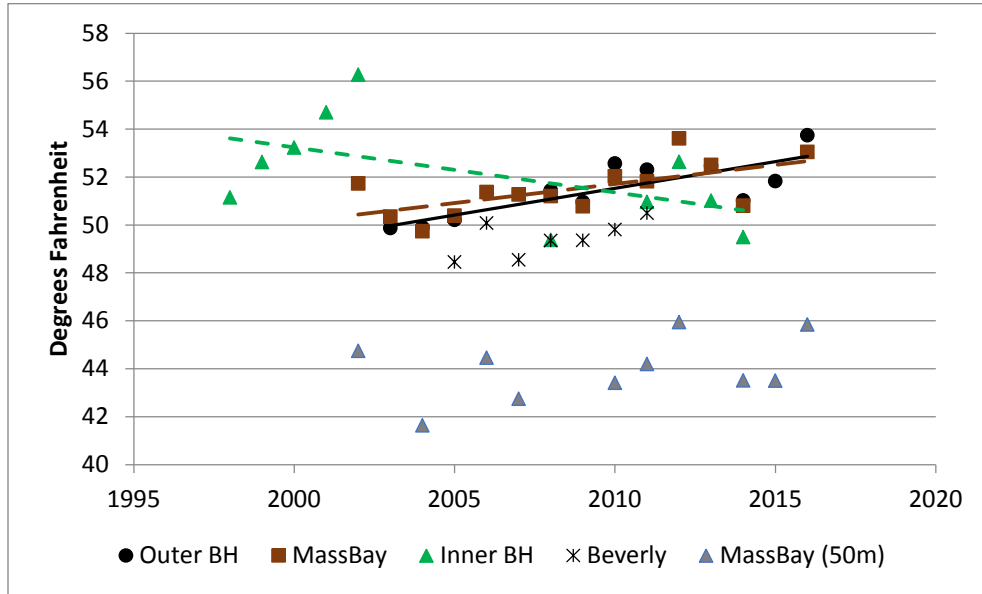
Figure 16. Annual average temperatures over time. Significant trends are indicated by trend lines (outer BH, Mass Bay, and Inner BH).

The average annual water temperature at Outer Boston Harbor and Mass Bay showed significant warming over time and Inner Boston Harbor showed significant cooling over time (Fig 16, Table 6). The cooling trend is found in the longest dataset, and is driven by a very high average temperature in 2002 driven by a strong El Niño episode. Record temperatures and drought were documented globally (Waple and Lawrimore 2003). Summers (Jun, Jul, Aug) are warming significantly in four of five datasets: Outer Boston Harbor, Mass Bay surface, Mass Bay bottom, and Beverly Harbor (Table 6).

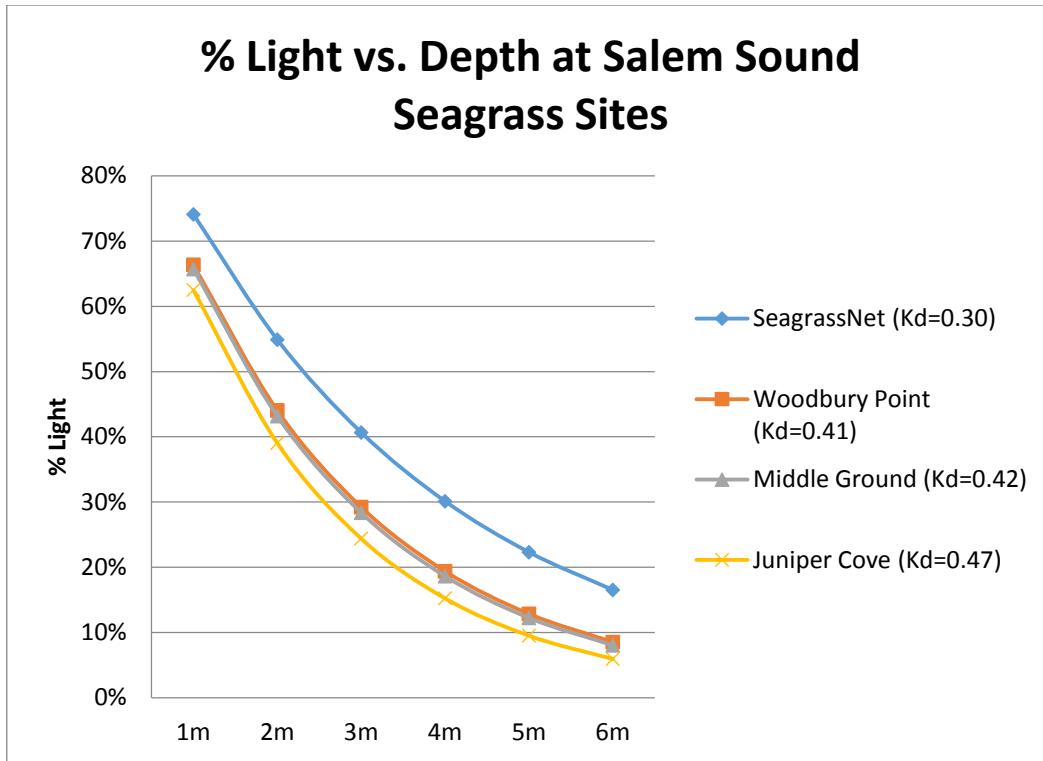
Figure 18. Light extinction curves for sites in Salem Sound.

Data from stations within Salem Sound were used to conduct a local-scale analysis of in-water light availability and assess other factors that could influence light availability in the embayment. Li-Cor and HOBO data were collected by DMF at the SeagrassNet monitoring site off West Beach and at several eelgrass restoration sites in Beverly (Woodbury Point) and Salem (Middle Ground, Juniper Cove). The SeagrassNet site percent light ranged between 18 and 24% (based on PAR) between sampling in 2011, 2014 and 2016 with a Kd of 0.30. In 2012, all restoration sites sampled had greater than 15% light (based on PAR) at the canopy and Kd values between 0.41 to 0.47 (Fig 18).

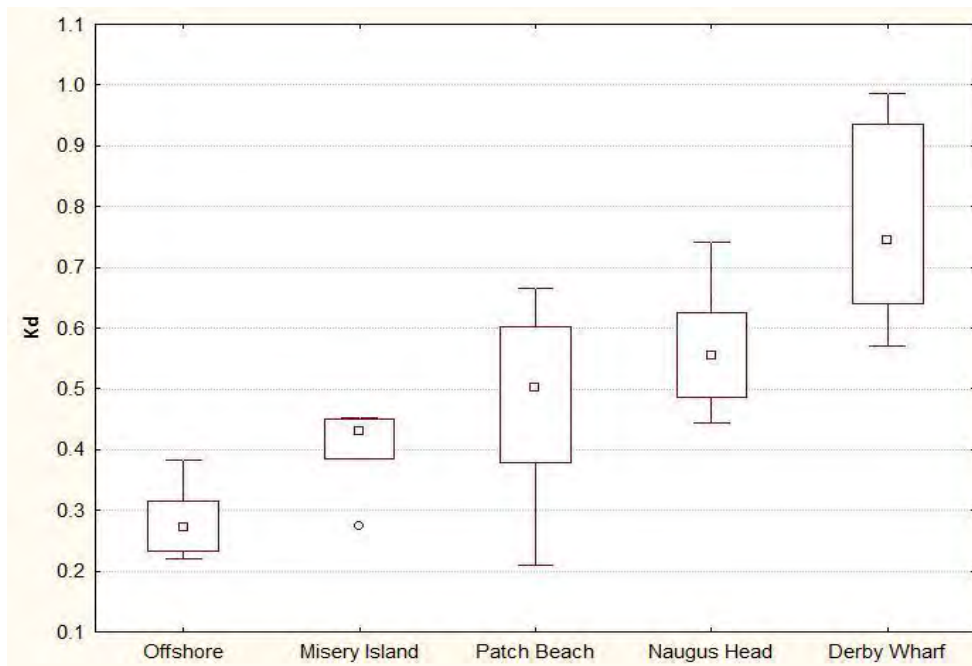
Figure 19. Light extinction compared to intensity of impact at eelgrass beds (from Liebman 2013). Figure reproduced with permission.

EPA also measured light extinction and found a strong relationship between light extinction and intensity of impact at eelgrass beds (Liebman 2013) (Fig 19).

strong relationship between light extinction and eelgrass impact was found by EPA (Liebman 2013) (Fig 19).

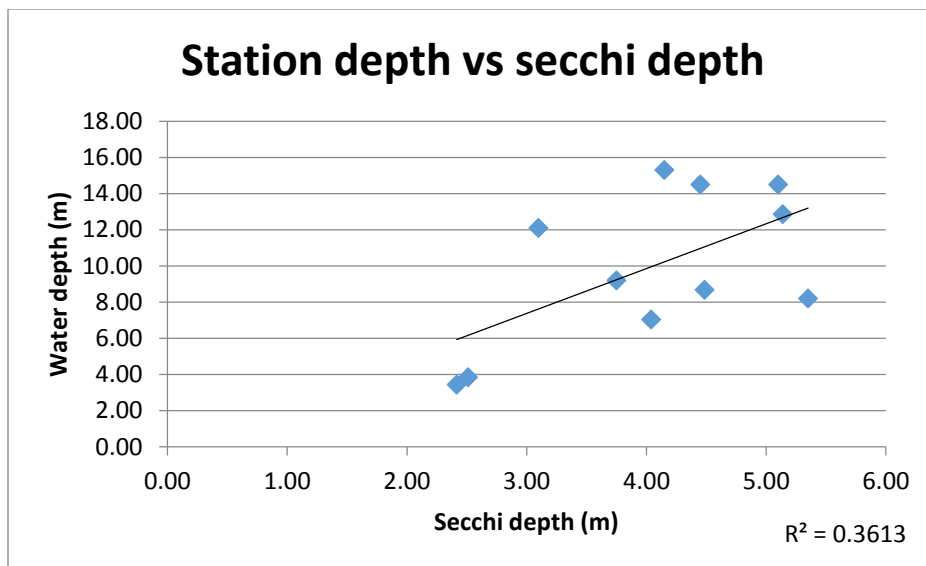
Figure 21. Station depth vs. secchi depths using both EPA and SSCW monitoring data (2010/2011).

Deeper stations have deeper secchi depths (Fig 21). But the shallower stations have higher index values, meaning that light is getting to the bottom at Salem 2, Danvers River, and Beverly Harbor (Fig 22). Late spring and summer had the lowest secchi index values (no winter data) (Fig 22).

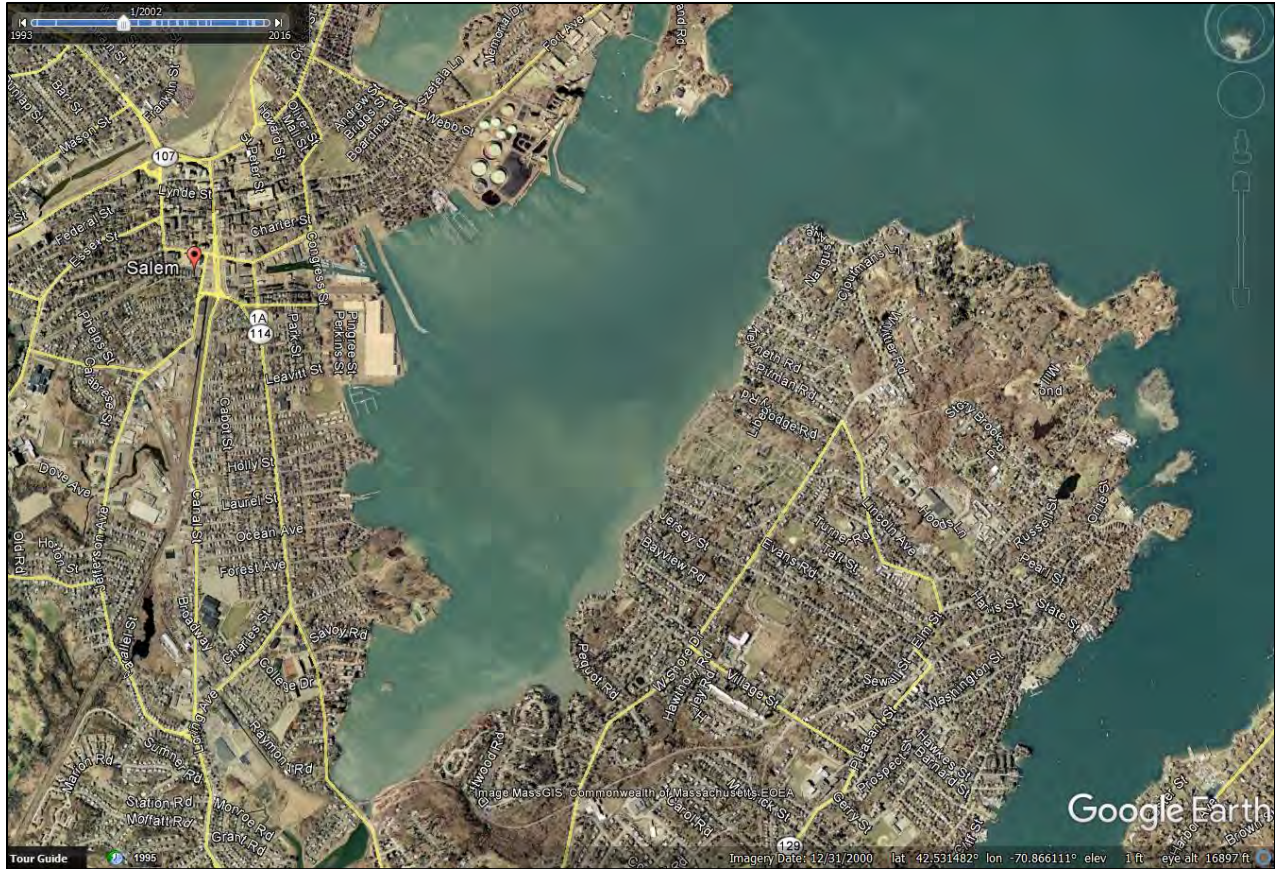
Figure 26. Turbidity event along the west shore of Marblehead, Salem Harbor. Google Earth 2000 image.

Turbidity is caused by both phytoplankton blooms and sediment suspension. Hubeny concluded that phytoplankton blooms dominate the suspended sediment load in Salem Sound (Hubeny et al. 2017a). Acute turbidity events are poorly documented but can be linked to storms and anthropogenic impacts such as coastal construction activities that disturb the seafloor. Google Earth imagery was used to document a turbidity event along the west shore of Marblehead in 2000 (Fig 26). It is not clear what caused this turbidity event.

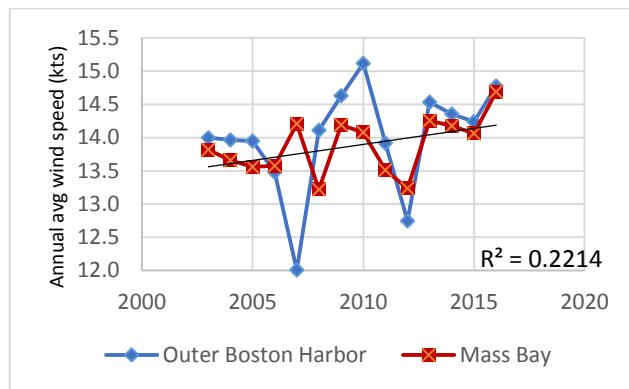
Figure 31. NERACOOS buoys annual average wind gust (kt) from 2003-2016. The trendline is for the Mass Bay station where a significant increase was measured.

Wind could also be causing physical impacts in the Sound by affecting turbidity, circulation, and eelgrass bed exposure. We looked at changes in average annual wind speed and at the average number of wind events each to determine if either is changing over time. There was no significant change in annual wind speed or direction since 2000 (Fig 30). There was a significant, but small, increase in average annual wind gusts at Mass Bay (from about 13.5 to 14.0 kts) (Fig 31).
