BOTTOM CLASSIFICATION SURVEY BUZZARDS BAY DISPOSAL SITE

CR Environmental, Inc.
639 Boxberry Hill Rd.
East Falmouth, MA 02536

June 2002

BOTTOM CLASSIFICATION SURVEY BUZZARDS BAY DISPOSAL SITE SURVEY REPORT

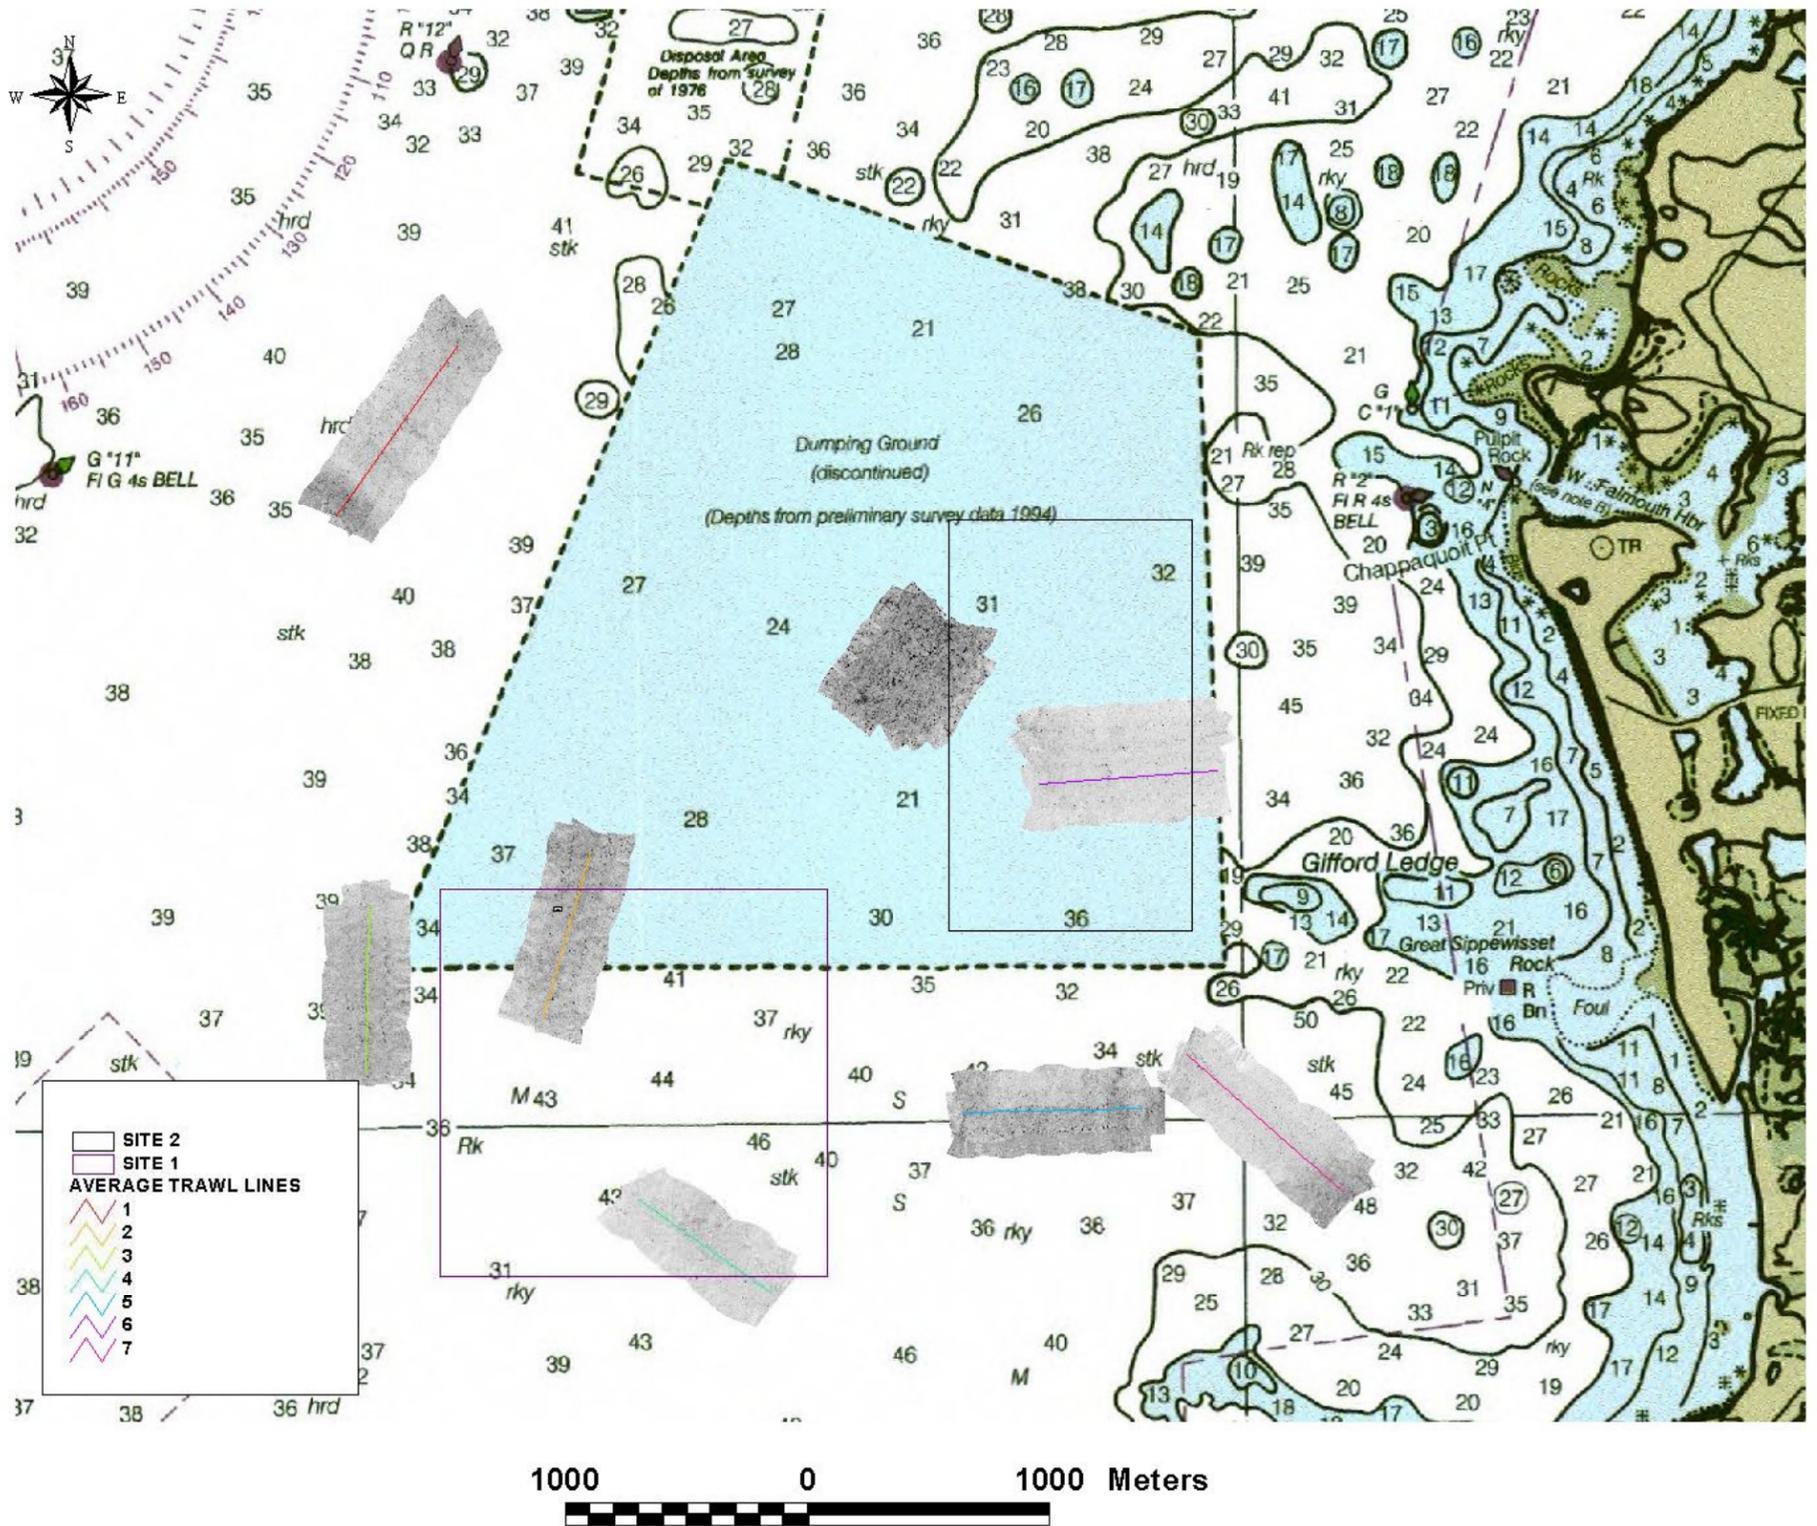
OVERVIEW OF SIDE SCAN SONAR SURVEYS BUZZARDS BAY DISPOSAL SITE

Seven lanes (T1-T7) were trawled in and around the BBDS (see Locus Overview) over the past year. A minimum of three side-scan survey lines with 150 ft line spacings were run in the vicinity of each of these seven lanes, i.e. one survey line along the lane trawled by the F/V Lady Jane and two offset either side by 150 ft. In addition, six survey lines were run with the side-scan system in the center of the disposal site where no trawling could be conducted.

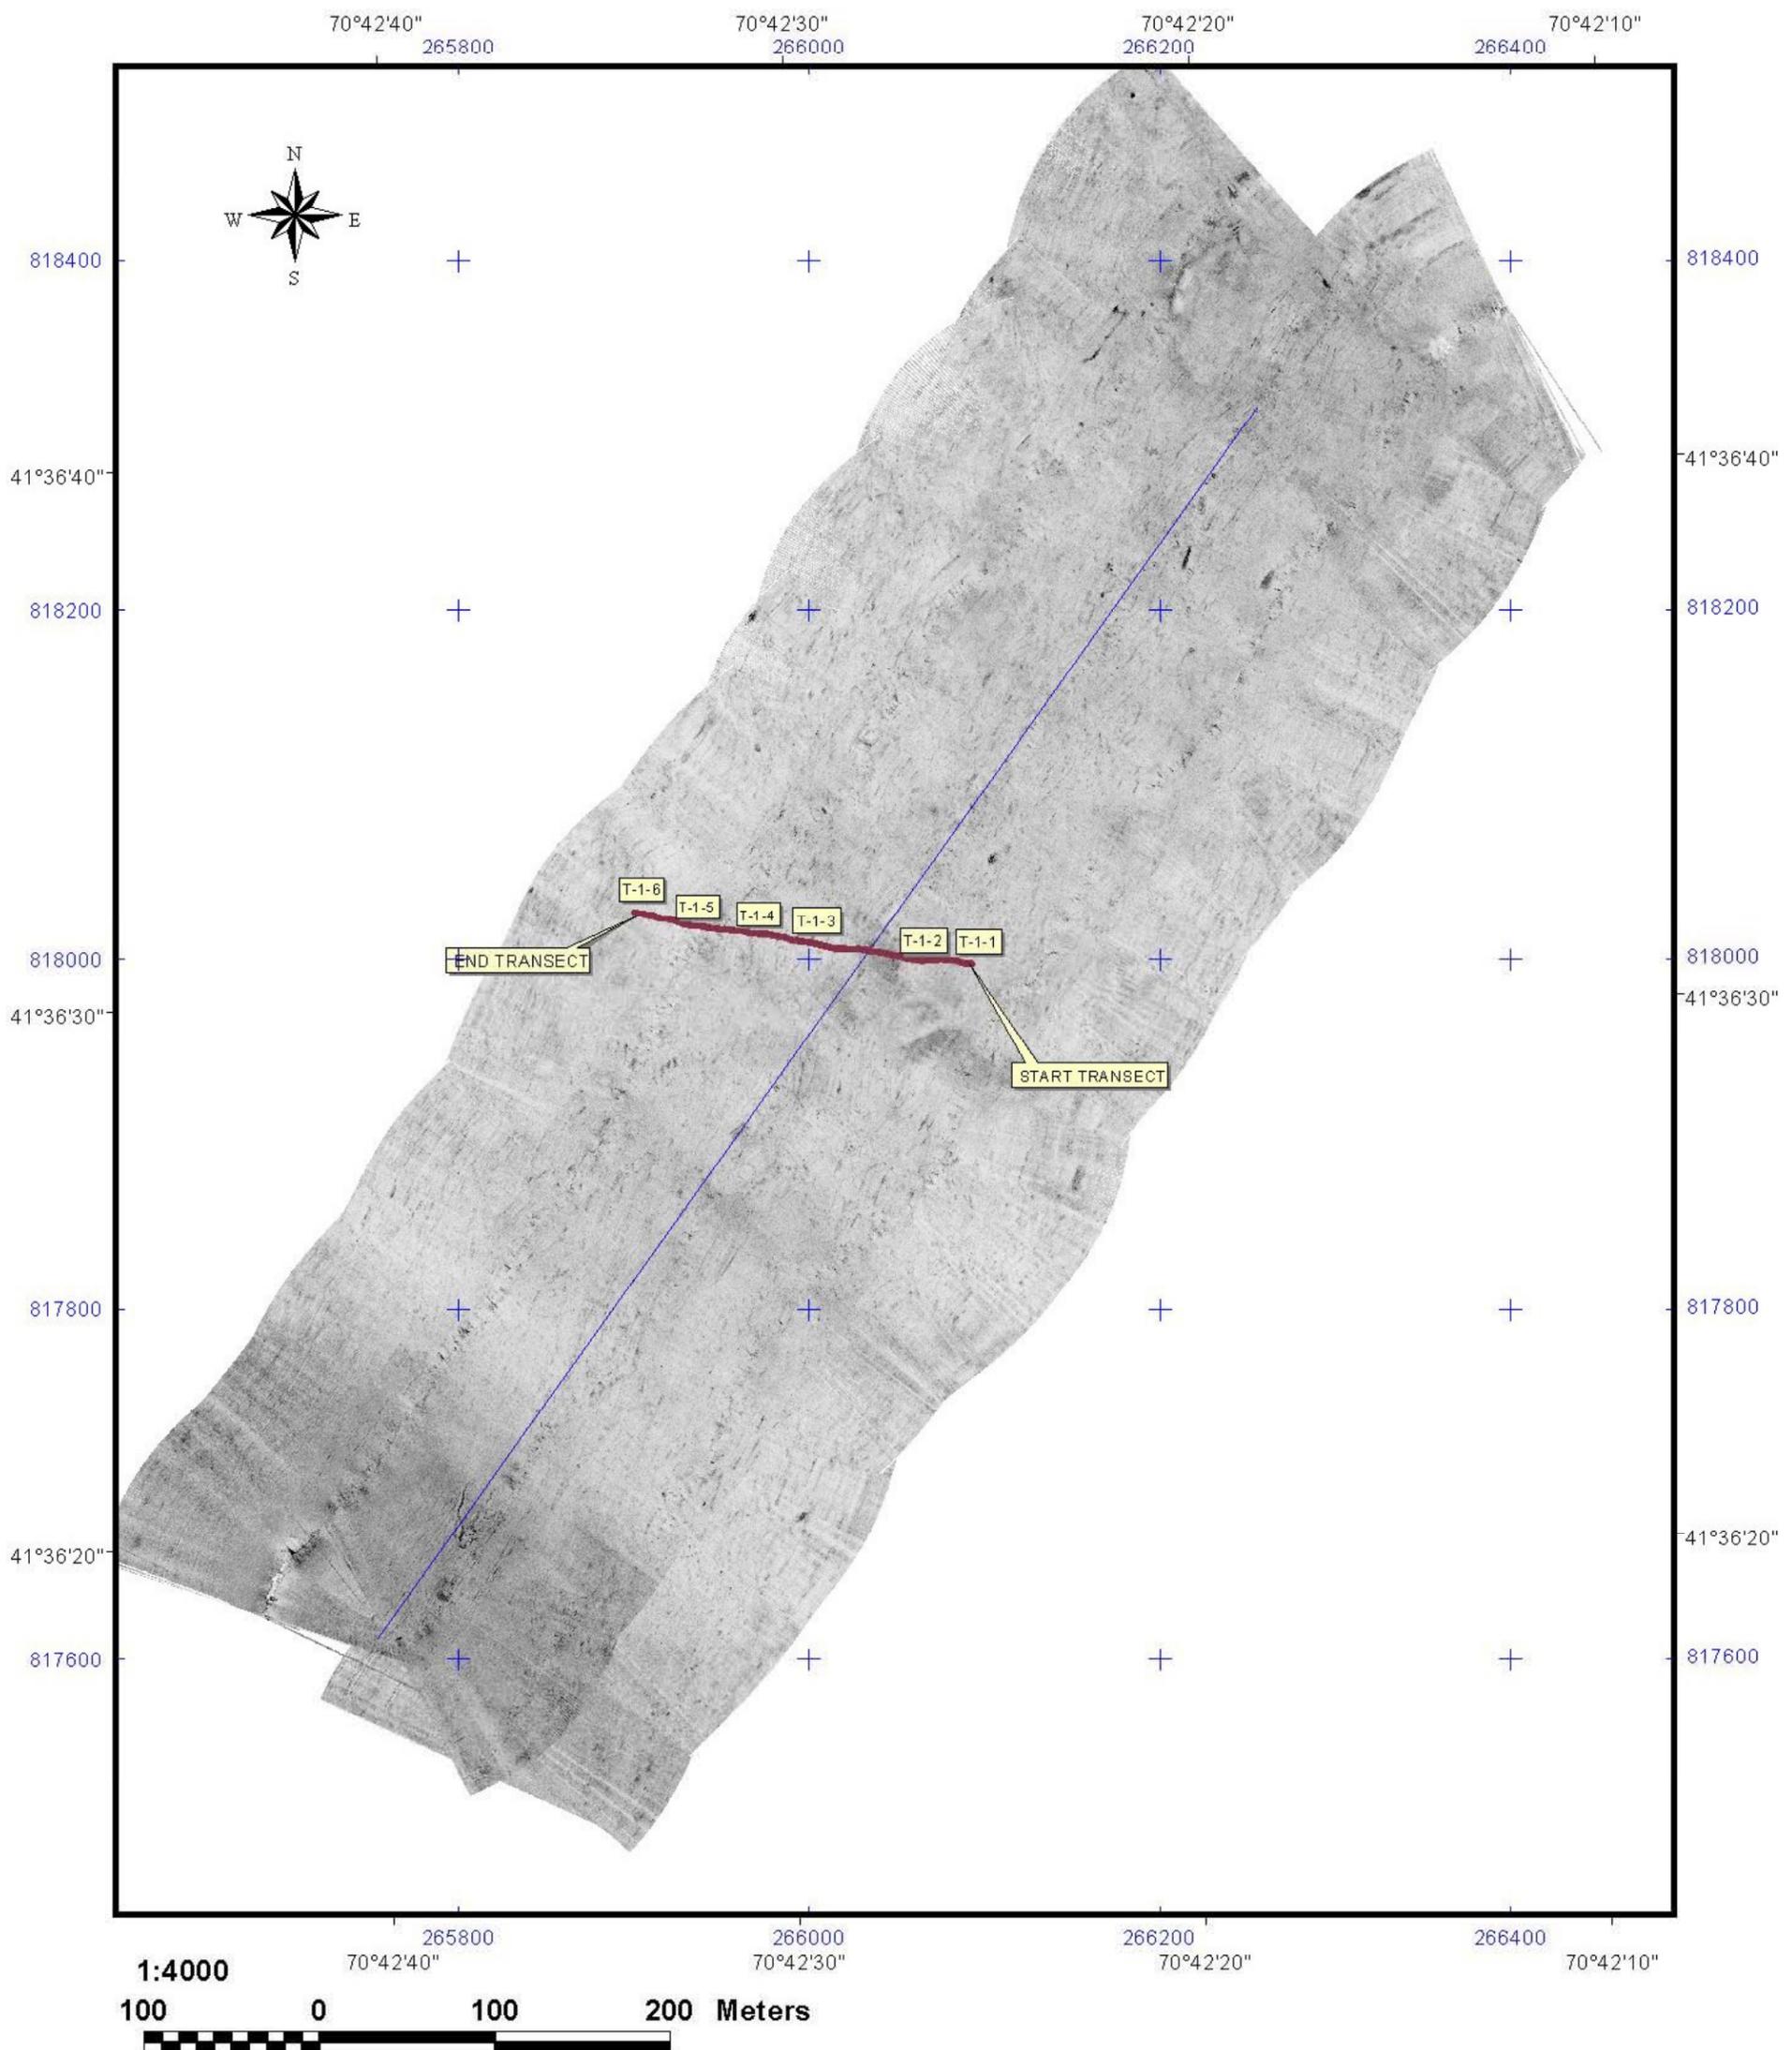
FIGURE 1

The side-scan data at T-1 shows a soft mud bottom in the center of the trawl lane and a harder mud/sand bottom at the southern and northern ends of the transect (Figure 1). The southern hard bottom area is labeled as "HRD" on the NOAA Nautical Chart for Buzzards Bay. The video at T-1 shows a sparse mud bottom with patches of brown 'mat' and a few isolated patches of red algae and parchment worm tubes (Figure 9).

**SIDE SCAN SONAR MOSAIC AND VIDEO DRIFT SURVEY
TRAWL LANE 1
BUZZARDS BAY DISPOSAL SITE**

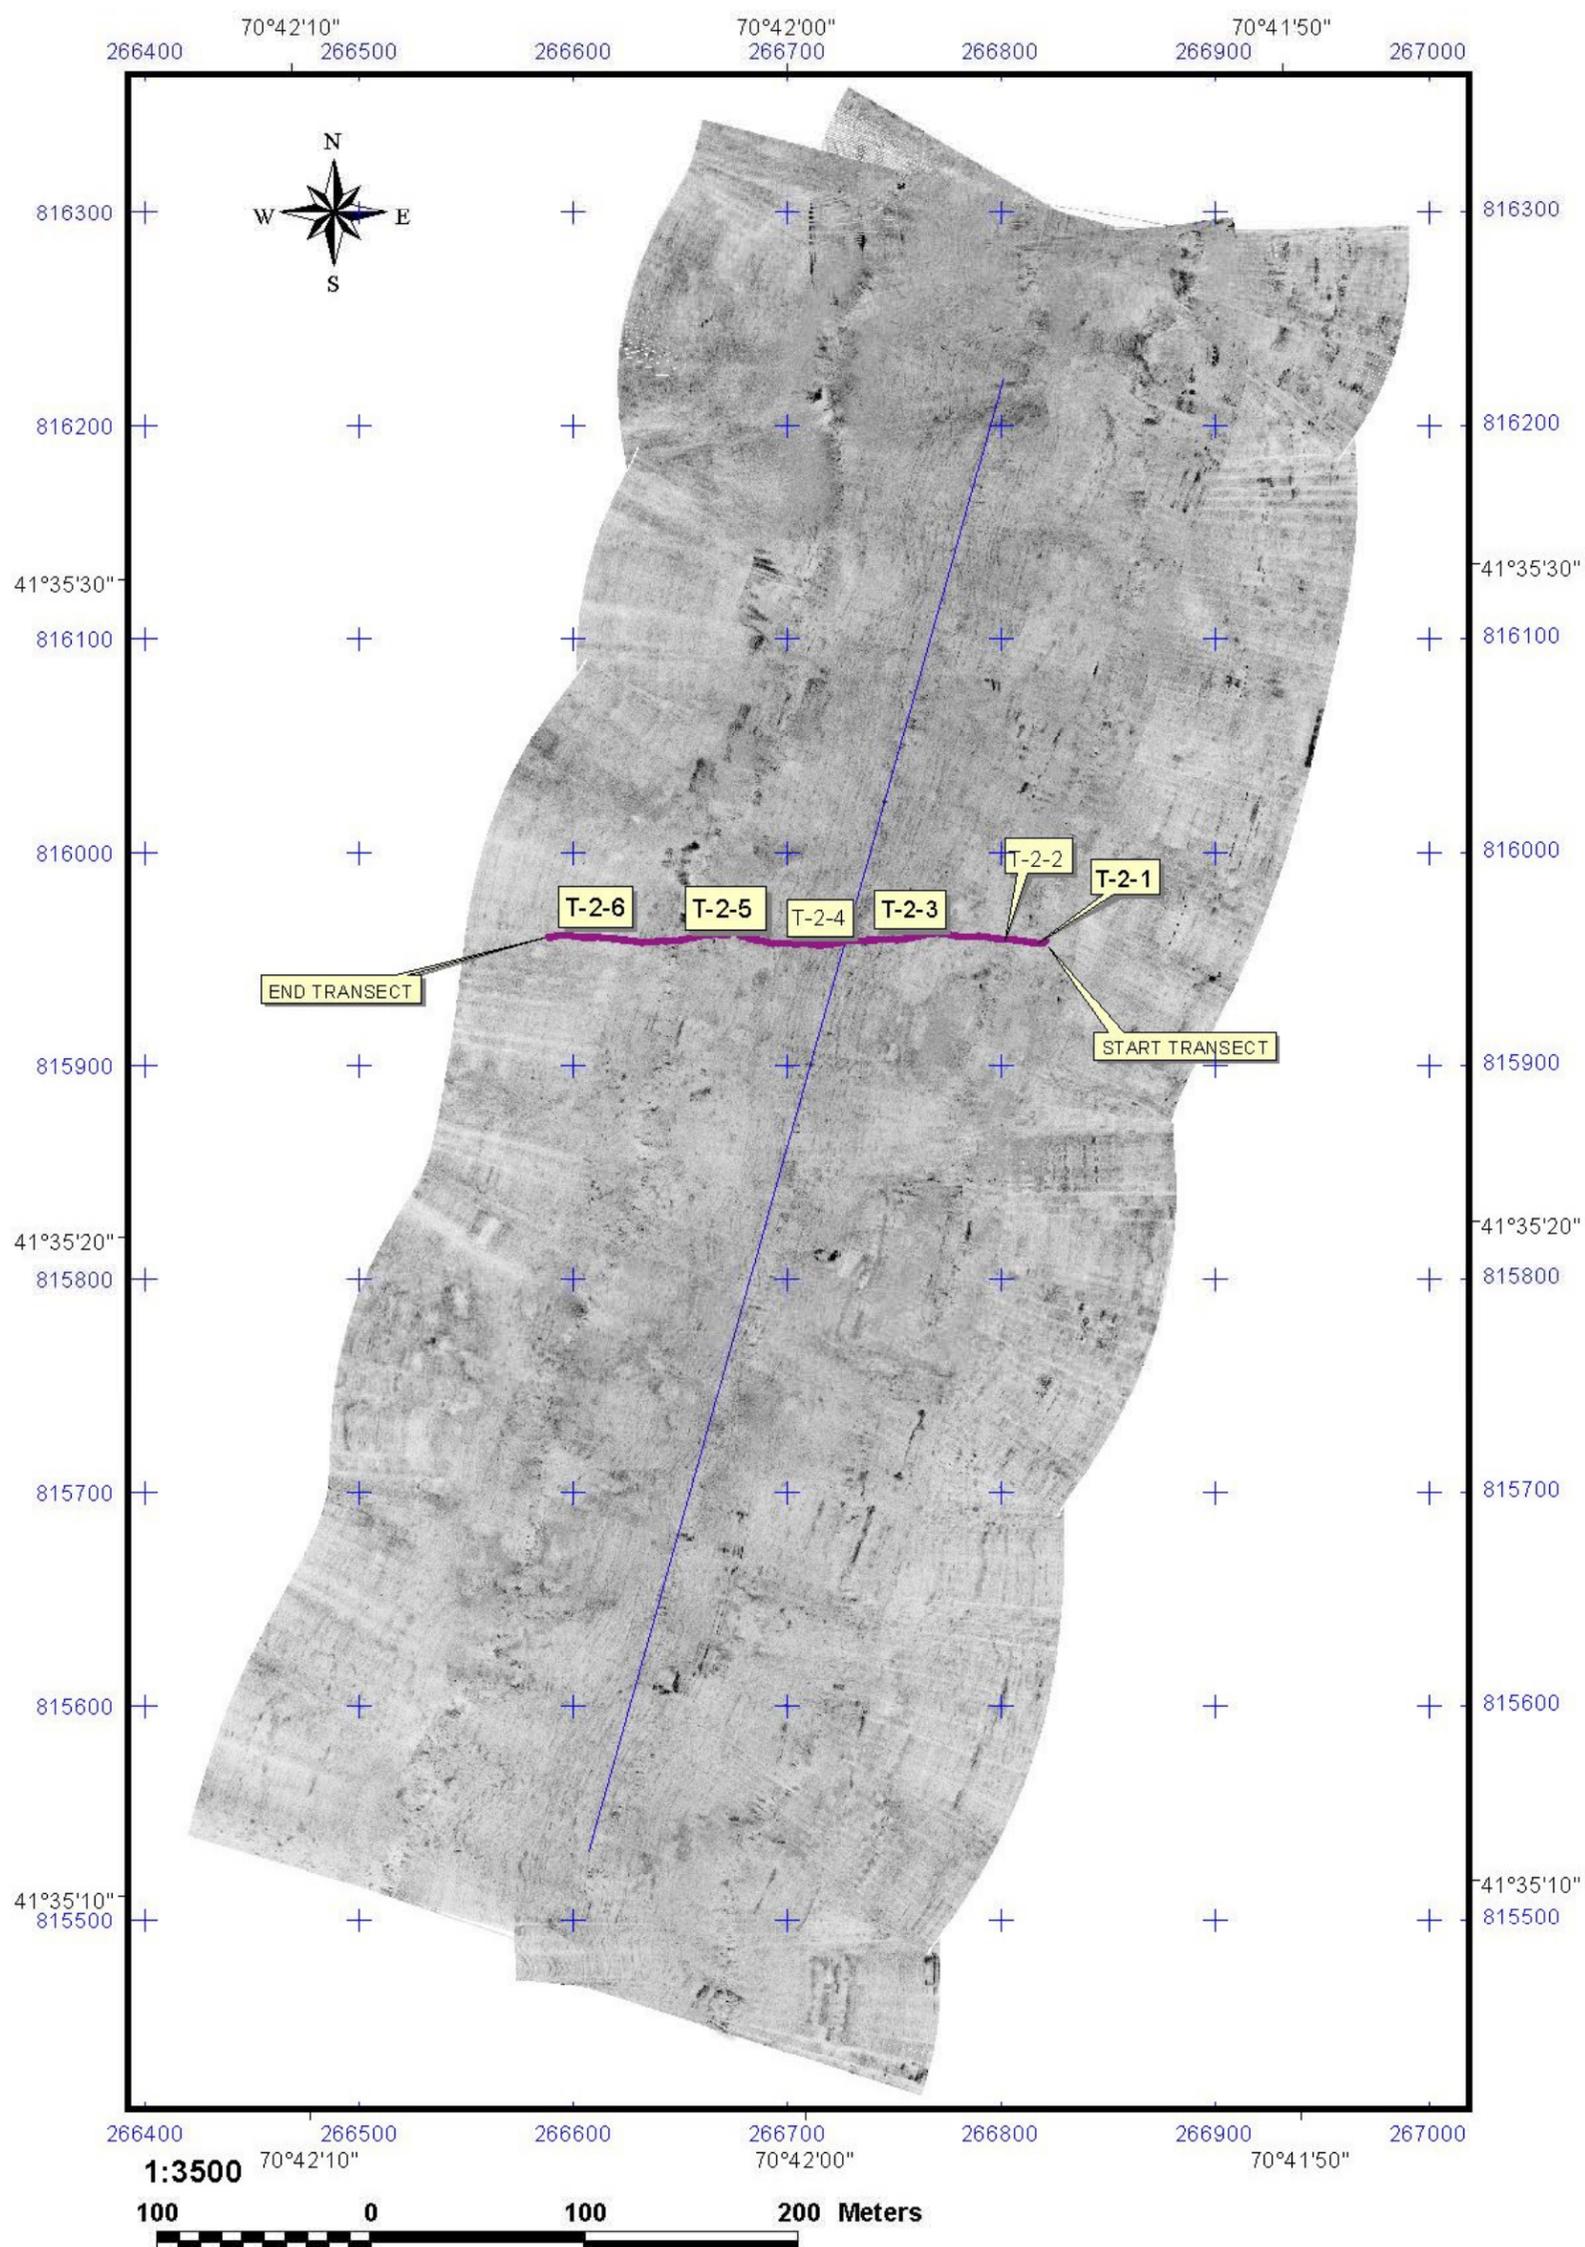
FIGURE 2

The side-scan data at T-2 shows a harder mud/sand bottom with evidence of dredged material (Figure 2). The dredged material is not detected on the underwater video. The dredged material is probably covered by a veneer of soft sediment. Some bottom scours were detected on the underwater video that could be trawl door marks. The video also shows some large patches of red algae, feeding depressions, mounds, worm holes and burrows (Figure 10).

SIDE SCAN SONAR MOSAIC AND VIDEO DRIFT SURVEY
TRAWL LANE 2
BUZZARDS BAY DISPOSAL SITE

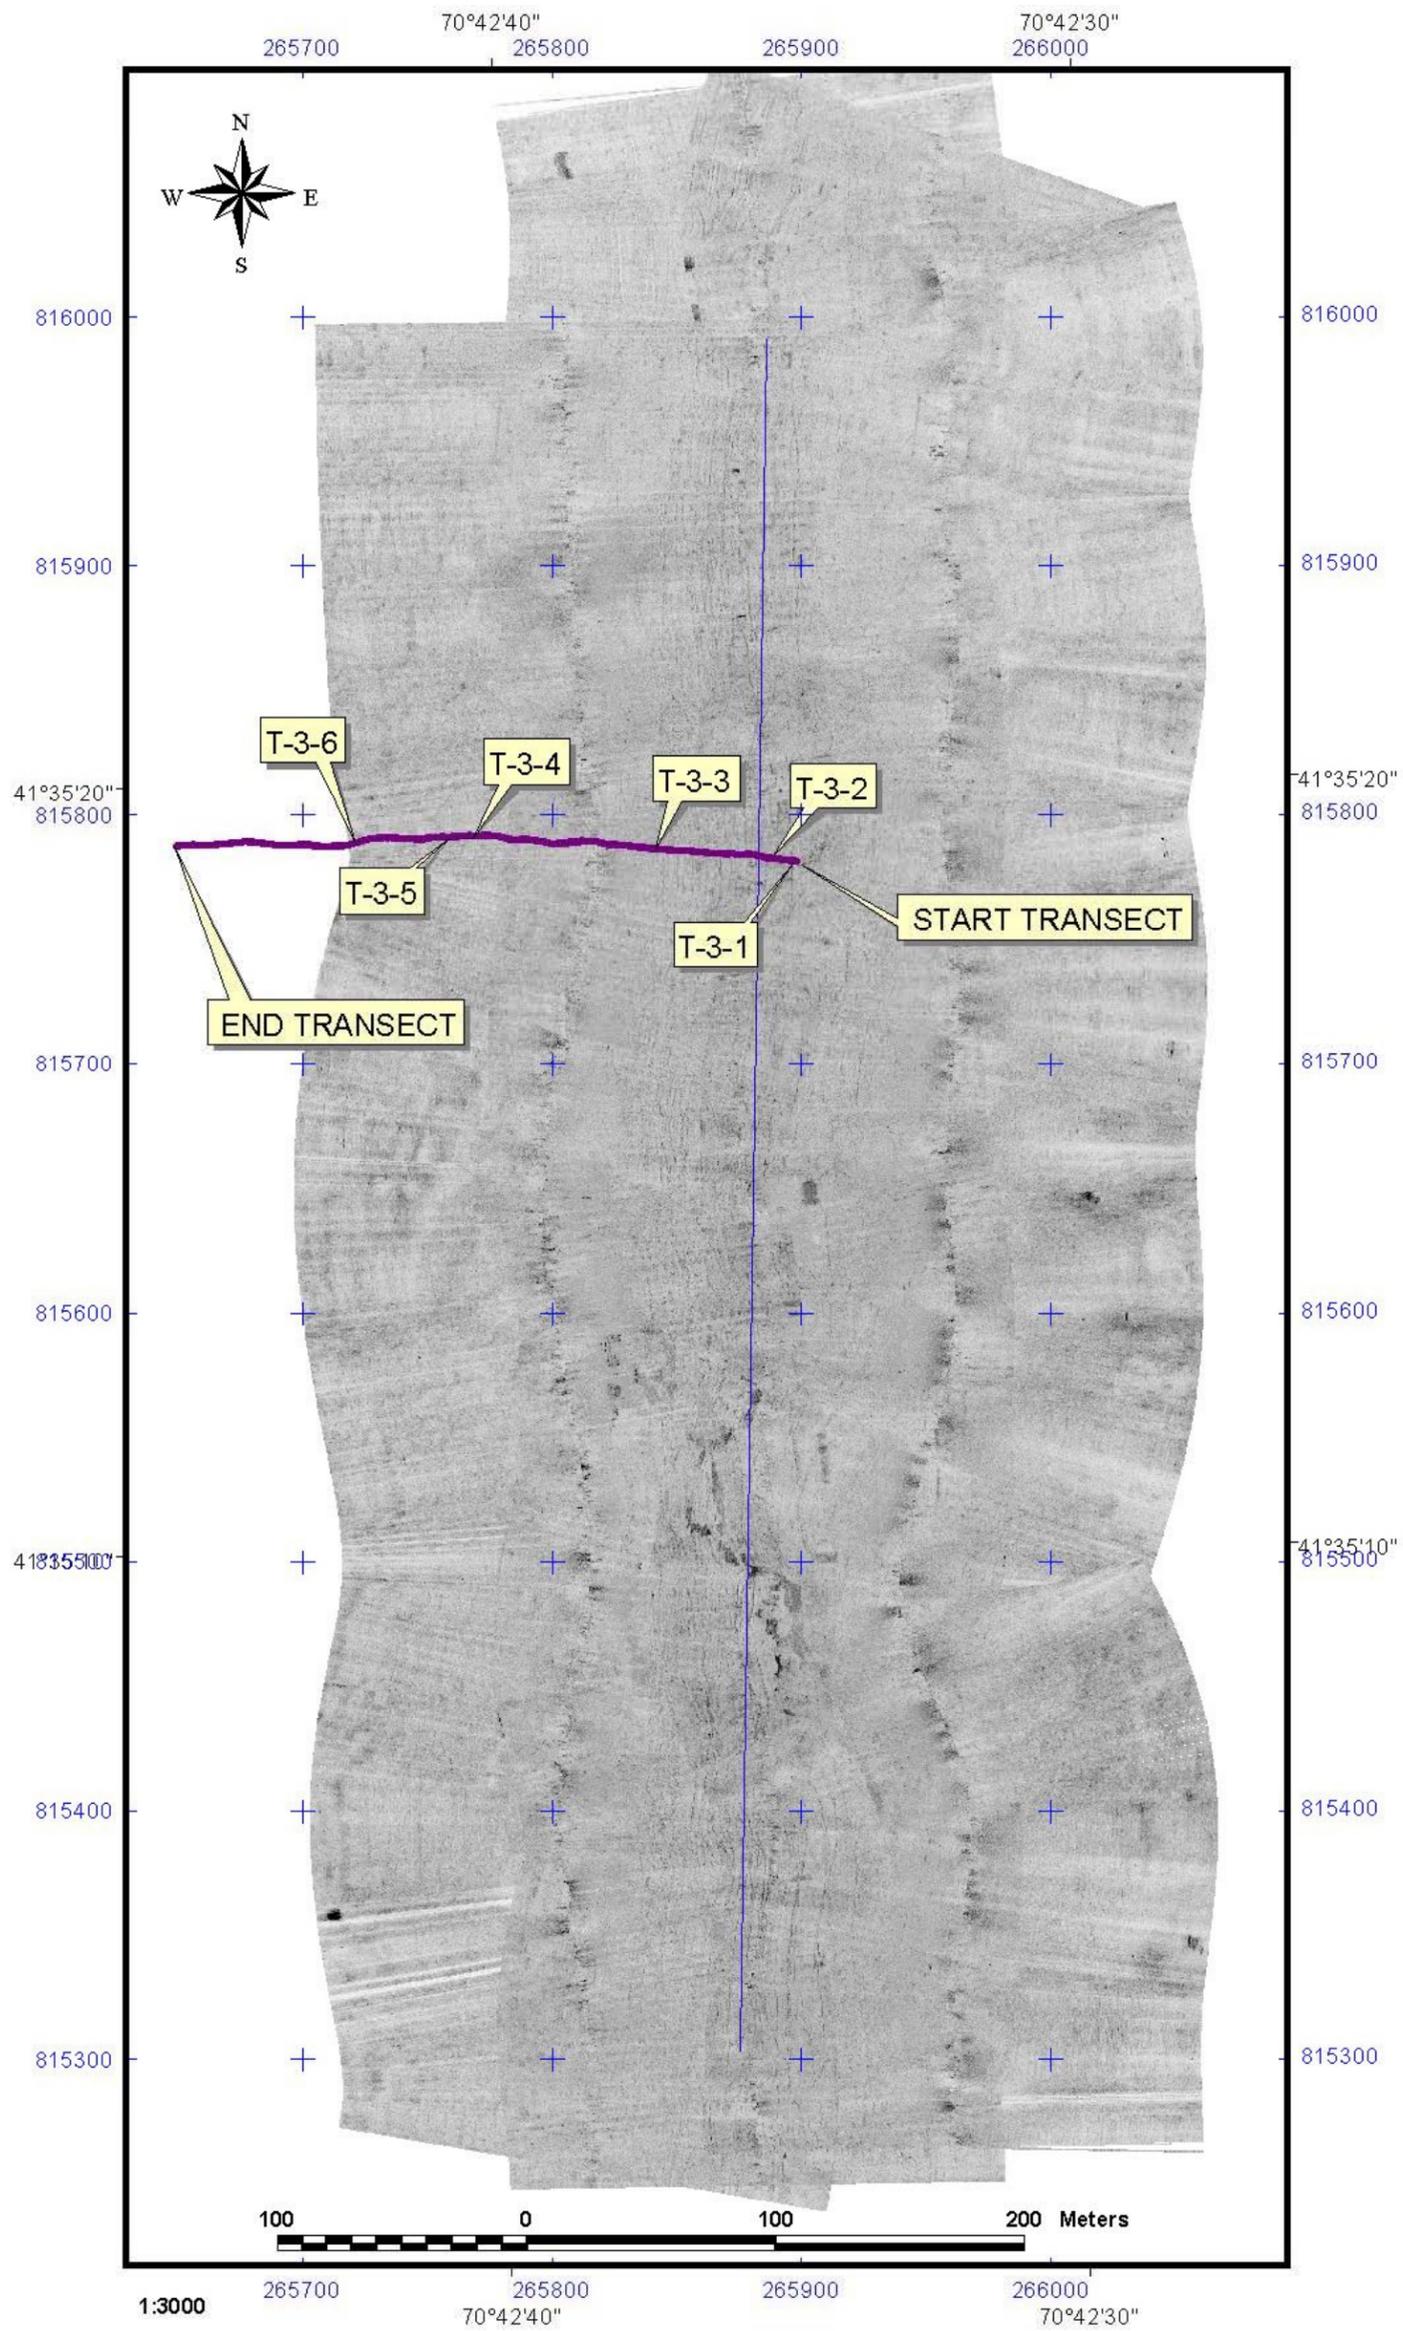
FIGURE 3

The side-scan mosaic for T-3 shows a mud/sand bottom with a small amount of harder dredged material (Figure 3). Similar to T-2, the underwater video showed feeding depressions, burrows, and worm holes with some patches of algae and some parchment worm tubes. A live quahog was also observed at the start of the video drift (Figure 11).

SIDE SCAN SONAR MOSAIC AND VIDEO DRIFT SURVEY
TRAWL LANE 3
BUZZARDS BAY DISPOSAL SITE

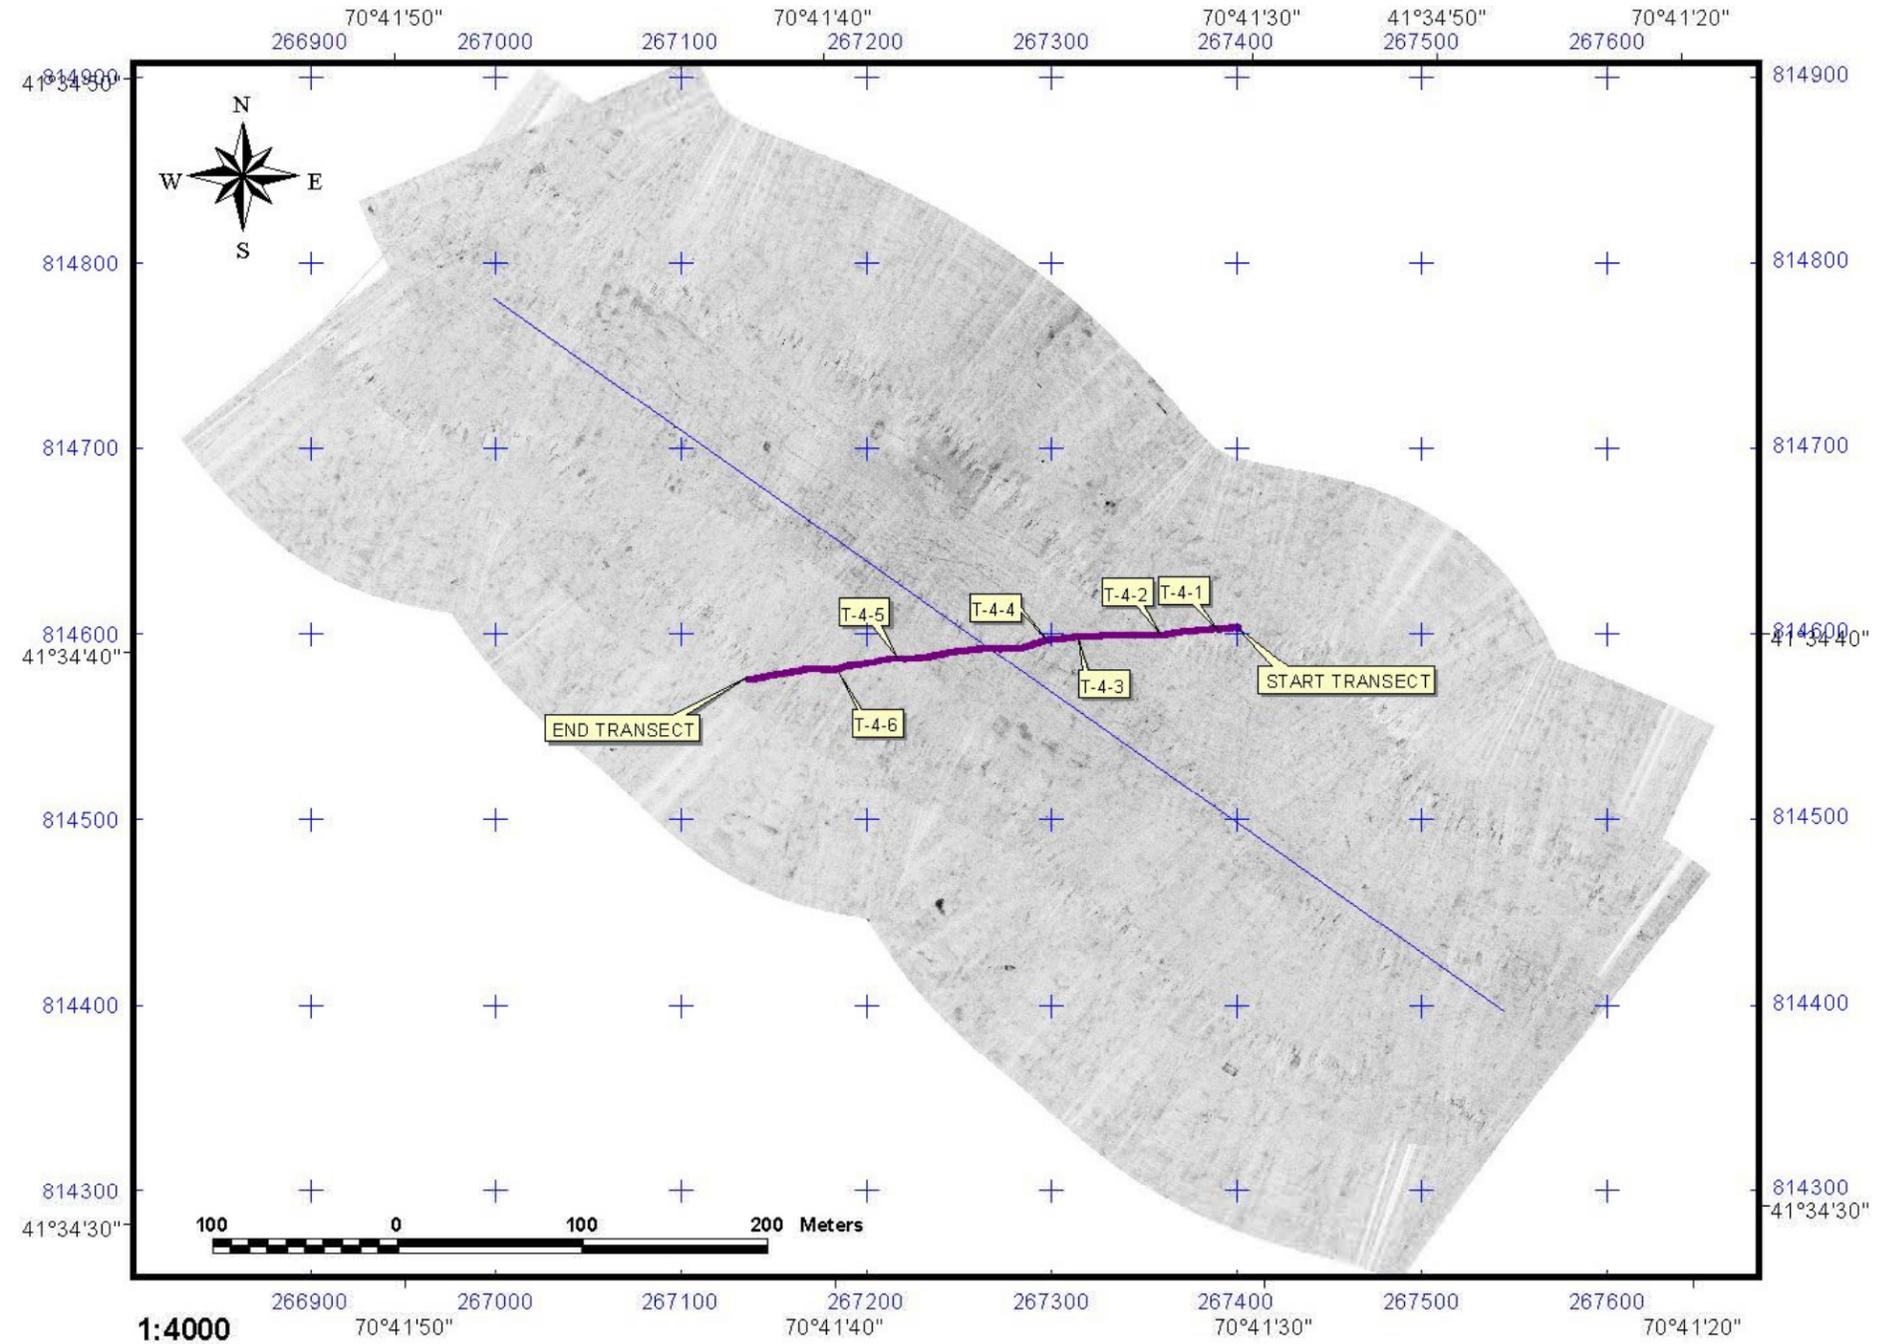
FIGURE 4

A softer mud bottom was observed at T-4 based on the side-scan data (Figure 4) and underwater video. Very large areas of red algae were observed on the video drift at this trawl lane, as well as numerous parchment worm tubes and many of the unidentified white worms (Figure 12).

SIDE SCAN SONAR MOSAIC AND VIDEO DRIFT SURVEY
TRAWL LANE 4
BUZZARDS BAY DISPOSAL SITE

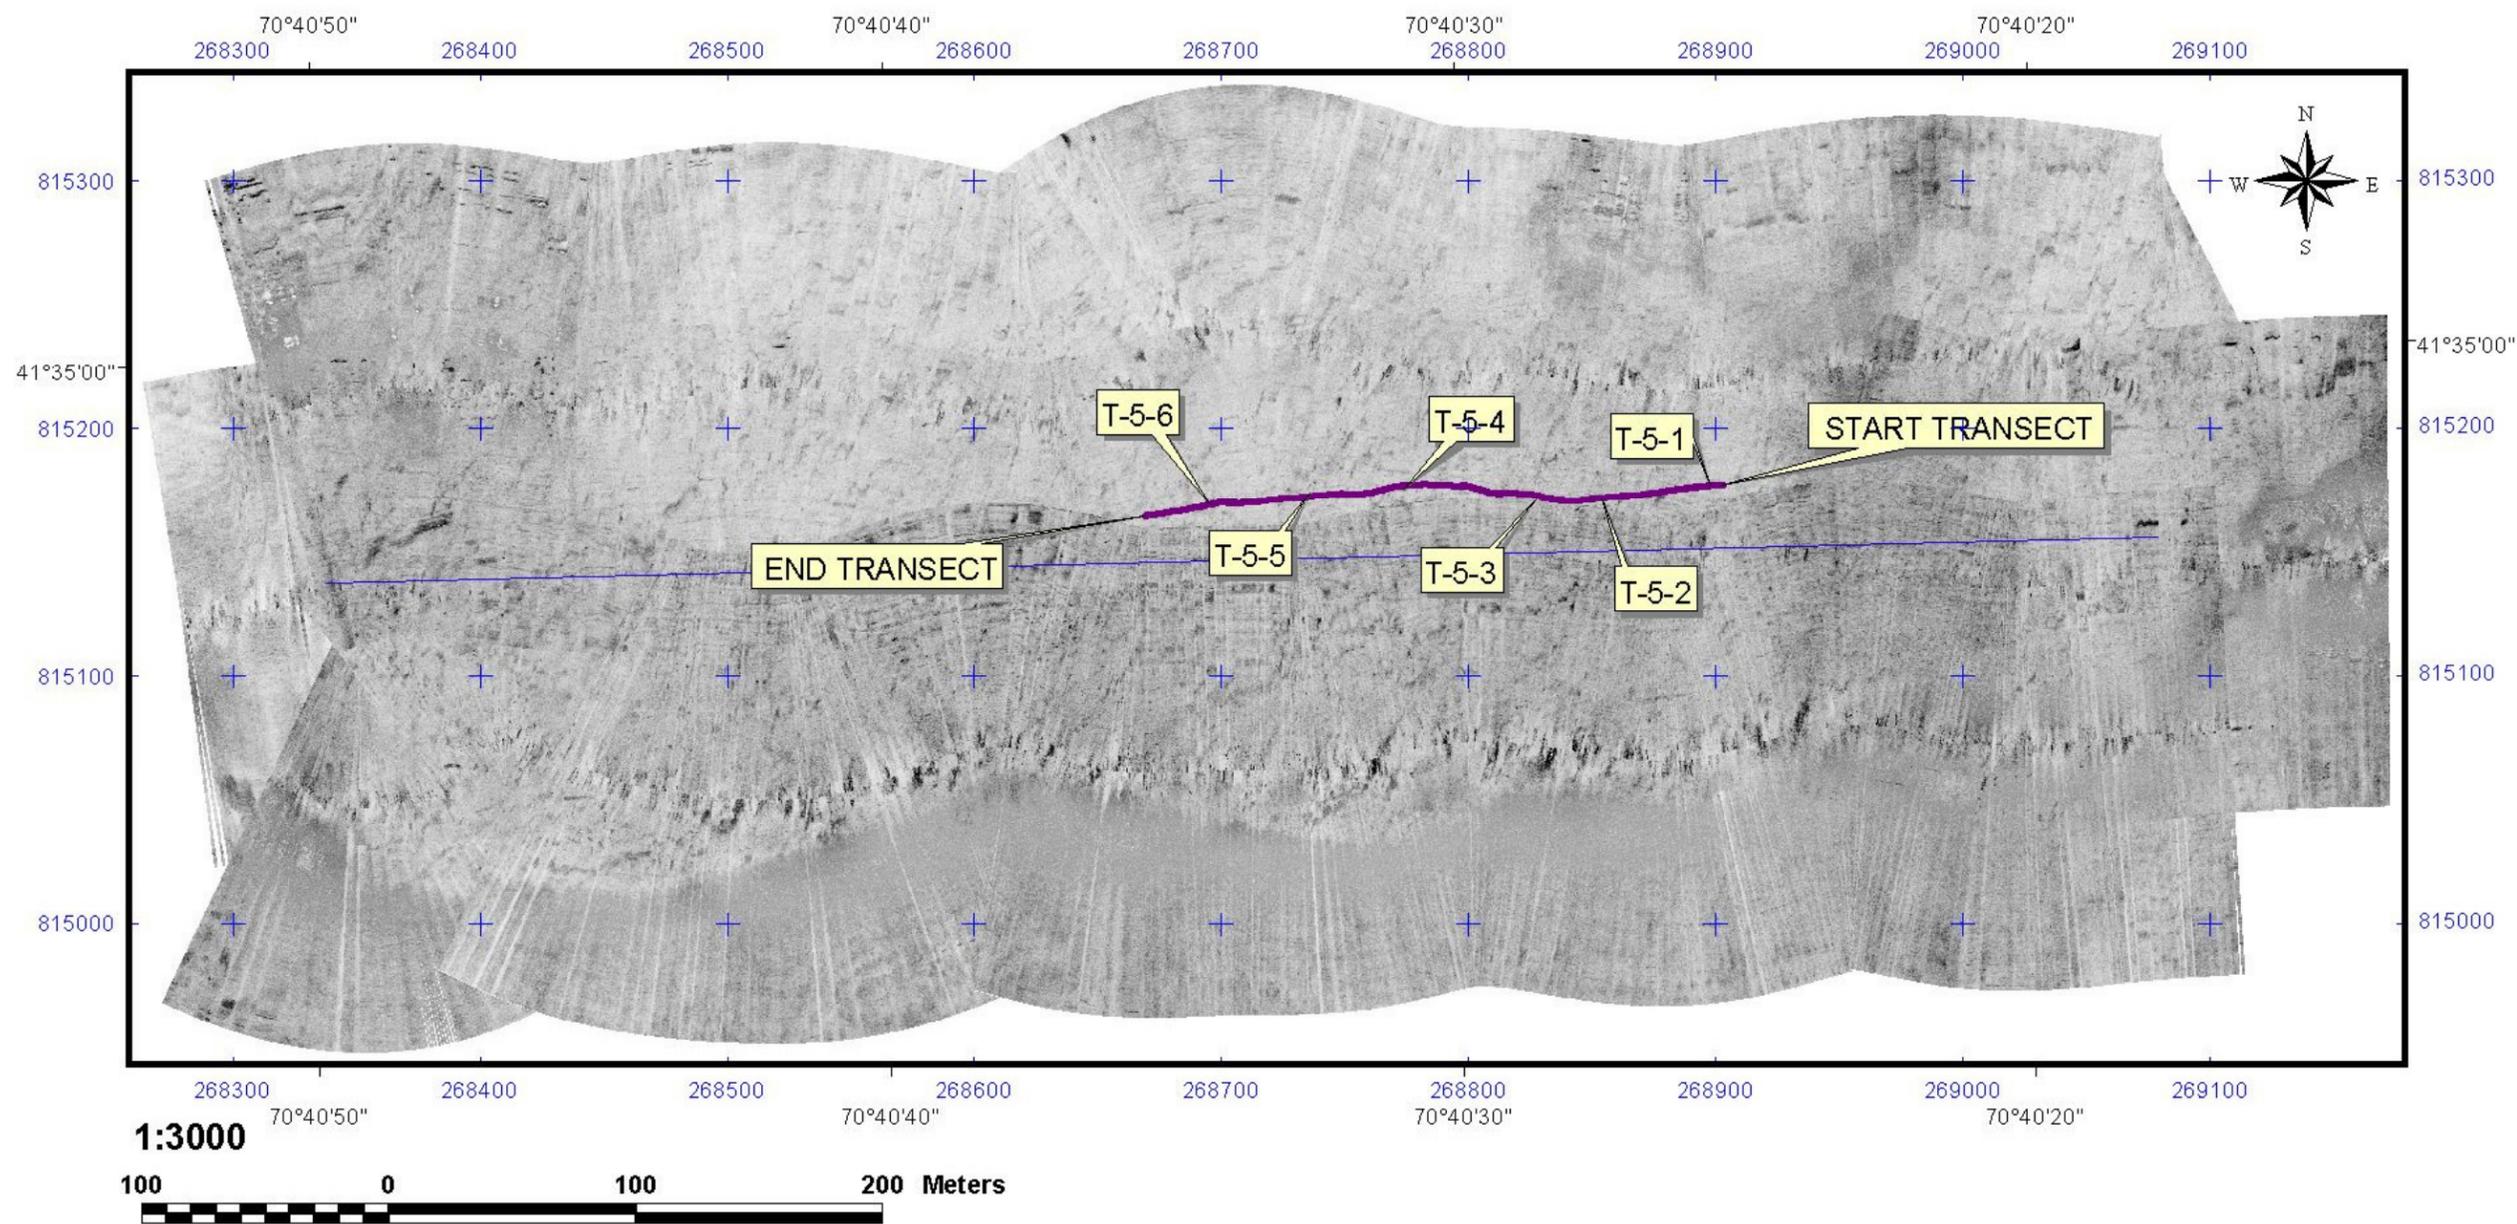
FIGURE 5

The T-5 side-scan mosaic (Figure 5) and video show harder mud/sand bottom with some large burrows and worm holes and some patches of algae and a few worm tubes (Figure 13). A horseshoe crab and whelk were also observed on the video drift.

SIDE SCAN SONAR MOSAIC AND VIDEO DRIFT SURVEY
TRAWL LANE 5
BUZZARDS BAY DISPOSAL SITE

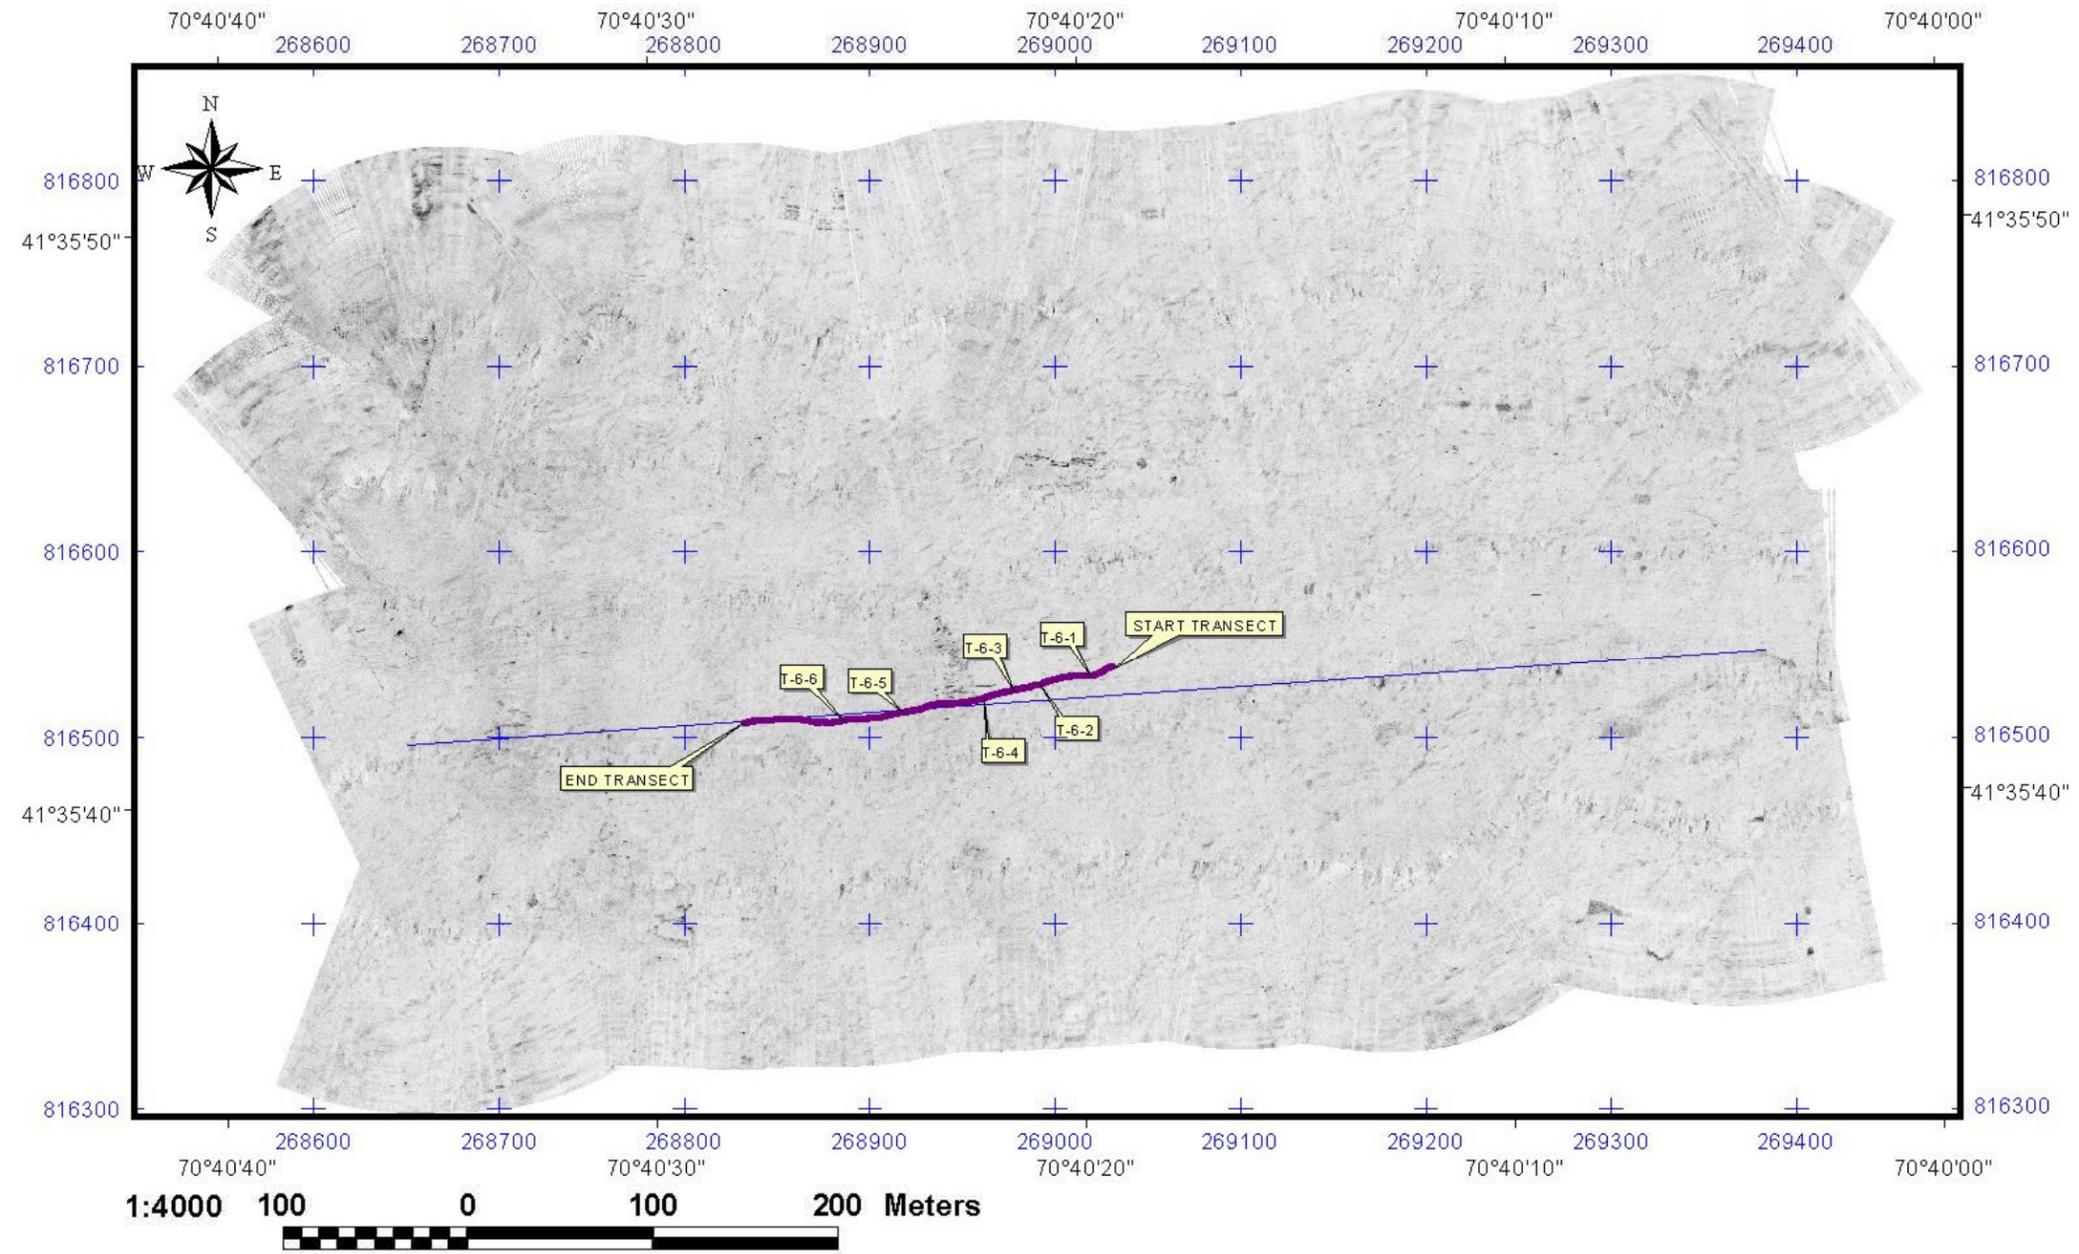
FIGURE 6

T-6 on the eastern edge of BBDS appears to be the soft mud bottom as indicated by the extremely light side-scan records (Figure 6). Here there are numerous worm holes, and large burrows that are possible juvenile lobster burrows. Also observed were large patches of algae with numerous glass shrimp and a few parchment worm tubes. A flounder, the only fish observed on the underwater video footage was observed at this transect (Figure 14).

SIDE SCAN SONAR MOSAIC AND VIDEO DRIFT SURVEY
TRAWL LANE 6
BUZZARDS BAY DISPOSAL SITE
