BOTTOM CLASSIFICATION SURVEY BUZZARDS BAY DISPOSAL SITE

CR Environmental, Inc.
639 Boxberry Hill Rd.
East Falmouth, MA 02536

June 2002

BOTTOM CLASSIFICATION SURVEY BUZZARDS BAY DISPOSAL SITE SURVEY REPORT

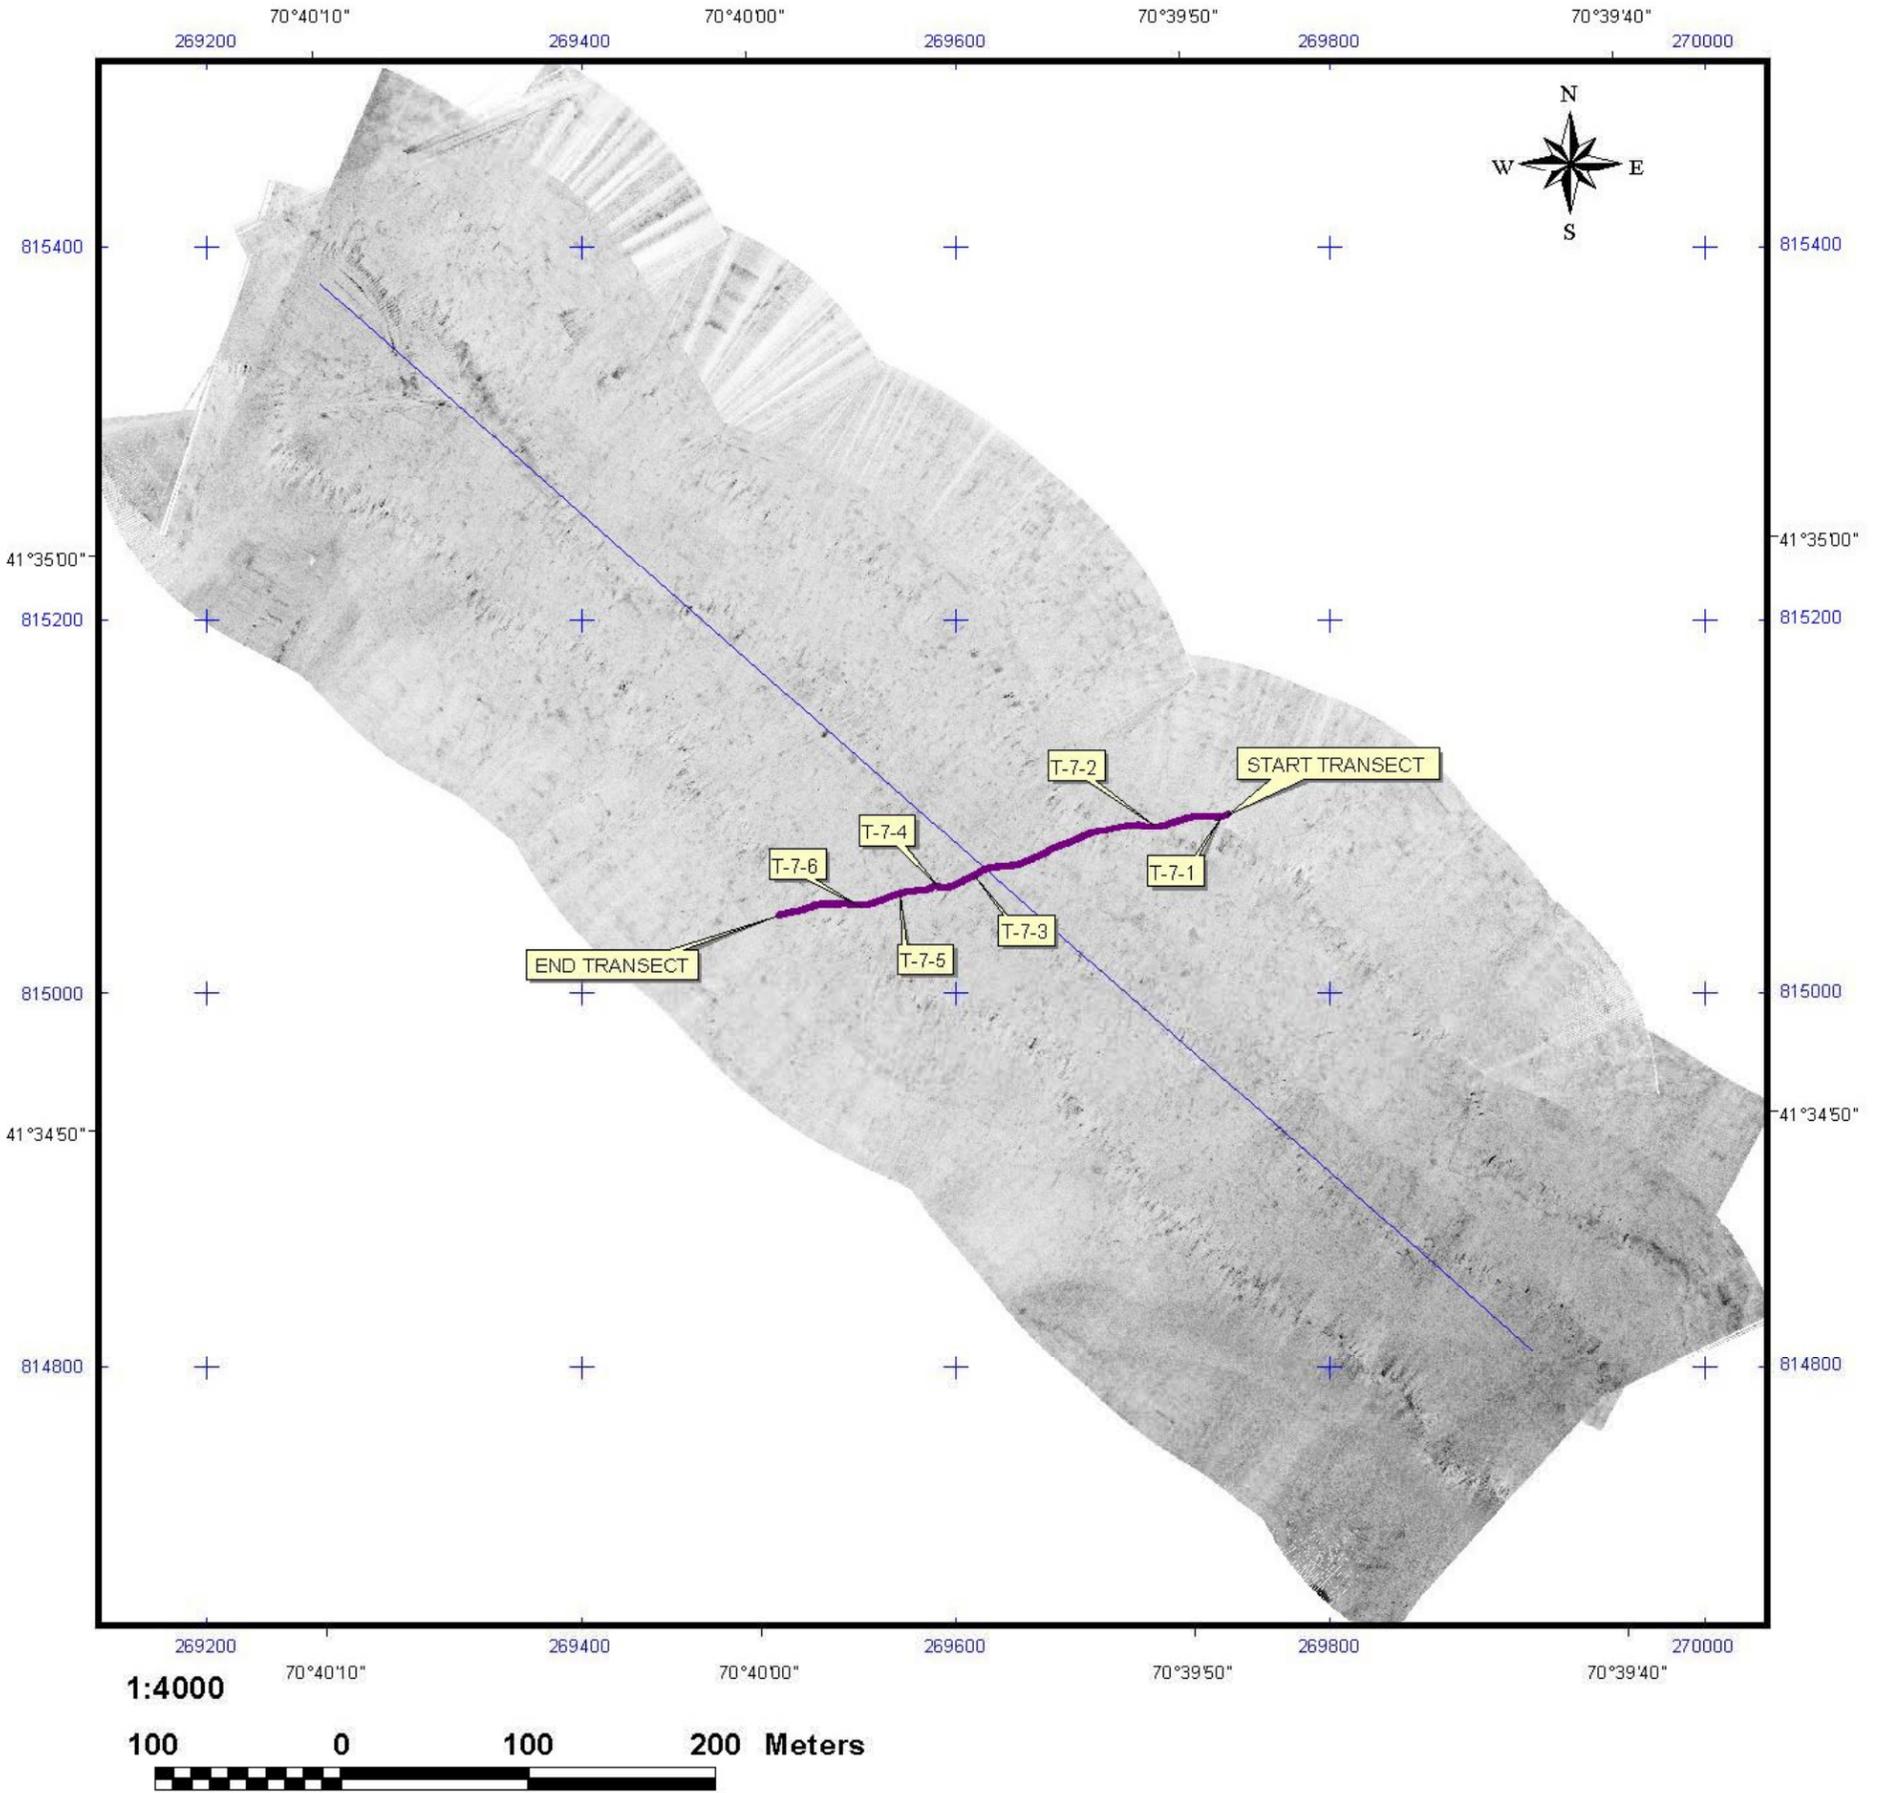
The side-scan sonar mosaic at T-7 shows a harder mud/sand bottom at the southeast corner of the transect transitioning to a mud bottom (Figure 7). The softer bottom is confirmed by the underwater video footage. The video shows numerous burrows and worm holes with a few parchment worm tubes. The bottom was generally flat with some patches of brown 'mat' and a few isolated patches of algae. A live quahog and spider crab were observed at this transect (Figure 15).

FIGURE 7
SIDE SCAN SONAR MOSAIC AND VIDEO DRIFT SURVEY
TRAWL LANE 7
BUZZARDS BAY DISPOSAL SITE

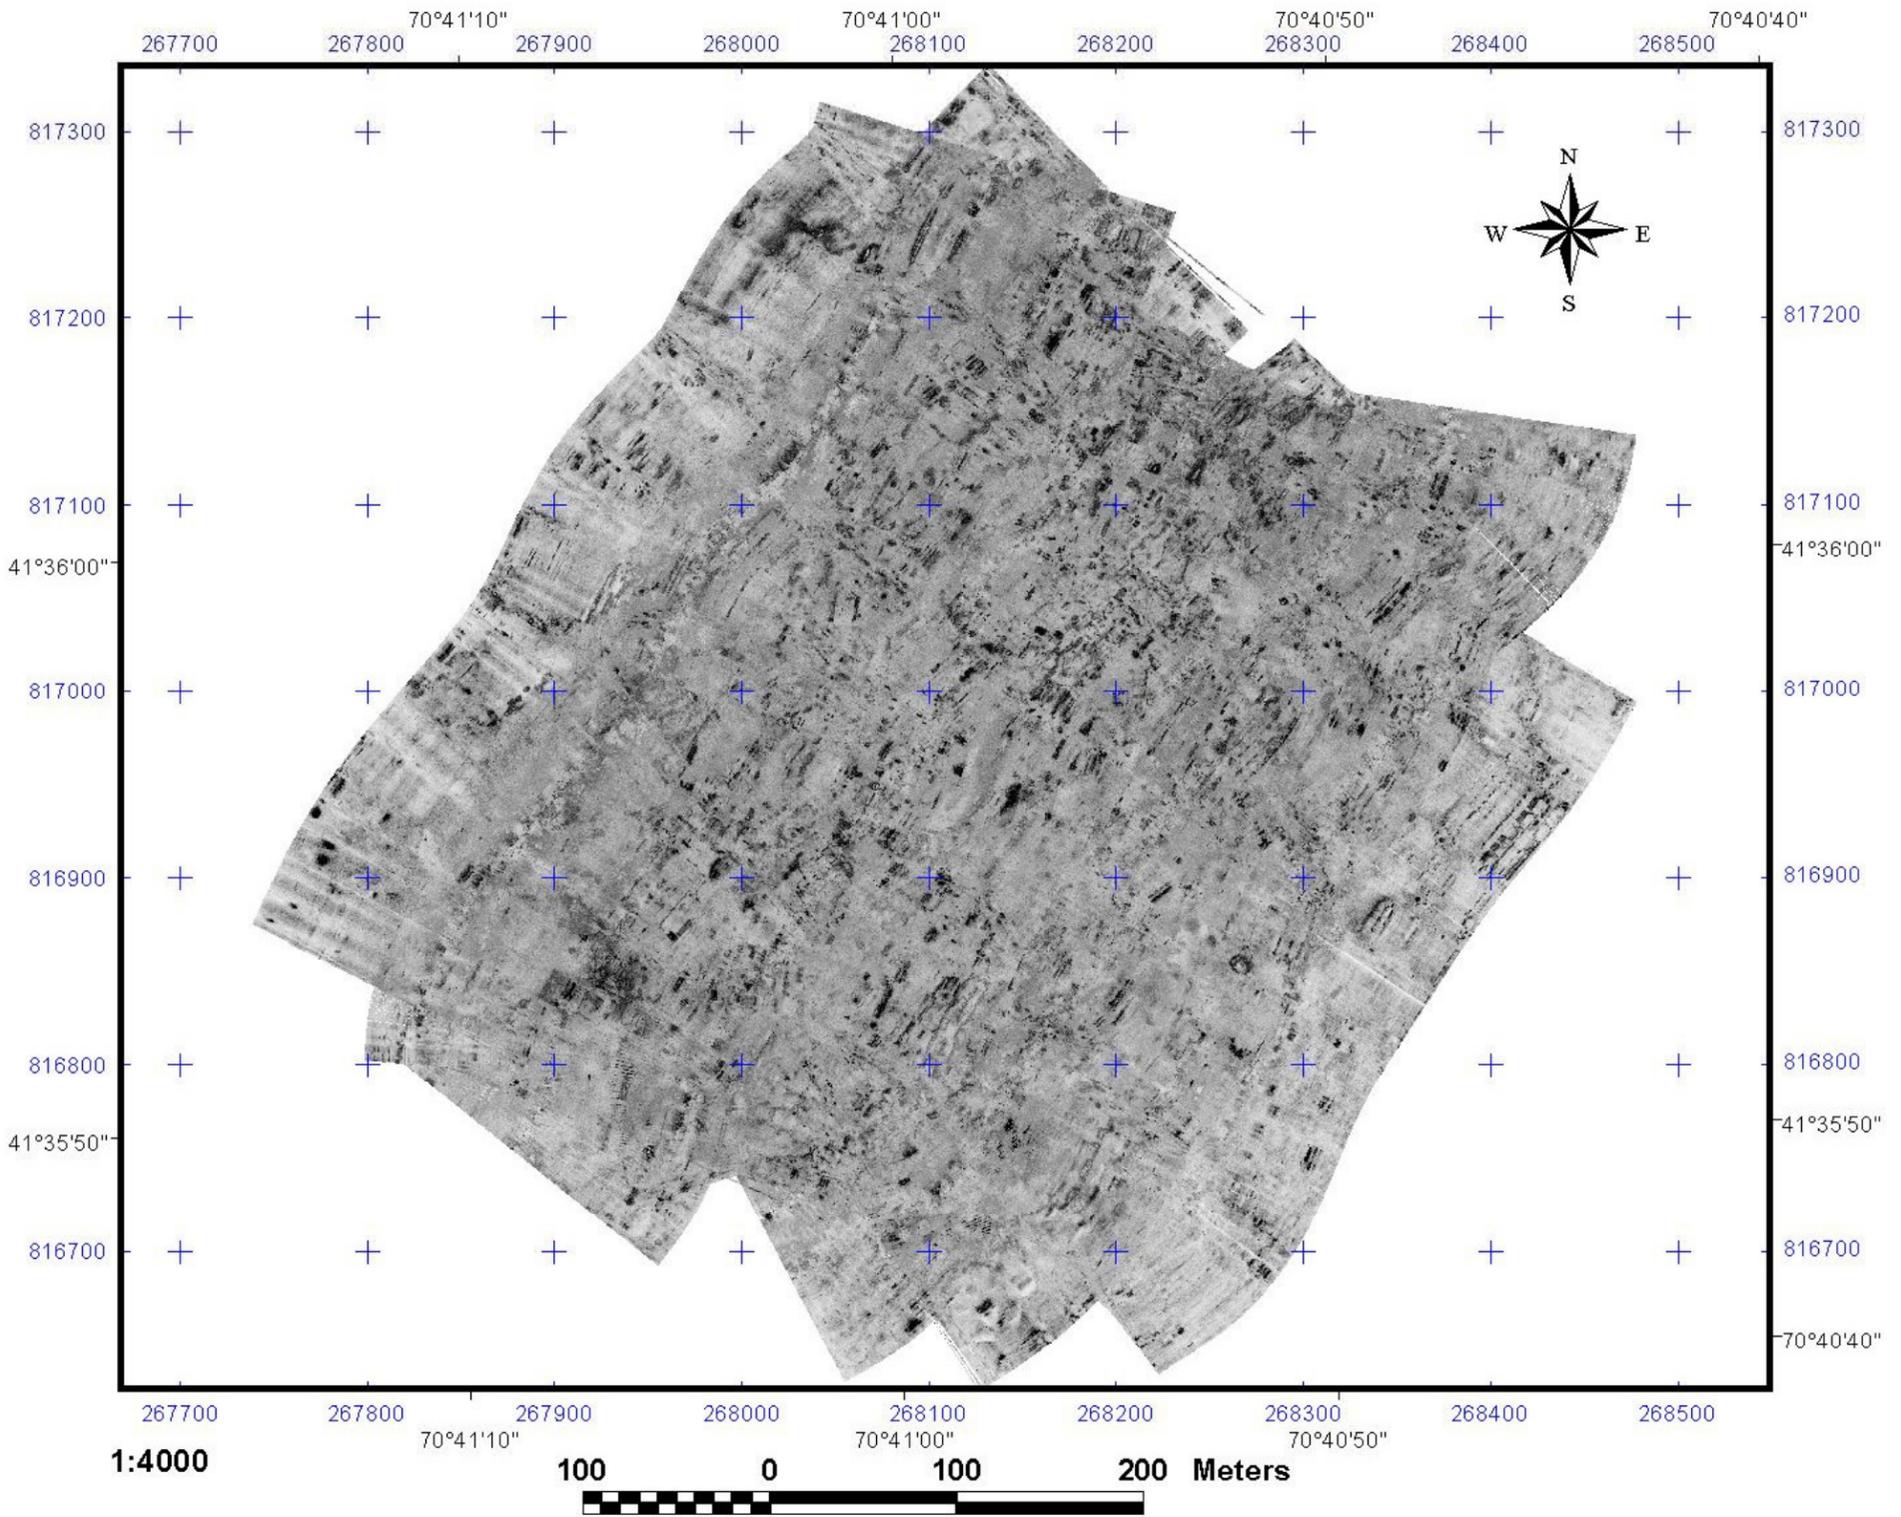
The side-scan mosaic for the center of the BBDS shows a generally hard bottom with numerous deposits of dredged material (Figure 8). The harder dredged material reflects the acoustic energy from the side-scan system and appears dark on the records. A few of these small mounds cast acoustic shadows that appear white on the records. No video data was collected at this site due to the risk of hanging up the video sled on the potential bottom obstructions and harder bottom.

FIGURE 8
SIDE SCAN SONAR MOSAIC
CENTRAL DUMP LOCATION INDICATED ON NAUTICAL CHART
BUZZARDS BAY DISPOSAL SITE

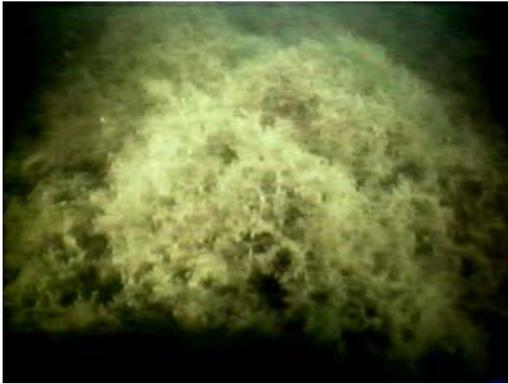
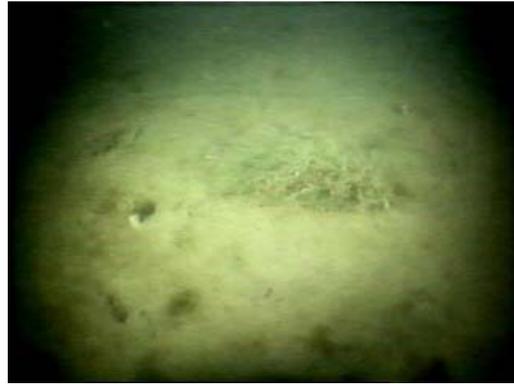
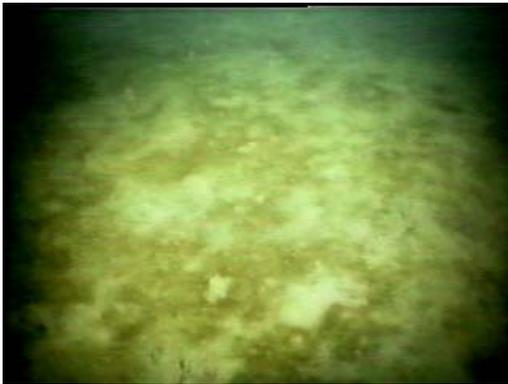
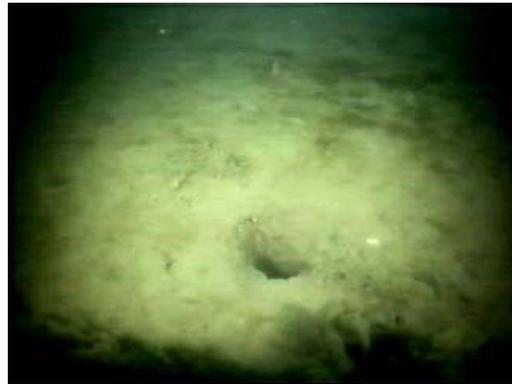
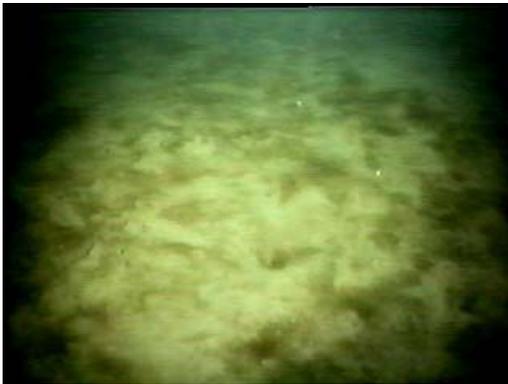
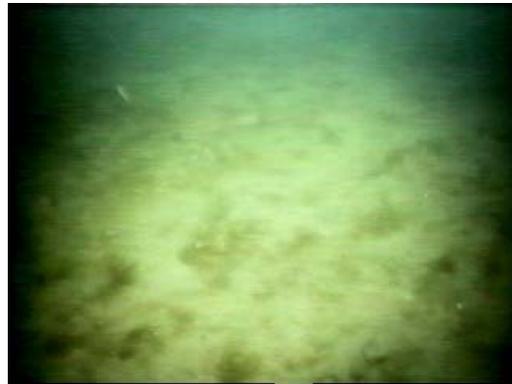
FIGURE 9 BBDS SCREEN CAPTURES VIDEO DRIFT – TRAWL LANE 1

The side-scan data at T-1 shows a soft mud bottom in the center of the trawl lane and a harder mud/sand bottom at the southern and northern ends of the transect (Figure 1). The southern hard bottom area is labeled as "HRD" on the NOAA Nautical Chart for Buzzards Bay. The video at T-1 shows a sparse mud bottom with patches of brown 'mat' and a few isolated patches of red algae and parchment worm tubes (Figure 9).

T-1-1 Patch of Red Algae

T-1-2 Worm Tube

T-1-3 Mud Bottom patches of Brown 'Mat'

T-1-4 Large Burrow

T-1-5 Flat mud bottom

T-1-6 Mud bottom

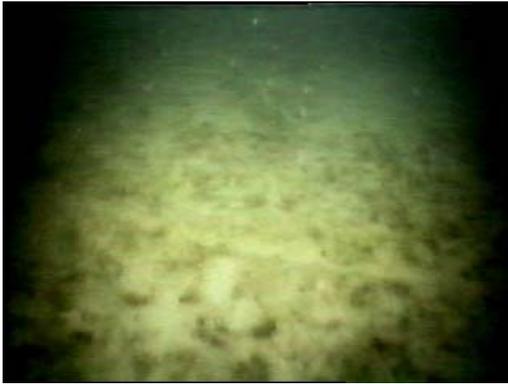
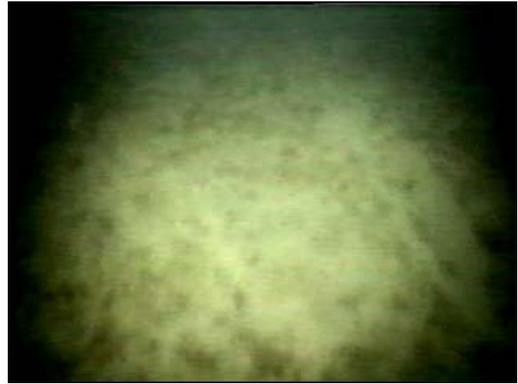
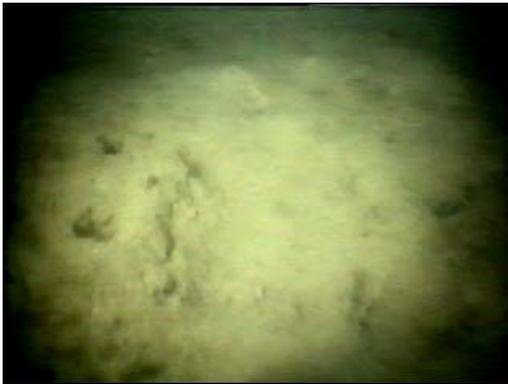
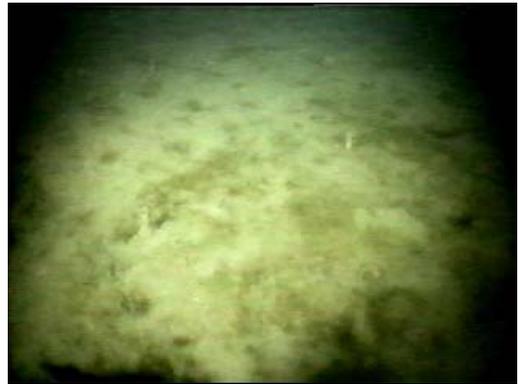
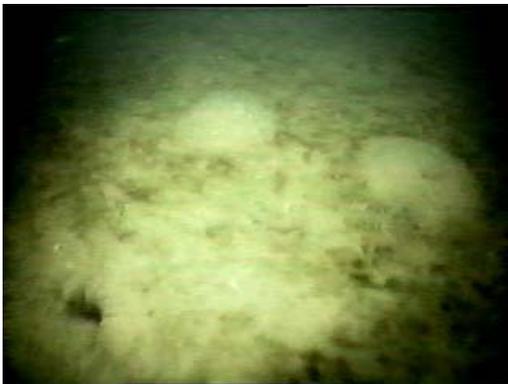
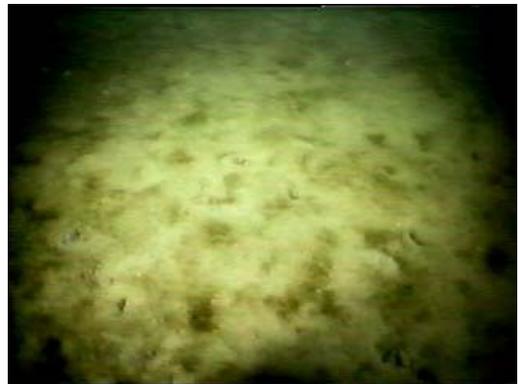
FIGURE 10 BBDS SCREEN CAPTURES VIDEO DRIFT – TRAWL LANE 2

The side-scan data at T-2 shows a harder mud/sand bottom with evidence of dredged material (Figure 2). The dredged material is not detected on the underwater video. The dredged material is probably covered by a veneer of soft sediment. Some bottom scours were detected on the underwater video that could be trawl door marks. The video also shows some large patches of red algae, feeding depressions, mounds, worm holes and burrows (Figure 10).

T-2-1 Possible trawl mark

T-2-2 Trawl door mark

T-2-3 Depression and burrows

T-2-4 Worm tube

T-2-5 Mounds worm holes

T-2-6 Patches of Brown 'Mat'

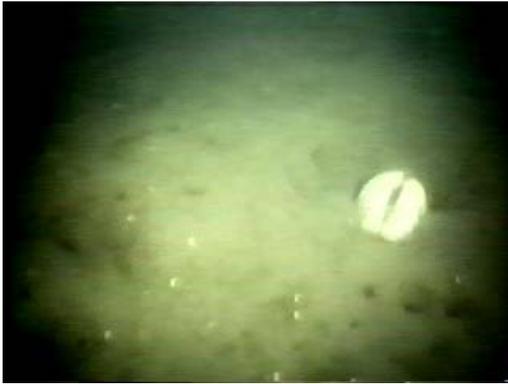
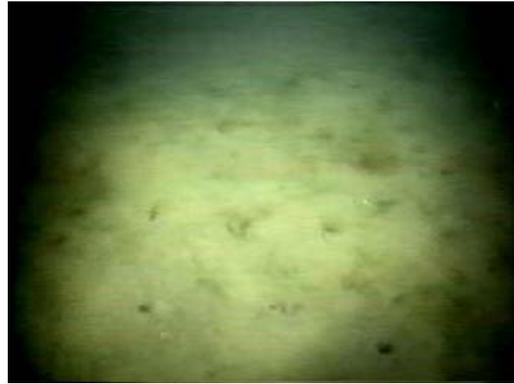
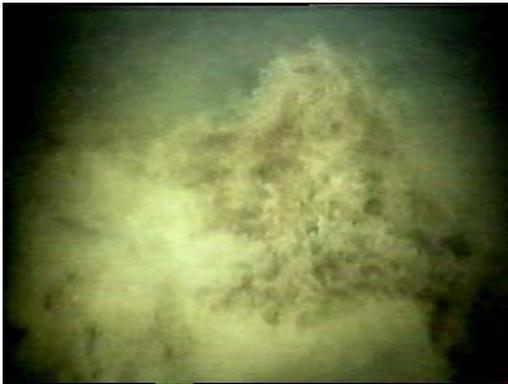
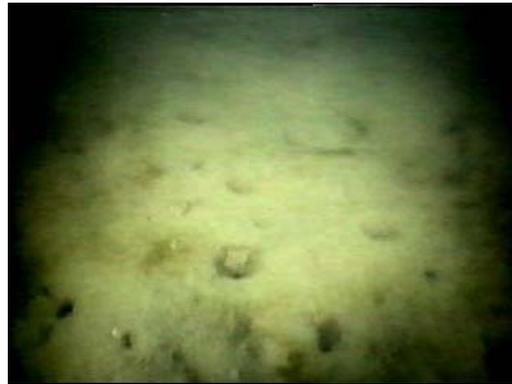
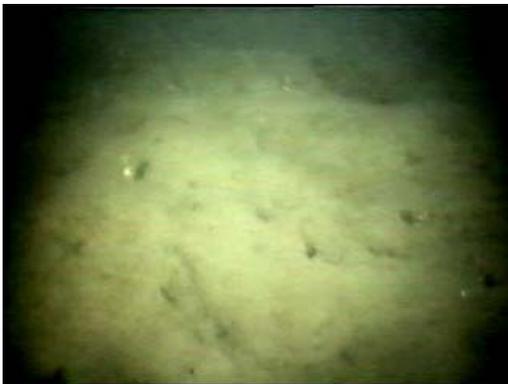
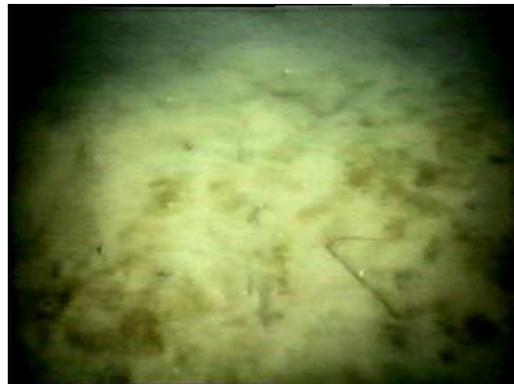
FIGURE 11 BBDS SCREEN CAPTURES VIDEO DRIFT – TRAWL LANE 3

The side-scan mosaic for T-3 shows a mud/sand bottom with a small amount of harder dredged material (Figure 3). Similar to T-2, the underwater video showed feeding depressions, burrows, and worm holes with some patches of algae and some parchment worm tubes. A live quahog was also observed at the start of the video drift (Figure 11).

T-3-1 Quahog

T-3-2 Worm holes

T-3-3 Red Algae

T-3-4 Large burrows

T-3-5 Worm tubes

T-3-6 Brown patches

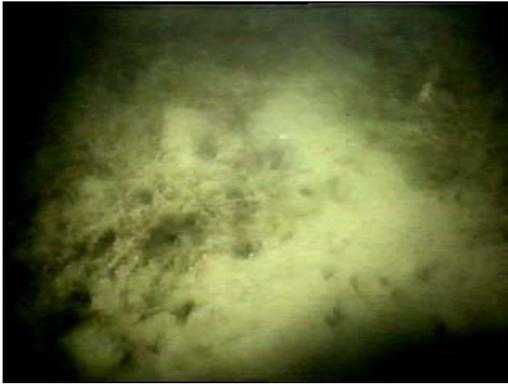
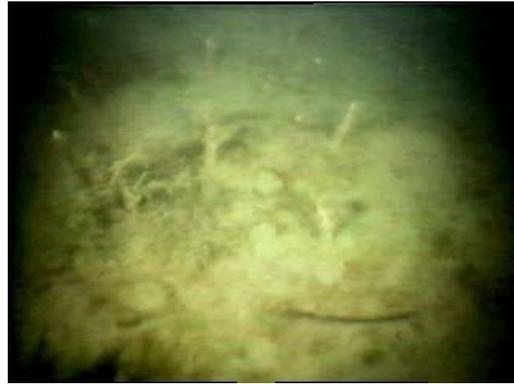
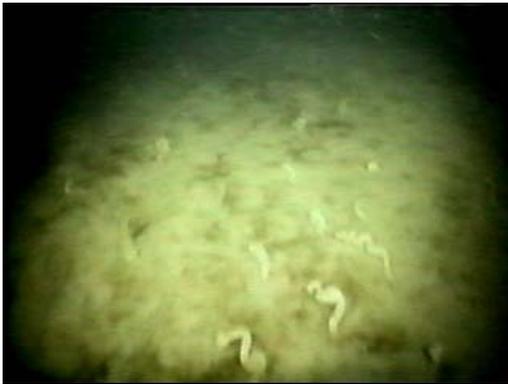
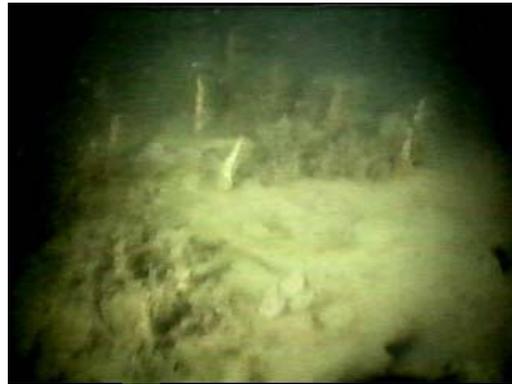
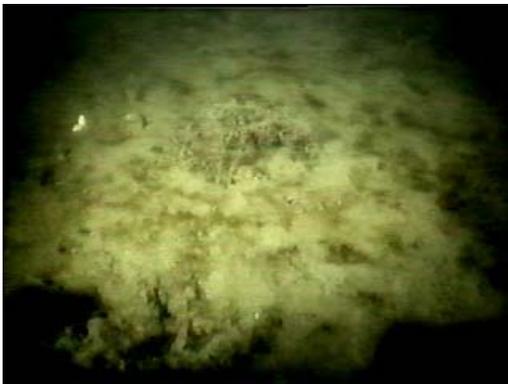
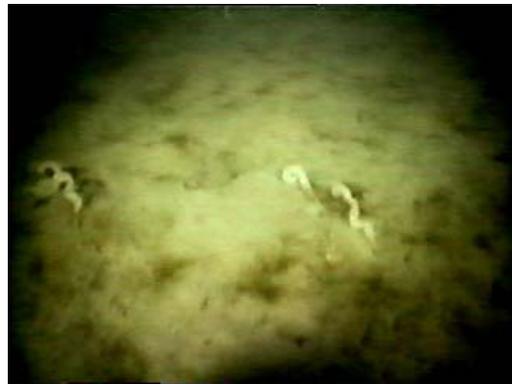
FIGURE 12 BBDS SCREEN CAPTURES VIDEO DRIFT – TRAWL LANE 4

A softer mud bottom was observed at T-4 based on the side-scan data (Figure 4) and underwater video. Very large areas of red algae were observed on the video drift at this trawl lane, as well as numerous parchment worm tubes and many of the unidentified white worms (Figure 12).

T-4-1 Red Algae patches

T-4-2 Worm tubes

T-4-3 Unidentified white worms

T-4-4 Many worm tubes

T-4-5 Algae patches

T-4-6 Unidentified white worms

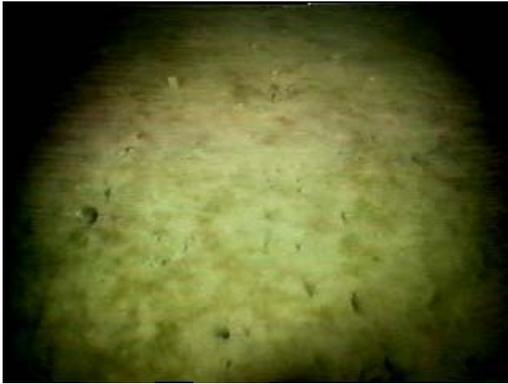
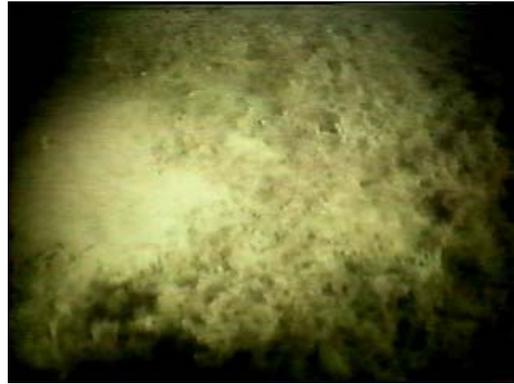
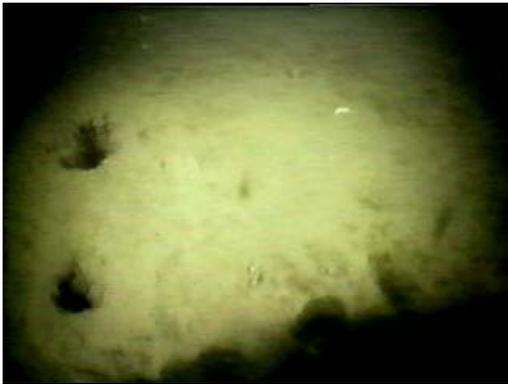
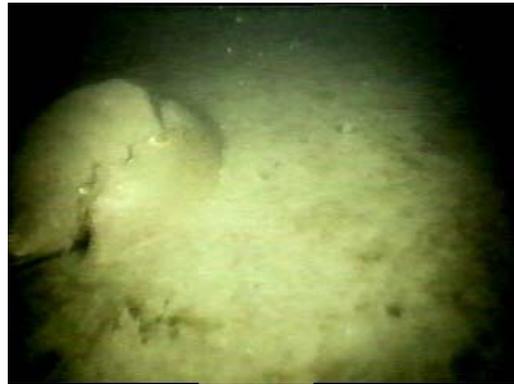
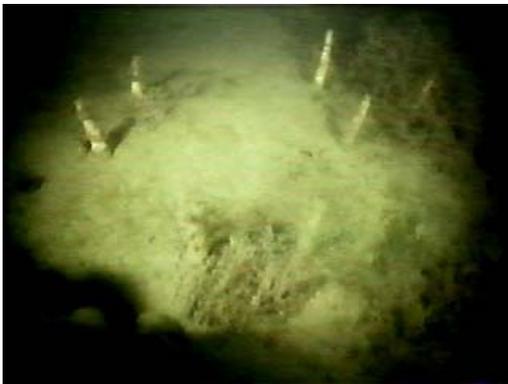
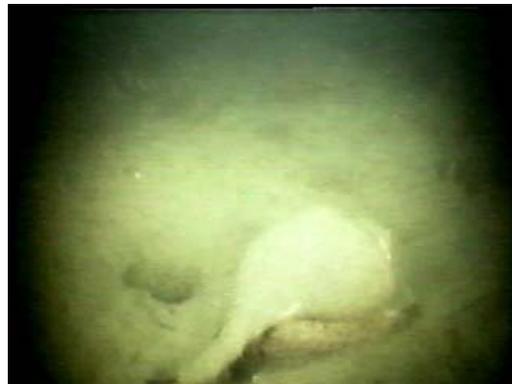
FIGURE 13 BBDS SCREEN CAPTURES VIDEO DRIFT – TRAWL LANE 5

The T-5 side-scan mosaic (Figure 5) and video show harder mud/sand bottom with some large burrows and worm holes and some patches of algae and a few worm tubes (Figure 13). A horseshoe crab and whelk were also observed on the video drift.

T-5-1 Few worm tubes

T-5-2 Depression with algae

T-5-3 Large burrows

T-5-4 Horseshoe crab

T-5-5 Worm tubes

T-5-6 Whelk

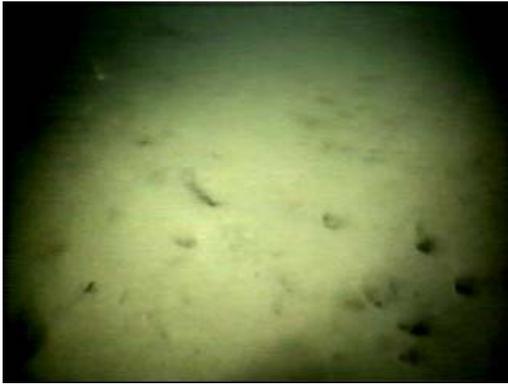
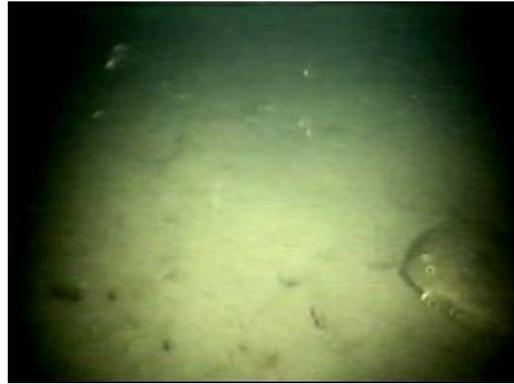
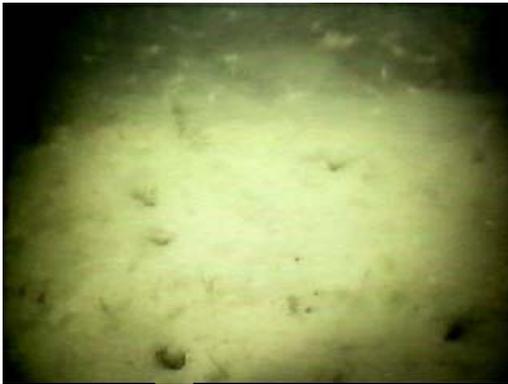
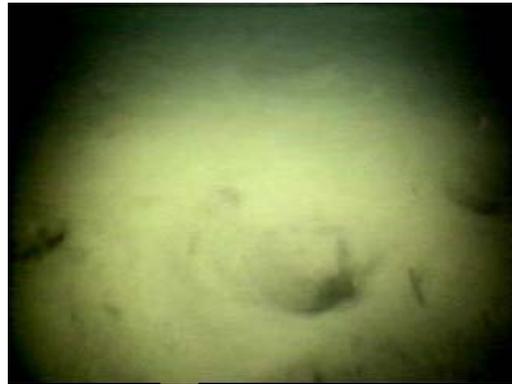
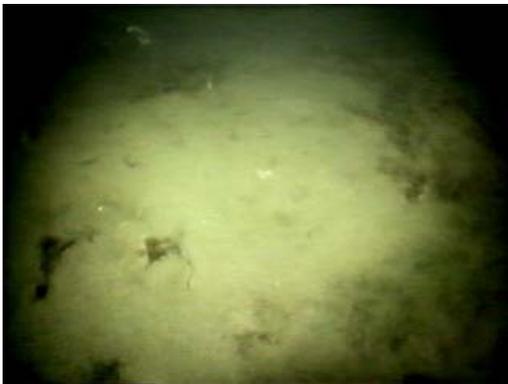
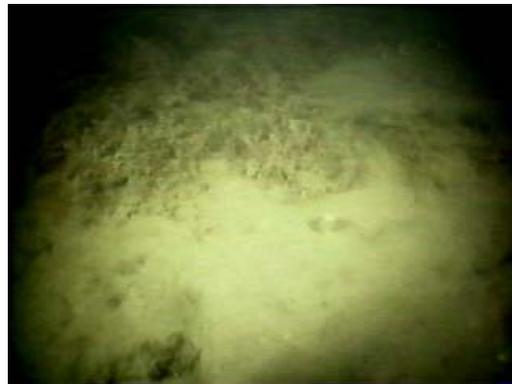
FIGURE 14 BBDS SCREEN CAPTURES VIDEO DRIFT – TRAWL LANE 6

T-6 on the eastern edge of BBDS appears to be the soft mud bottom as indicated by the extremely light side-scan records (Figure 6). Here there are numerous worm holes, and large burrows that are possible juvenile lobster burrows. Also observed were large patches of algae with numerous glass shrimp and a few parchment worm tubes. A flounder, the only fish observed on the underwater video footage was observed at this transect (Figure 14).

T-6-1 Many burrows and worm holes

T-6-2 Flounder

T-6-3 Many grass shrimp

T-6-4 Large burrow

T-6-5 Green algae

T-6-6 Red Algae

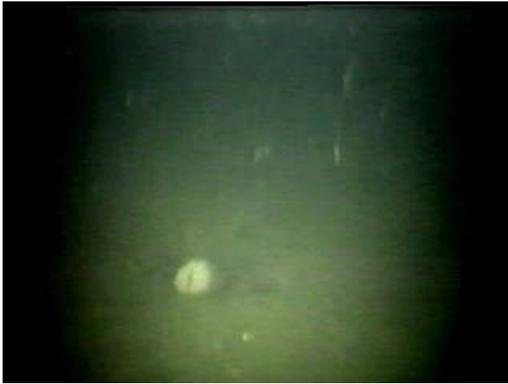
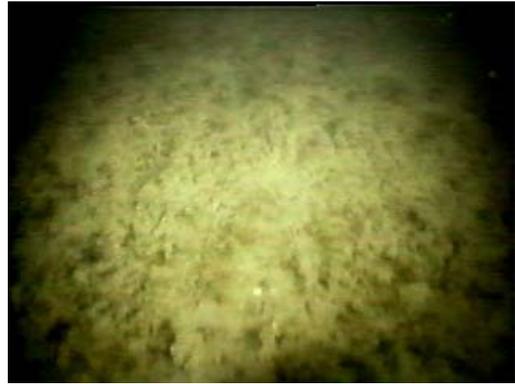
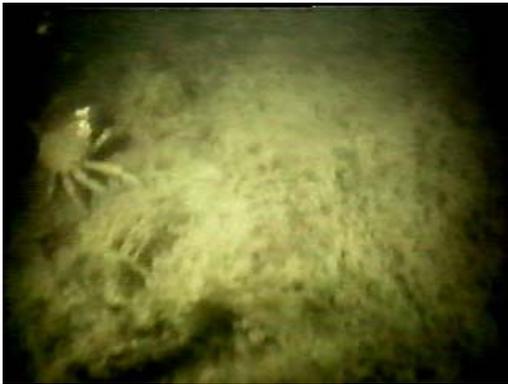
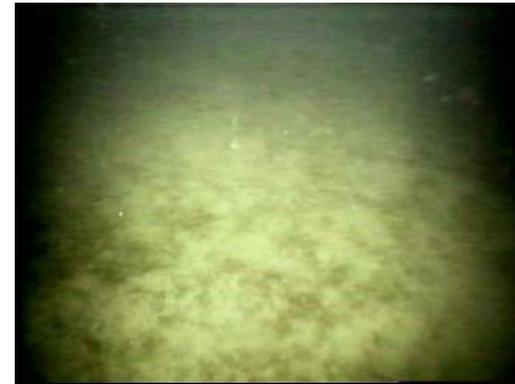
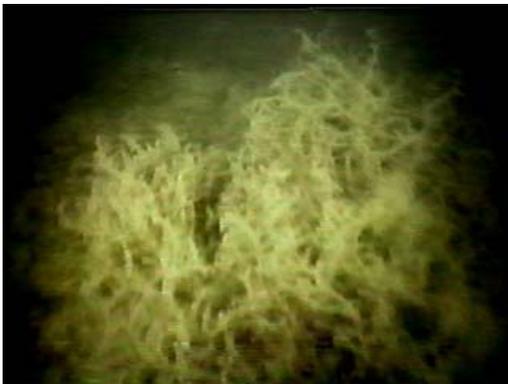
FIGURE 15 BBDS SCREEN CAPTURES VIDEO DRIFT – TRAWL LANE 7

T-7-1 Live quahog

T-7-2 Patches of algae

T-7-3 Spider crab

T-7-4 Open bottom

T-7-5 Red Algae patches

T-7-6 Mud bottom with algae
