# Saving Silver Lake

Used mainly for recreational purposes, Silver Lake, in Wilmington, Massachusetts, previously received direct discharges of storm-water runoff. Low-impact development features were installed to help runoff enter the soil, thereby reducing pollutant loadings in the aesthetically important lake.

**By Steven P. Roy and Andrea M. Braga, A.M.ASCE**

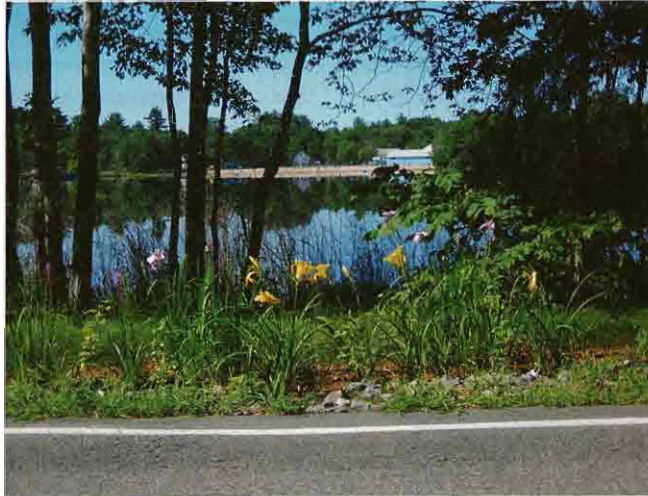
Several rain gardens constructed throughout the residential project area are expected to improve the quality of storm-water runoff and facilitate infiltration to recharge groundwater.

The construction of several rain gardens throughout the residential project area is expected to improve the quality of storm-water runoff and facilitate groundwater recharge by disconnecting flow paths—in this case, roofs, driveways, and roadways—from the storm drain system. Runoff from roofs, driveways, and roadways will enter the rain gardens rather than flow directly to the storm drain system.

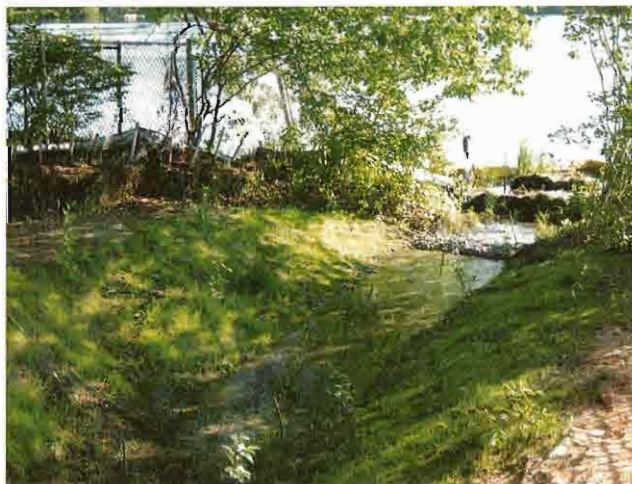
Two vegetated swales were designed and installed to replace a storm-water outfall that discharged directly to Silver Lake.

designed and installed to replace storm-water outfalls along the northwestern and southeastern boundaries of the town beach. Approximately 10 ft (3 m) wide and 80 ft (24 m) long, each swale collects runoff from the retrofit parking lot and adjacent streets and conveys it into Silver Lake.

Each of the two existing storm-water pipes, which previously had discharged through the outfalls directly to the lake, was redirected into one of the swales. The swales were overexcavated

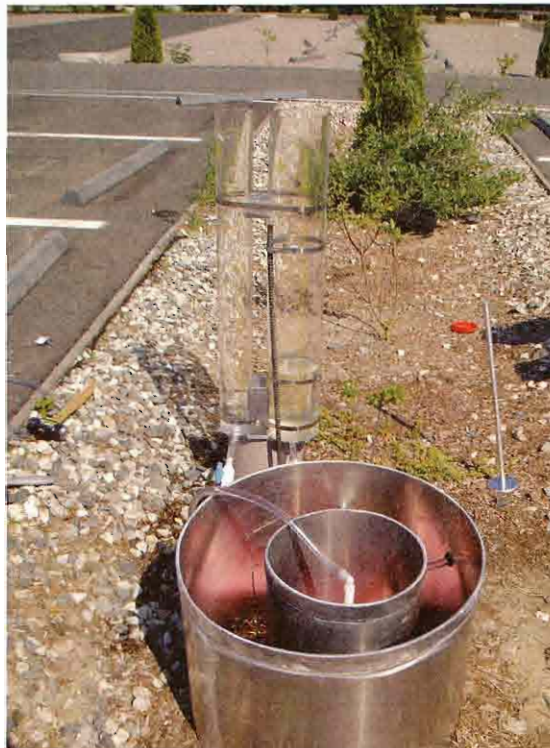
**Because of their ability to directly measure vertical flow into the soil, single-ring and double-ring infiltrometer tests were used to assess surface infiltration rates on two bioretention cells, one rain garden, and all four porous pavement surfaces at the project site.**

Surface infiltration rate tests were conducted on two bioretention cells, one rain garden, and all four porous pavement surfaces at the project site. Single-ring and double-ring infiltrometer tests were chosen to determine infiltration rates at the sites because of their ability to directly measure vertical flow into the soil.

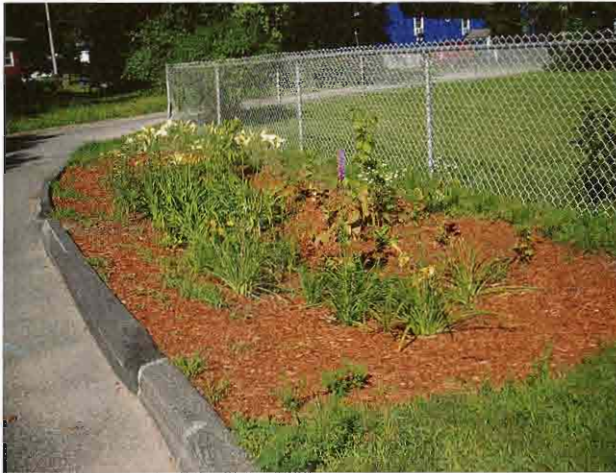
Twelve rain gardens were constructed on right-of-way owned by the Town of Wilmington in the Silver Lake watershed. In choosing the garden sites, preference was given to locations that would make it easy to convey runoff from the street.

In the spring of 2006, the last component of the project, namely, the installation of 12 rain gardens on the town-owned right-of-way in the Silver Lake watershed, was undertaken.

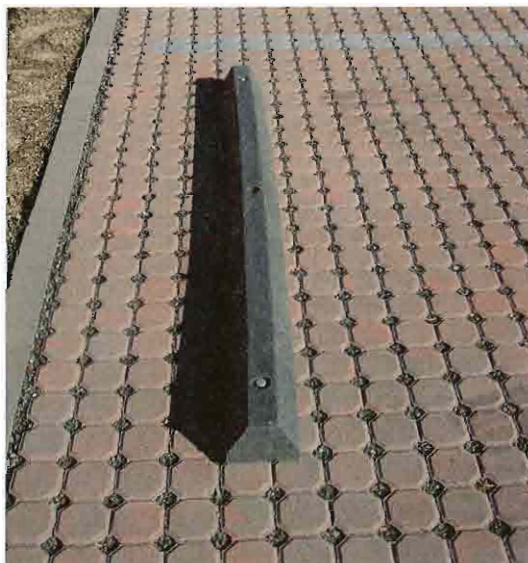
Tire stops made of recycled plastic were included at each parking space.

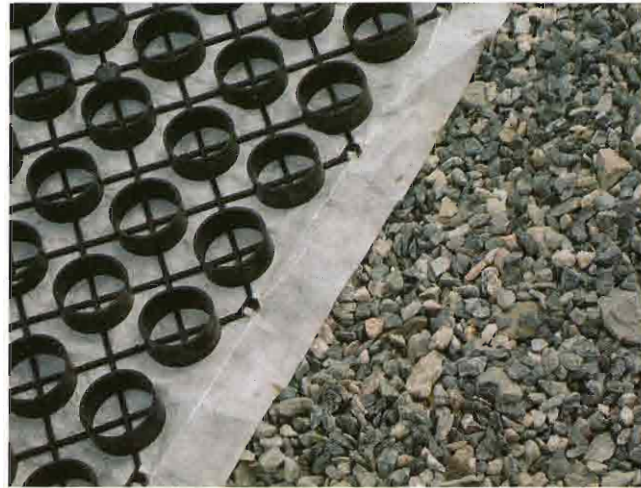
One of two porous paving systems installed in an overflow parking lot, GravelPave consists of gravel contained in small plastic containers that provide structural integrity.

The GravelPave was the most difficult porous surface to monitor. The single-ring infiltrometer was used to determine the infiltration rate, which was estimated to be approximately 7,100 in./h (180,300 mm/h). However, this estimate may not be entirely accurate, as a seal could not be established between the infiltrometer and the porous surface because of the inability to tamp the infiltrometer into the surface or affix plumber's putty to the gravel. Moreover, the water infiltrated into the GravelPave so quickly that maintaining a constant head of 1 in. (25 mm) became quite difficult. In fact, it was nearly impossible to maintain any standing water in the infiltrometer. Therefore, the actual rates of infiltration might be underestimated and hence are not displayed in table 2.

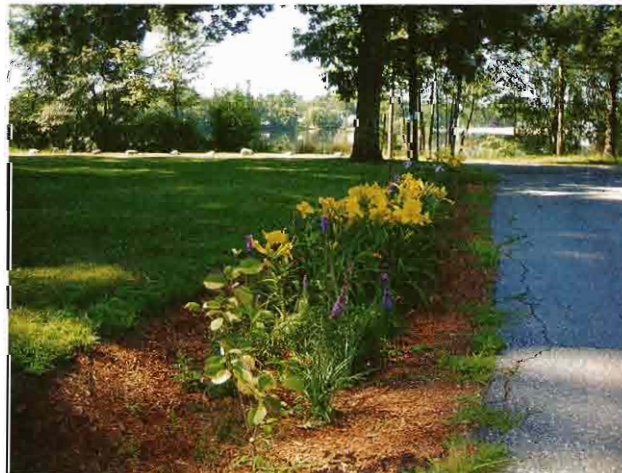
At sites at which lawns were higher than the roadway, rain gardens were redesigned in a longer, narrower fashion to create a gradual slope from the rain garden up to the lawn area.

The rain garden sites were placed where the storm-water runoff is most easily conveyed from the street. The gardens were also spaced so as to collect the maximum amount of runoff. This neighborhood was particularly challenging because on one side of the street the lawns were approximately 4 to 6 in. (100 to 150 mm) above the roadway. Because the rain garden was initially designed to be 6 in. (150 mm) lower than the road, the grade difference appeared to render those locations unsuitable. However, the rain gardens were redesigned in a longer, narrower fashion to create a gradual slope from the rain garden up to the lawn area.

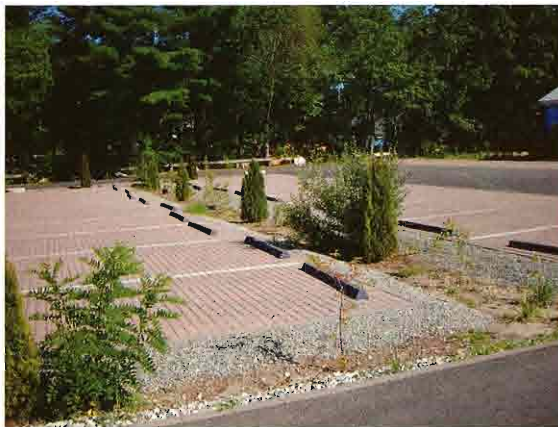
Permeable interlocking concrete pavement units, also known as porous pavers, were installed within the parking spaces at the Silver Lake town beach, and multiple bioretention cells were constructed along the perimeter and as a central traffic island.

**P**ermeable interlocking concrete pavement—also known as porous pavers—and porous asphalt were installed to replace approximately half of the 34,000 sq ft (3,159 m<sup>2</sup>) paved parking lot at the Silver Lake town beach. The porous pavers were installed within the parking spaces, and porous asphalt was installed adjacent to the pavers in the aisles. A 12 in. (31 cm) deep stone infiltration bed was installed continuously beneath both porous surfaces. The voids between the pavers were filled with small crushed stone that allows water to percolate down into the underlying stone bed. The porous asphalt functions in the same way, the voids in the asphalt enabling water to percolate into the subbase. However, since the entire surface of the asphalt is pervious, rainfall can percolate directly through the surface and into the underlying stone basin, eliminating runoff. For financial reasons, the southern half of the parking lot was resurfaced with standard asphalt.

Multiple bioretention cells were constructed along the perimeter and as a center island in the parking lot. The bioretention cells are landscaped depressions designed to store and promote the infiltration of storm-water runoff from the parking lot and to capture and remove sediment and nutrients. The cells include specialized plantings and a bioretentive soil mixture that exhibits a high infiltration rate. The bioretentive soil is engineered
