# UMass Medical Center Master Plan

Massachusetts State Project UMW 0301 ST1  
Volume I

## Discovery & Analysis

Tsoi/Kobus & Associates  
TK&A #23024-000  
November 2005

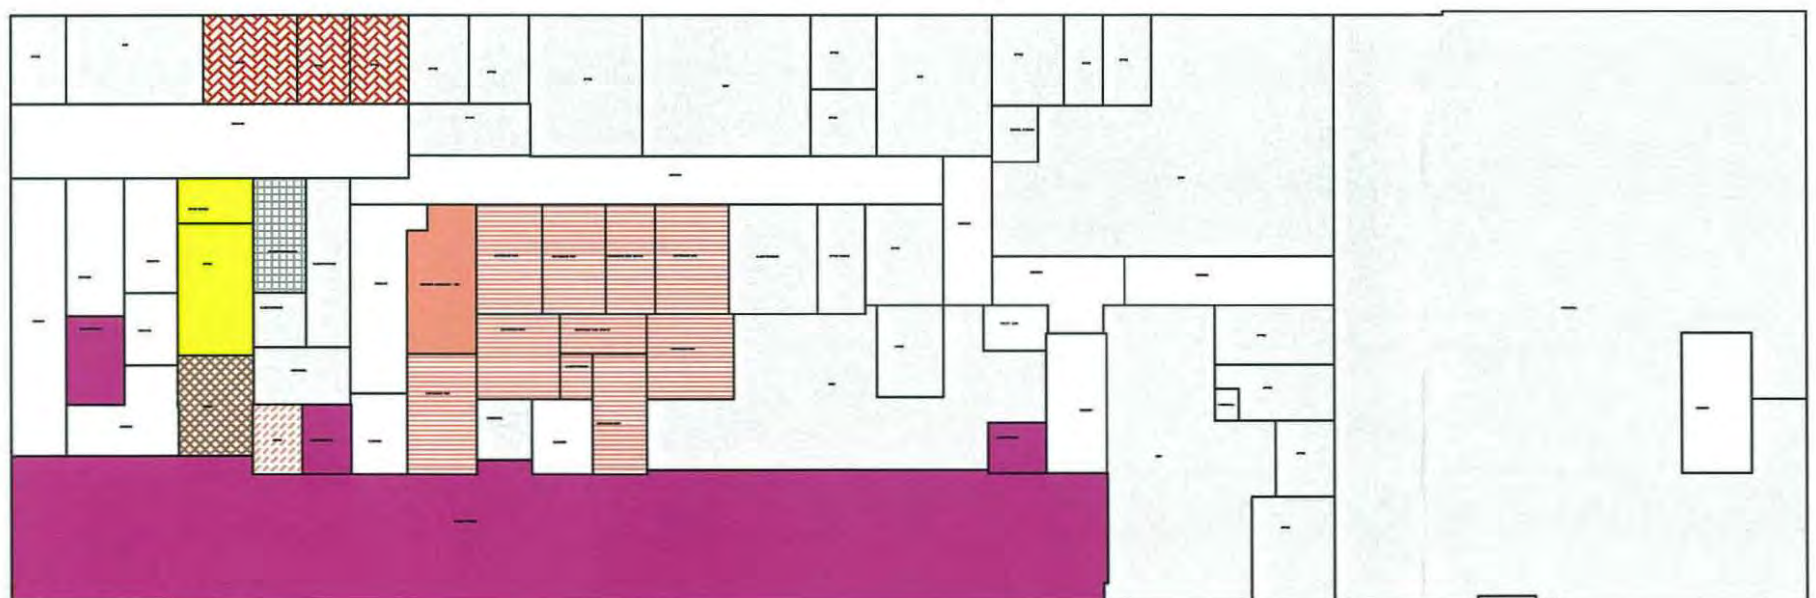
**S-B**

UNIV. OF MASS. MEDICAL CENTER CAMPUS  
 SCHOOL  
 B LEVEL  
 AS BUILT

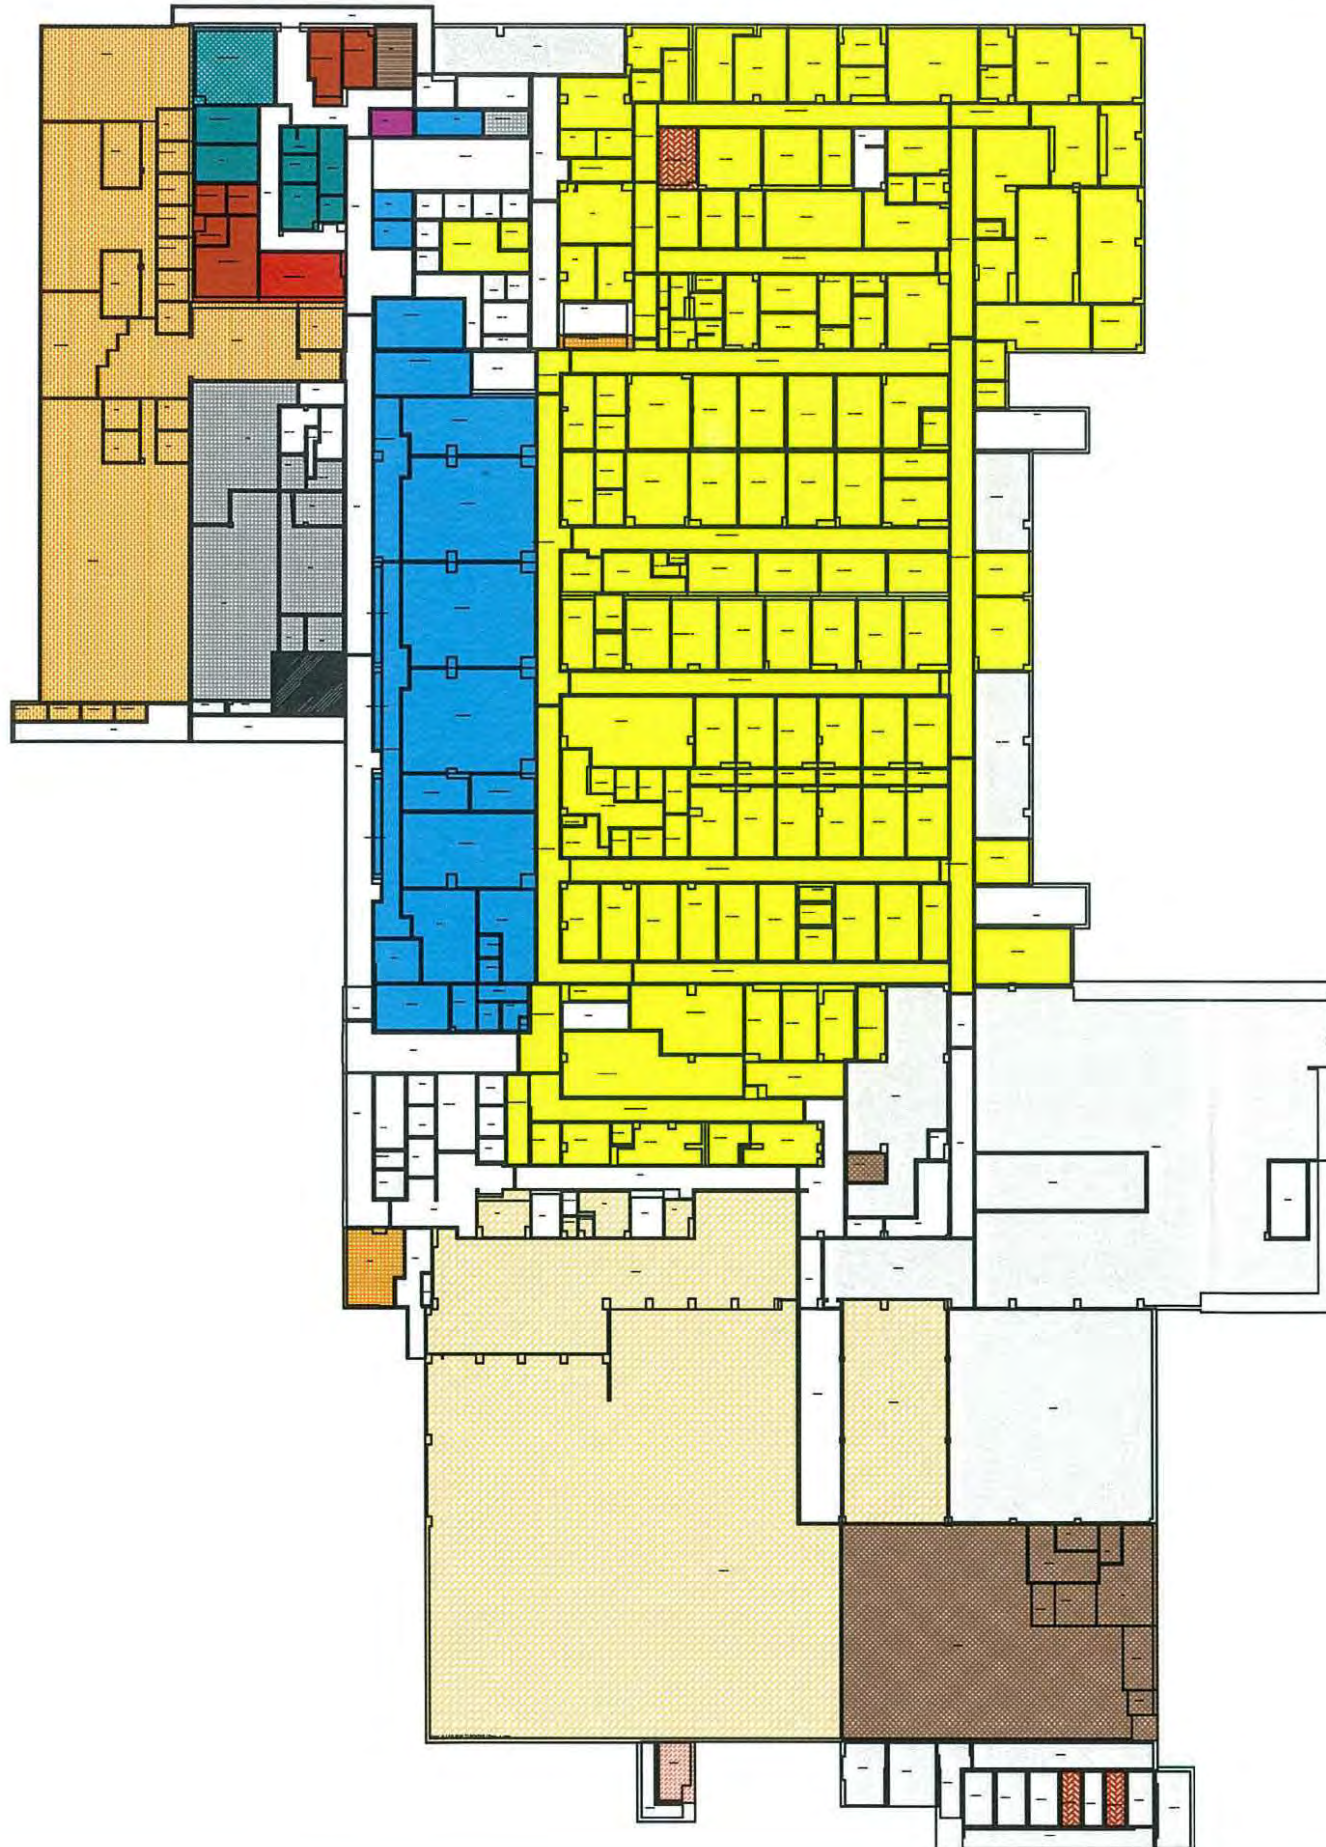
S-A

UNIV. OF MASS. MEDICAL CENTER CAMPUS  
 SCHOOL A LEVEL  
 AS BUILT

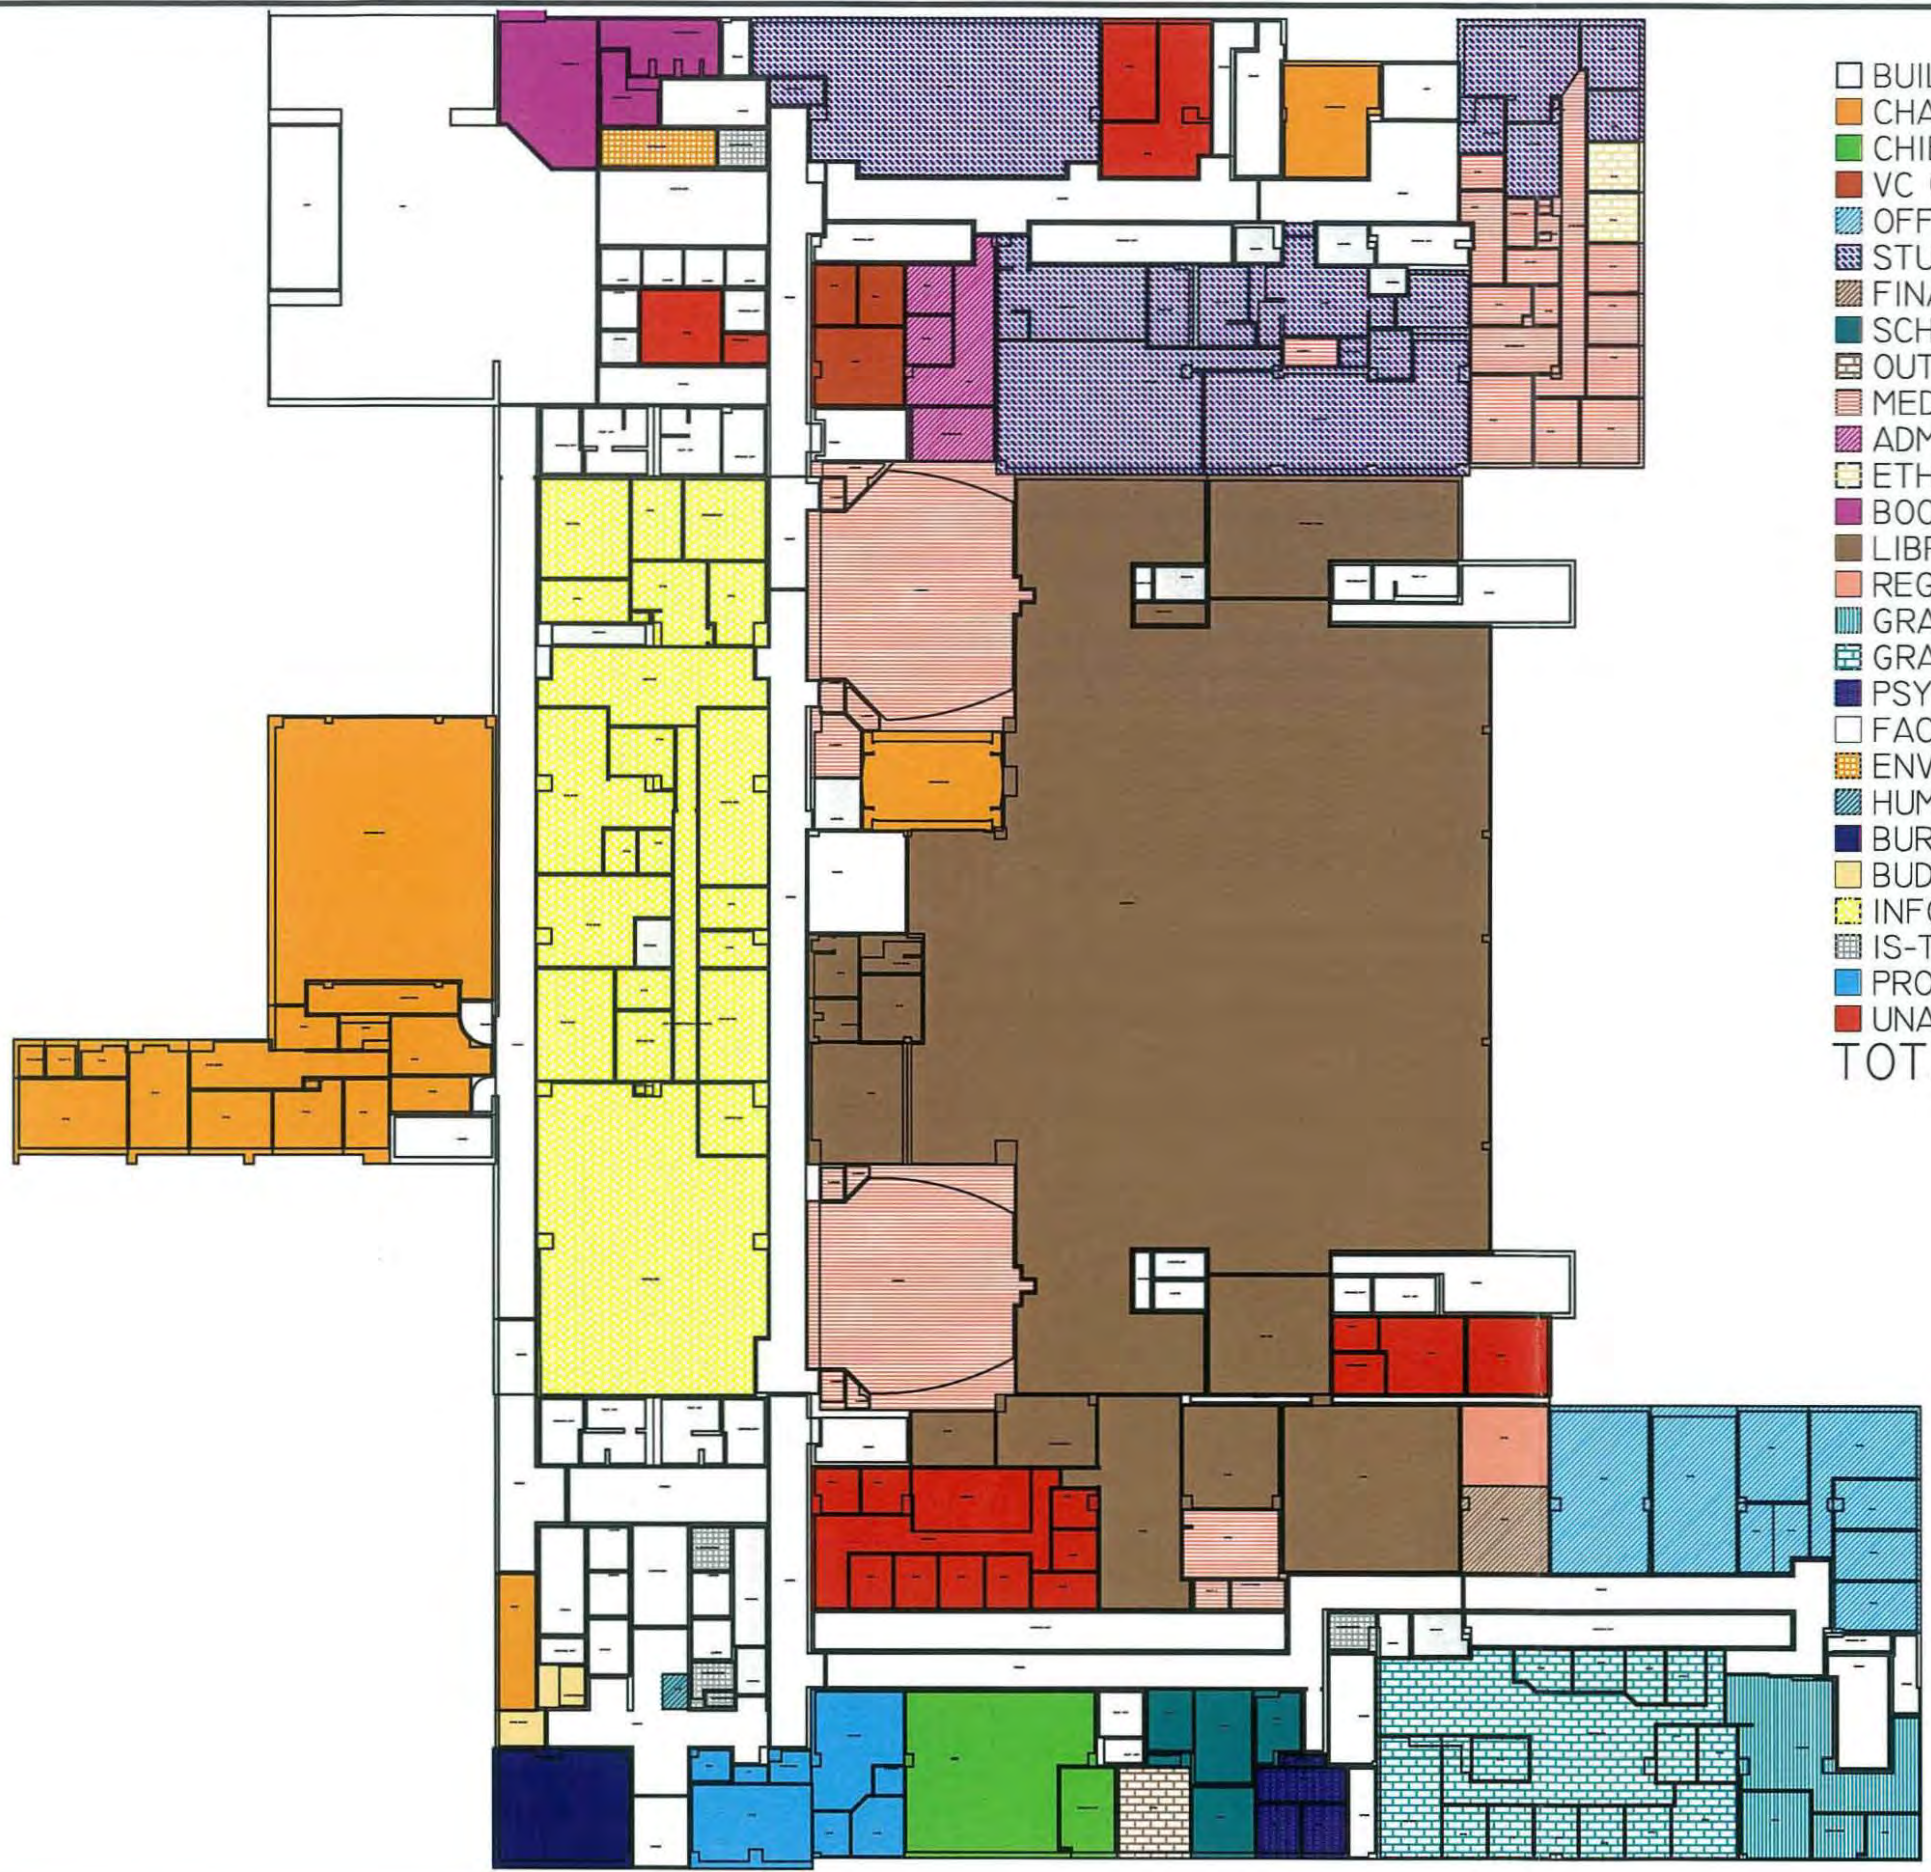
UNIV. OF MASS. MEDICAL CENTER CAMPUS  
 SCHOOL  
 FIRST FLOOR  
 AS BUILT

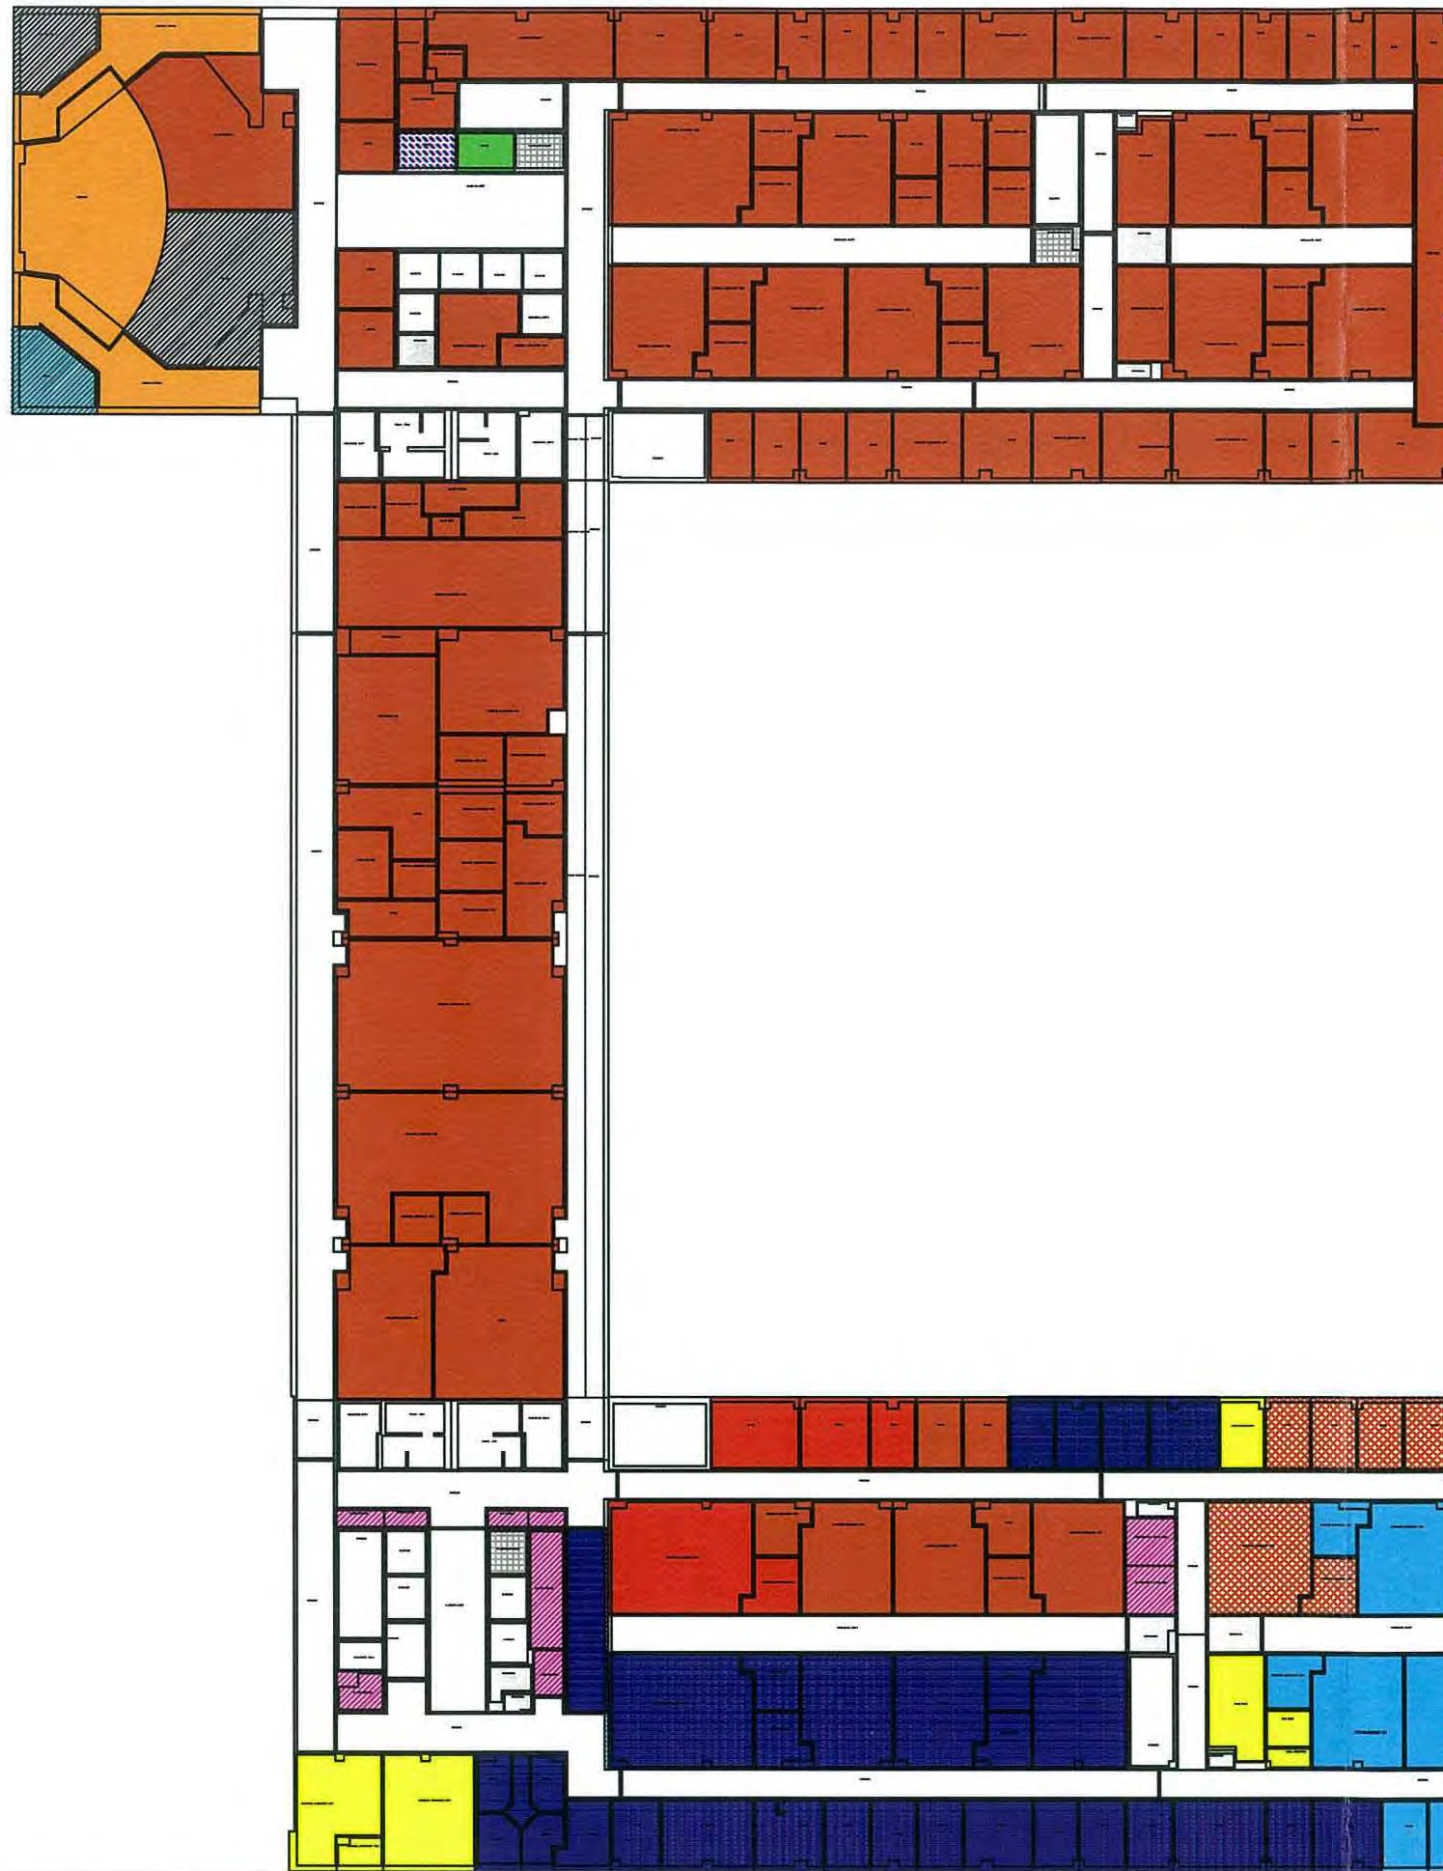
UNIV. OF MASS. MEDICAL CENTER CAMPUS  
 SCHOOL  
 FOURTH FLOOR  
 AS BUILT

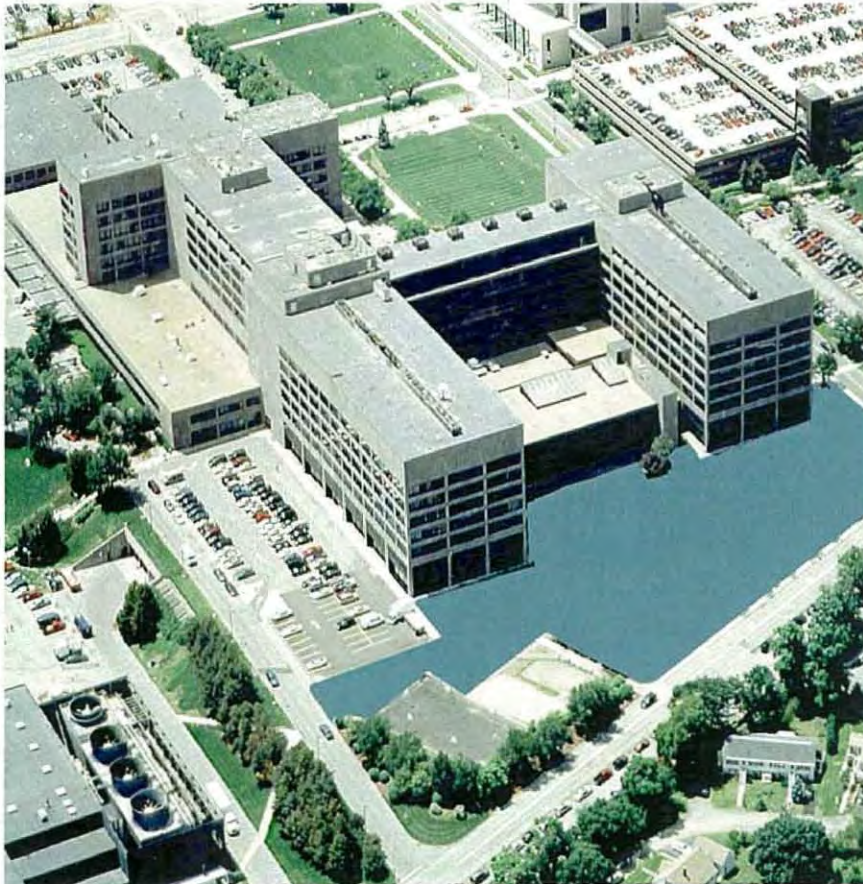
- ◆ The area in green shows the main staging and enabling area for the façade project materials and construction trailers
- ◆ This fenced, paved and secure area will be returned to green space in 2006

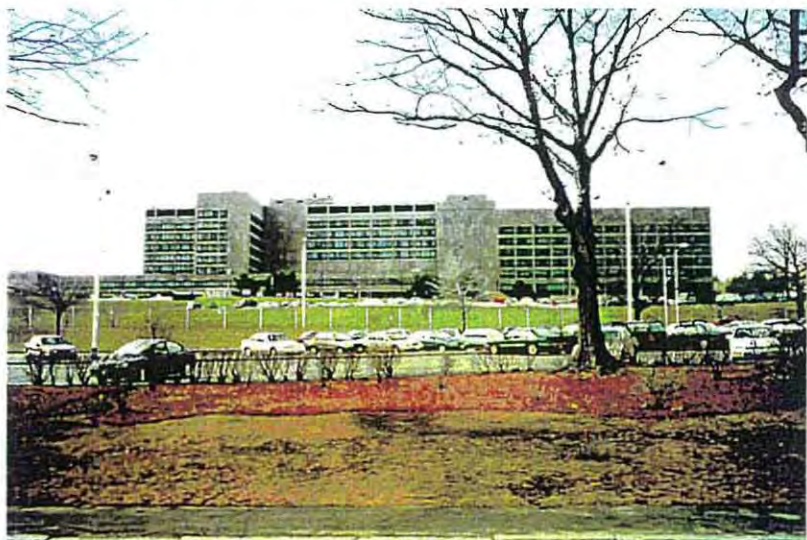
**Masonry** – Dark gray granite spandrel panels (*Note: UMMS intends to replace the granite spandrel panels at some future date.*)

**Evaluation** – Although well maintained and in acceptable condition, the single glazed units do not meet current energy codes, and are an area of significant heat loss for the Library.

University of Massachusetts Medical School  
View from Lake Avenue

**Recommendation** – Replacement of all single glazed windows with double glazed, thermally broken frames

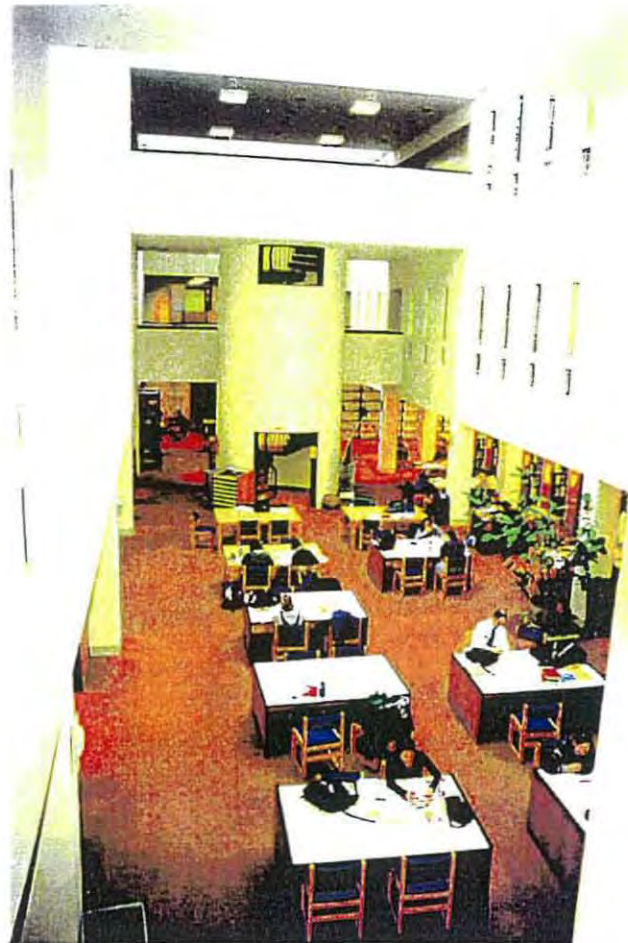
Main Reading Room

**Skylights** A series of large skylights are above the main Reading area. They are presumed to be single glazed units, and again there are no apparent leaks or water damage, although Library staff noted that there have been leaks in the past.

*Evaluation* – Although well maintained and in acceptable condition, the single glazed units do not meet current energy codes, and are an area of significant heat loss for the Library.

*Recommendation* – Replacement of all single glazed skylights with double glazed, thermally broken metal frames.

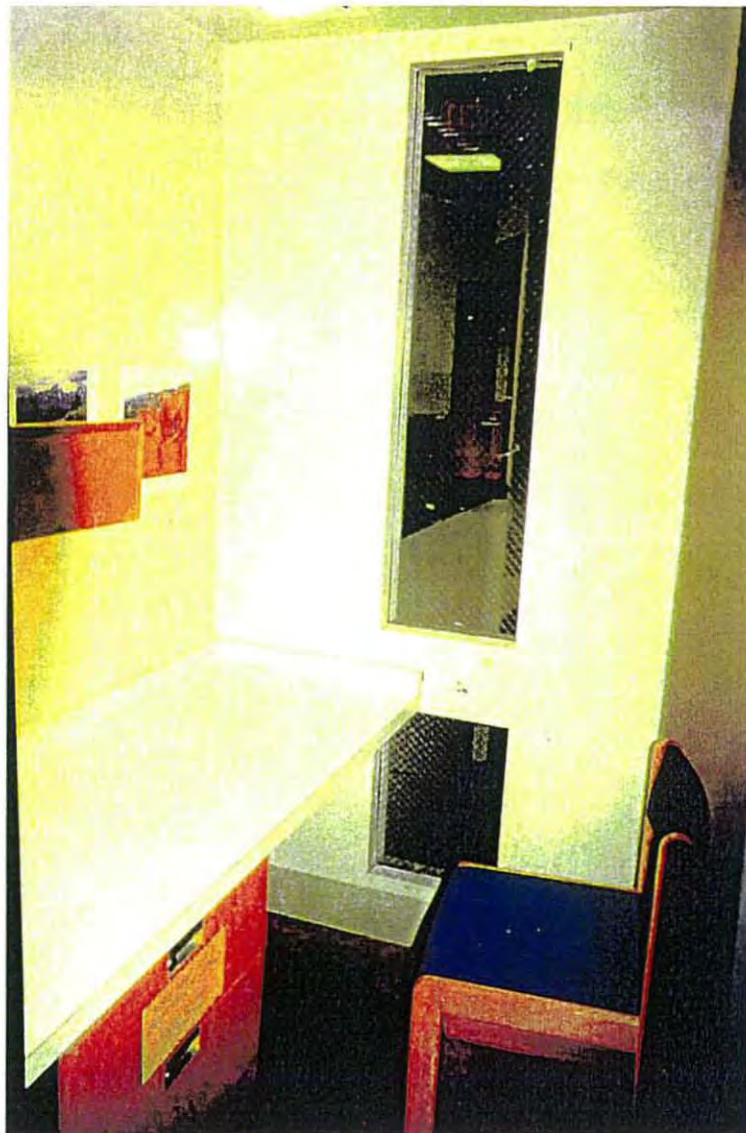
Fixed Carrel – Levels 2 & 3

**Fixed Carrels** Access to current fixed carrels does not comply with code.  
(12.2.2)

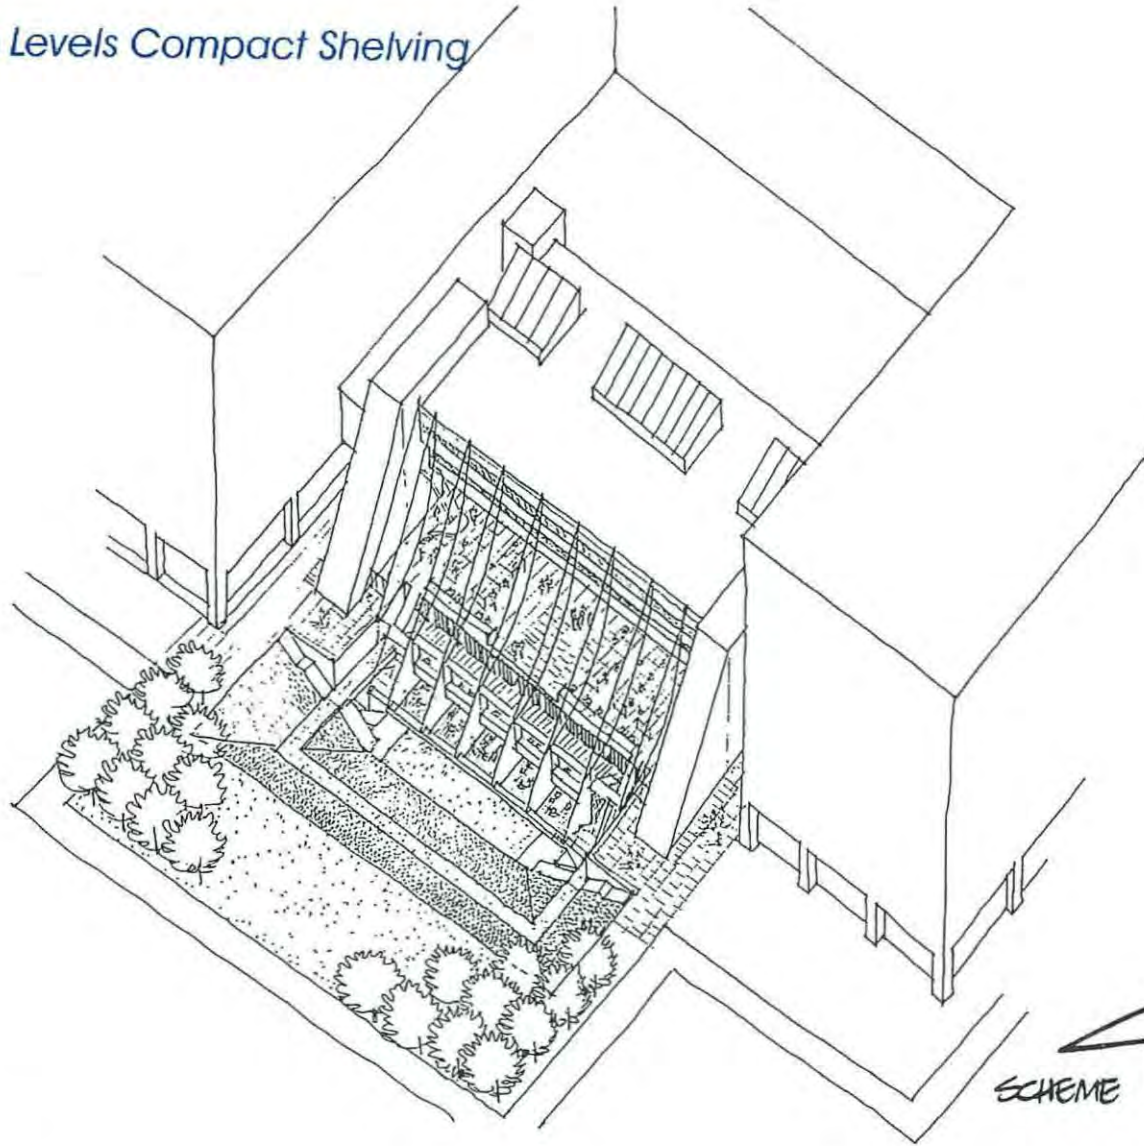
Scheme 4 - Two Levels Compact Shelving  
Exterior View

- ATRIUM READING ROOM AS EXTENSION OF LEVEL 1
- COMPACT SHELVING IN TWO LEVELS, L1 & L2, BELOW LEVEL 1
- GROUP STUDY RMs @ L1
- SLOPED LANDSCAPING FROM LEVEL L1 TO LEVEL 1 GRADE OR AMPHITHEATER.

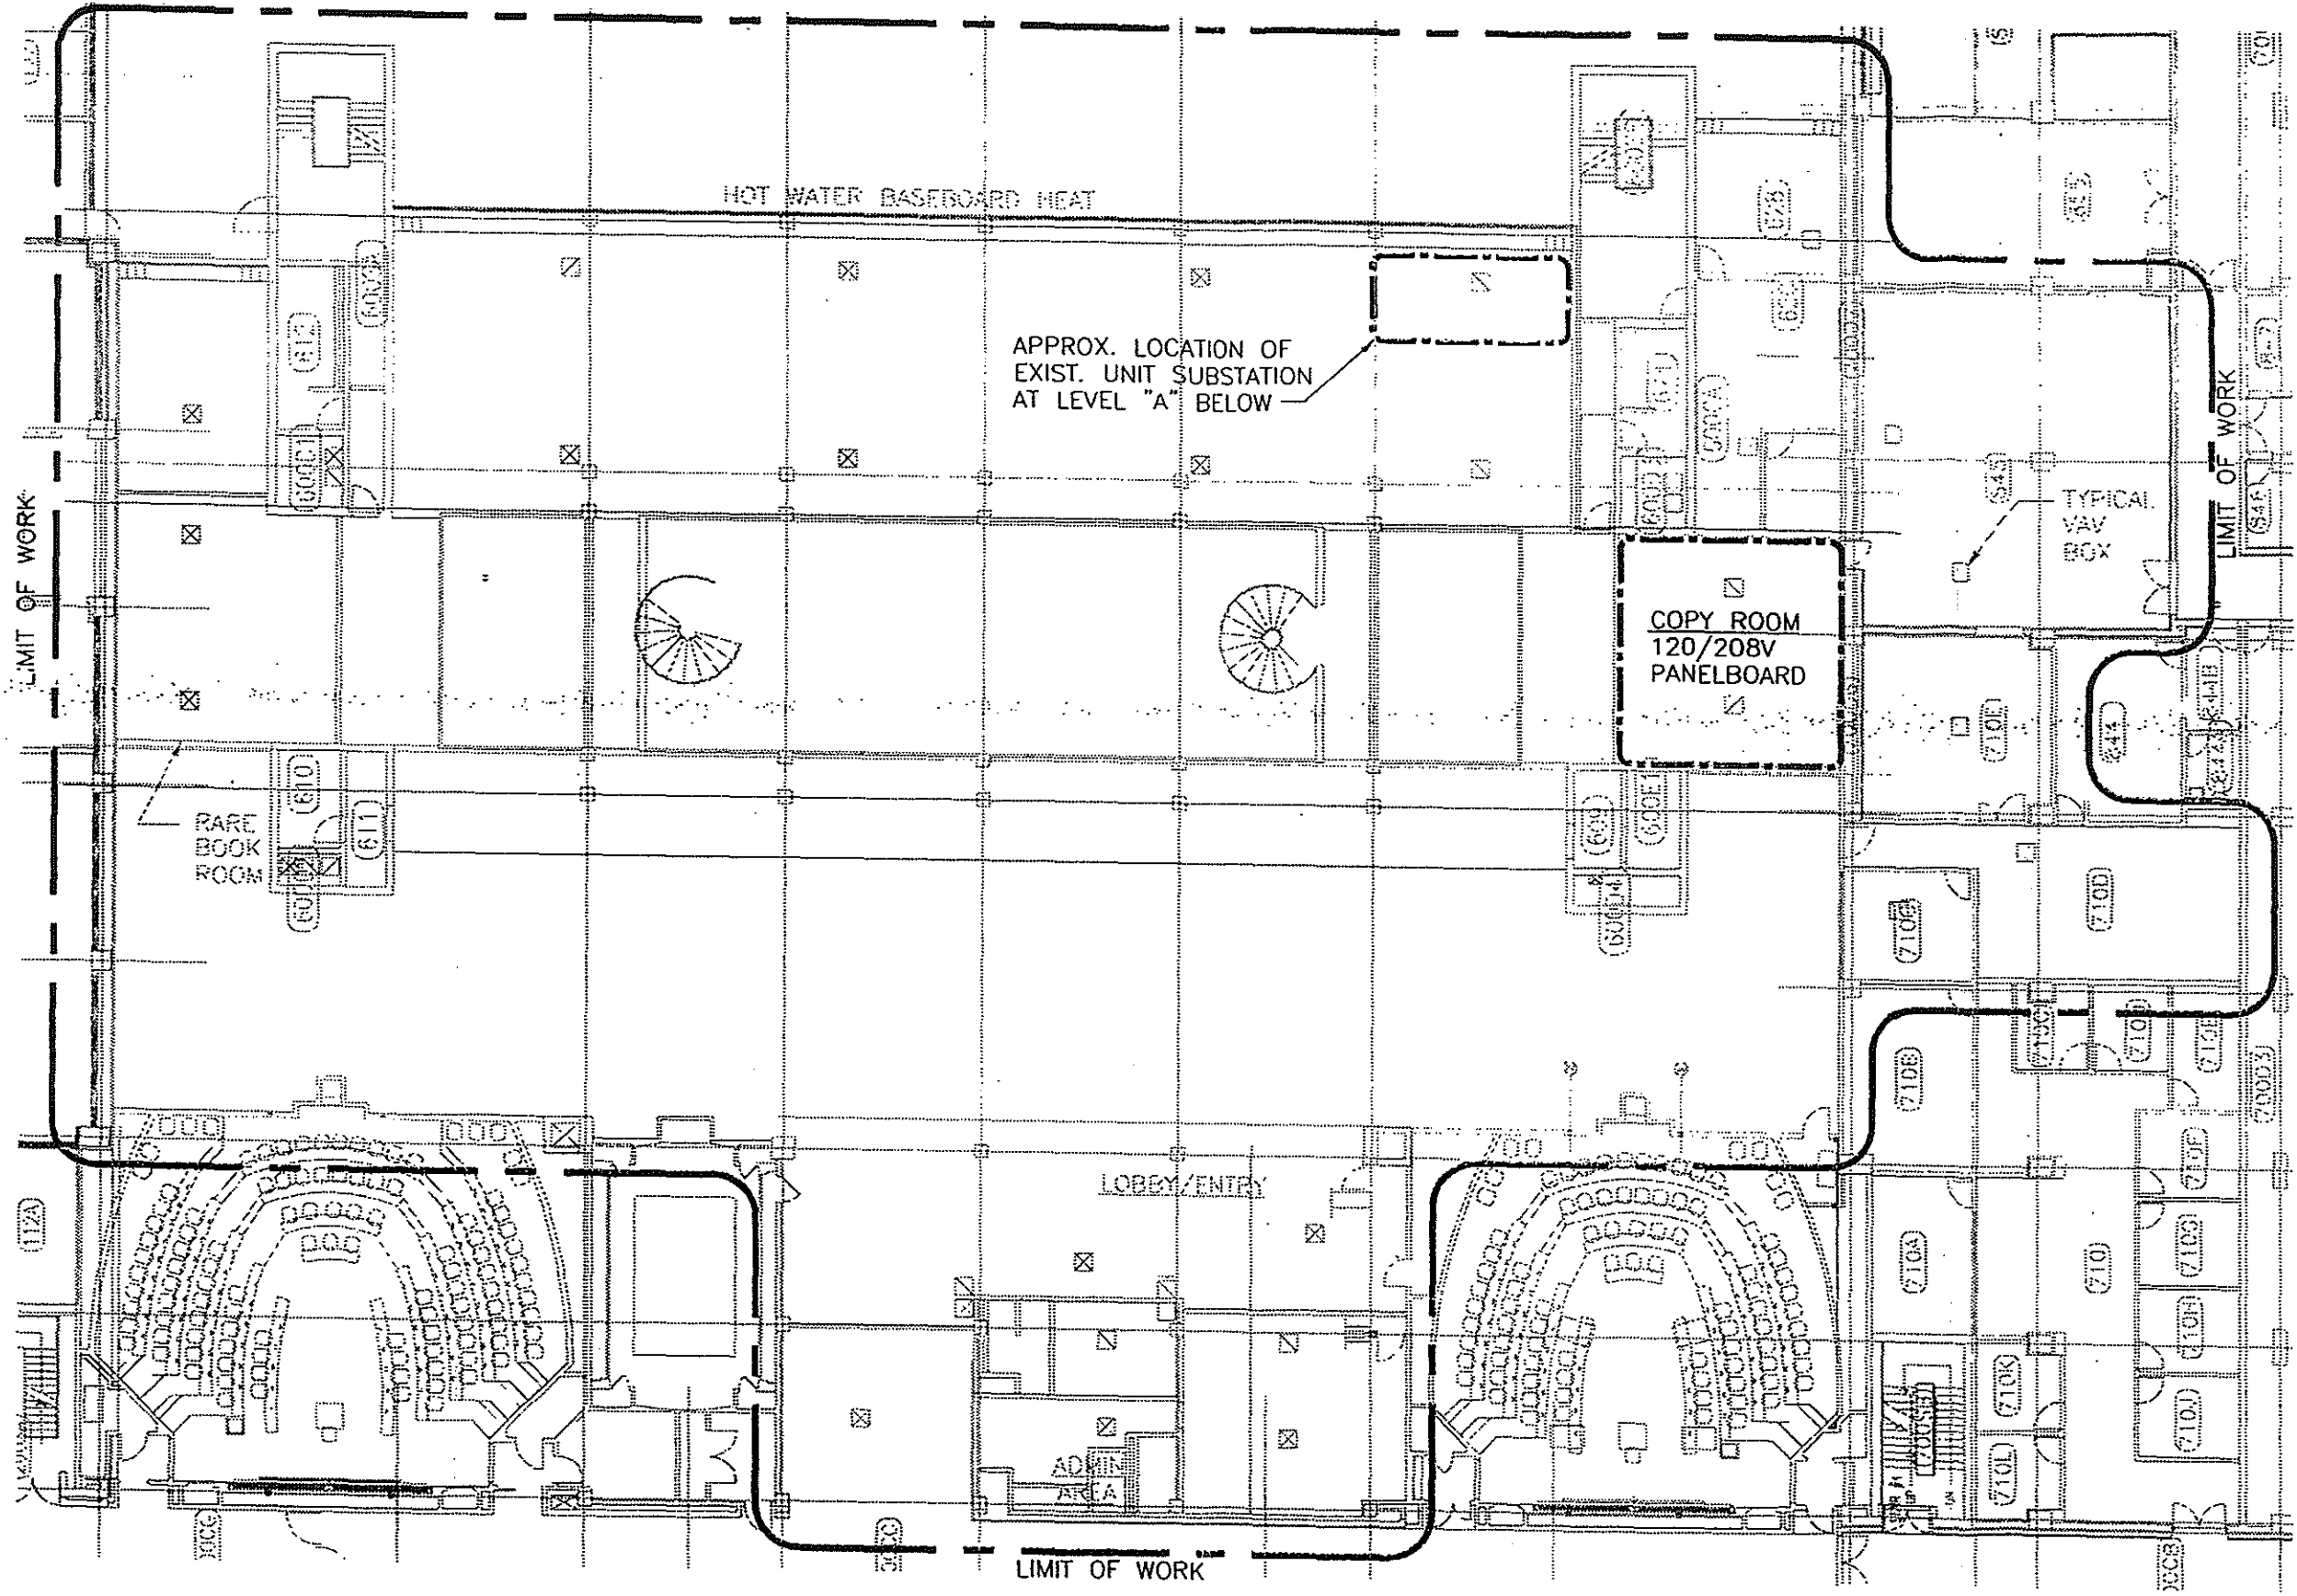
**ELECTRICAL SCHEMATIC FIRST FLOOR PLAN**  
 SCALE 1"=20'-0"

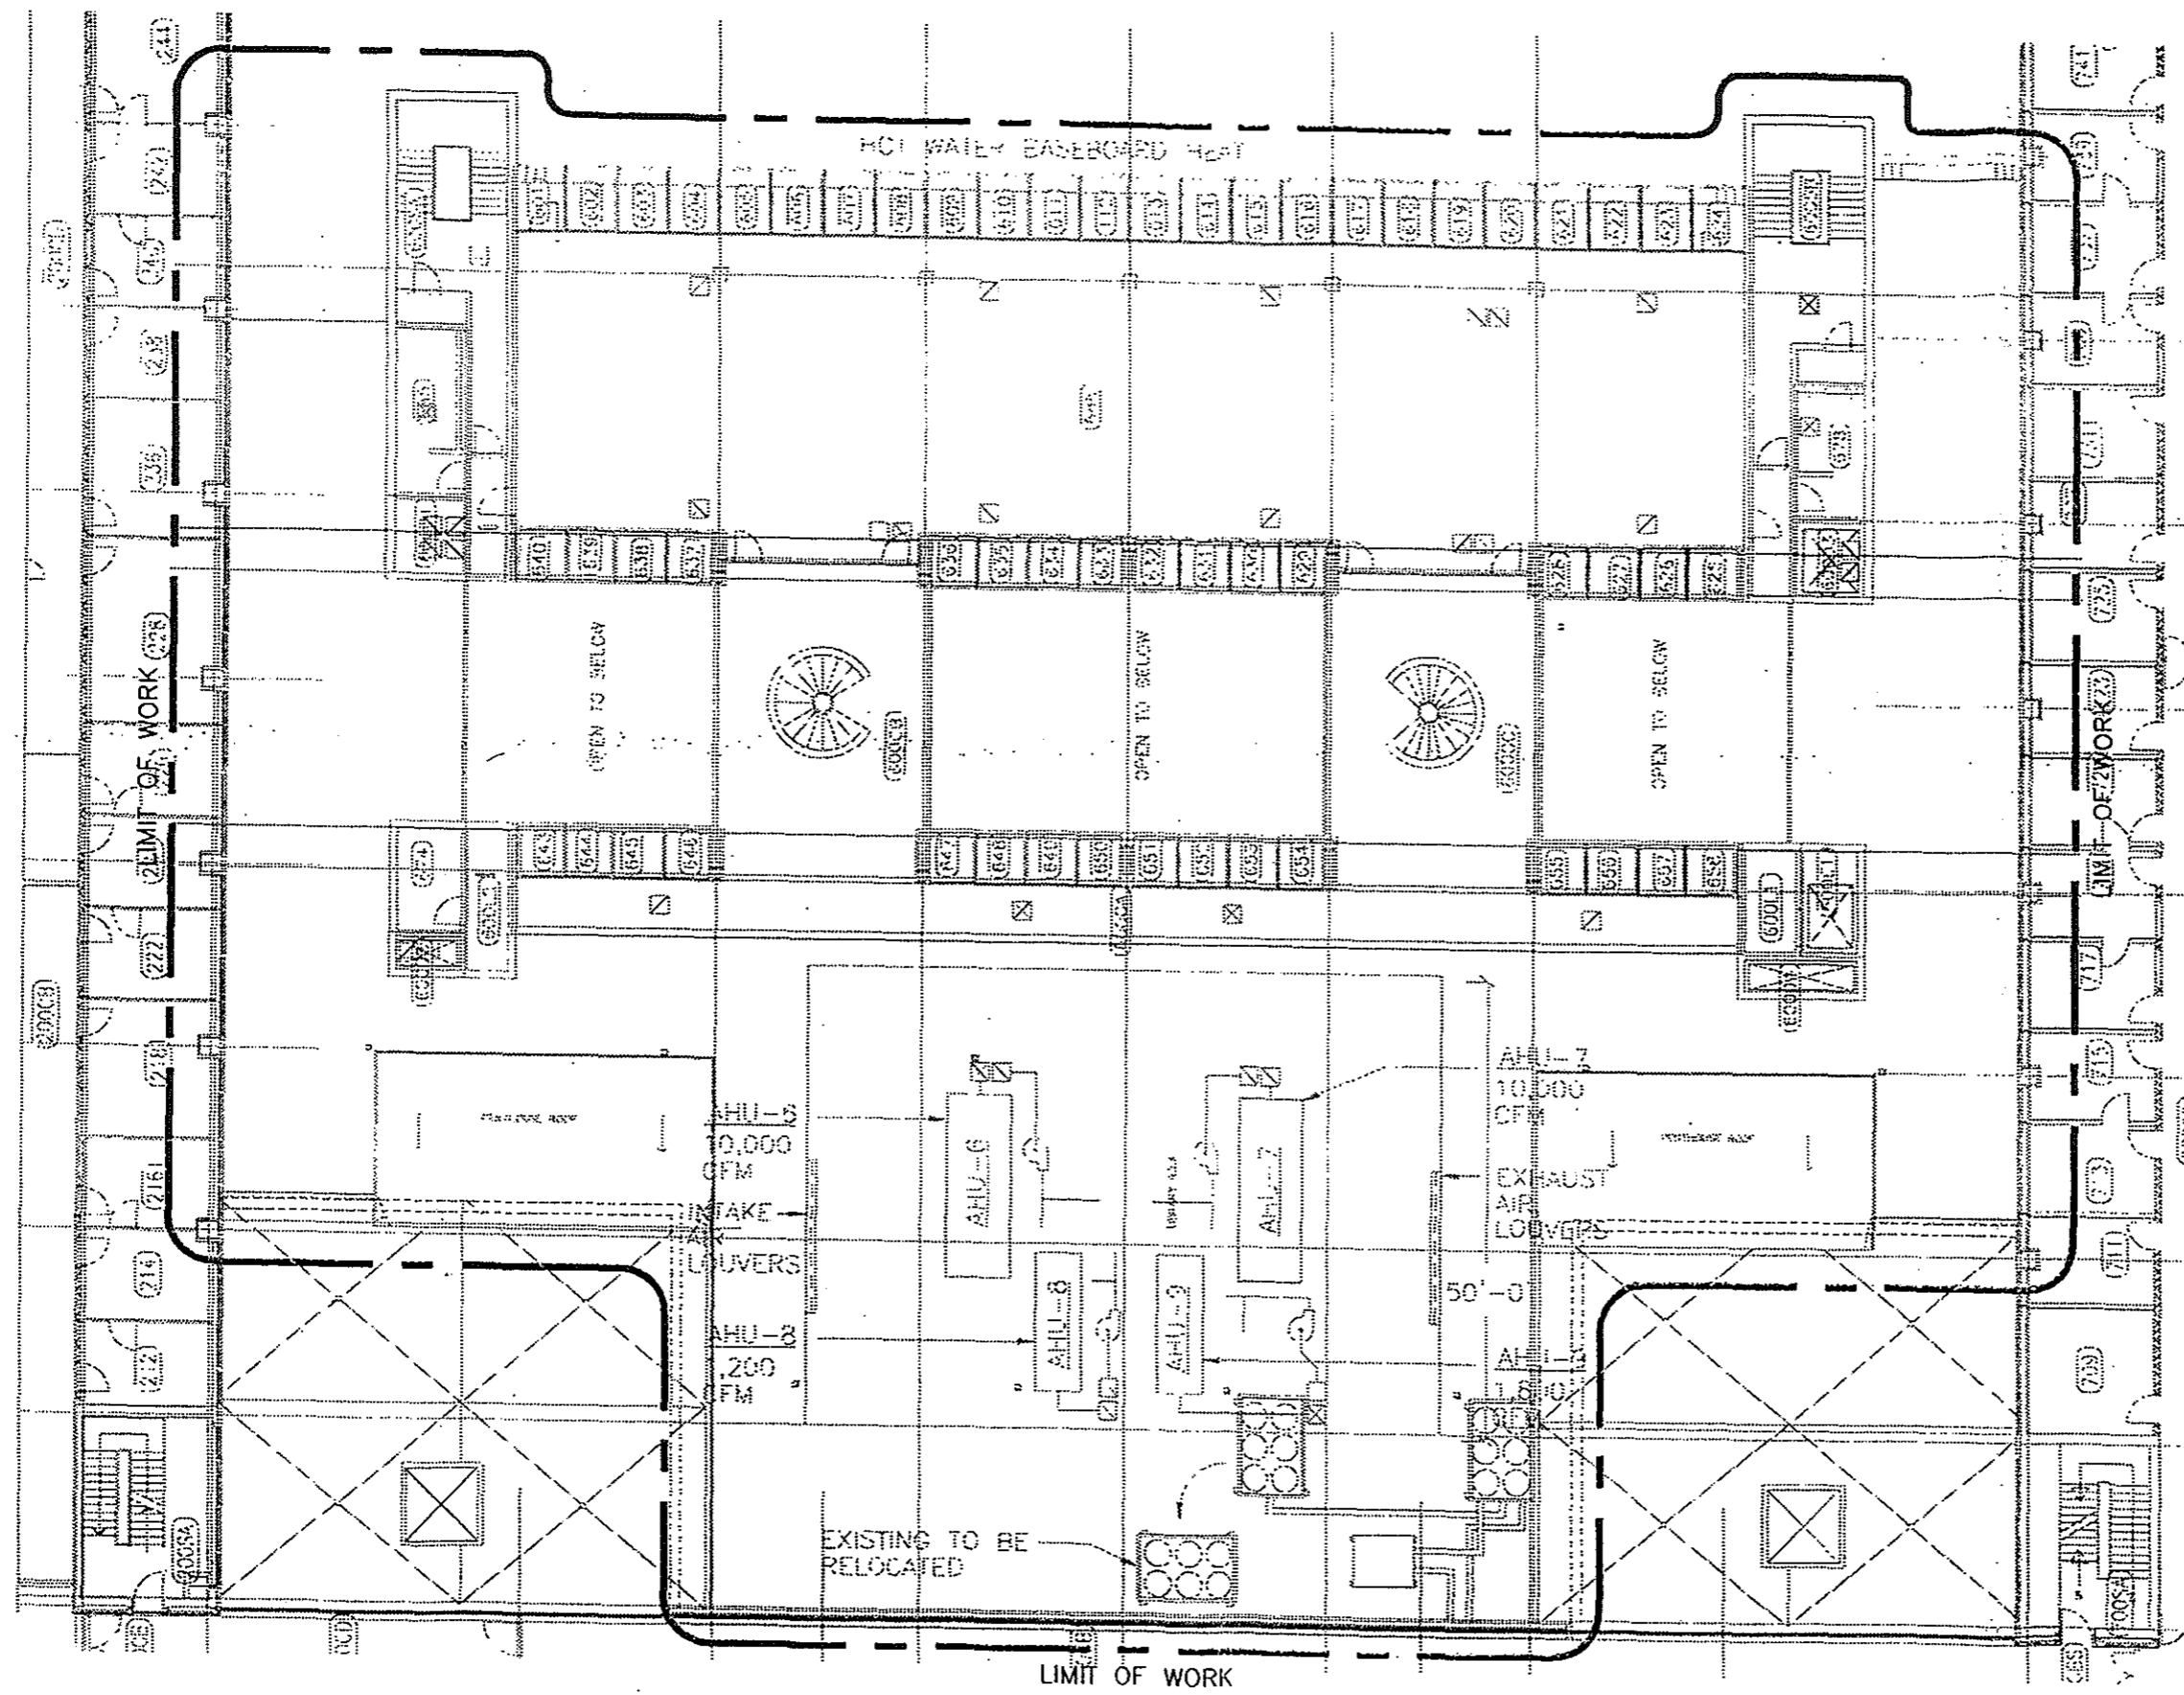
**ELECTRICAL SCHEMATIC THIRD FLOOR PLAN**  
SCALE 1"=20'-0"
