# UMass Medical Center Master Plan

Massachusetts State Project UMW 0301 ST1  
Volume I

## Discovery & Analysis

Tsoi/Kobus & Associates  
TK&A #23024-000  
November 2005

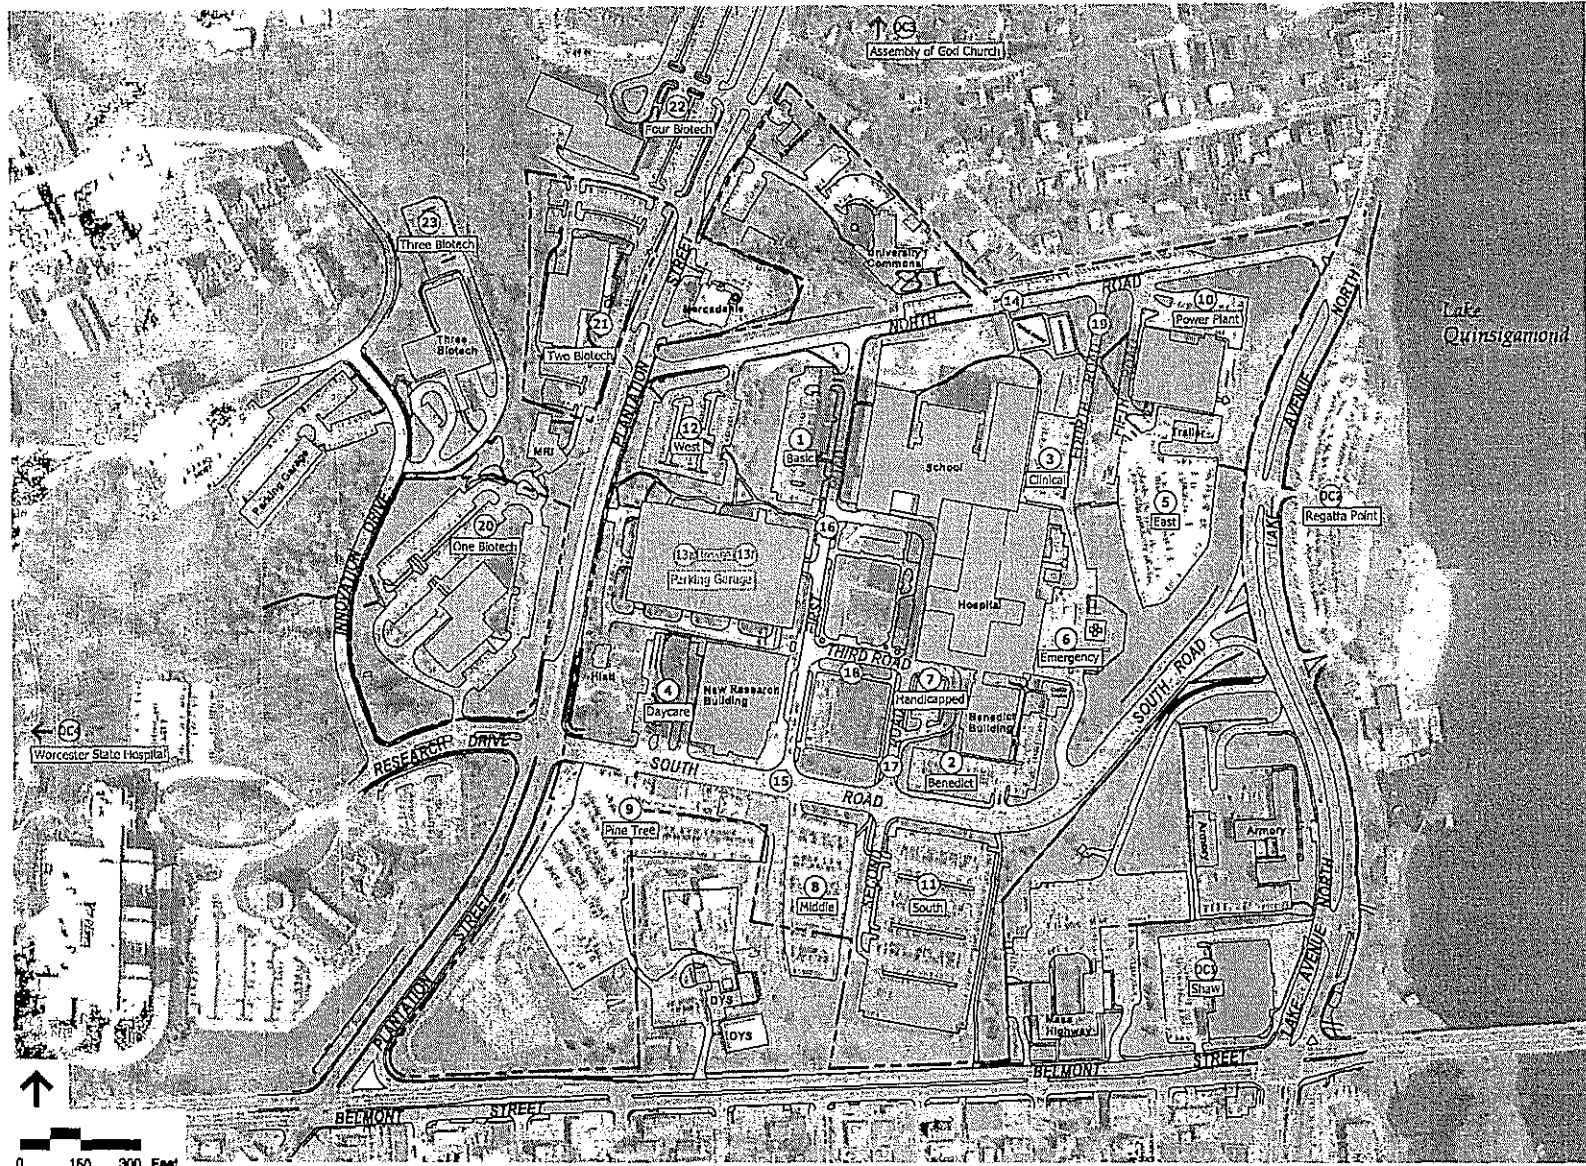
Figure 1  
Existing Campus Parking Supply  
UMMS/UMMHCs Campus  
Modernization Program  
Worcester, Massachusetts

Parking Area	Number of Spaces
<b>Campus Lots</b>	
1 Basic	126
2 Benedict	103
3 Clinical	92
4 Daycare	15
5 East	269
6 Emergency	58
7 Handicapped	19
8 Middle	210
9 Pine Tree	469
10 Power Plant	43
11 South	49
12 West	101
<b>Subtotal</b>	<b>1,954</b>
<b>Existing Parking Garage</b>	
13 Level 1	60
14 Level 2	202
15 Level 3	310
16 Level 4	370
17 Level 5	269
18 Level 6	268
<b>Subtotal</b>	<b>1,460</b>
<b>Campus Streets / Street Lots</b>	
14 North Road	59
15 South Road	70
16 First Road	7
17 Second Road	18
18 Third Road	8
19 Fourth Road	8
<b>Subtotal</b>	<b>170</b>
<b>Off-Campus Lots</b>	
20 One Biotech	205
21 Two Biotech	183
22 Four Biotech	101
23 Three Biotech	49
24 Shaw	144
25 Regatta Point	260
26 Assembly of God Church	300
27 Worcester State Hospital	100
<b>Subtotal</b>	<b>1,341</b>
<b>Campus Total</b>	<b>4,934</b>
