## DCR Division of Water Supply Protection: FY2022 Forest Harvest Proposals

# Quabbin Harvest Proposal HA-22-4

# Quabbin Harvest Proposal HA-22-5

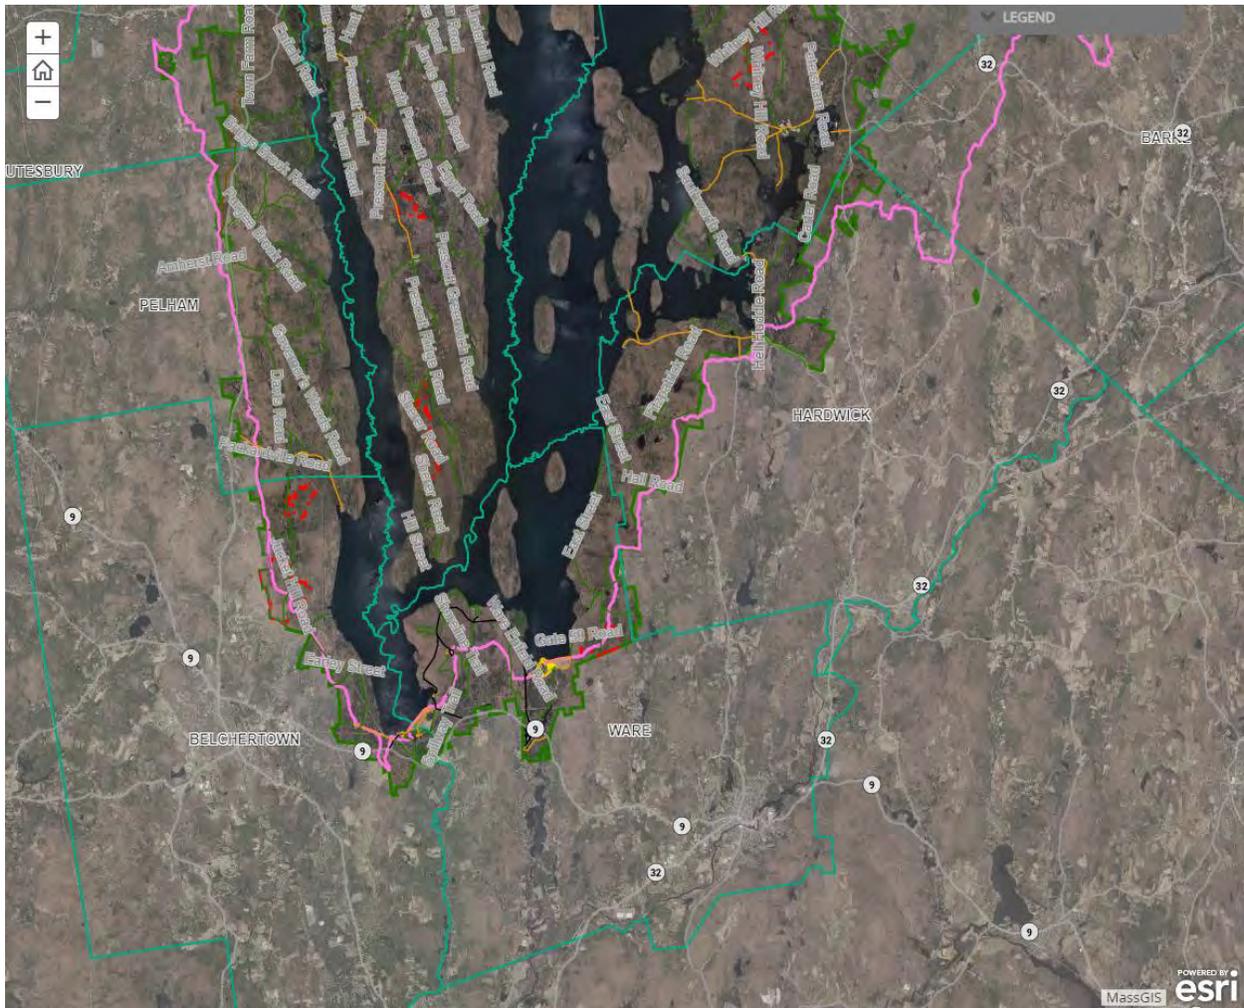
Wooded area east of Goodnough Dike Road and north of the lower road (wooded area NE of road intersection and west of the mowed areas of dike).

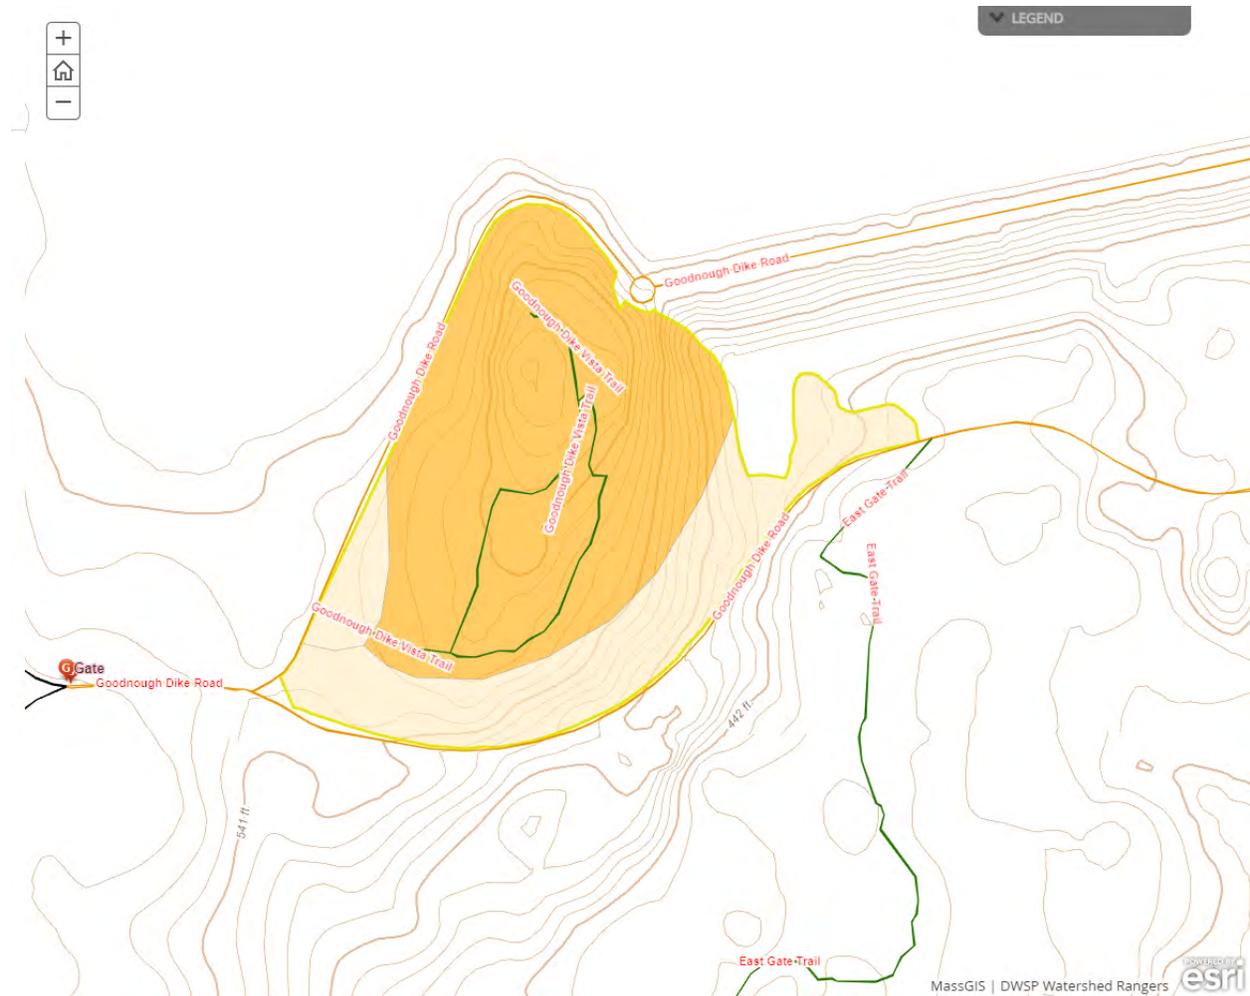
## Soils

Drainage Class	%
Excessively Drained	34
Well Drained Thin	66
Well Drained Thick	0
Moderately Well Drained	0
Poorly to Very Poorly Drained	0

Mainly well drained 103E Charlton-Hollis-Rock outcrop complex; eastern and southern flat is excessively drained 253E Hinckley loamy sand.

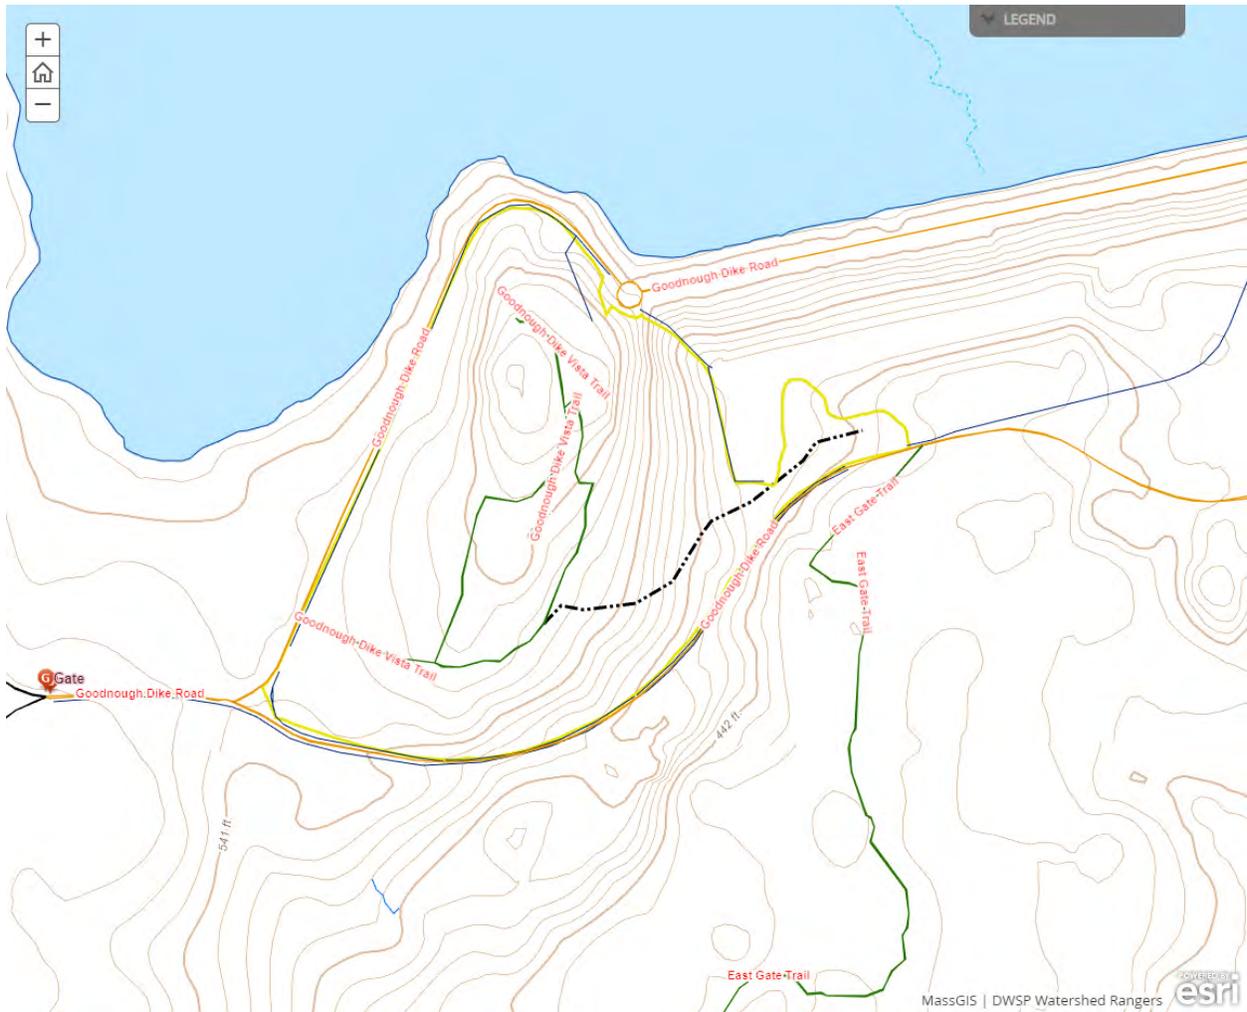
## Wetlands

- Wetlands present? - **No**
- Streams present? - **No**
- Vernal pools present? - **No**
- Seeps present? - **No**
- Are stream crossings required? - **No**
- Are wetland crossings required? - **No**
- Is logging in filter strips planned? - **No** ([Riparian Zone Mgt](#))
- Is logging in wetlands planned? - **No**

None known, site is all well to excessively drained.

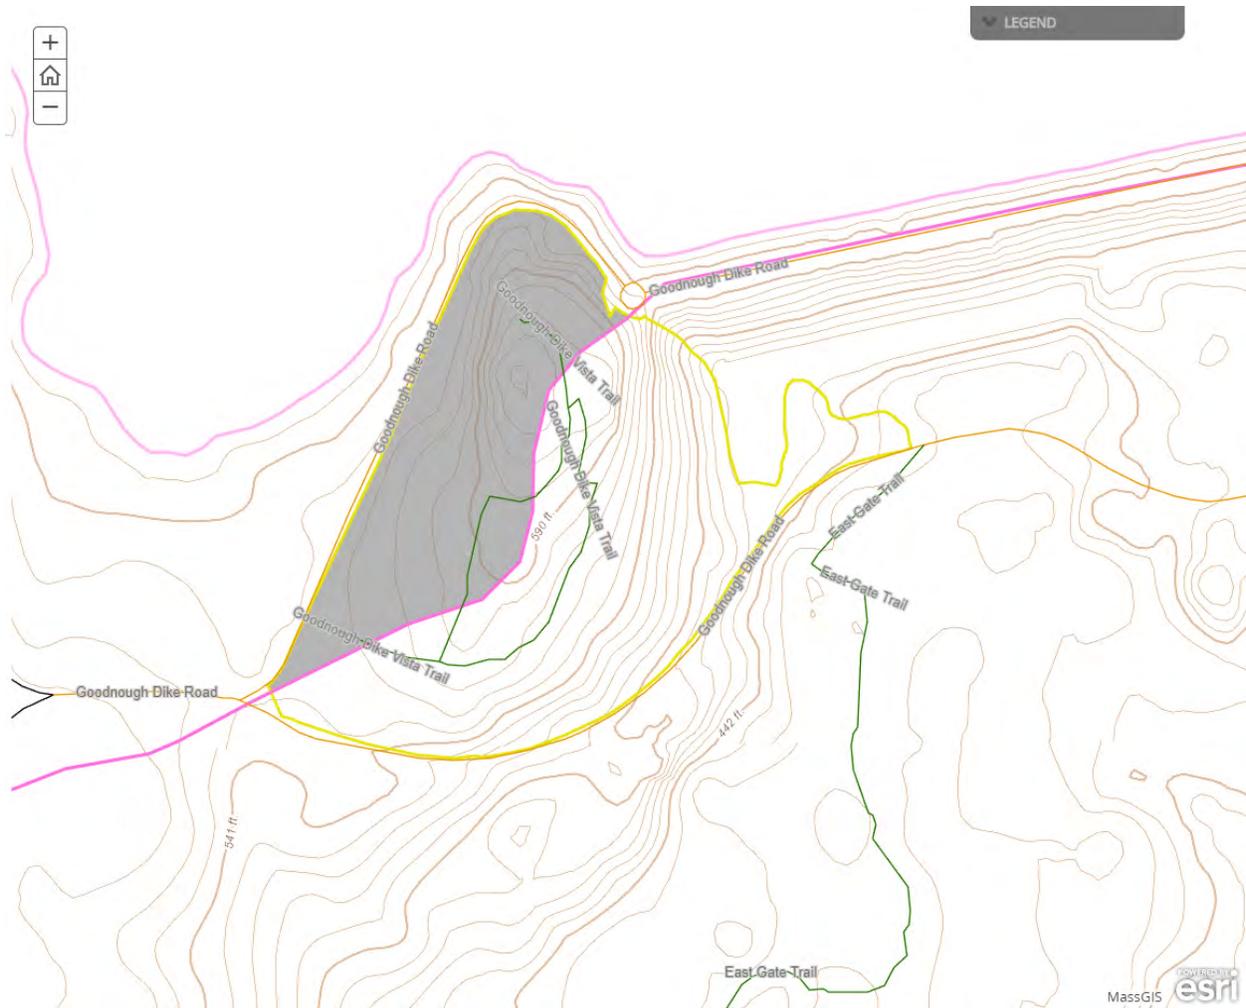
### Subwatershed Analysis

Sub-watershed number	Total DCR-owned Acres	Acres Regenerated on DCR Land in the last 10 years	Acres Remaining for Regenerating Up to the 25% / 10 Year	Acres part of this proposal
72 (Quabbin Park East)	325	12	69	11
Off-watershed	-	-	-	18

Only 11.15 acres of this proposal are on the watershed. The acres remaining to harvest in the sub-watershed far exceeds this so there is no way to exceed the 25% limit.

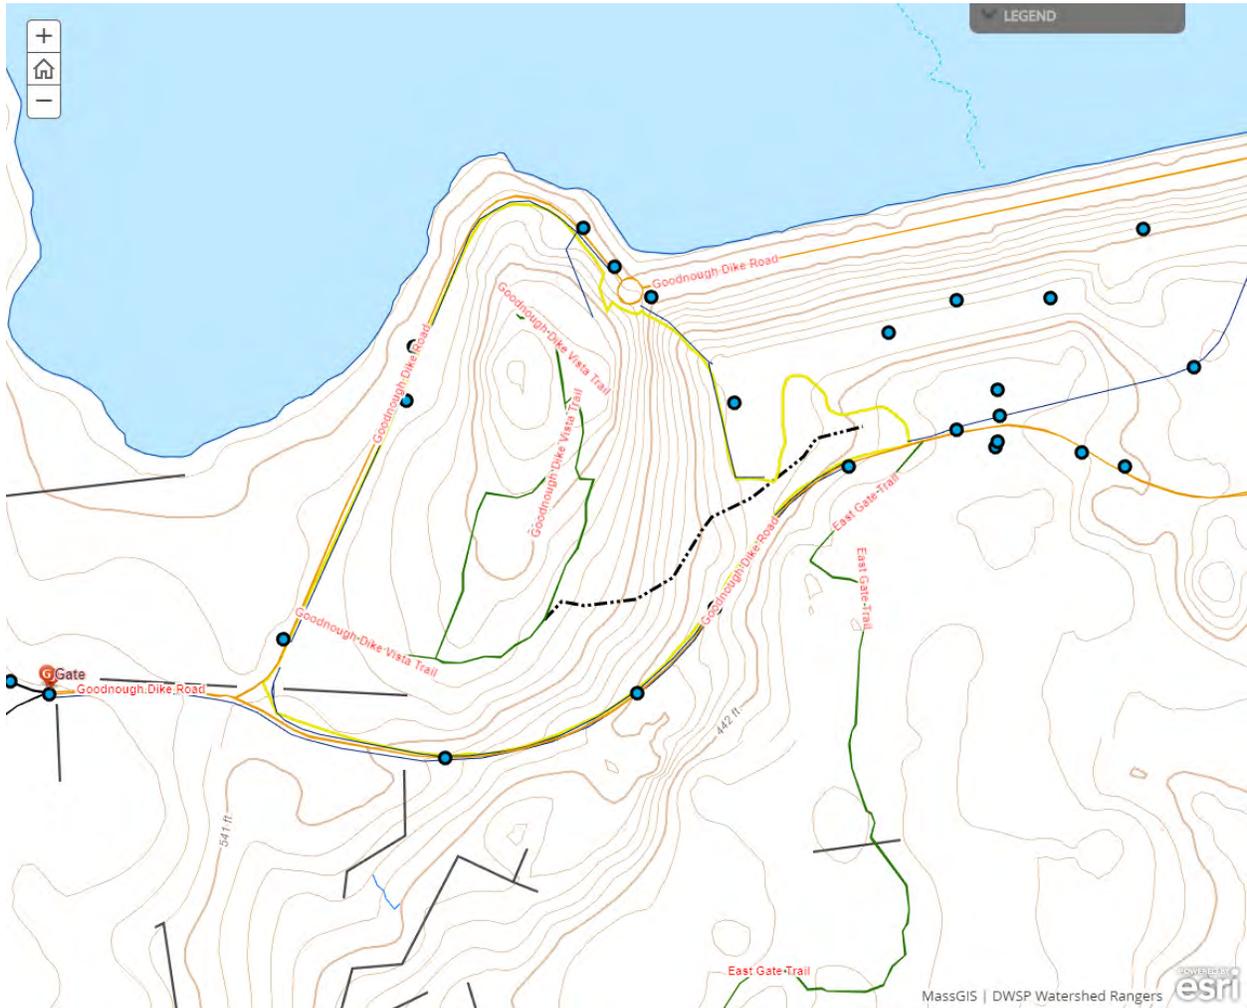
## Harvesting Limitations

A whole tree chipping operation is preferred by NHESP ecologists to create desirable habitat and to create conditions favorable for future fire management. Landing area will be cleaned of chips and other woody debris removed from the site at end of job. There is a steep hillside towards Goodnough Dike with 2 mapped steep and rocky areas that are inoperable. There is also a large,

split bedrock outcrop here. Any skid trails through this steep section will require water bars at least every 100'.

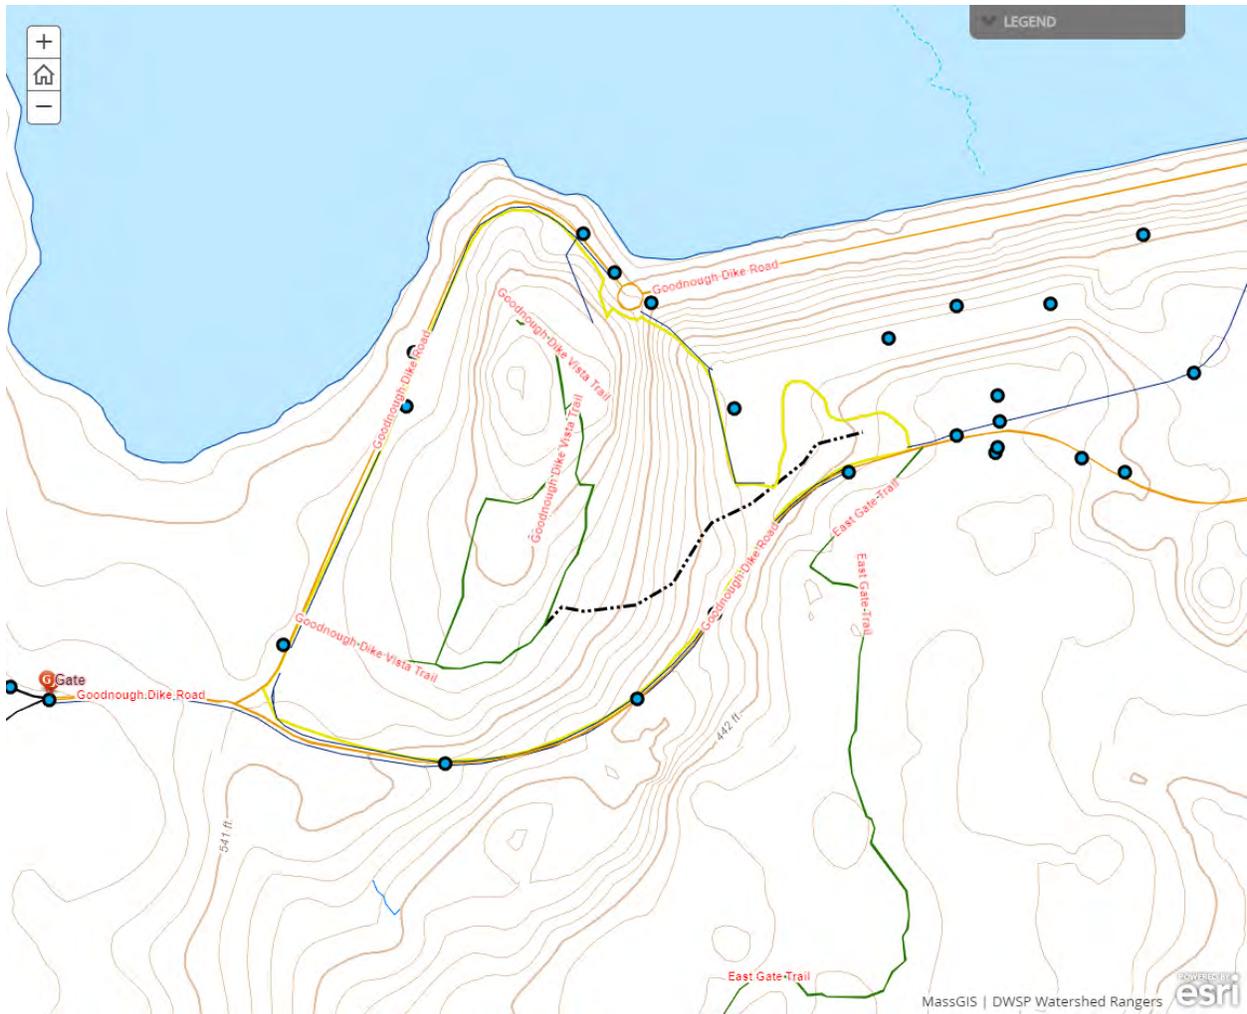
## Forest Access Engineering

Access is through high security gate 50A. One or 2 of the bollards will need to be removed to allow trailer access to site. A landing suitable for a chipping operation will be established just NE of the junction of upper and lower Goodnough Dike Road; gravel may be needed to protect the edge of the paved Dike Road.

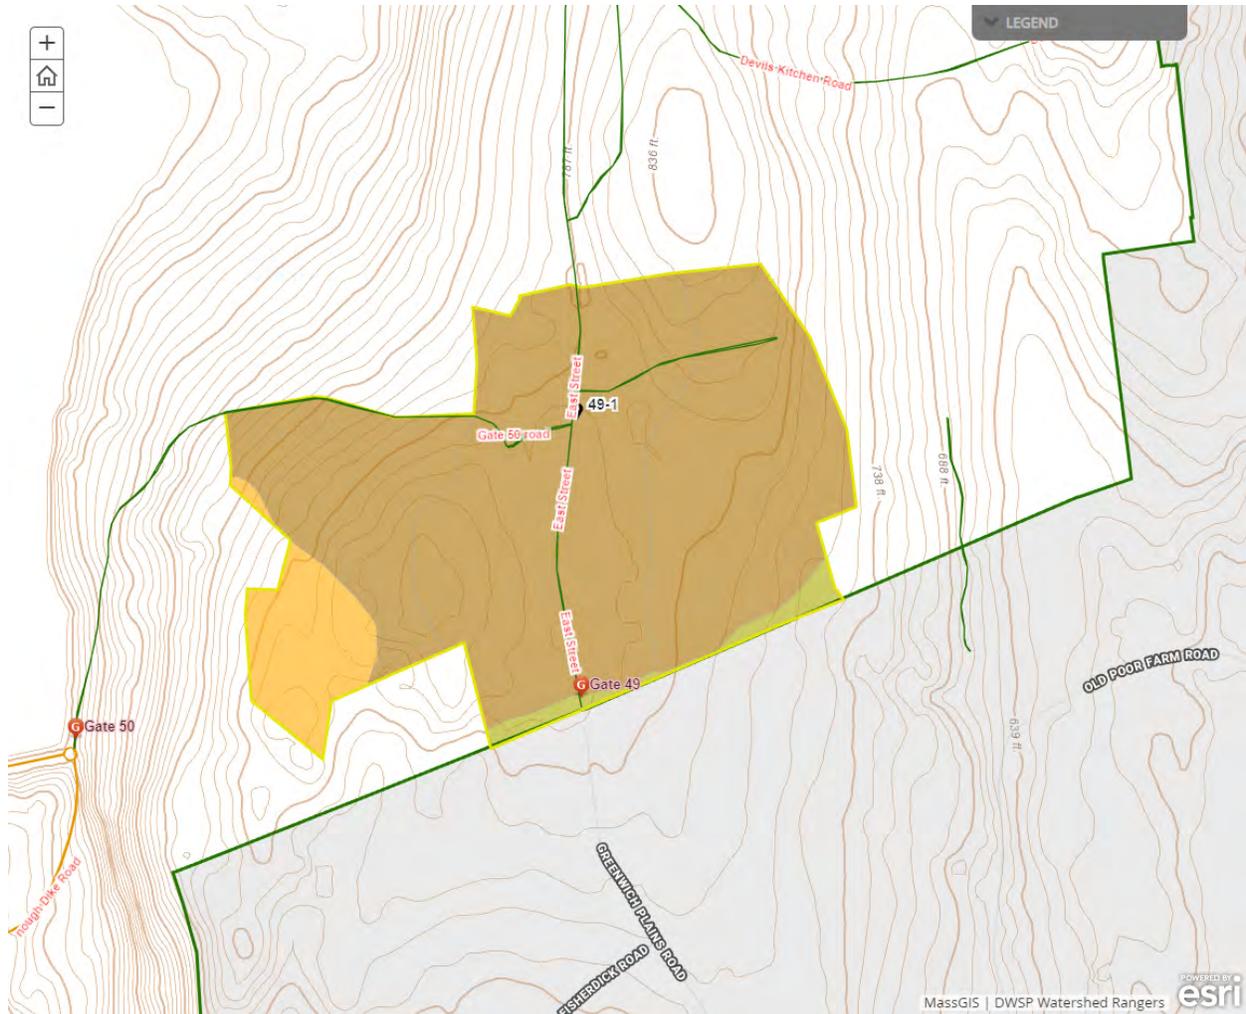
**Soils**

Drainage Class	%
Excessively Drained	0

<b>Well Drained Thin</b>	9
<b>Well Drained Thick</b>	88
<b>Moderately Well Drained</b>	3
<b>Poorly to Very Poorly Drained</b>	0

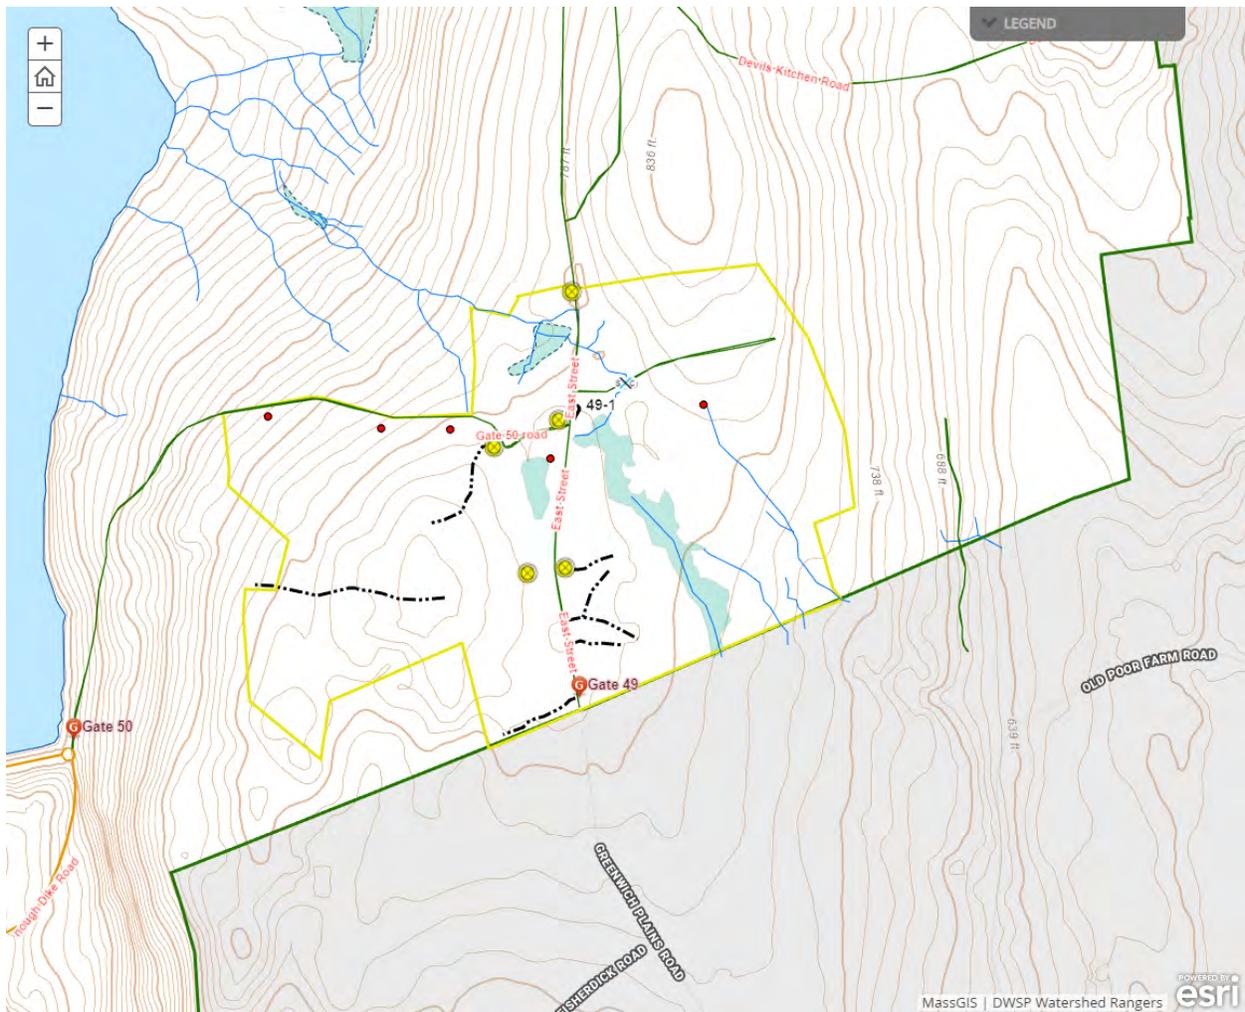
## Wetlands

The only crossing that should be required is over an intermittent brook that passes through a stone culvert in an old roadway. There are now 4 vernal pools identified south of Gate 50 Road. 2 are located in old gravel pits, one is an old gravel test hole and the third is a large shrub swamp/wooded wetland complex that has had vernal pool species identified in it. This last area stays wet all year. 2 more pools were identified and confirmed this year. 1111 was created by the above mentioned stone culvert which has become partially blocked with sediment over the years. The existing roadway has been used as a main skid trail and is the best access to the land to the east. Care needs to be taken when this access is used so as not to disturb the pool or create ruts in road. A portable bridge should be required to protect the stone culvert from damage. The last pool 2222 is in a depression that was probably dug long ago to water livestock. There is a well beside the intermittent brook that drains out of this pool.

Note the long skinny wetland that runs from the southern boundary to the old lane and vernal pool crosses the Quabbin watershed boundary. The northern end of this wetland is a large flat area that drains both to the south across the boundary and northwest out of the stone culvert. The latter intermittent stream forms another wetland after it crosses East Street.

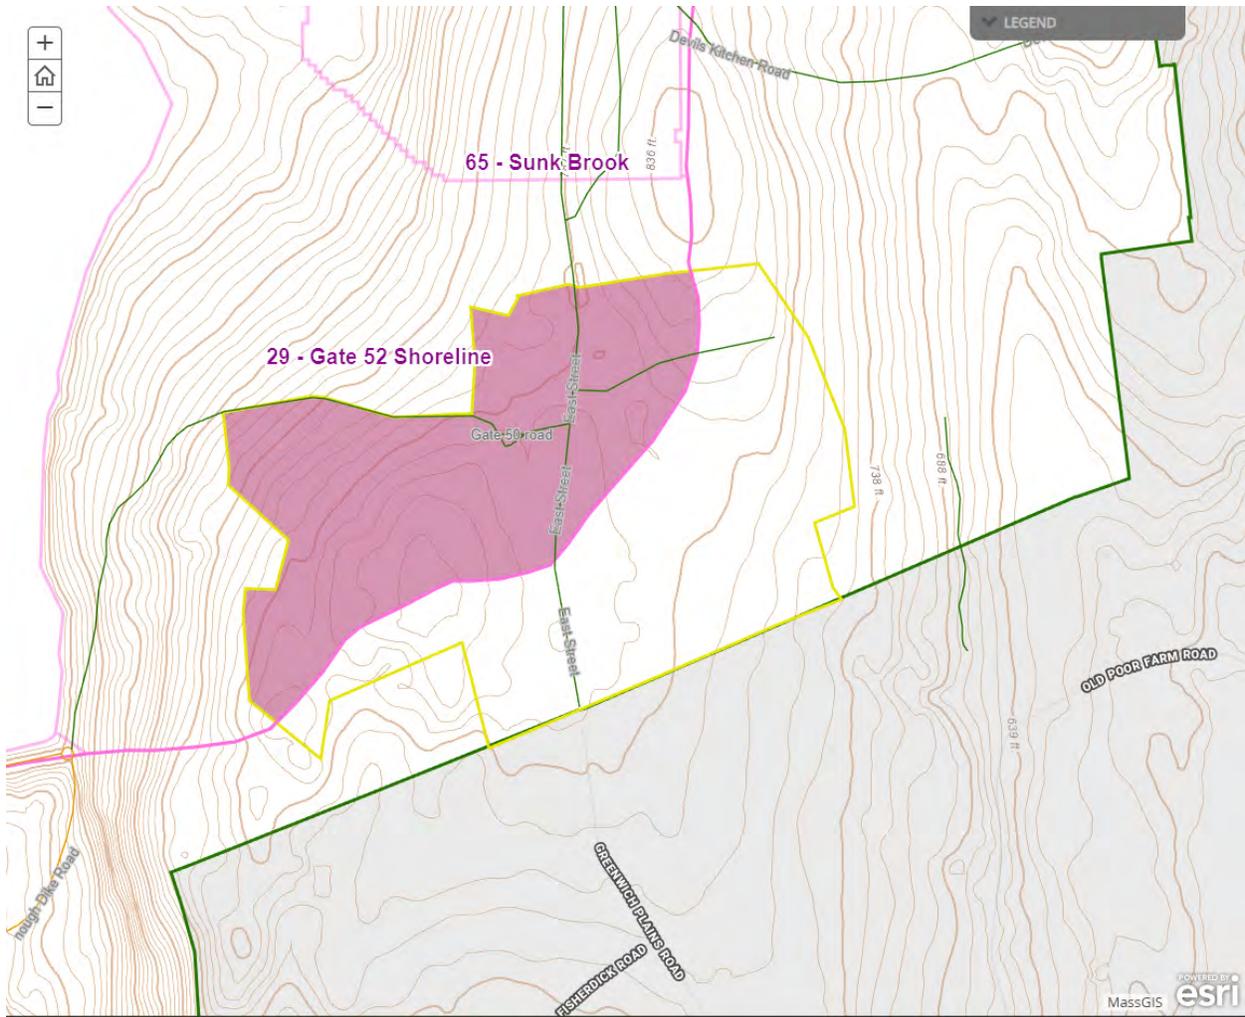
## Subwatershed Analysis

Sub-watershed number	Total DCR-owned Acres	Acres Regenerated on DCR Land in the last 10 years	Acres Remaining for Regenerating Up to the 25% / 10 Year	Acres part of this proposal
29 (Gate 52 Shoreline)	224	10	46	67
Off-watershed	-	-	-	68

Half (68 acres) of this proposal are off watershed. Of the acres in watershed it could be possible, though unlikely, to exceed the 25% harvest limit. The only cut within 10 years that is affecting this calculation is from lot 1040 which was a harvest of red pine completed 2/19/2014 so these 10 acres will drop out of calculation in less than 3 years. The area cut is now all stable and fully regenerated. Also since typically we are only regenerating 25% of an area that would come out to 14.2 acres which is well below the 45.7 acre threshold. Proposed harvesting will not exceed the 25% threshold.

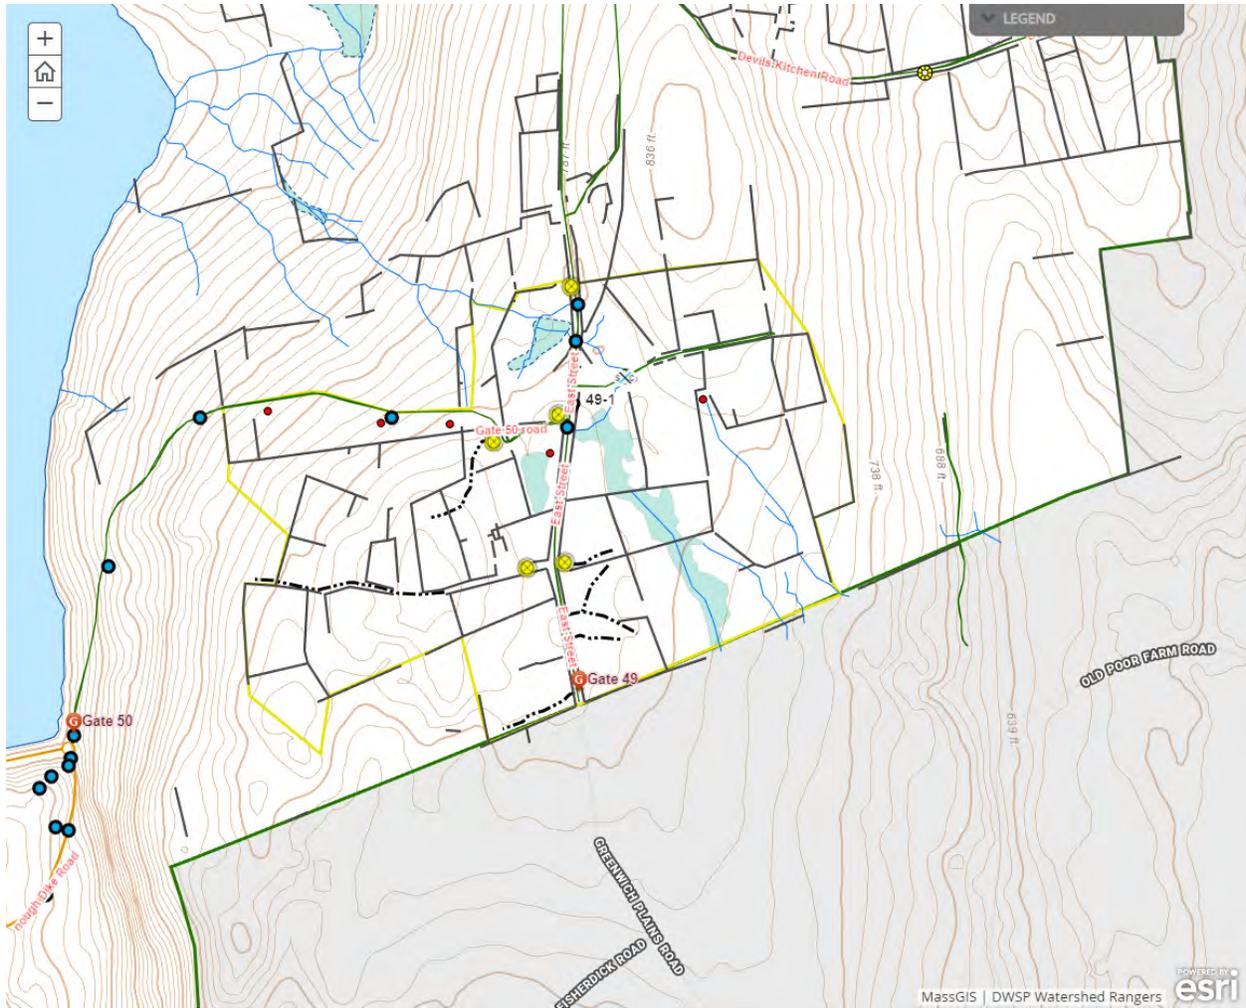
## Harvesting Limitations

Due to the number of walls and historic features to be worked around a 6- or 8-wheel forwarder with tracks available will be required, as will ability to winch or directionally fell trees within filter strips and around historic features.

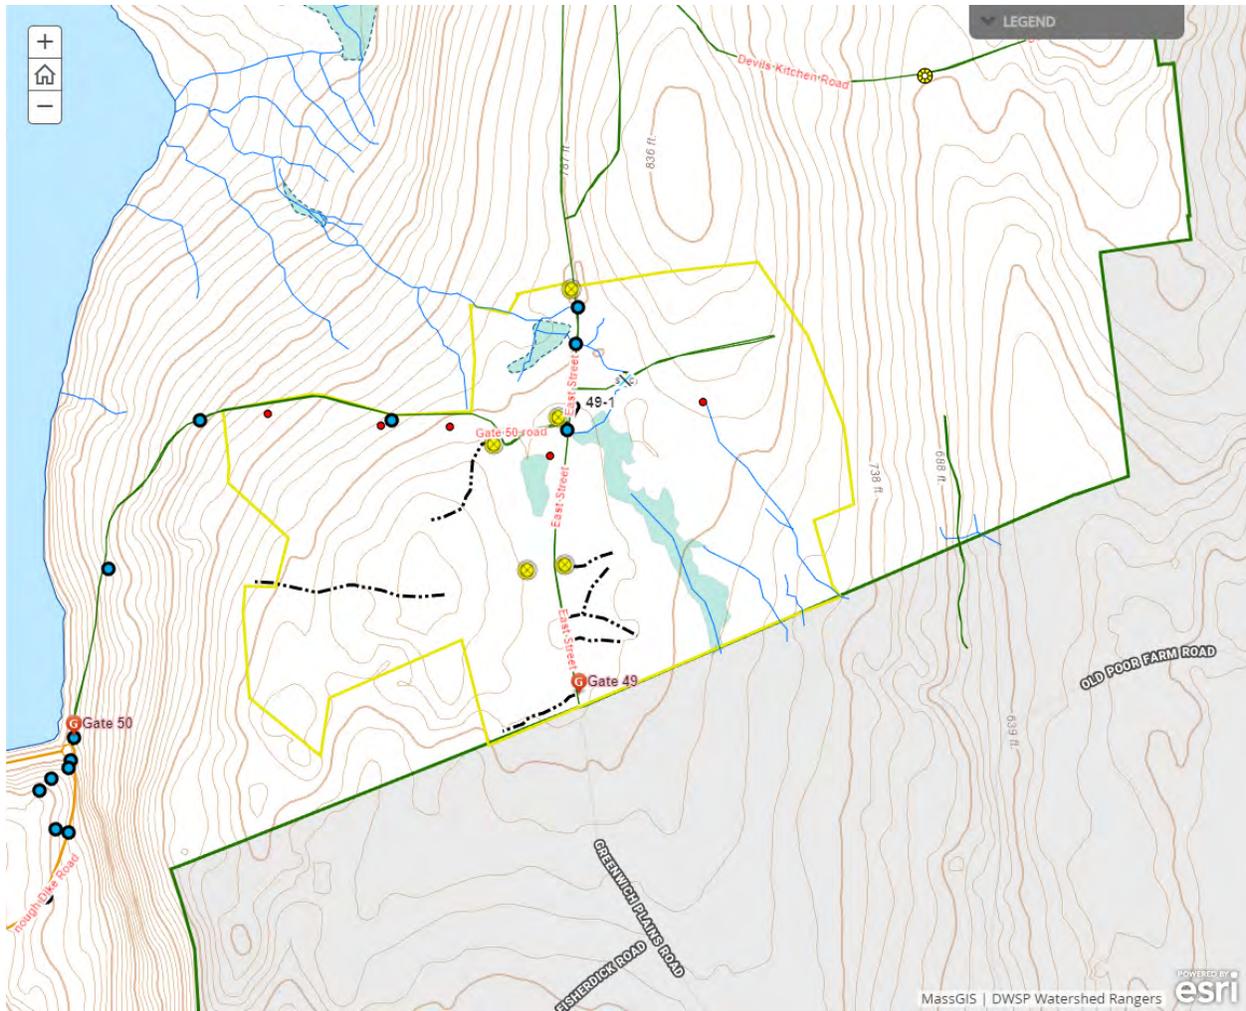
## Environmental Quality Engineering

Only one intermittent stream crossing in an old road which has a stone culvert. Flow is very low and intermittent. Bridge panels will be used to protect stone work and prevent siltation at the crossing location.
