NUMBER 32
Fall 2014

Massachusetts Department
of Conservation and Recreation
Division of Water Supply Protection
www.mass.gov/dcr/watersupply

Grassland Habitat

Managing the ecosystem of Wachusett's North Dike

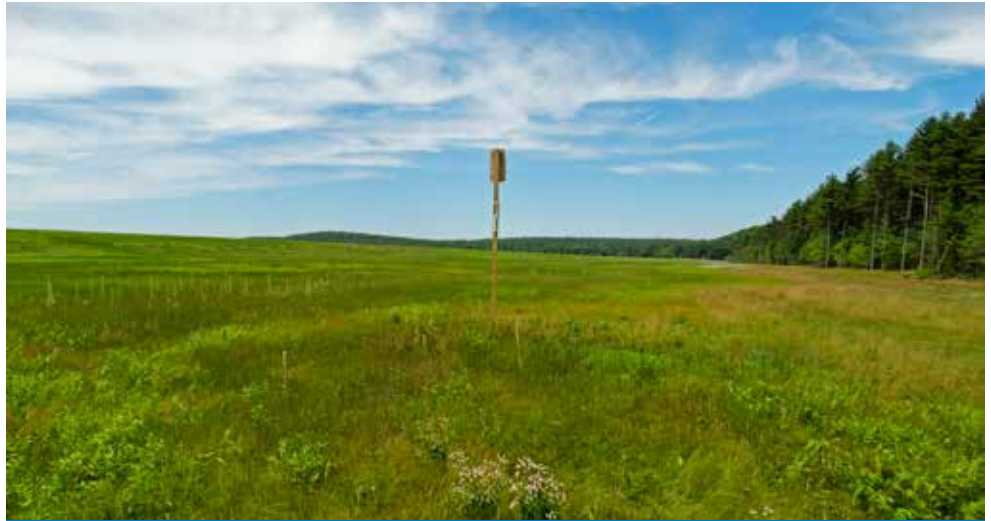
A kestrel nest box stands sentry in the middle of Wachusett Reservoir's North Dike. DCR has started managing a portion of the dike's expanse as habitat for several breeding birds.

After seeing kestrels hunting on North Dike West in the spring of 2013, MassWildlife Ornithologist Dr. Andrew Vitz proposed installing a kestrel nest box on the Dike. Generally an open area of 50 acres is needed to support a breeding pair of kestrels, but smaller patches like the North Dike will suffice if there is a considerable amount of open habitat around the nest box. In early 2014 the nest

box was erected on the eastern portion of North Dike West. The results were better than expected: the pair occupied the box in its first year. MassWildlife banded the adult female and five nestlings in early July 2014. They fledged less than two weeks later and were

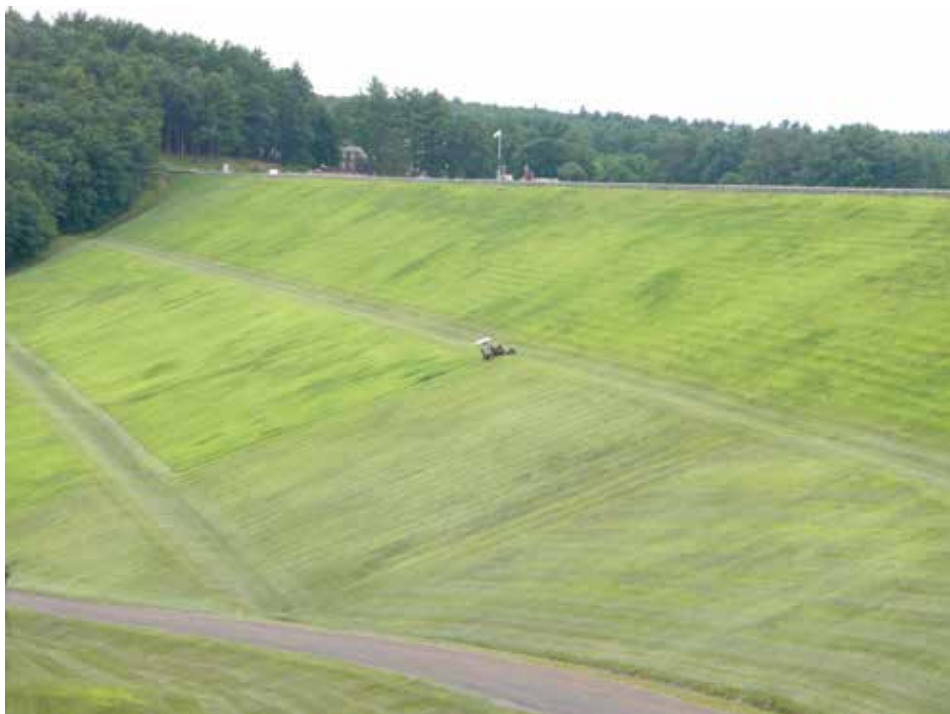
A slippery slope? This view of the back of Quabbin Reservoir's Winsor Dam shows the daunting task facing the mower (in the center of the picture). It takes two days to mow the whole face of the dam.

cover that is easily inspected and resistant to erosion. As many homeowners could personally attest to, challenges to maintaining a healthy turf cover are many, including competing weeds, soil drought, and nutrient deficiencies to name a few. These conditions are only made worse on steeply sloping grounds such as those that occupy the downstream embankments of the two structures whose grades approach 50% (i.e., 1 on 2 - rise to run). It is a daunting task to operate equipment that can traverse these steep slopes.

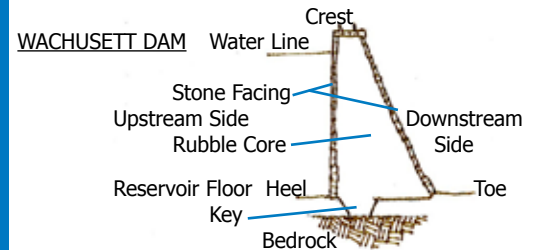
The Wachusett Dam utilizes a rubble and concrete core, with a 'key' reaching down to bedrock. The dam is encased on both sides with concrete and cut stone construction.

Wachusett's North and South Dikes are constructed of layers of fill and silt excavated during construction of the reservoir, bermed up to a flat top and faced with stone rip-rap on the reservoir side.

The Winsor Dam at the Quabbin Reservoir is more elaborately constructed, with a concrete caisson wall set on bedrock, rising up through the center of the dam. This wall is further encased on both sides by a clay core and fill is used as a 'shoulder' to give the dam its shape. The reservoir side of the dam is faced with rip-rap near the top, graduating to finer crushed stone beneath the water's surface. The back of the dam is dressed with topsoil and maintained turf.

Dams and dikes have similar functions: to hold back water. The difference? A dam has active features, such as a spillway to send excess water on its way downstream, as well as control structures, like intakes, valves and gates. A dike merely functions as an impounding 'shoreline', keeping water in place. There are a variety of dam and dike designs. These cross-section diagrams of the Wachusett Dam, Wachusett Dikes, and Quabbin Reservoir's Winsor Dam are common designs used in the New England area.

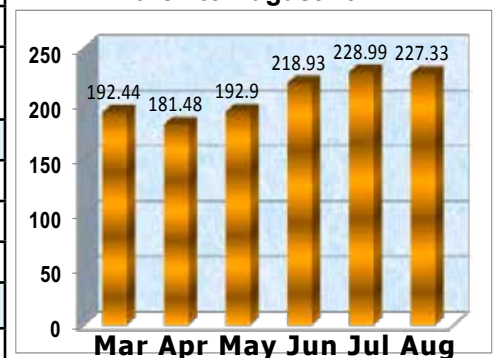
Reservoir levels and 6-month precipitation

Reservoir	Quabbin	Wachusett
Minimum	524.95'	388.1'
% Full	90.7%	86.4%
Date(s)	3/3/14 3/12/14	3/10/14
Maximum	529.26'	391.06'
% Full	98.6%	92.1%
Date(s)	5/28/14	5/3/14
Precipitation	26.23"	24.12"
Seasonal Avg	25.22"	23.36"

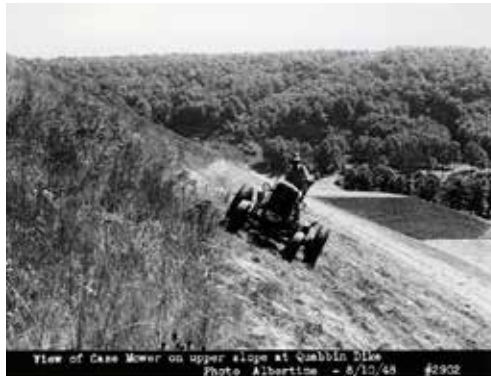
View of Case Mower on upper slope at Quabbin Dike
Photo Albertine - 8/10/49 #2902

at the Dike. Today, DCR utilizes a specialized, dual-tired slope mower that offers a low center of gravity and built-in weight transfer system specifically designed to improve stability and traction on steep slopes.

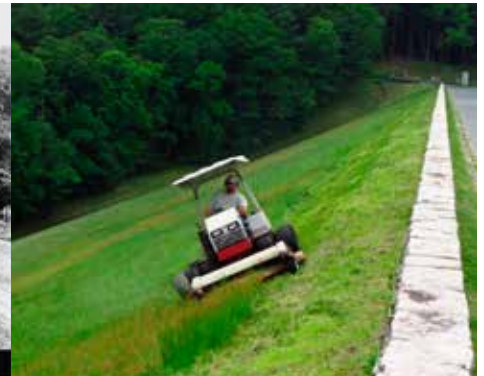
Mowing at Quabbin Reservoir, past and present. While the equipment has been upgraded over the years, maintenance staff still have to lean into their work to keep the dam and dike neat and safe.
