The Commonwealth of Massachusetts
Department of Public Safety
One Ashburton Place, Room 1301
Boston, Massachusetts 02108-1618
Phone (617) 727-3200
Fax (617) 727-5732
TTY (617) 727-0019
www.mass.gov/dps

Dominion Energy New England - Salem Harbor Station
Salem, MA
Boiler #3 Failure - November 6, 2007

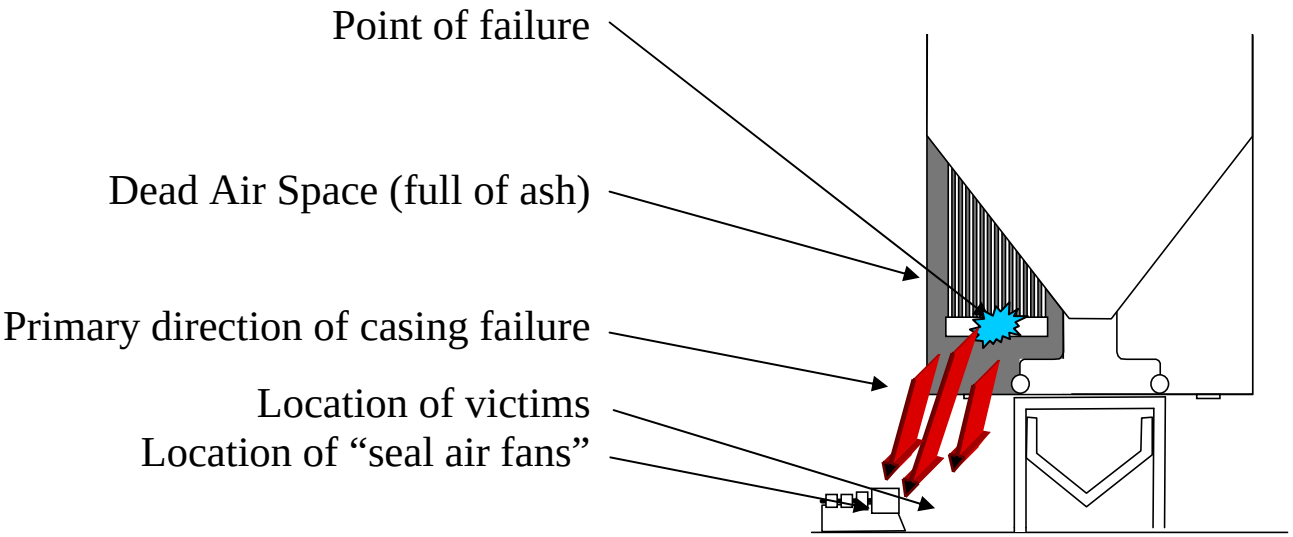
Graphic representation of failure area

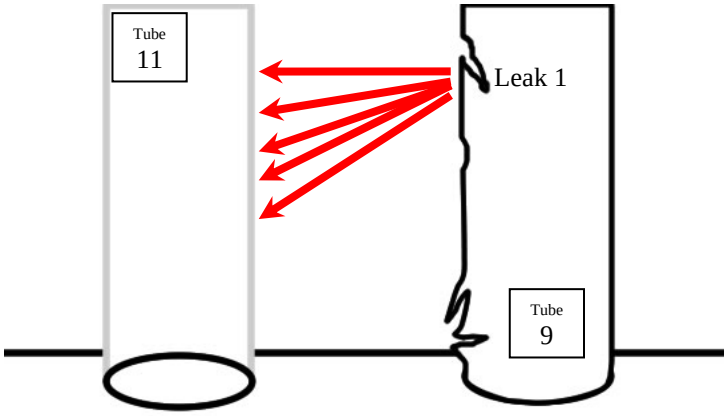
1. Tube 9 begins to leak as a result of a significant welding flaw at the time of manufacture, and external corrosion
    a. Leak strikes Tube 10 and 11 causing "collateral damage"

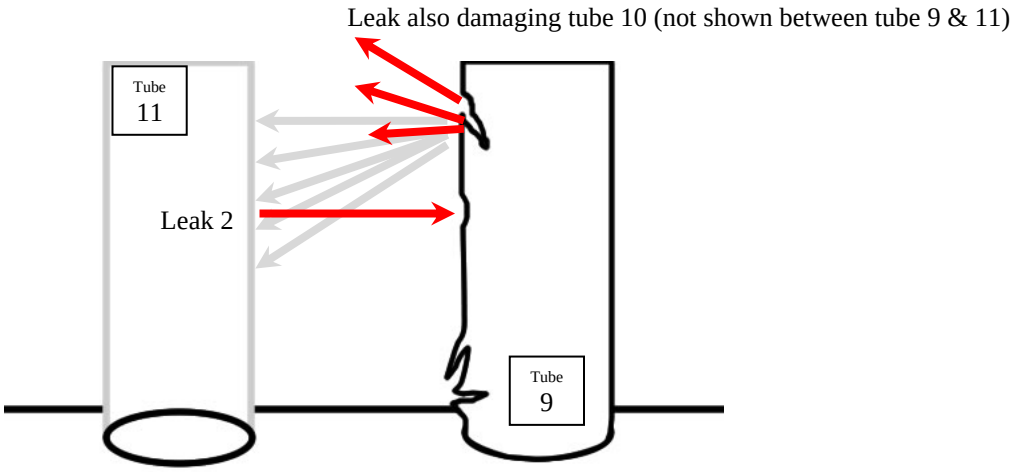
2. Initial leak in Tube 9 continues to damage Tube 10 and 11
    a. Tube 11 begins to leak and starts to damage Tube 9

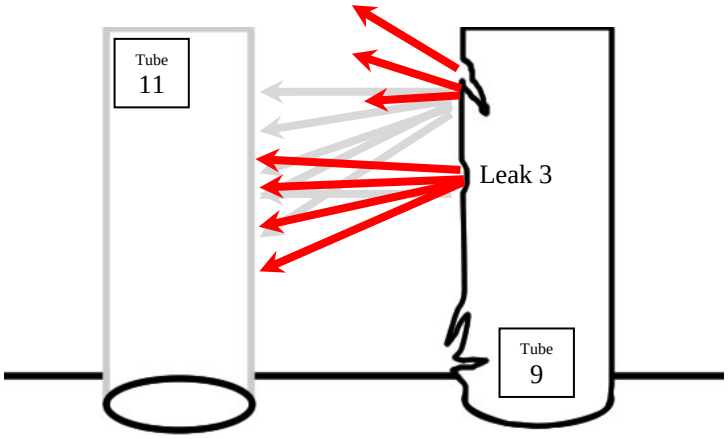
3. All leaks continue to progress.
   a. Leak from Tube 11 results in a new leak in Tube 9, continues to damage Tube 10

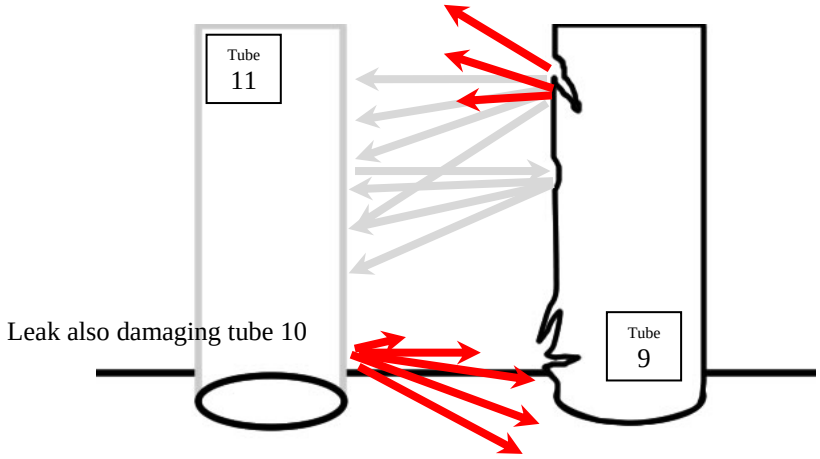
4. All leaks continue to progress and worsen
   a. New leaks from collateral impingement damage develop

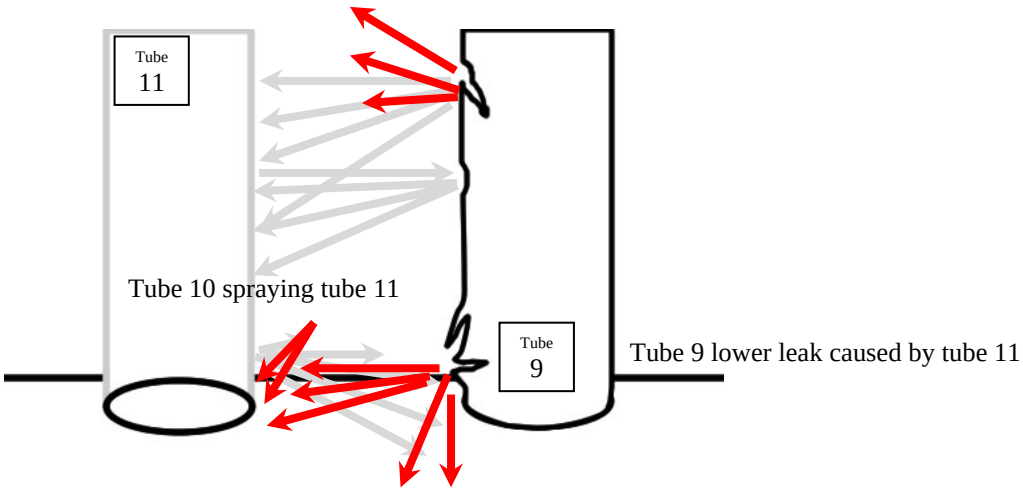
5. All leaks continue to progressively worsen over time
   a. Tube 10 is thinned along one plane far below minimum wall thickness
   b. Tube 11 is also thinned considerably below minimum wall thickness
   c. Tube 10 fails catastrophically forcing steam/hot water in the direction of Tube 11
   d. The lateral force applied by the failure of Tube 10 toward the weakened Tube 11 causes Tube 11 to separate from the header.

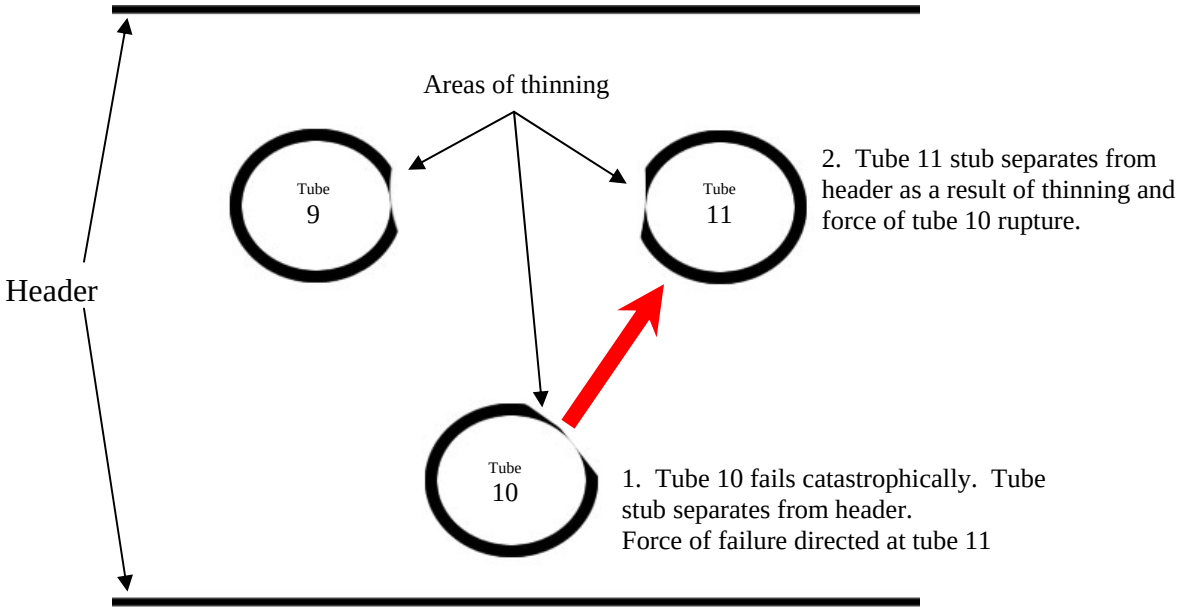
6. View of tube arrangement on header looking down.
   a. As stated in (5) above, the lateral force applied by the failure of Tube 10 toward Tube 11 caused the already weakened Tube 11 to separate from the header.

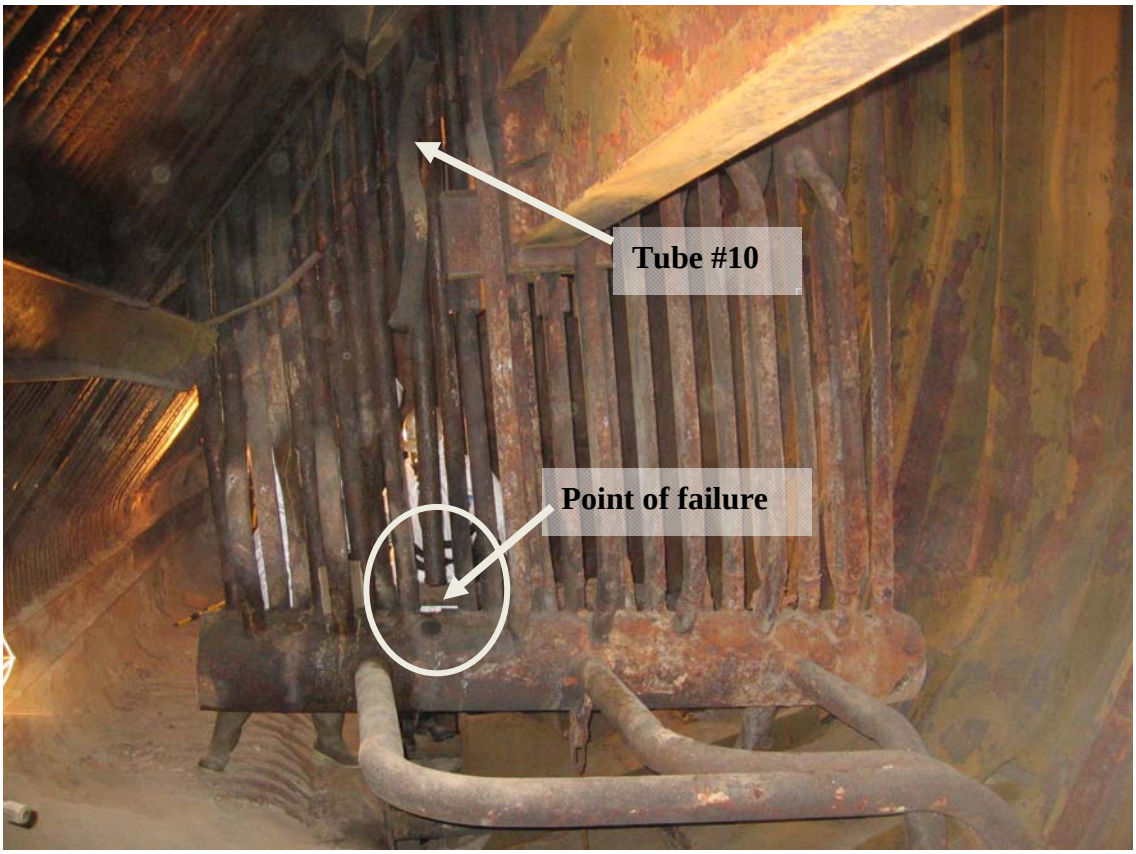
2. Boiler #3 Division Wall Header (facing north)

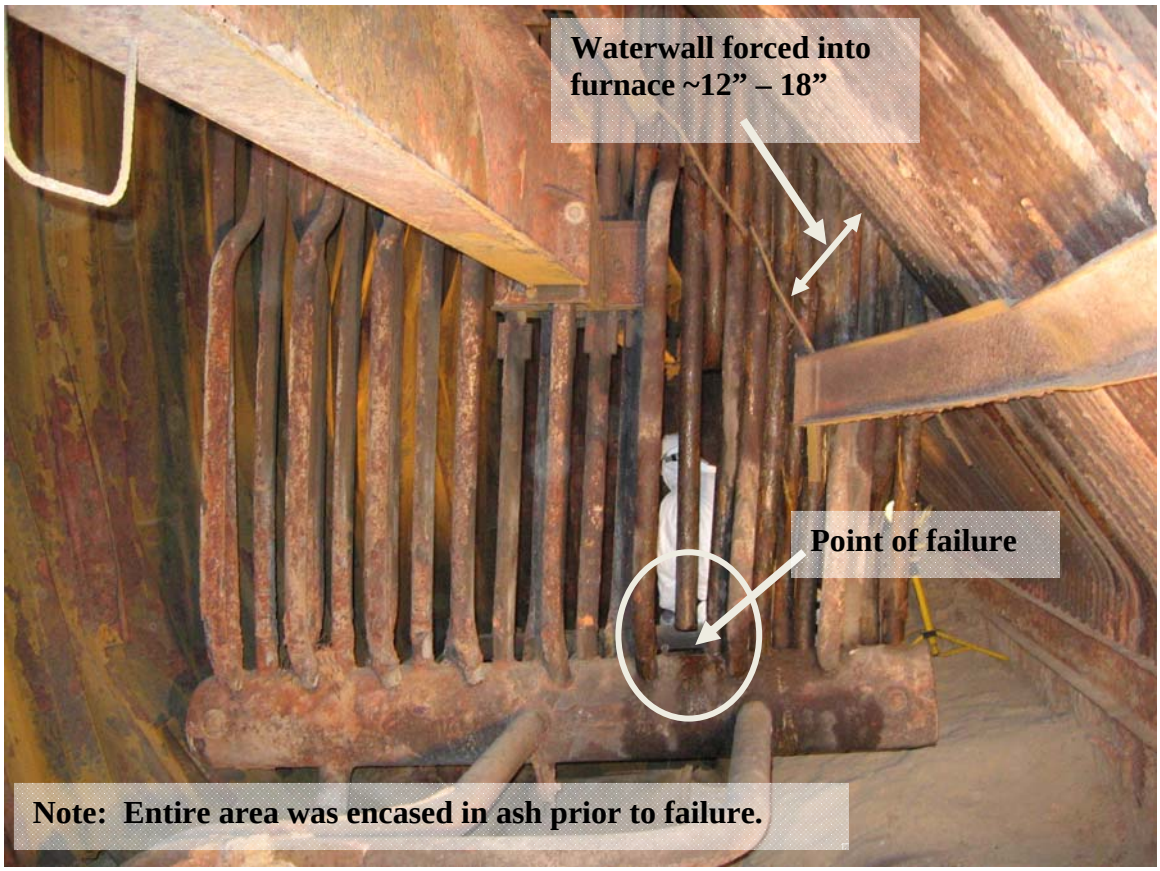
3. Boiler #3 Division Wall Header (facing south)

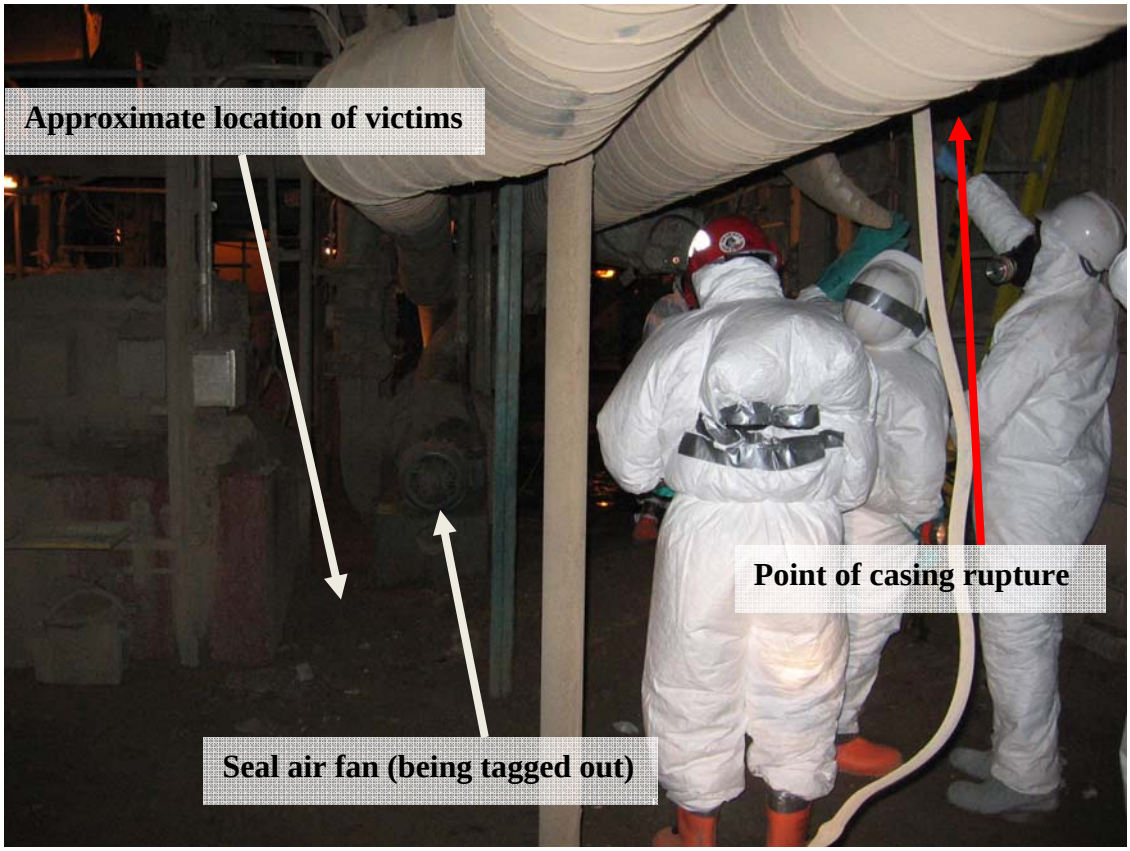
4. Dead air space showing ruptured boiler casing (facing south)

5. **Dead air space showing ruptured boiler casing (looking down, facing south)**

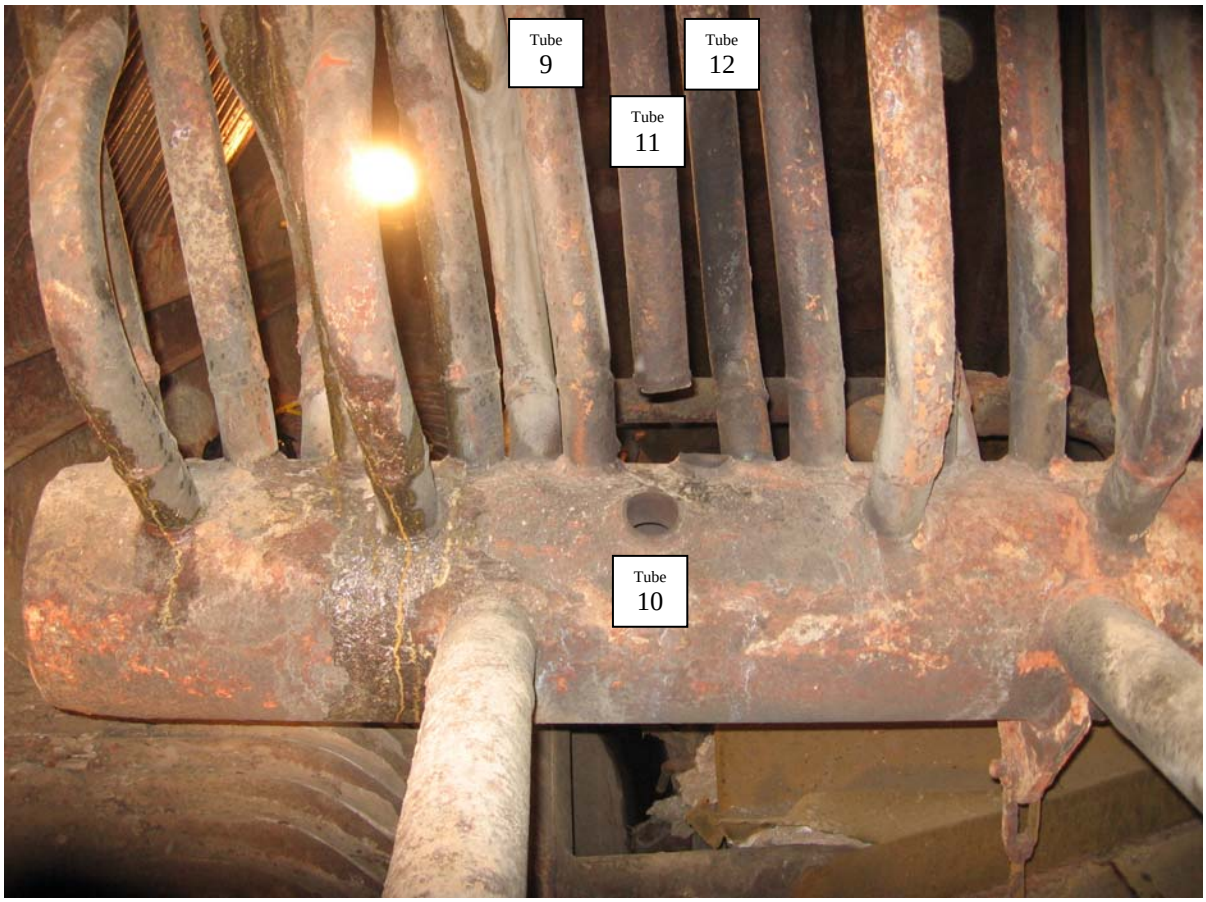
9. Division Wall Header

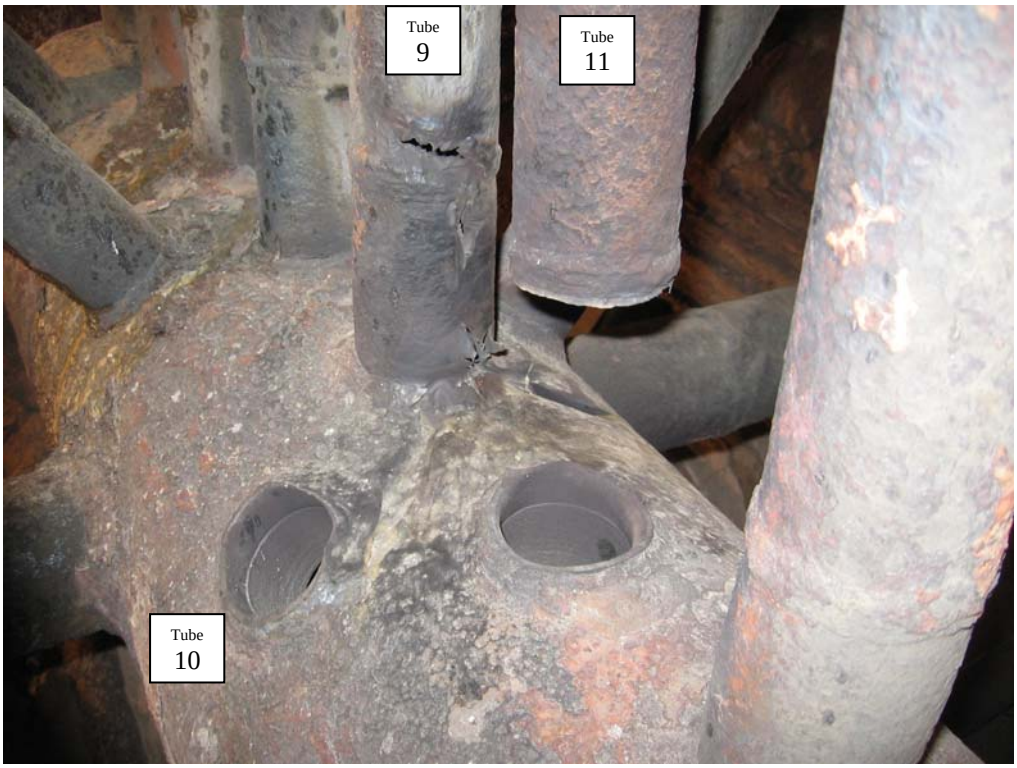
10. Division Wall Header.

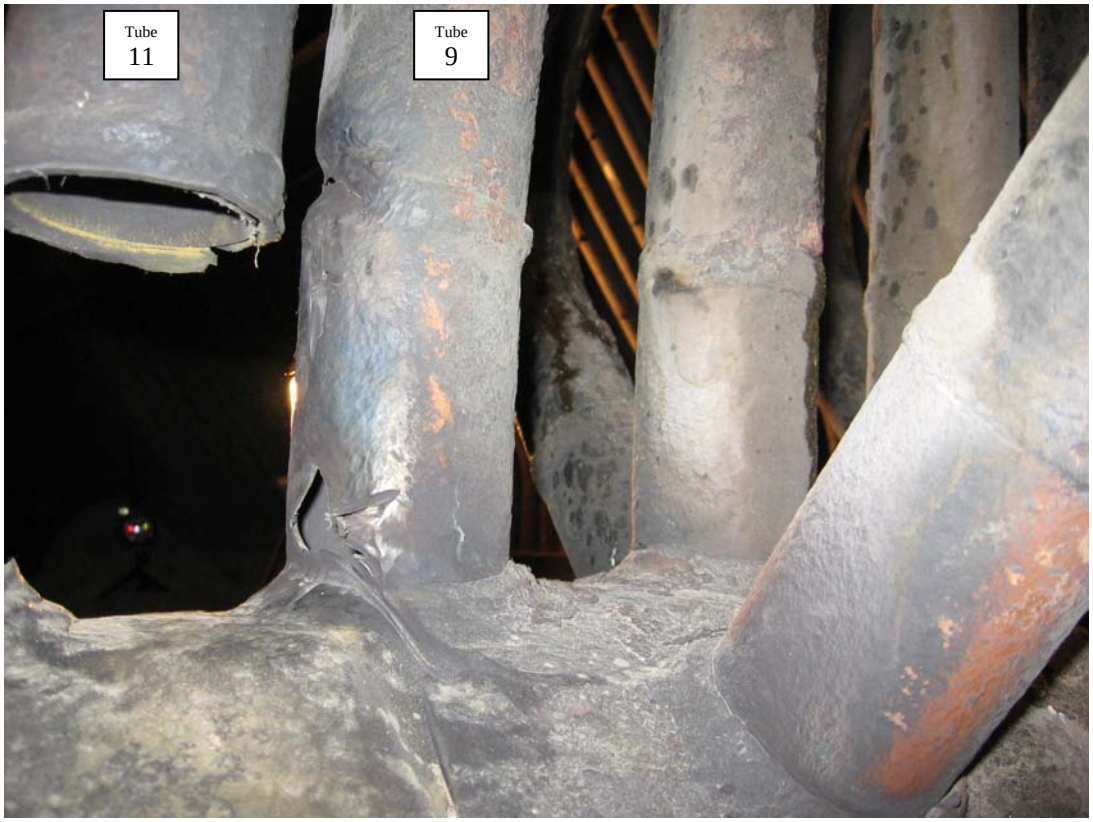
11. Close up of tube 9 and header

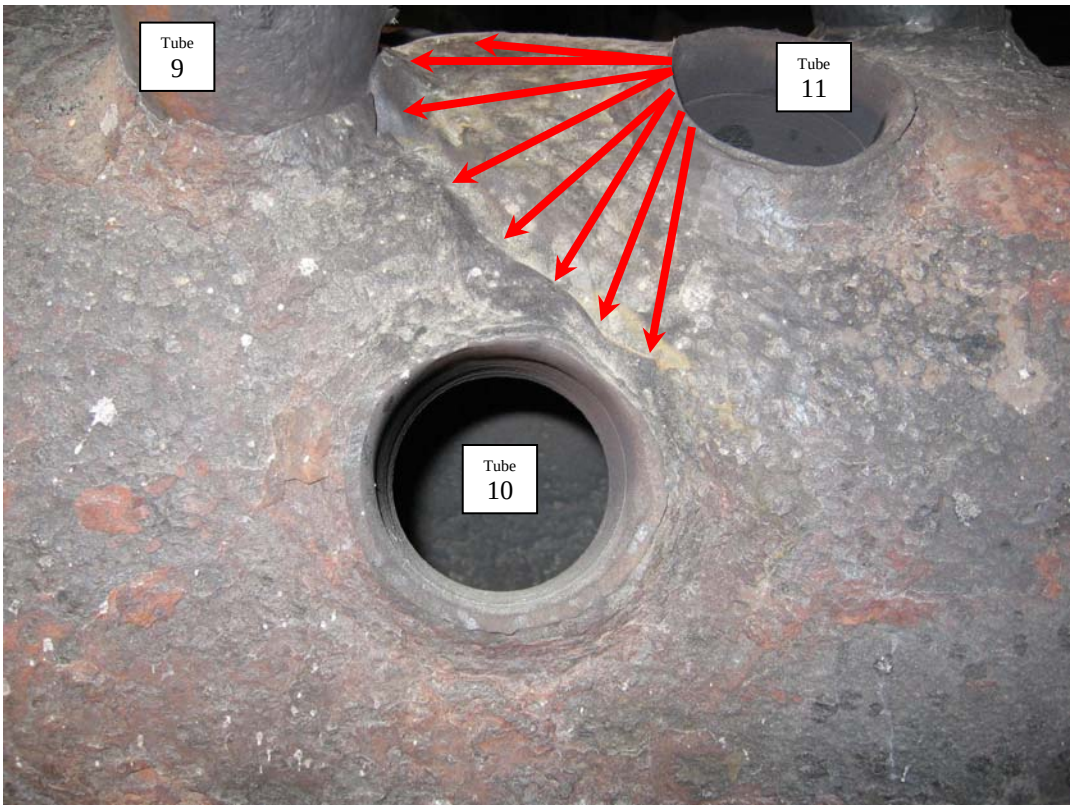
12. Close-up of tube 9 and header

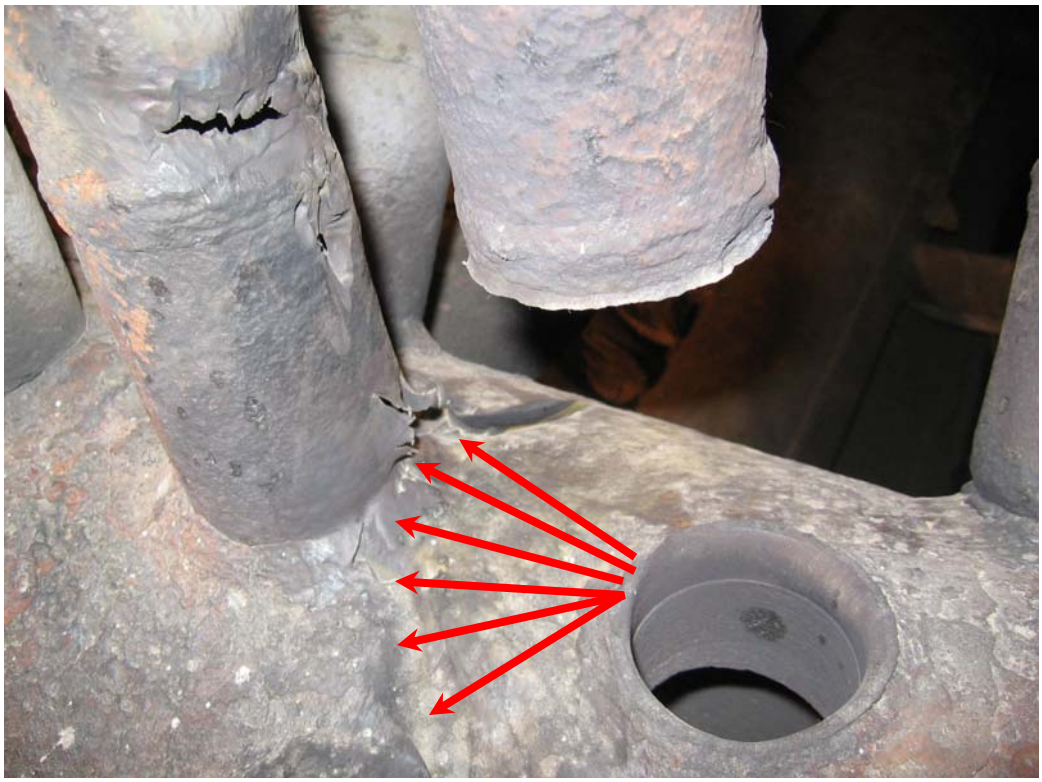
13. Close-up of header at tube 10 and 11

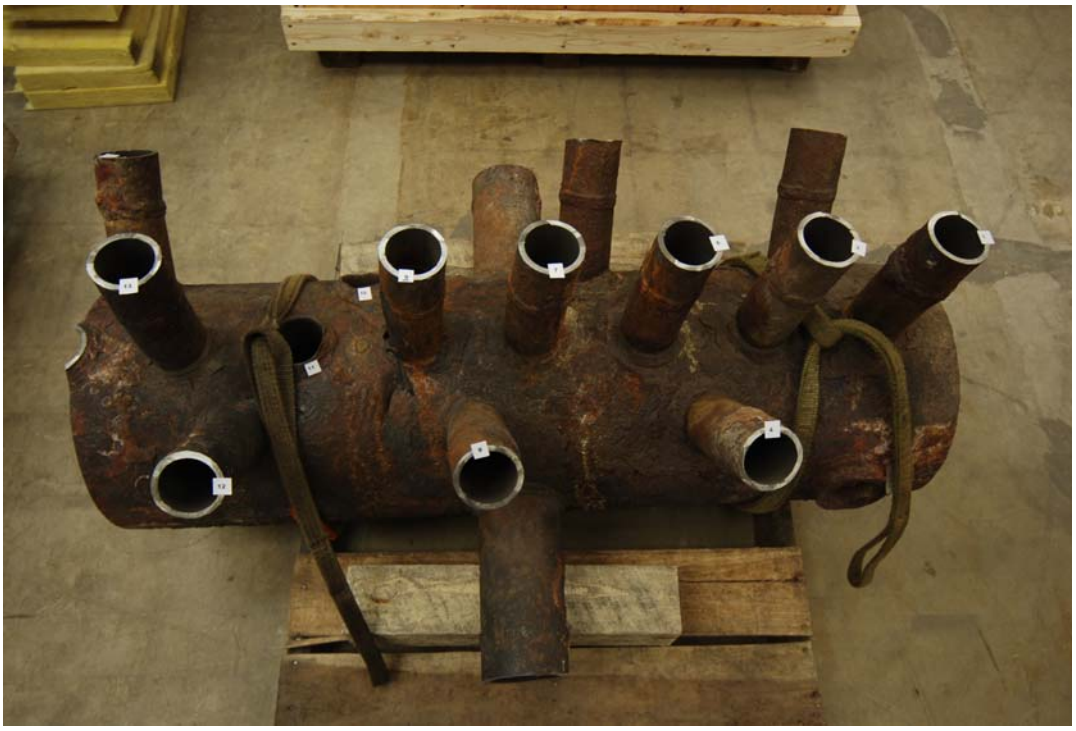
14. Close-up of header at tube 9 and 11

15. Steam impingement indications between tube 9 and 11

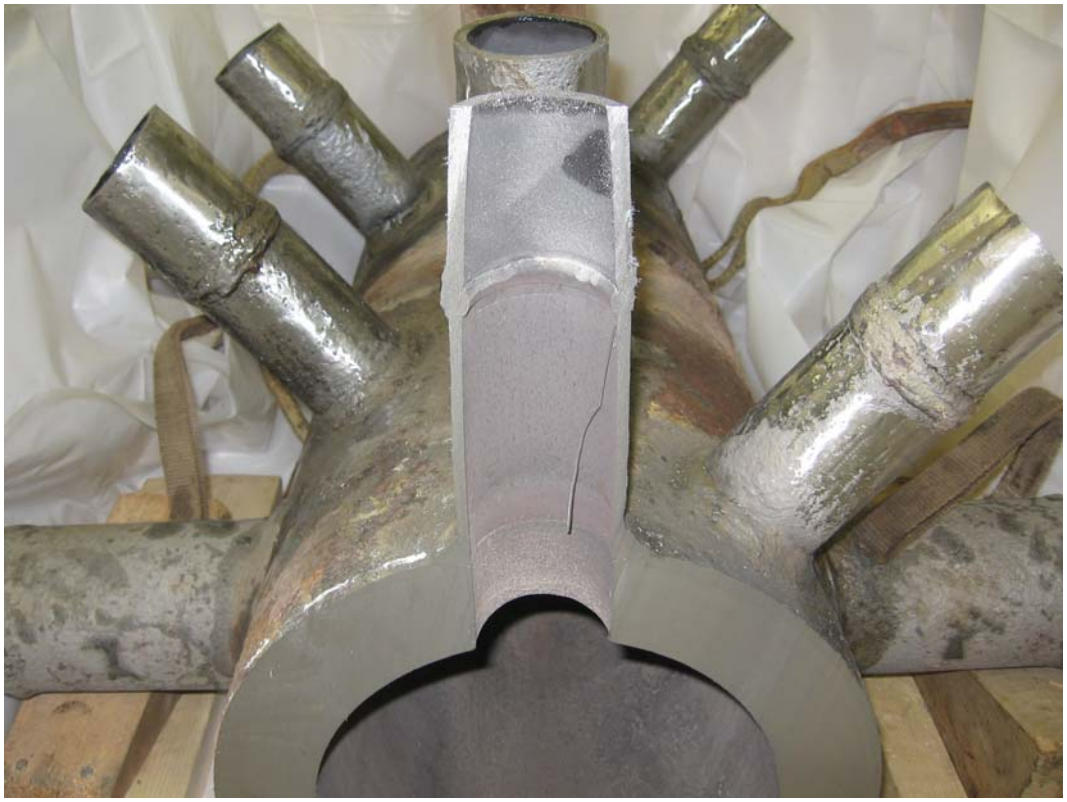
37. View of header after cleaning

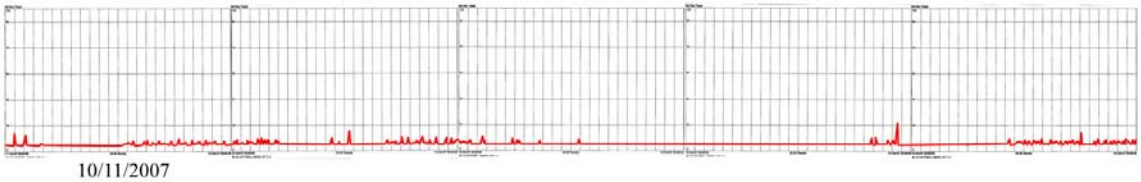
10/11/2007

Feedwater makeup began a slow and steady increase in fluctuation

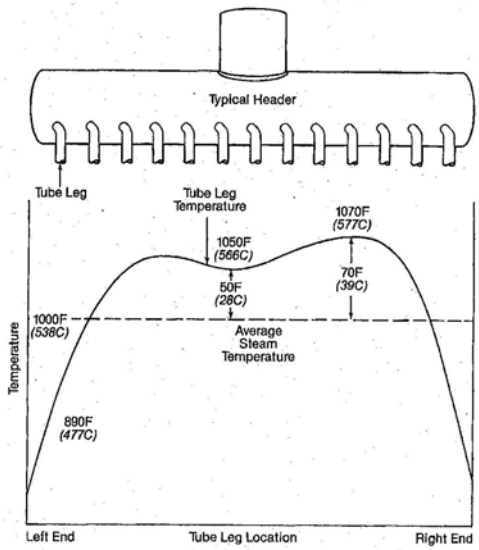
Fig. 2 Steam temperature variation in a header.

occur (Fig. 2). Changes in boiler load further aggravate the temperature difference between the individual tube legs and the bulk header. As boiler load increases, the firing rate must increase to maintain pressure. During this transient, the boiler is temporarily over-fired to compensate for the increasing steam flow and decreasing pressure. During load decreases, the firing rate decreases slightly faster than steam flow in the superheater with a resulting decrease in tube outlet temperature relative to that of the bulk header. As a consequence of these temperature gradients, the header experiences localized stresses much greater than those associated with steam pressure (Fig. 3) and can result in large ligament cracks (Fig. 4).

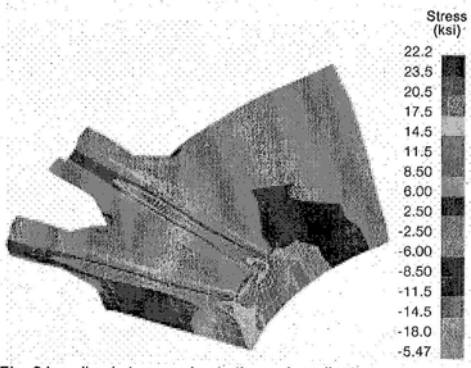
Fig. 3 Localized stresses due to thermal gradients.

Fig. 4 Large ligament cracks on header ID.

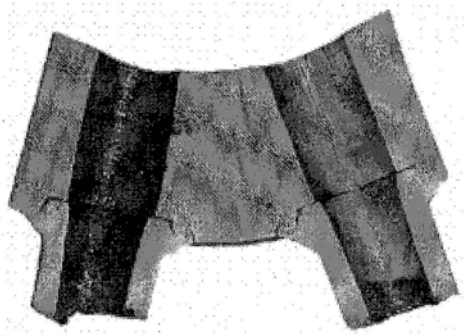
- Ligament and Bore Hole Inspection–The major cause of header end-of-life in the US is creep fatigue. This results in ligament and bore hole cracking. A total of two to three of the hottest or highest stressed areas should be inspected. B&W strongly believes that effective bore hole examination must be preceded by removal of the high temperature oxide. It is important that the base metal of the header be examined for cracking (Fig. 5). B&W developed a unique process for this inspection which is called the Hone & Glow® exam.

Fig. 5 Header bore hole cracking.
