2004 Leak Reports
(last 25)

Manual Distribution Work Order

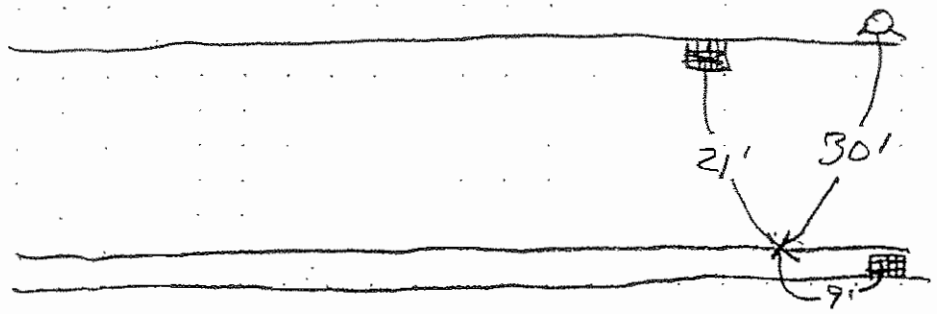
Work Description
Class 1 Leak

New Pipe	Exposed Pipe	Retired Pipe
Pipe Size		2"	
Pipe Type		B.S.	
Coat Type		Bare	
Pressure		High	
Length			
Cut	S M L		
Depth		10"	
Year		? 1926	
Pipe Cond.		LN - F - P - VP	LN - F - P - VP
Coat Cond		G - MD - ED	
Pit Depth			
# of Fits			
Fit Size			
Rate Class

Comments: Installed 1 2" horizontal

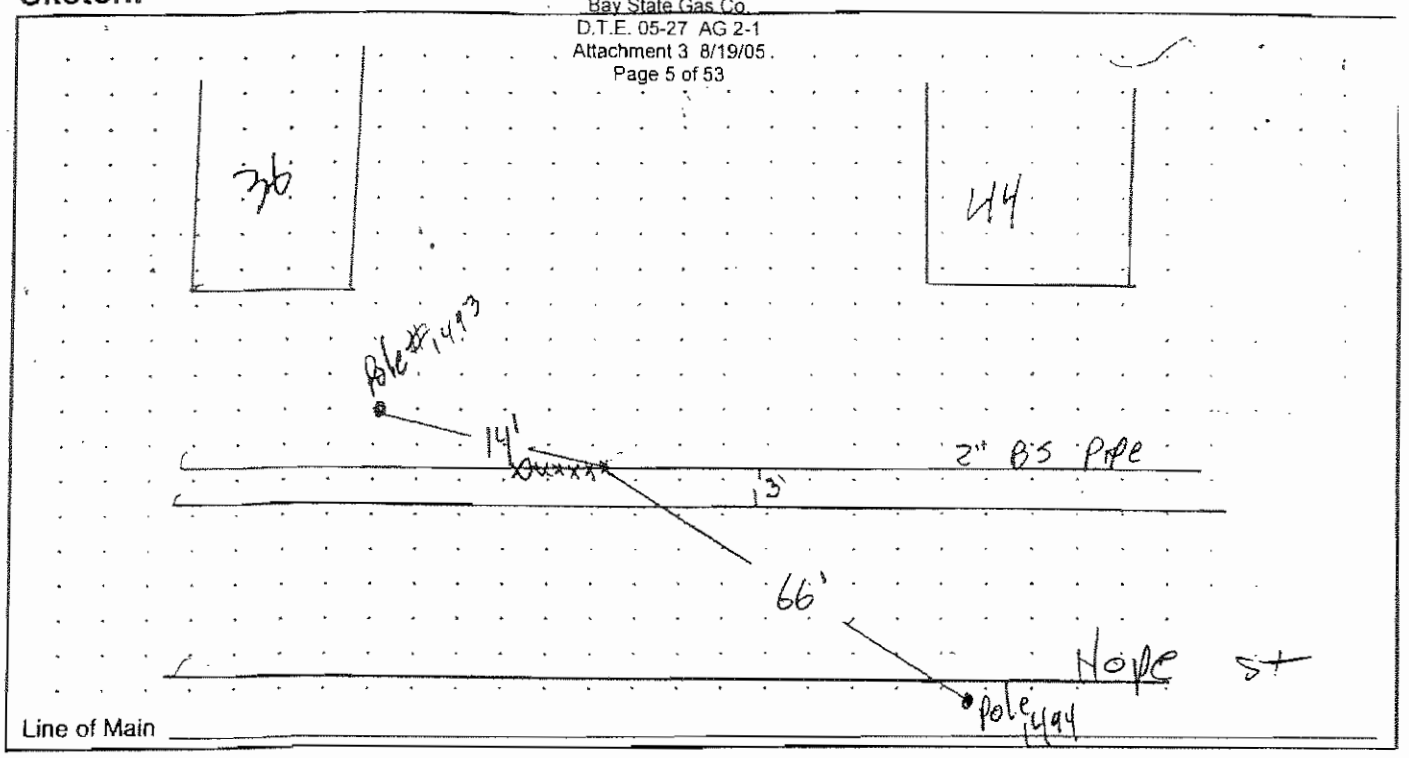
CLASS 2 LEAK STANDBY 60% 12.11.94

very poor Pipe

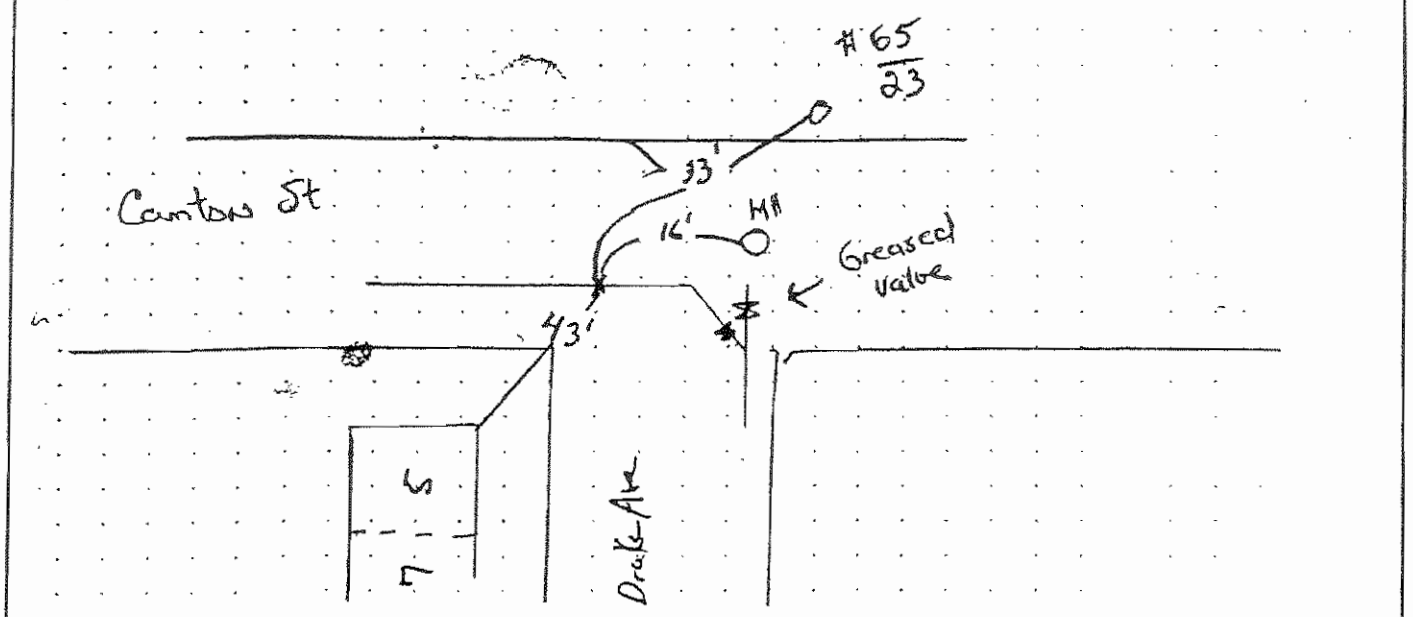
CLASS 2 LEAK STANDBY CALL OUT 30%
12/15/04

Cause of Leak	BSG Crew Assigned
CORR

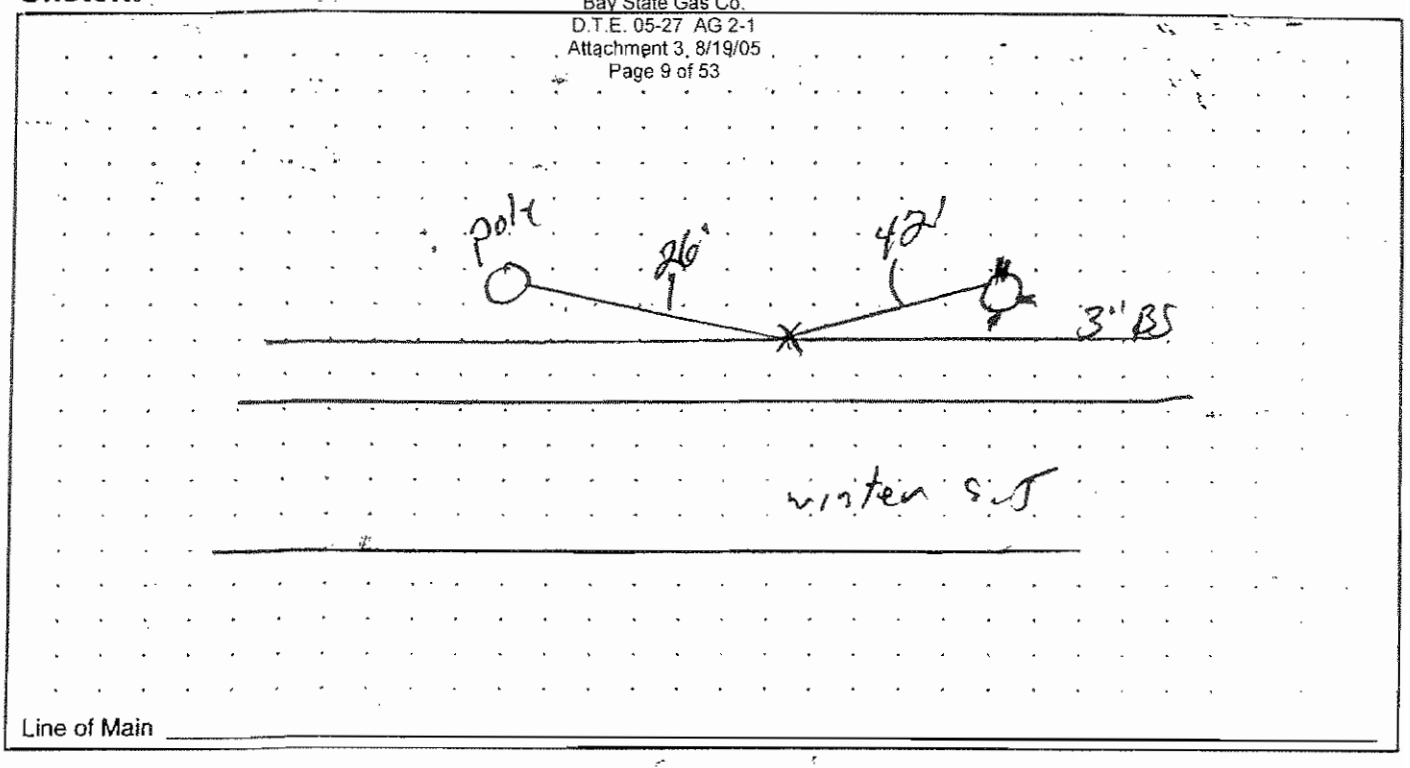
CLASS 2 LEAK POC 40% 2004

Cause of Leak	BSG Crew Assigned
Corr	1764

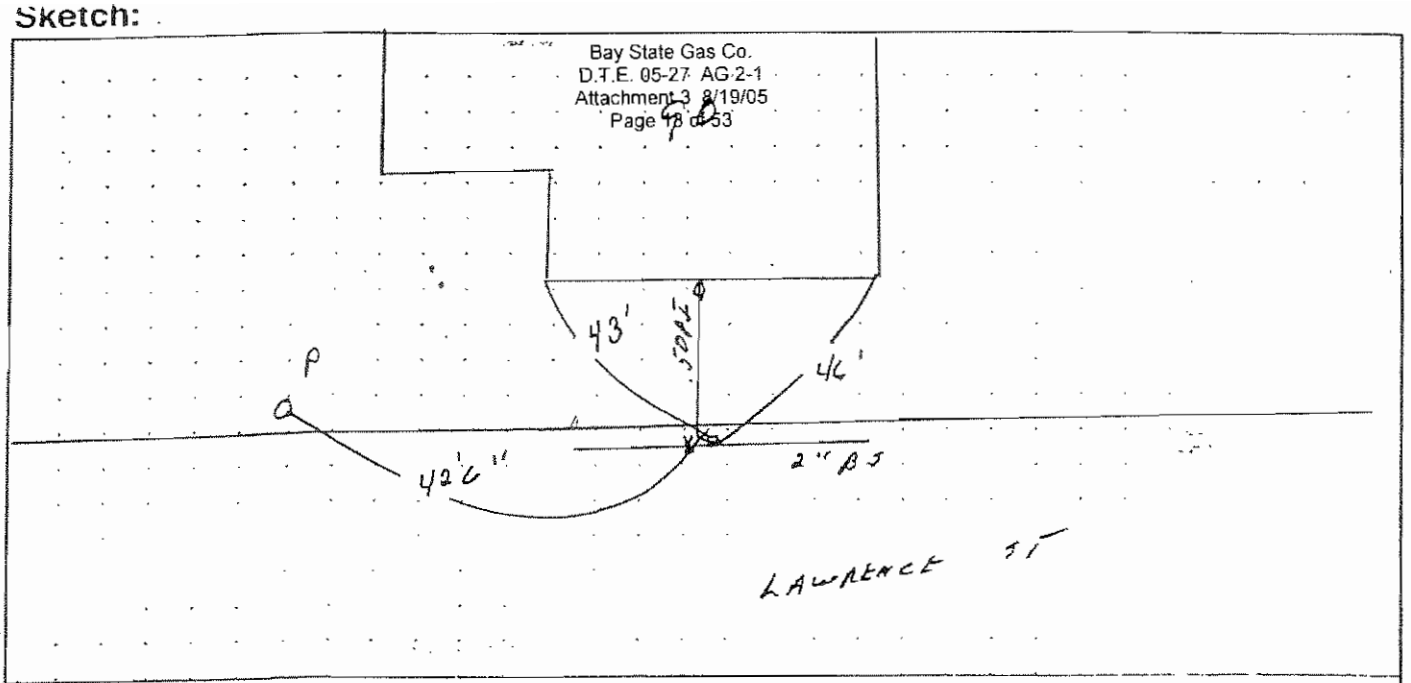
Work Description CLASS 1

Comments: INSTALLED 2" HANDY BAND ON B.S. MAIN

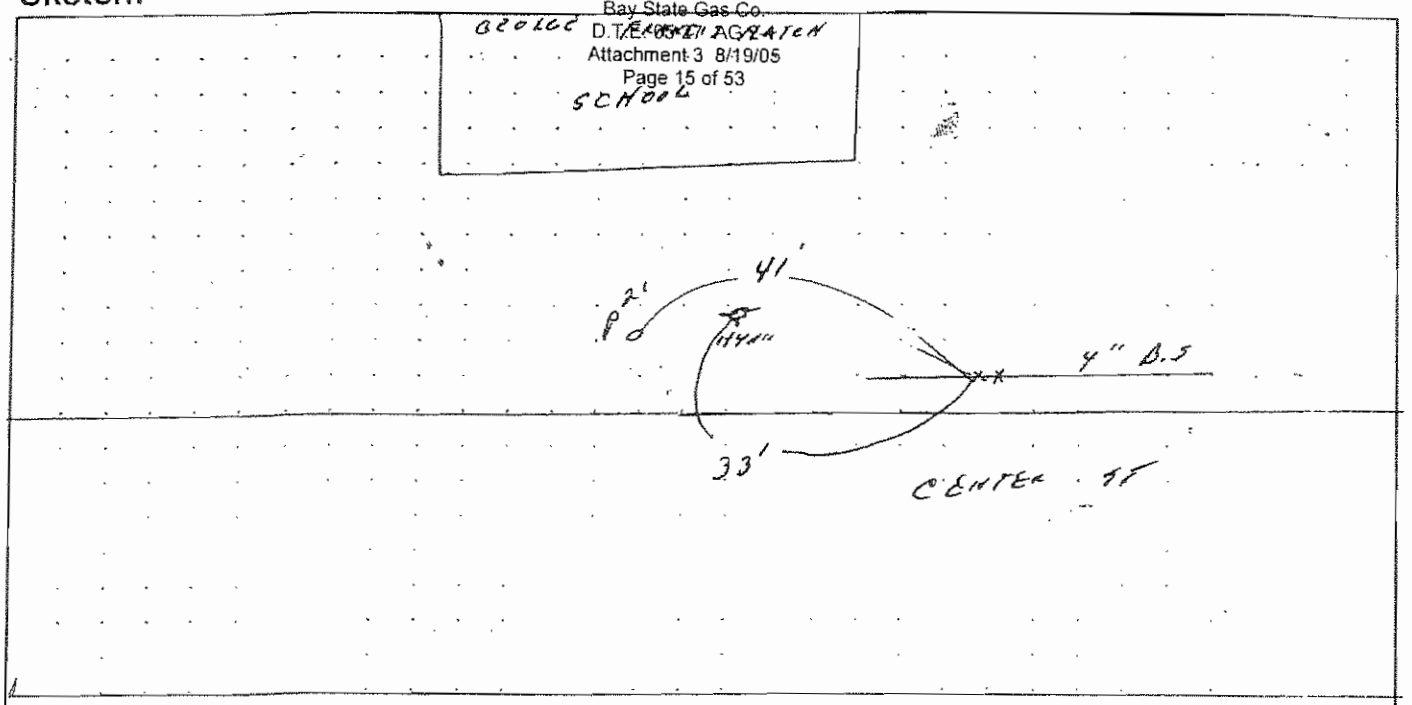
Sketch:

Work Description: STREET LEAK

Leak Priority: HIGH

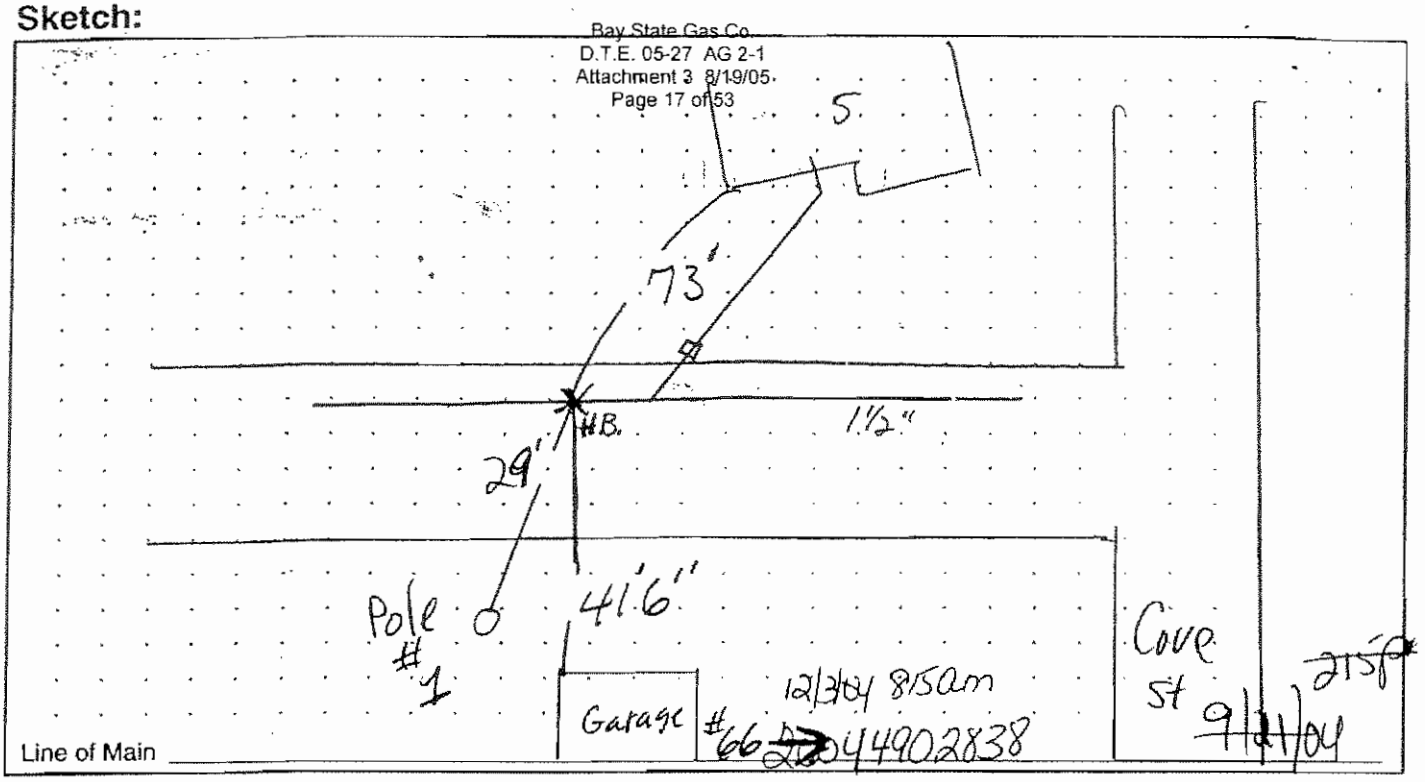
Outgoing Comments:
CLASS 2B LEAK MS 40-50% 2004
P.I LOVERS LN.
COMPLETED
DS

Cause of Leak	BSG Crew Assigned
Corrosion	1382-1433

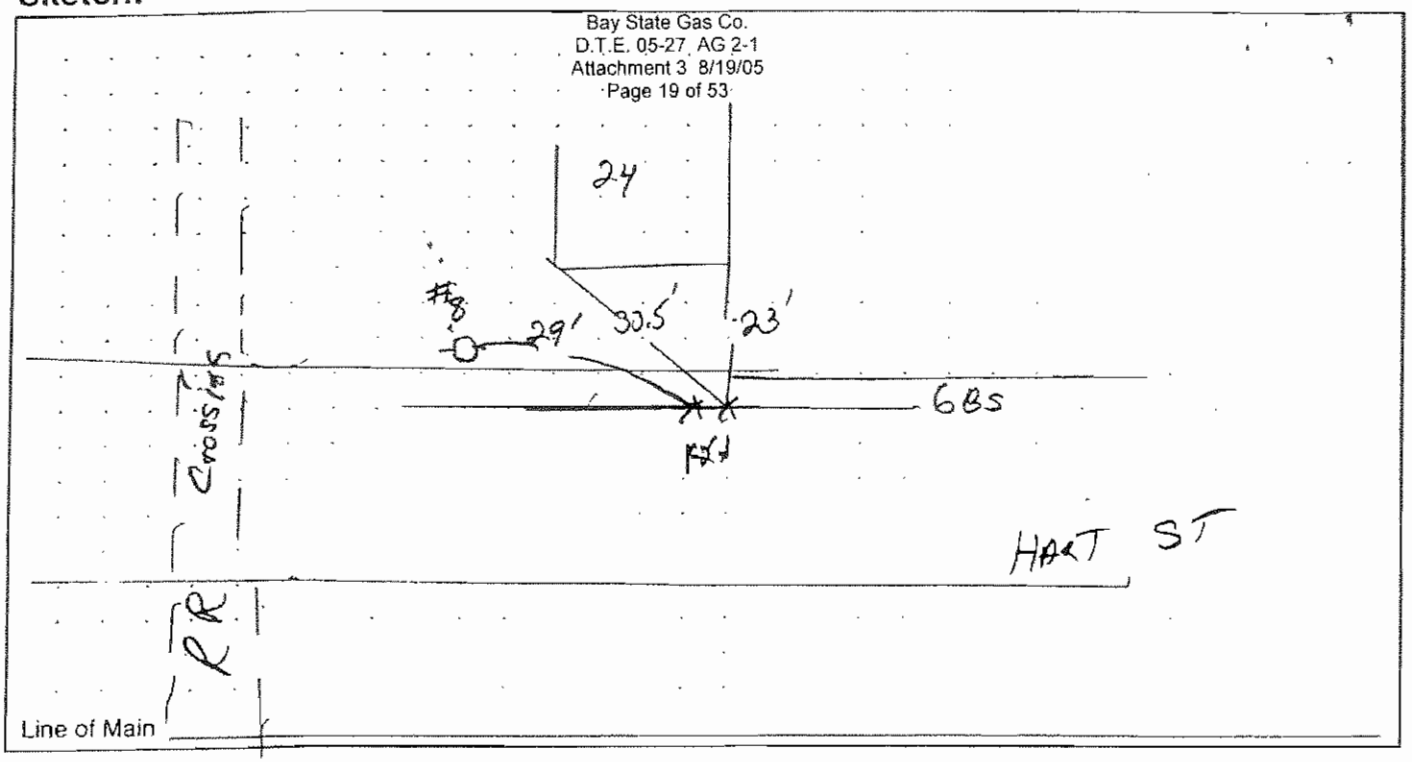
Sketch:

Work Description CLASS 1 LEAK

Cause of Leak CORR

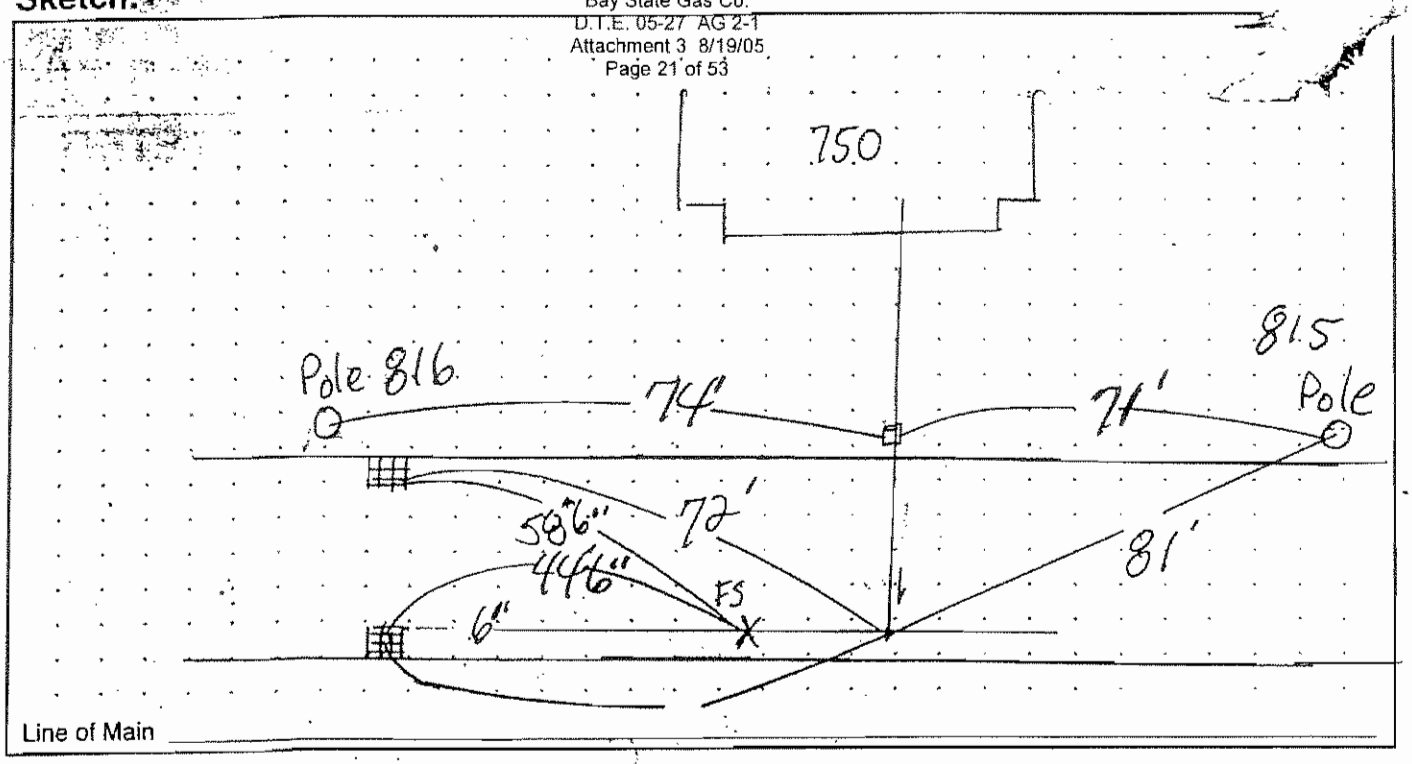
Sketch:

Leak Priority	Employee Assigned
CLASS 2	BAKER, PAUL F
	Maderio

CLASS 2 LEAK [illegible] 2004

Cause of Leak	BSG Crew Assigned
	Standby

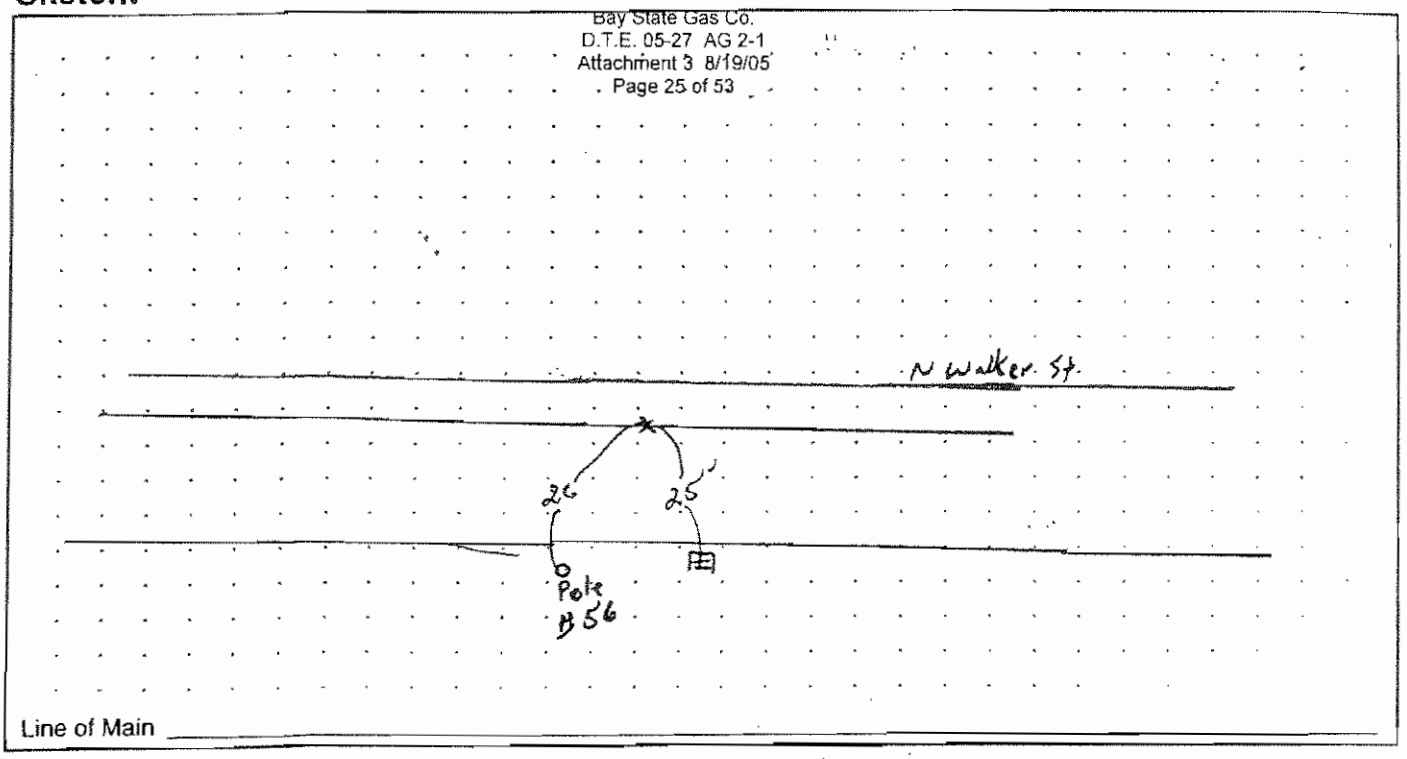
Sketch:

CLASS 2 LEAK STANDBY CALL OUT P
BAKER 80% 2004

Cause of Leak	BSG Crew Assigned
CDW	H Gurney 1126

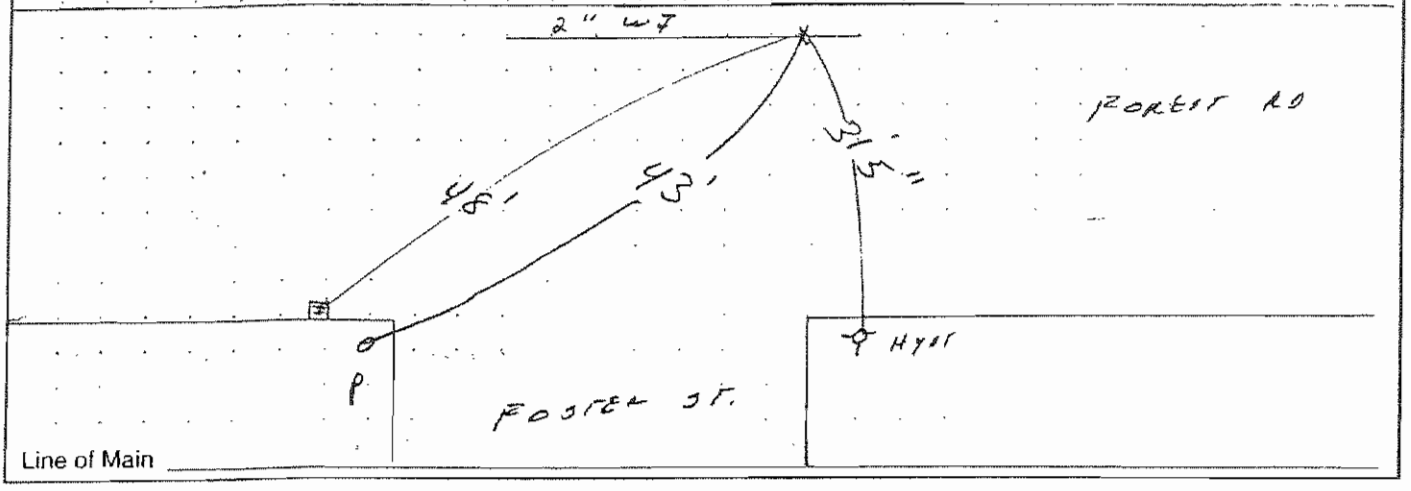
Sketch:

Leak Priority: HIGH

Cause of Leak: CORR

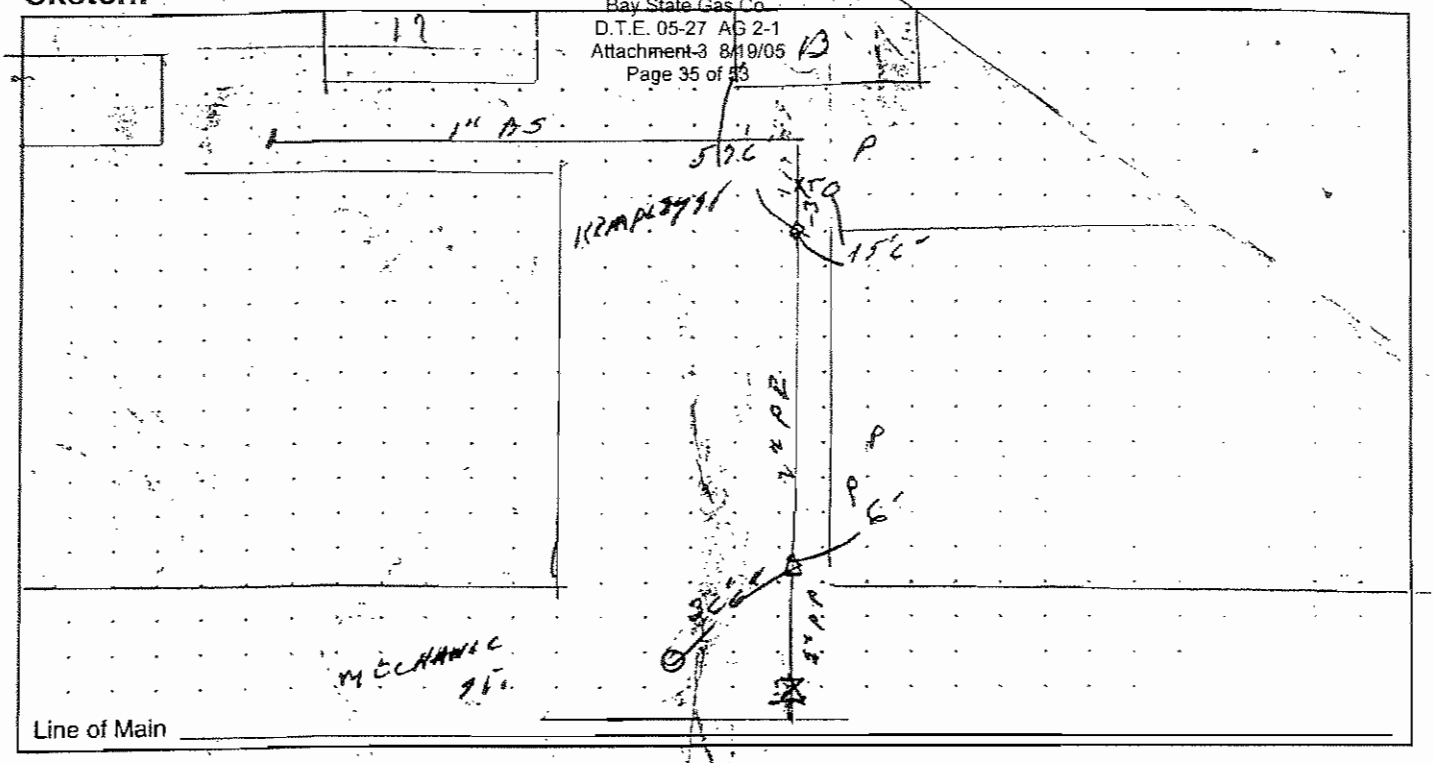
Sketch:

Outgoing Comments: CLASS 2 LEAK 50% POC 2003

Cause of Leak	BSG Crew Assigned
Corr	331

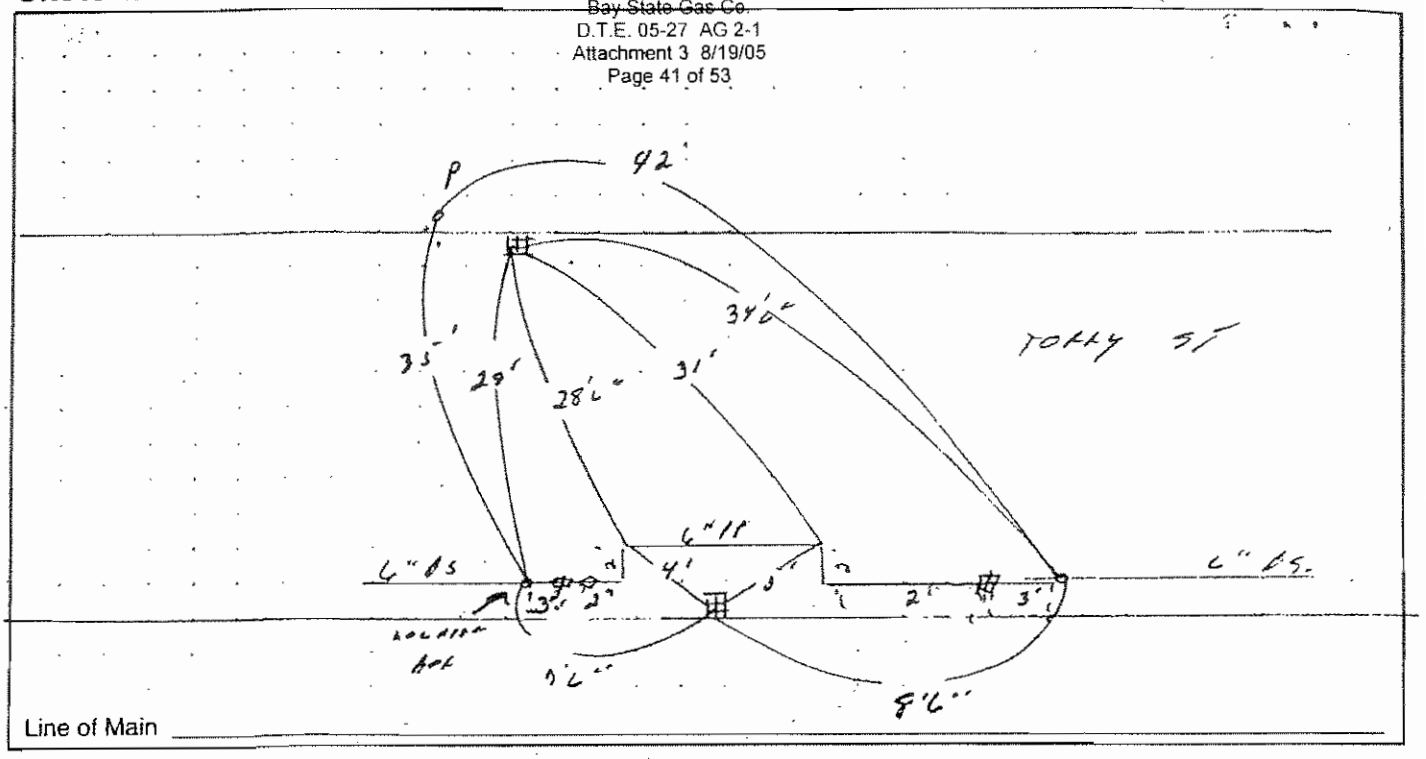
Sketch:

CLASS 2* LEAK - F.I.U. - 03/08/04.
COP

Cause of Leak	BSG Crew Assigned
Corr	353

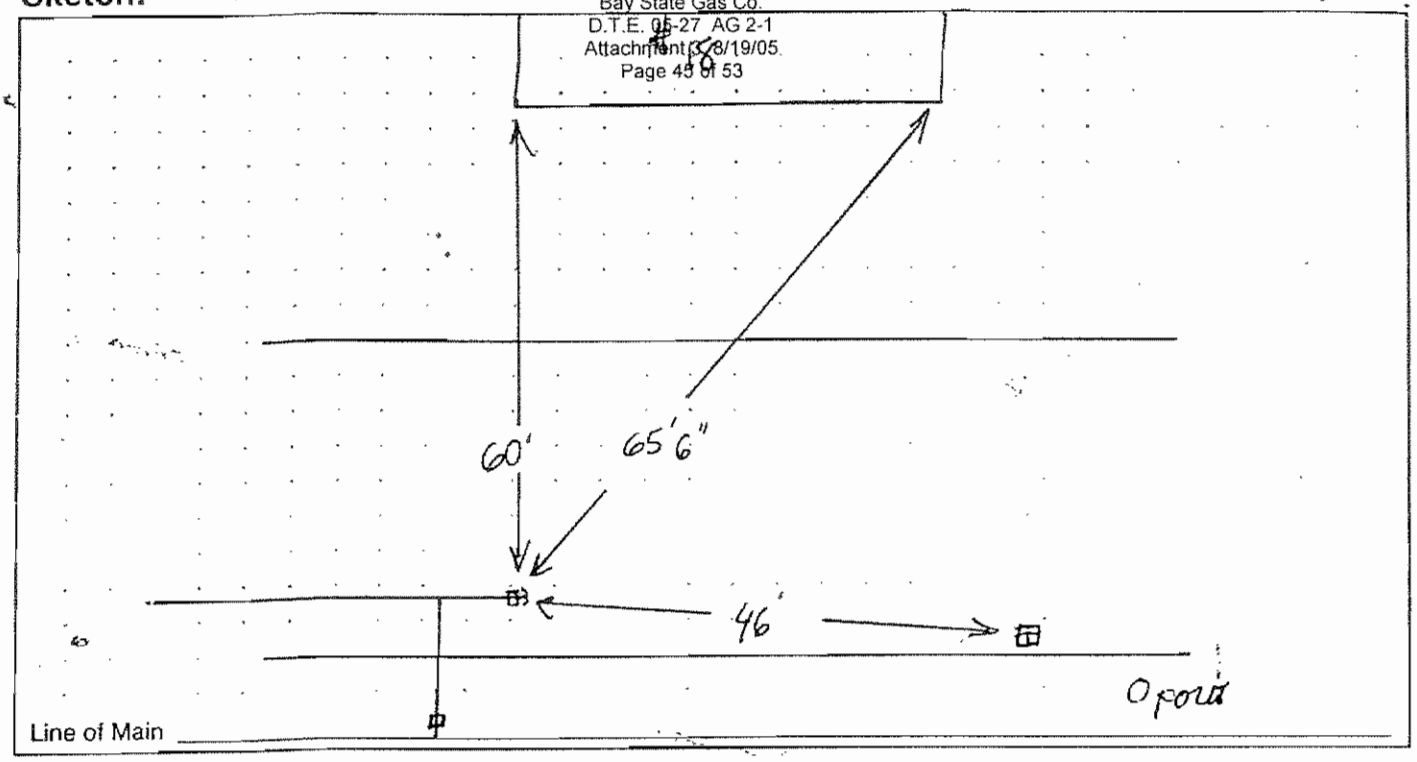
Sketch:

PER DAN BARRETT CLASS 1 50 % MIDDLE OF LAWN 10 % 12 FT FROM FOUNDATION COUPLE OF % AT FOUNDATION

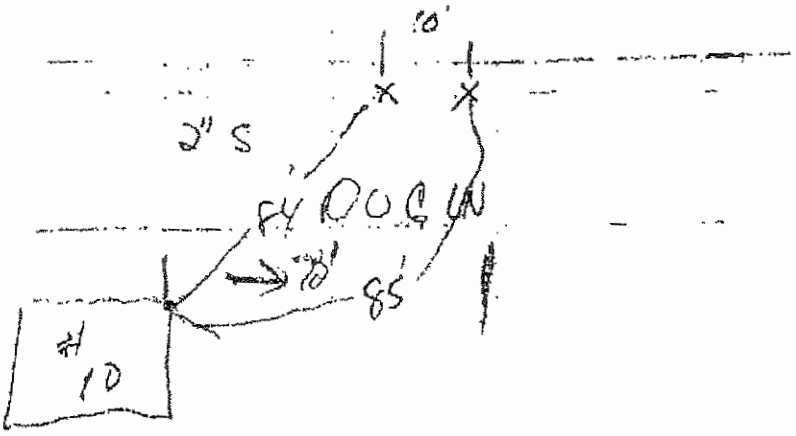
Outgoing Comments	Cause of Leak	BSG Crew Assigned
CLASS 2 LEAK 65% MS 2005	CORR

Comments: Repaired 3 leak on 2" gas main bar test OK
