# Integrated Water Infrastructure Vulnerability Assessment and Climate Resiliency Plan

## TOWN OF CHARLTON & TOWN OF SPENCER, MASSACHUSETTS

JUNE 2019

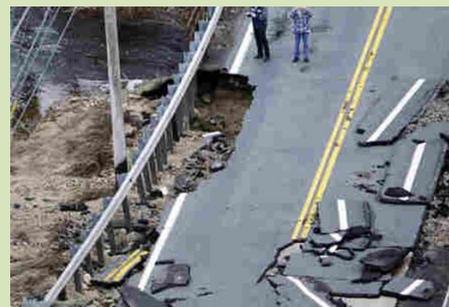
##### *Undersized or Inadequate Crossings*

Undersized or inadequate crossings can restrict natural streamflow during high flows, causing scour and erosion, backing up water and depositing sediment behind the crossing, creating higher flow velocity and erosion downstream, clogging, and washout. Crossings should be large enough to accommodate high flows and to pass fish and other wildlife.

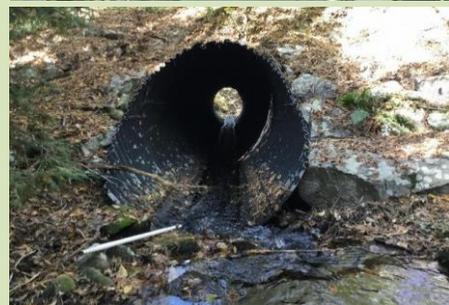
##### *Shallow Crossings*

Shallow crossings have water depths that are too low for many organisms to move through, and the bottom may lack appropriate stream bed material. Crossings should have an open bottom or should be buried into the streambed. Natural substrate should be used within the crossing, it should match the upstream and downstream substrates, and it should resist displacement during floods.

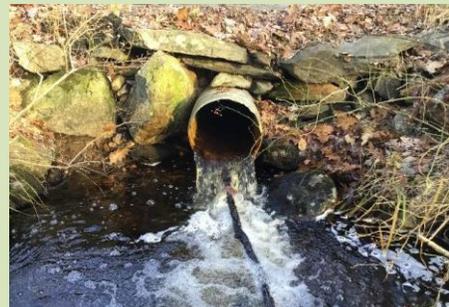
##### *Perched Crossings*

Perched crossings are above the level of the stream bottom at the downstream end, restricting upstream passage by fish and other aquatic organisms and contributing to downstream bed scour. Crossings should be open-bottomed or embedded into the bottom of the stream channel to prevent perching.

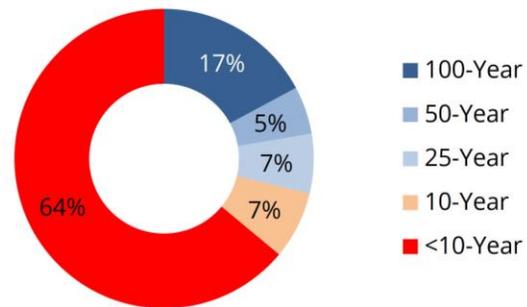
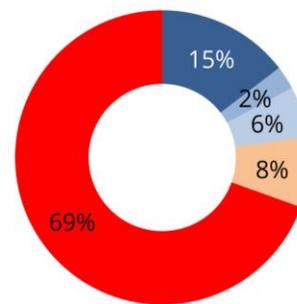
Figure 4-2. Percentage of assessed crossings by existing and future hydraulic capacity ratings.

- **An estimated 64% of the assessed stream crossings are hydraulically undersized relative to their ability to convey the 10-year peak flow. This number increases to 69% for expected future conditions under climate change.** Figure 4-2 shows the percentage of existing and predicted future hydraulic capacity ratings of the assessed stream crossings. Hydraulic capacity rating reflects the largest recurrence interval peak discharge that a structure can convey without failing. Circular pipes and box culverts make up the majority of the hydraulically undersized stream crossings in both towns.

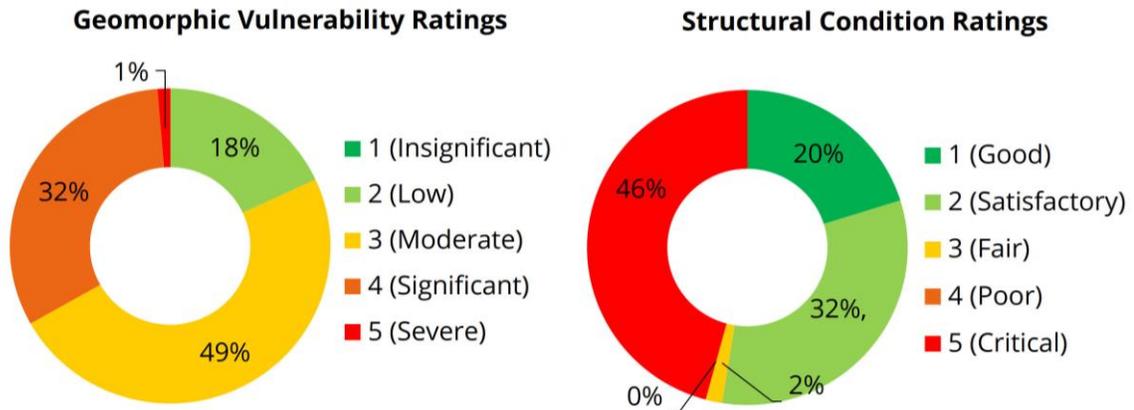
Figure 4-3. Percentage of assessed crossings by geomorphic vulnerability (left) and structural condition (right) ratings.

- **33% of the assessed structures in the two communities have a high geomorphic vulnerability rating (Figure 4-3).** Geomorphic vulnerability of a culvert or bridge refers to the likelihood of potential impacts of the structure on channel stability based on consideration of the physical characteristics of the structure and stream channel. Crossings with the highest geomorphic risk include crossings on Mill Street, May Street, Gold Nugget Road, Marble Road, and Wire Village Road in Spencer and Route 169/Southbridge Road and Stafford Street in Charlton.

- **46% of the assessed structures were rated as critical relative to structural condition, while 52% were rated as either good or satisfactory (Figure 4-3).** Of the ten crossings that rated highest for structural risk based on structural condition and potential for flooding impacts, five are also among the top priority crossings overall. The crossings with the highest (most critical) structural condition ratings are clustered in the Spencer town center area.

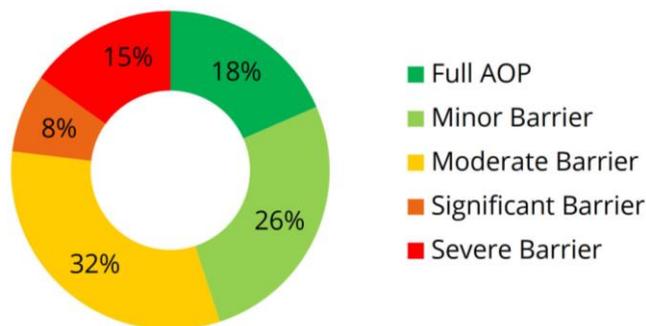
Figure 4-4. Percentage of assessed crossings by aquatic organism passage (AOP) classification.

- 19% of stream crossings within the two towns provide for full passage of aquatic organisms (Figure 4-4).** The percentage of assessed structures that were identified as moderate to severe barriers (55%) to aquatic organism passage is consistent with other regional stream crossing assessments in New England. Bridges generally have the largest openings and provide the greatest continuity, while box culverts and circular pipes are the greatest barriers to aquatic organism passage. Among the 34 crossings with the highest potential AOP benefit scores—that is, crossings which are barriers to aquatic organism passage but which are also at locations where improved passage would have the greatest benefit—25 were also scored as high priority overall. The majority of the crossings with the highest AOP benefit scores are evenly split between the Sevenmile River, Buffumville Lake-Little River, and Cady Brook-Quinebaug River watersheds.

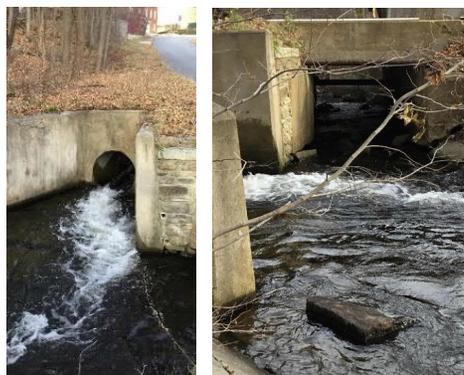
Image 3: View of Valley Street crossing outlet and secondary structure (left) during field assessment on November 12, 2018.

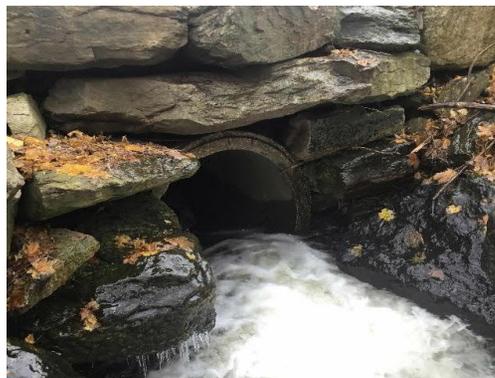
Image 1: View of crossing inlet during field assessment on November 15, 2018.

- Replace the existing undersized culvert with a 12-foot wide open-bottom arch to accommodate the 1.2 times bankfull width design standard of the Massachusetts River and Stream Crossing Standards.
- Reconstruct the stream channel and banks through the crossing to match the existing channel and banks, including stream substrate and slope.
- The proposed culvert replacement design concepts will:
  - Provide increased hydraulic capacity to accommodate peak flows and reduce risks from flooding
  - Reduce the potential for scour and erosion and associated geomorphic risk by reducing constriction

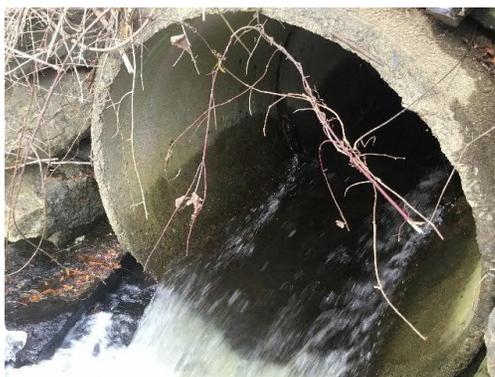
Image 2: View of crossing outlet during field assessment on November 15, 2018.

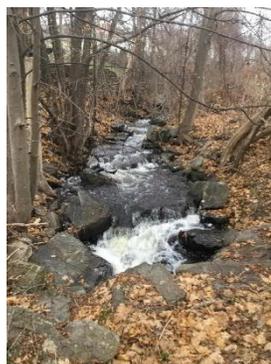
Image 3: View of upstream channel on November 15, 2018.

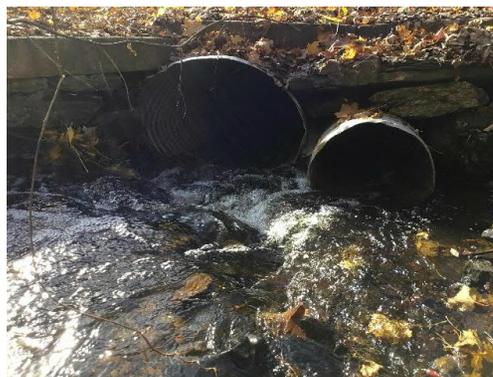
Image 2: View of crossing inlet during field assessment on November 8, 2018.

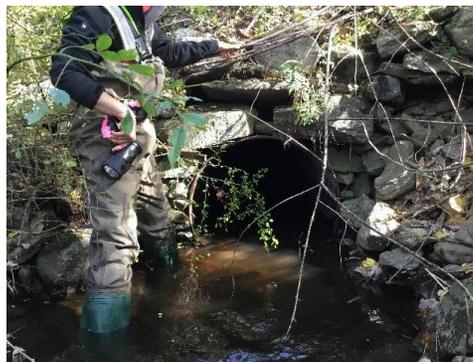
Image 1: View of structure outlet taken during field assessment on October 16, 2018.

- Replace the existing undersized culvert with a 14-foot wide embedded box culvert to accommodate the 1.2 times bankfull width design standard of the Massachusetts River and Stream Crossing Standards. Reconstruct stream banks at the crossing to match the existing stream channel upstream and downstream of the crossing.
- The proposed culvert replacement design concept will:
  - Provide increased hydraulic capacity to reduce flooding risk
  - Improve hydraulic flow through the culvert by replacing the structure with one of uniform shape and material
  - Reduce potential for blockages and accumulated debris at the undersized inlet

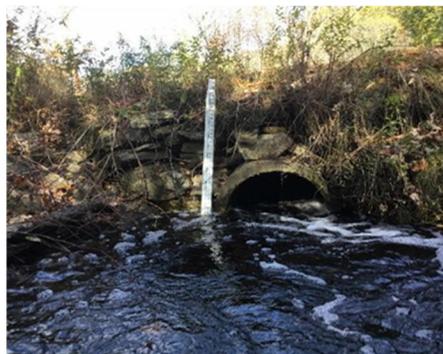
Image 1: View of partially submerged outlet at crossing on Center Depot Road on October 31, 2018.

- Stafford Street:
  - Replace the existing undersized culvert with a 7.5-foot wide open-bottom arch
  - Realign crossing to better match existing stream channel alignment
  - Reconstruct stream banks and channel at and within the crossing to match existing stream channel up and downstream of the crossing
- Center Depot Road:
  - Replace the existing undersized culvert with a 7.5-foot wide embedded box culvert
- The proposed culvert replacement design concepts will:
  - Reduce geomorphic risk at the Stafford Street crossing
  - Protect Stafford Street crossing from outlet scour
  - Eliminate backwater condition at Center Depot Road crossing
  - Provide increased hydraulic capacity
  - Improve aquatic and terrestrial passage

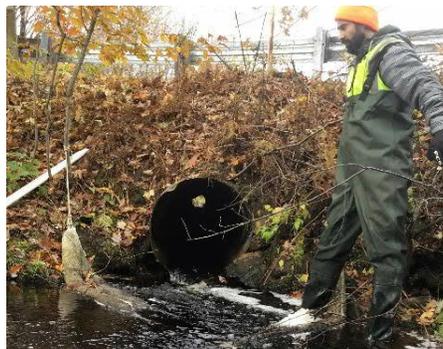
Image 2: View of crossing outlet at the Stafford Street crossing taken on October 29, 2018.

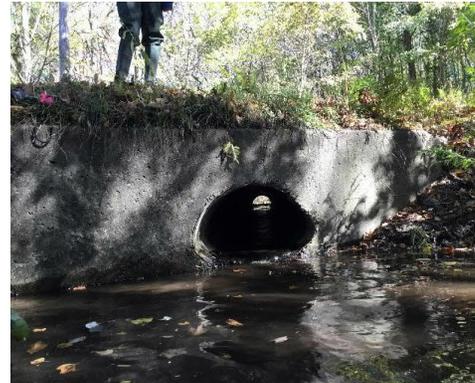
Image 1: View of crossing outlet and scour pool taken during field assessment on October 18, 2018.

- Replace the existing undersized culvert with a 10-foot wide embedded box culvert to accommodate the 1.2 times bankfull width design standard of the Massachusetts River and Stream Crossing Standards. Restore the stream banks and stream channel to repair scour.
- The proposed culvert replacement design concept will:
  - Provide increased hydraulic capacity to reduce risks of flooding
  - Reduce the potential for scour and erosion and associated geomorphic risk by reducing constriction
  - Improve hydrologic connectivity of the upstream and downstream ecosystems

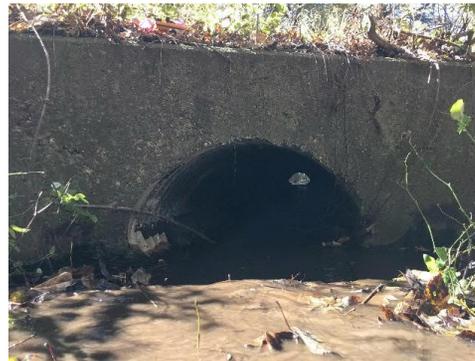
Image 2: View of inlet, October 18, 2018.

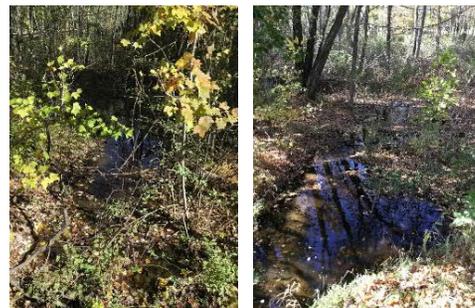
Image 3: View of upstream channel (left) and downstream channel (right) on October 18, 2018.

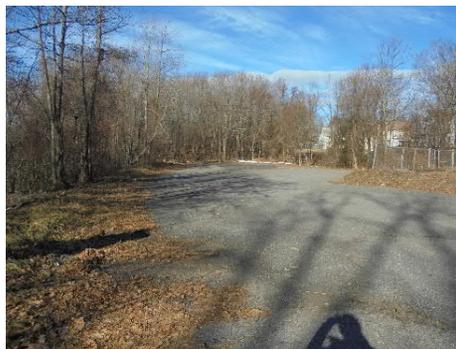
Image 1: Area of proposed pavement removal.

- Assess parking utilization of the upper lot during periods of peak usage and consider reducing impervious cover at the site by removing parking. Consider converting a portion of the upper parking lot to an alternate use or to pervious parking (grass parking, permeable pavers, or similar permeable material suitable for low-traffic applications).

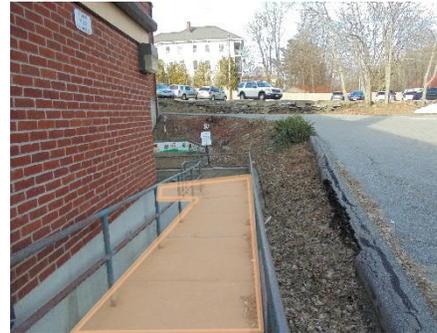
Image 1: View of existing ramp with proposed area of permeable pavers.

- Install permeable pavers to form a crosswalk from the base of the stairs at the edge of the parking lot to the top of the ramp leading to the rear door of the library. If feasible, continue the installation of the permeable pavers down the ramp to the library door. Design the pavers with a color scheme and shape that helps convey their role in stormwater treatment and infiltration. The pavers would reduce stormwater runoff and may increase pedestrian safety in the parking lot.

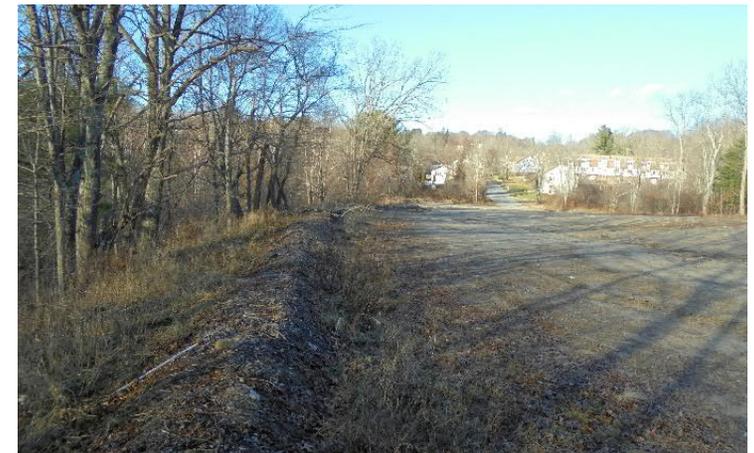
Image 2: Berm of plowed material at the edge of the parking lot.

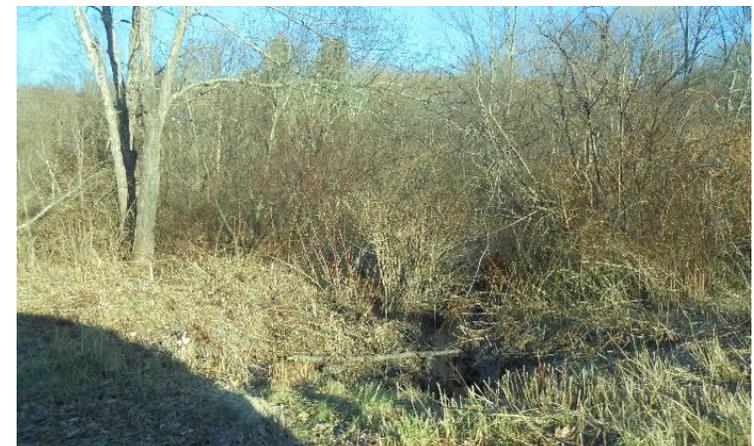
Image 3: Stream at the north end of the project site.
