## MODEL REFINEMENT AND CALIBRATION REPORT

### Appendix A

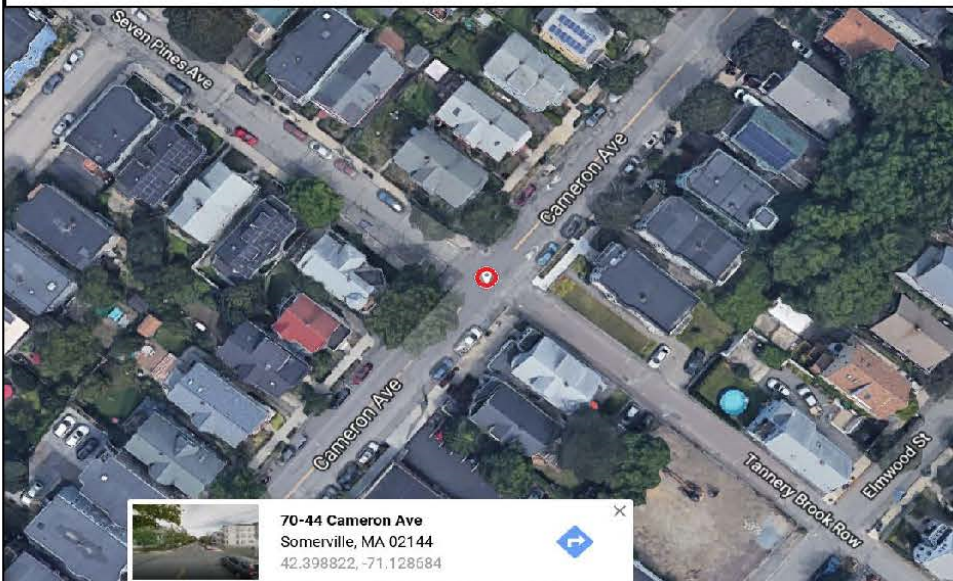
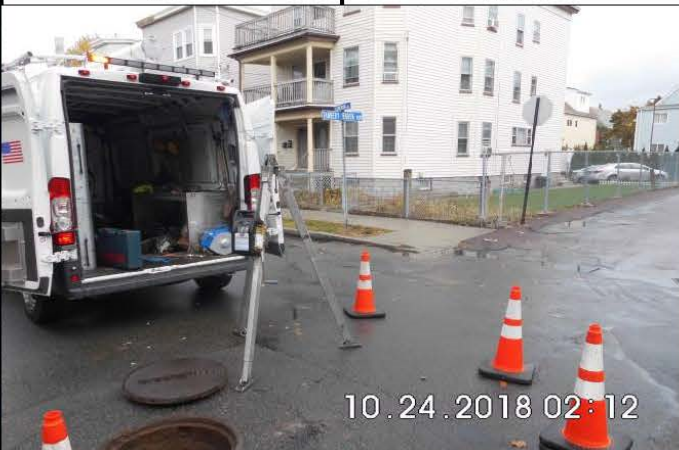
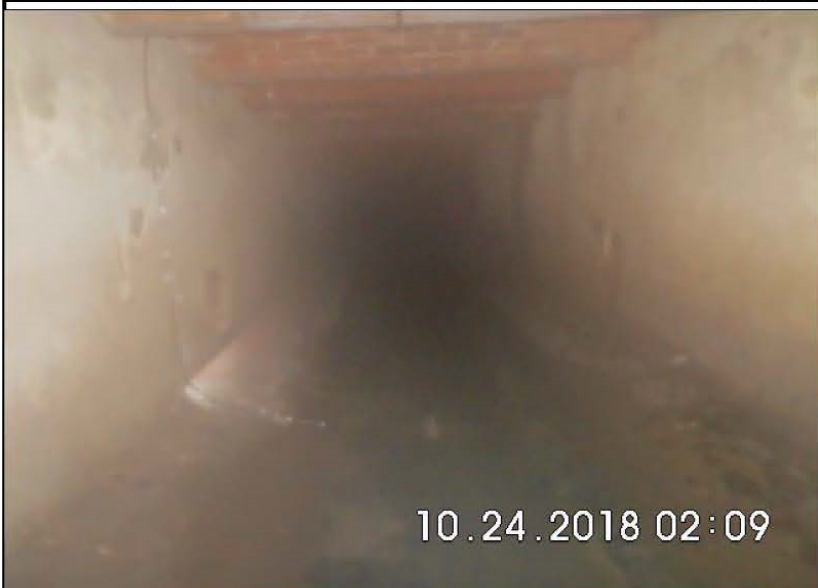
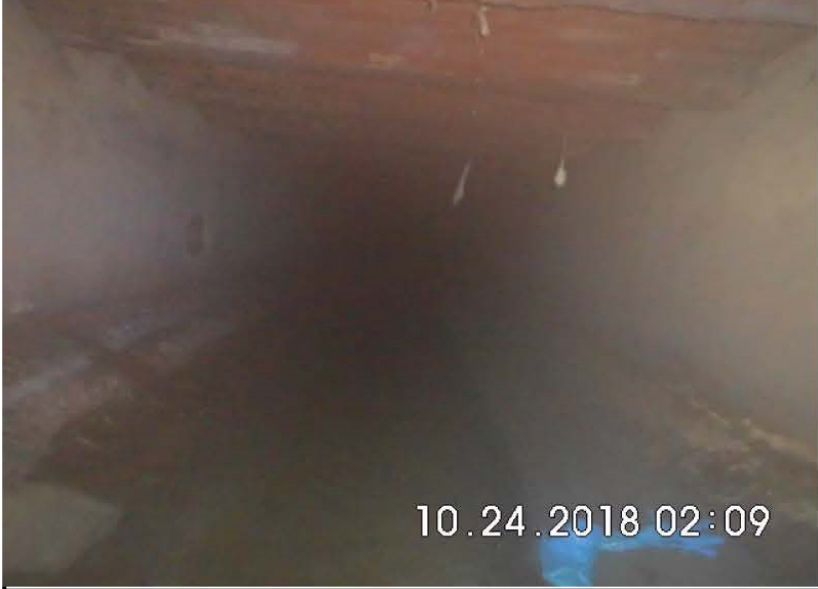
Figure E.8 Tannery Brook (2) Meter Install Report

Peak Velocity (fps) 1.65		Velocity Sensor Offset (in) N/A	
		Silt (in) 0		Silt Type N/A	
		Hydraulic Comments: Low Flow			
		Manhole / Pipe Information:			
		Manhole Depth (Approx. FT): 10		Manhole Configuration Common Trench	
		Manhole Material: Brick		Manhole Condition: Fair	
		Manhole Opening Diameter (in) N/A		Manhole Diameter (Approx.): N/A	
		Manhole Cover Vented		Manhole Frame Normal	
		Active Drop Connections No		Air Quality: Good	
		Pipe Material Concrete		Pipe Condition: Fair	
		Communication Information:			
		Communication Type Serial		Antenna Location Drilled Pavement / Concrete	
		Additional Site Info. / Comments: S/N: 52132 I/P: 107.80.16.192			
ADS Project Name:		Smerville, MA Stantec 18			
ADS Project Number:		32547.11.325

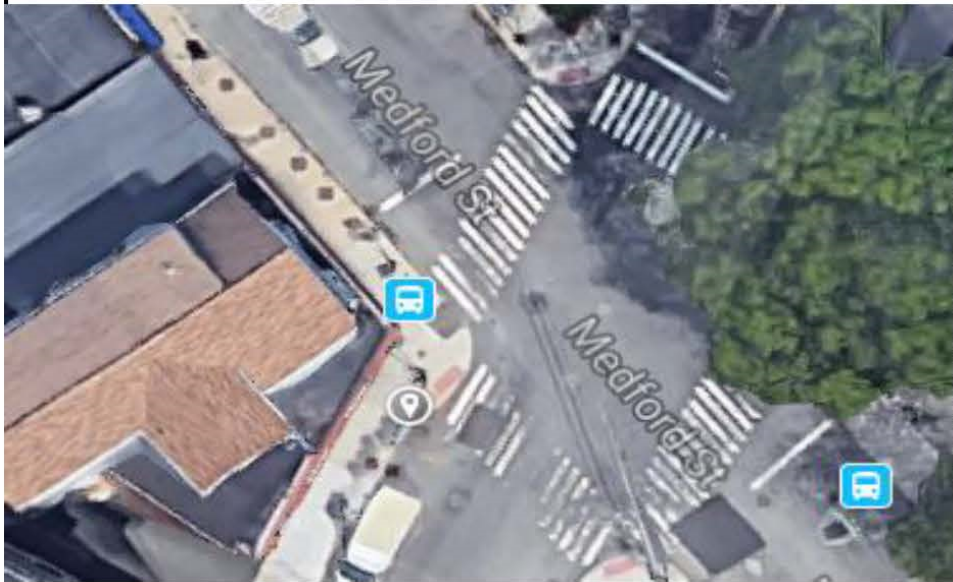
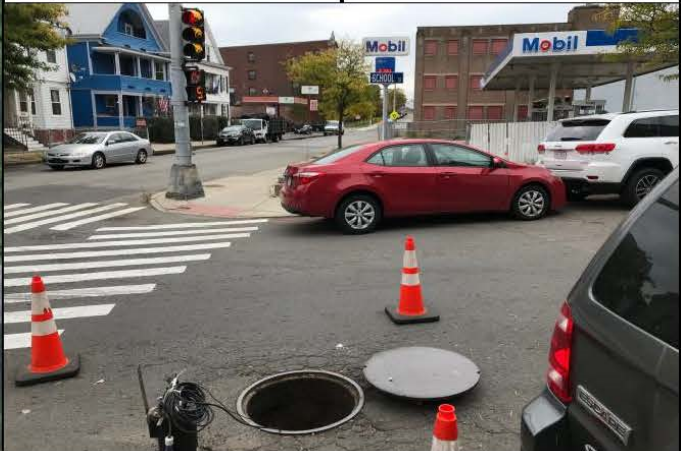
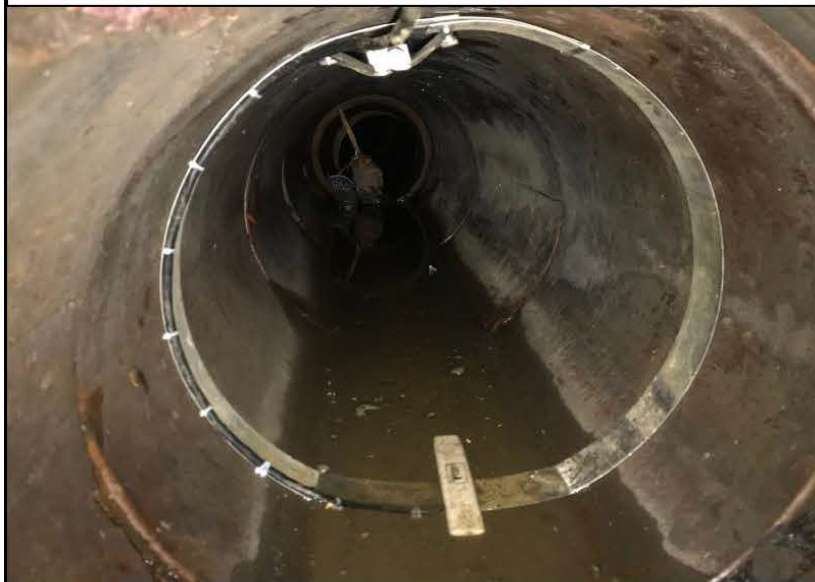
Site I.D.	
Flow Monitoring Site Installation Report			30-5112	
Site Address / Location: School Street At Medford Stree, Somerville, MA		Monitor Series TRITON+	Location Type Temporary	
Site Access: Drive		Pipe Size (H x W) 18.00" X 18.50"	Pipe Shape Elliptical

Silt (in) 0		Silt Type N/A
		Hydraulic Comments: Water Is Usually Stagnant		
		Manhole / Pipe Information:		
		Manhole Depth (Approx. FT): N/A		Manhole Configuration CSO Flow Divider
		Manhole Material: Concrete		Manhole Condition: Good
Manhole Opening Diameter (in) N/A		Manhole Diameter (Approx.): N/A		
Manhole Cover Unbolted		Manhole Frame Normal		
Active Drop Connections No		Air Quality: Safe To Enter		
Pipe Material Concrete		Pipe Condition: Good		
Communication Information:				
Communication Type Wireless		Antenna Location Drilled Pavement / Concrete		
Additional Site Info. / Comments:				
Serial Number: 64702 I.P. 166.219.19.166 Coordinates: N 42.389092 W -71.097266				
ADS Project Name:		Somerville TFM 2018		
ADS Project Number:

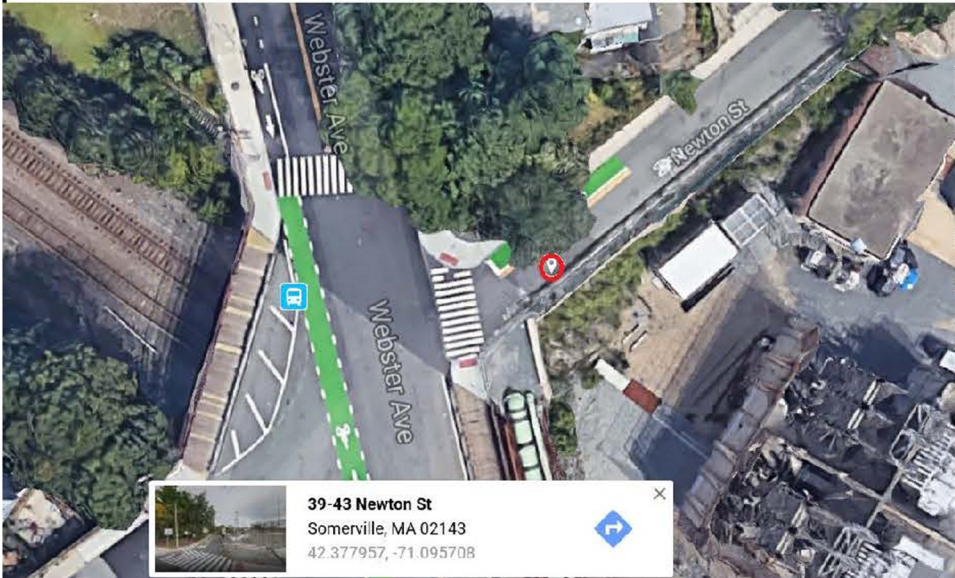
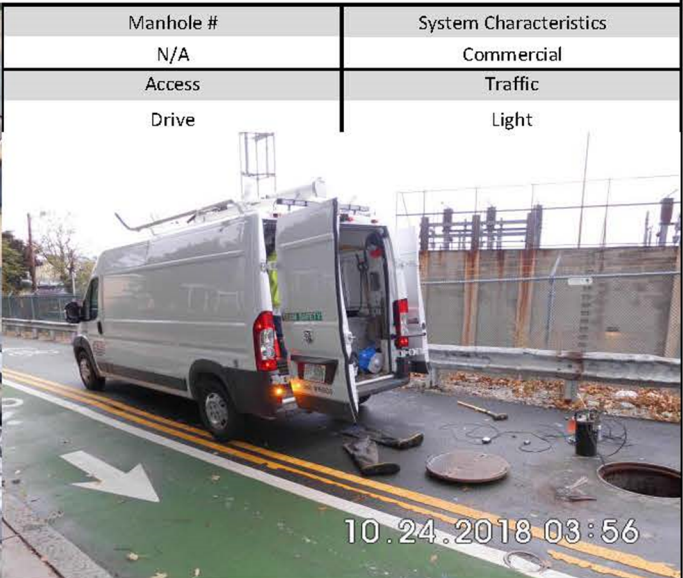
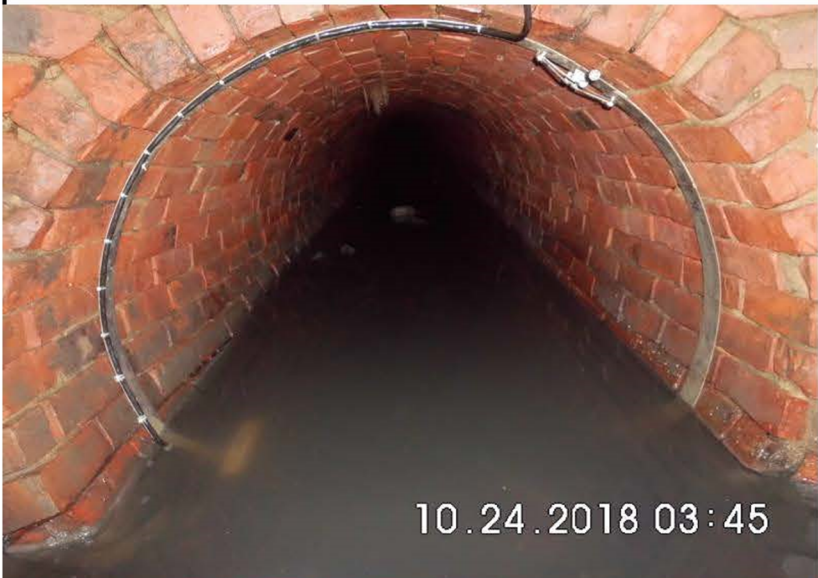
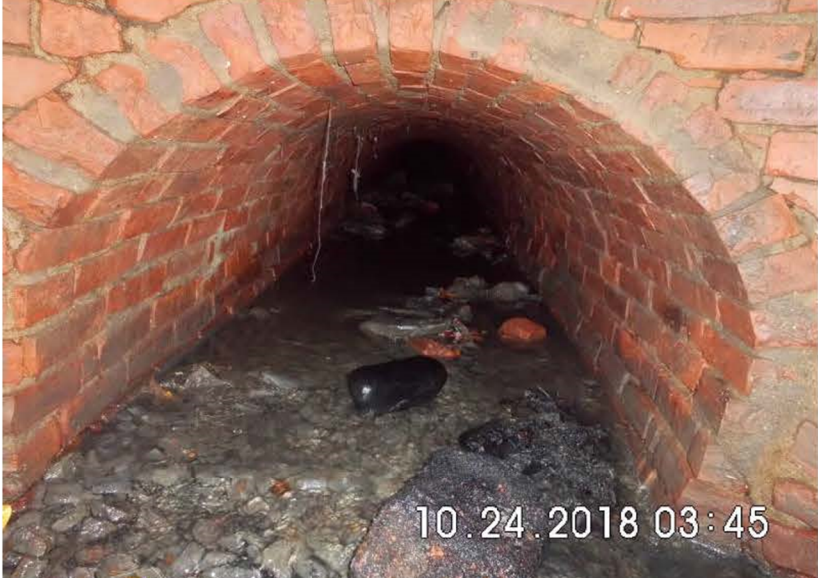
Site I.D.	
Flow Monitoring Site Installation Report				C2-1994 MP1	
Site Address / Location: Webster Ave at Newton St.		Monitor Series TRITON+		Location Type Temporary	
Site Access: Drive, Close Off Newton St.		Pipe Size (H x W) 35.75H x 37.5W		Pipe Shape Elliptical

Peak Velocity (fps) 0.5		Velocity Sensor Offset (in) N/A	
		Silt (in) 2.5		Silt Type N/A	
		Hydraulic Comments: Slow, Smooth Flow, 6.5 P.O.			
		Manhole / Pipe Information:			
		Manhole Depth (Approx. FT): 30		Manhole Configuration Common Trench	
		Manhole Material: Brick		Manhole Condition: Fair	
		Manhole Opening Diameter (in) N/A		Manhole Diameter (Approx.): N/A	
		Manhole Cover Vented		Manhole Frame Normal	
		Active Drop Connections No		Air Quality: Good	
		Pipe Material Concrete		Pipe Condition: Fair	
		Communication Information:			
		Communication Type Serial		Antenna Location Drilled Pavement / Concrete	
		Additional Site Info. / Comments: S/N: 61873 I/P: 107.80.27.184			
ADS Project Name:		Smerville, MA Stantec 18			
ADS Project Number:		32547.11.325

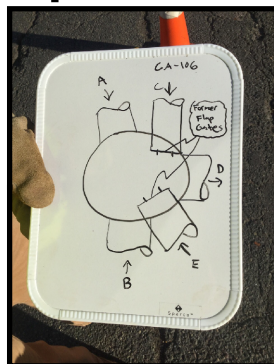
**General Comments:** Corroded Flap Gates on E and C Pipes

**MH Channel Condition:** Fair

Paved- Cracked

Pipe Size	Material	From / To MH#	Invert Depth (from rim)	Flow Depth (from invert)	Debris Depth (from invert)	Condition
A.	36"	Brick	FIT-148	13.89'	12"	8"	Good
B.	Unknown	Brick	CA-341	13.86'	12"	0"	Good
C.	24"	RCP	CA-5209	12.63'	0"	0"	Good
D.	Unknown	Unknown	CA-107	13.92'	12"	8"	Good
E.	24"	RCP	CA-5208	7.86'	0"	4"	Good
F.							
G.							
H.

**Recommendations-** Clean/Remove Debris from invert

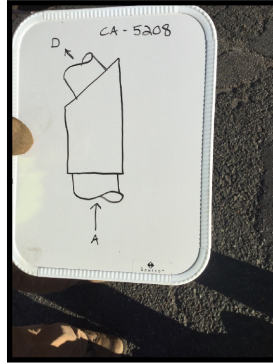
MH# CA-5208

Paved- Cracked

Pipe Size	Material	From / To MH#	Invert Depth (from rim)	Flow Depth (from invert)	Debris Depth (from invert)	Condition
A.	48"	RCP	CA-5207	8.64'	3"	0"	Good
B.							
C.							
D.	24"	RCP	CA-106	8.54'	2"	1"	Good
E.							
F.							
G.							
H.

**Recommendations- Clean/Remove Depris from invert**

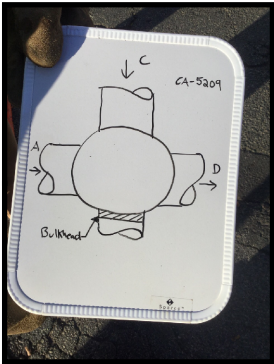
MH#CA-5209

Area Around MH Condition:  
Paved- Cracked

MH Condition:  
Good

Pipe Size	Material	From / To MH#	Invert Depth (from rim)	Flow Depth (from invert)	Debris Depth (from invert)	Condition
A.	36"	RCP	CA-5210	8.70'	<1"	0"	Good
B.							
C.	Unknown	Unknown	CA-5212	12.05'	<1"	0"	Good
D.	Unknown	RCP	A-5351	12.30'	<1"	0"	Good
E.							
F.							
G.							
H.

Recommendations- No Action
