*Massachusetts Coastal Infrastructure
Inventory and Assessment Project
Coastal Hazards Commission*

South Coastal

Fairhaven
Mattapoissett
Marion
Wareham

July 6, 2009

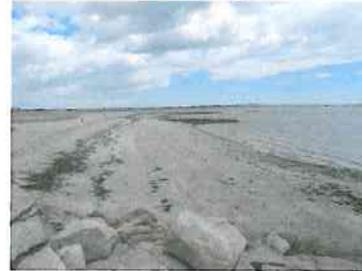
Coarse sandy beach with dune, park and picnic area behind it. Two groins are stablizing beach is there is no sign of erosion.

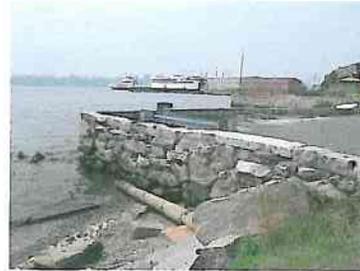
The stone block mortared seawall has a street located behind it. There stones that make up the wall are approximately 2 feet by 1 foot on average. There are areas of mortar loss throughout. There is no visible scour.

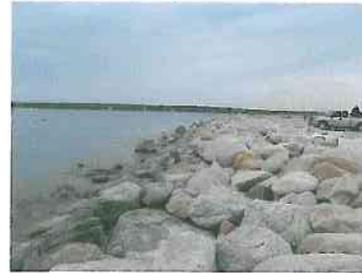
The stone revetment is in good condition. There is parking around the lighthouse. Revetment consists of large 3 to 4 feet stones. There are no signs of erosion or stone movement.

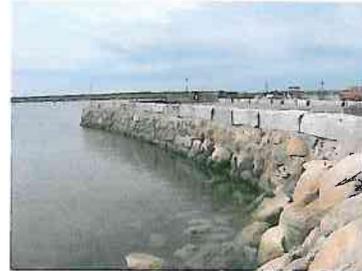
A filled wharf in fair condition. Mortar filled joints above mean high water. No mortar observed below mean high water mark. There are signs of minor stone movement.

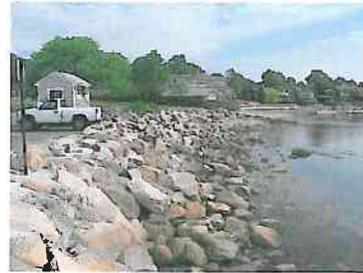
The stone revetment is in good condition. There is some concrete fill along the top edge. The revetment consists of 12 inches to 24 inches of dumped stone. There is a parking lot located along the top edge.

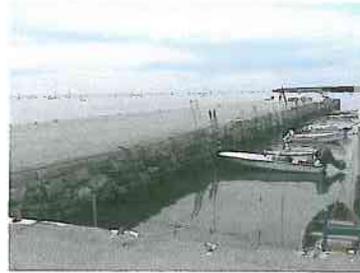
The filled wharf has a stone dry stack wall around its perimeter in fair condition. Stones are rounded with no chinking stone to fill voids. Walls are 3 feet wide at the top with signs of maintenance repair of filling the top voids with concrete.

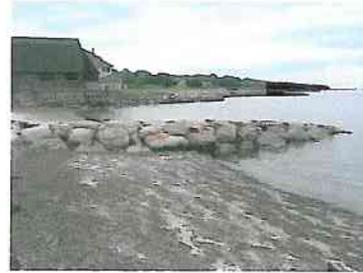
The stone groin is in good condition. Groin consists of 2 feet stones with no sign of erosion or movement.

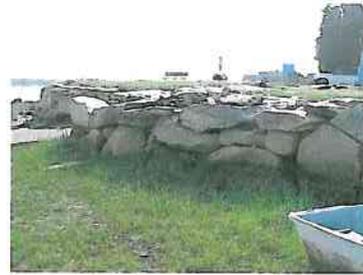
The stone wall is in good condition. There is a parking area and boat ramp located near it. Wall edges parking area. At high water the wall is 2 feet wide and under 5 feet in height.

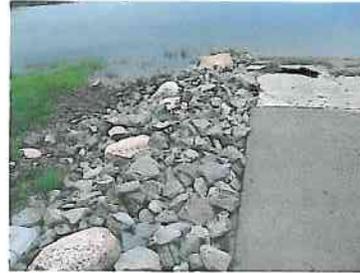
| <i>Description</i> | Structure observed to exhibit very minor problems, superficial in nature. Minor erosion to landform is present. Structure / landform adequate to provide protection from a major coastal storm with no damage. Actions taken to prevent / limit future deterioration and extend life of structure. | <i>Description</i> | No Inshore Structures or Residential Dwelling Units Present |

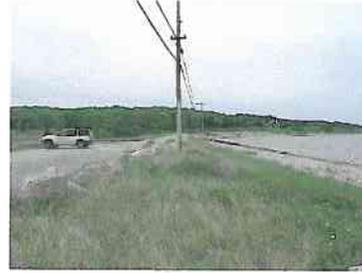
There is a stone revetment along the edge of the road. The top of the stone is flush with grade. The revetment is set at a very gradual grade to the beach. The road is the only access for residential area.

| <i>Description</i> | Like new condition. Structure expected to withstand major coastal storm without damage. Stable landform (beach, dune or bank). Adequate system exists to provide protection from major coastal storm. |

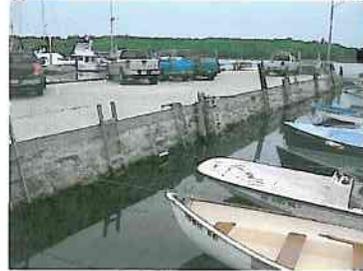
Two filled wharfs with a mortar stone wall around the perimeter capped with a concrete deck. There are no signs of settlement or loss of fill. Mortared joints exhibit minor spalling. No loss of stone observed

| <i>Description</i> | Structure observed to exhibit very minor problems, superficial in nature. Minor erosion to landform is present. Structure / landform adequate to provide protection from a major coastal storm with no damage. Actions taken to prevent / limit future deterioration and extend life of structure. | <i>Description</i> | No Inshore Structures or Residential Dwelling Units Present |

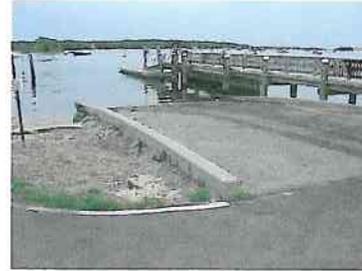
Structure Summary :
 The boat ramp includes a concrete wall along the edge of it with a stone revetment. 12 inch to 18 inch high concrete wall provides curb down the sides of the boat ramp. The 12 inch revetment stones are found along the base of the walls. No signs of erosion or movement.

| <i>Description</i> | Like new condition. Structure expected to withstand major coastal storm without damage. Stable landform (beach, dune or bank). Adequate system exists to provide protection from major coastal storm. | <i>Description</i> | No Inshore Structures or Residential Dwelling Units Present |

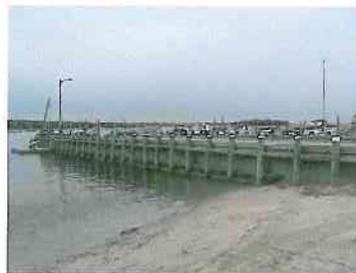
Filled wharf with a steel bulkhead and concrete wall around the perimeter. There is no settlement or wall movement observed. There is minor cracking on the concrete wall.

| <i>Description</i> | Structure is sound but may exhibit minor deterioration, section loss, cracking, spalling, undermining, and/or scour. Structure adequate to withstand major coastal storm with little to moderate damage. Actions taken to reinforce structure to provide full protection from major coastal storm and for extending life of structure. Moderate wind or wave damage to landform exists. Landform may not be sufficient to fully protect shoreline during a major coastal storm. Actions taken to provide addition material for full protection and extended life. | <i>Description</i> | No Inshore Structures or Residential Dwelling Units Present |

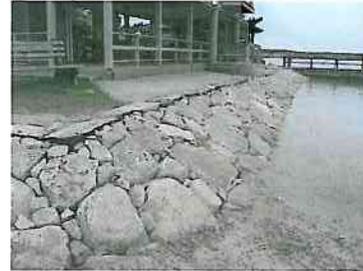
| <i>Description</i> | Like new condition. Structure expected to withstand major coastal storm without damage. Stable landform (beach, dune or bank). Adequate system exists to provide protection from major coastal storm. | <i>Description</i> | No Inshore Structures or Residential Dwelling Units Present |

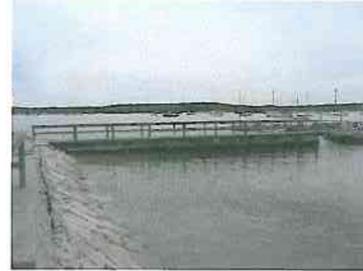
| <i>Description</i> | Structure is sound but may exhibit minor deterioration, section loss, cracking, spalling, undermining, and/or scour. Structure adequate to withstand major coastal storm with little to moderate damage. Actions taken to reinforce structure to provide full protection from major coastal storm and for extending life of structure. Moderate wind or wave damage to landform exists. Landform may not be sufficient to fully protect shoreline during a major coastal storm. Actions taken to provide addition material for full protection and extended life. | <i>Description</i> | No Inshore Structures or Residential Dwelling Units Present |

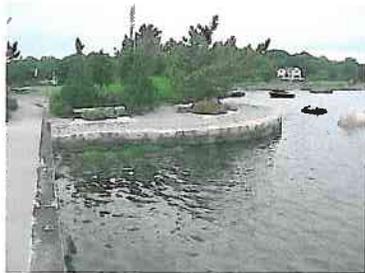
Structure Summary :
 The stone wall is in fair condition. There is loss of fill behind and throughout the wall. Portions of the wall have concrete fill behind it, but there are still signs of fill loss. The wall is 2 feet wide at the top.

| <i>Description</i> | Structure is sound but may exhibit minor deterioration, section loss, cracking, spalling, undermining, and/or scour. Structure adequate to withstand major coastal storm with little to moderate damage. Actions taken to reinforce structure to provide full protection from major coastal storm and for extending life of structure. Moderate wind or wave damage to landform exists. Landform may not be sufficient to fully protect shoreline during a major coastal storm. Actions taken to provide addition material for full protection and extended life. | <i>Description</i> | No Inshore Structures or Residential Dwelling Units Present |

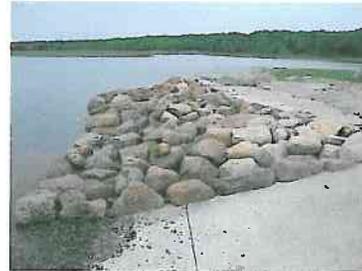
The stone revetment is in good condition. There is a parking area at the boat ramp. The revetment consists of 18 inch to 24 inch stones that are on a gradual slope. There are no signs of erosion or stone movement.

| <i>Description</i> | Structure observed to exhibit very minor problems, superficial in nature. Minor erosion to landform is present. Structure / landform adequate to provide protection from a major coastal storm with no damage. Actions taken to prevent / limit future deterioration and extend life of structure. | <i>Description</i> | No Inshore Structures or Residential Dwelling Units Present |

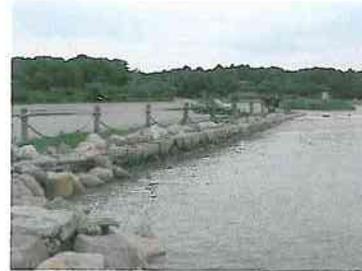
Stone wall located at the edge of the beach along the parking area. The wall consists of dry stack stones that are 2 feet wide and 2 to 3 feet in height.

Structure is sound but may exhibit minor deterioration, section loss, cracking, spalling, undermining, and/or scour. Structure adequate to withstand major coastal storm with little to moderate damage. Actions taken to reinforce structure to provide full protection from major coastal storm and for extending life of structure. Moderate wind or wave damage to landform exists. Landform may not be sufficient to fully protect shoreline during a major coastal storm. Actions taken to provide addition material for full protection and extended life.

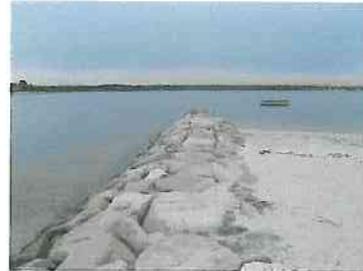
The stone groin on the beach is in good condition. The stons are approximately 3 feet by 2 feet by 4 feet in size. The top width of the groin is 4 feet. There are no signs of erosion or stone movement.

Condition A
Rating Excellent
Level of Action None
Description Like new condition. Structure expected to withstand major coastal storm without damage. Stable landform (beach, dune or bank). Adequate system exists to provide protection from major coastal storm.

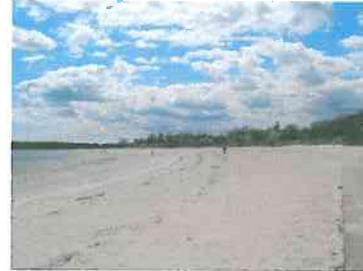
Primary Type: Coastal Beach
 Primary Material: Sand
 Primary Height: 5 to 10 Feet

| <i>Description</i> | Structure observed to exhibit very minor problems, superficial in nature. Minor erosion to landform is present. Structure / landform adequate to provide protection from a major coastal storm with no damage. Actions taken to prevent / limit future deterioration and extend life of structure. | <i>Description</i> | Inshore Structures Present with Limited potential for Significant Infrastructure Damage |

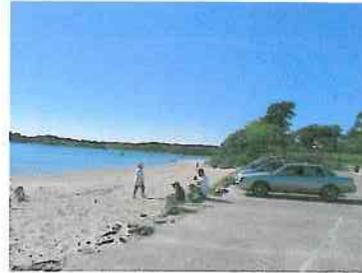
Structure is sound but may exhibit minor deterioration, section loss, cracking, spalling, undermining, and/or scour. Structure adequate to withstand major coastal storm with little to moderate damage. Actions taken to reinforce structure to provide full protection from major coastal storm and for extending life of structure. Moderate wind or wave damage to landform exists. Landform may not be sufficient to fully protect shoreline during a major coastal storm. Actions taken to provide addition material for full protection and extended life.

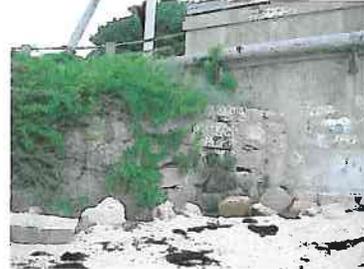
The stone block seawall has stones that are approximately 4 feet by 1 foot by 2 feet in size. The stones have been mortared together. Most of the mortar has fallen out. The stones have moderate signs of rotation and settling. The riprap at the base of the wall is mostly buried or missing. The stones average 3 feet by 2 feet by 1 foot in size.

Structure is sound but may exhibit minor deterioration, section loss, cracking, spalling, undermining, and/or scour. Structure adequate to withstand major coastal storm with little to moderate damage. Actions taken to reinforce structure to provide full protection from major coastal storm and for extending life of structure. Moderate wind or wave damage to landform exists. Landform may not be sufficient to fully protect shoreline during a major coastal storm. Actions taken to provide addition material for full protection and extended life.

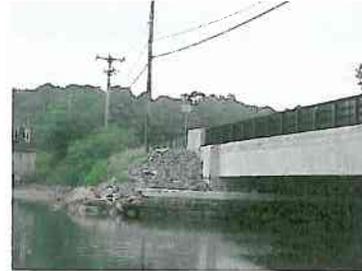
The stone block seawall has stones that average 3 feet by 2 feet by 2 feet in size. The stones have been placed tightly together and have a concrete cap. The wall is approximately 4 feet wide. Behind the wall is dumped riprap with on average 100 pound stones. The stones are at a 1 on 2 slope. There is no visible scour. There is minor section loss. Behind the structures is the bridge abutment for the bridge over East River.

Structure observed to exhibit very minor problems, superficial in nature. Minor erosion to landform is present. Structure / landform adequate to provide protection from a major coastal storm with no damage. Actions taken to prevent / limit future deterioration and extend life of structure.

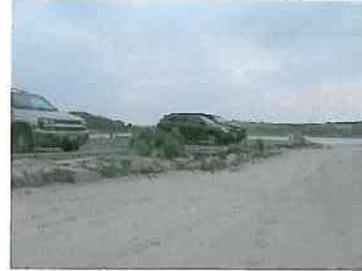
The stone block seawall is made up of stones that are 2 feet by 1 foot by 1 foot in size. The stones have been mortared together. Most of the wall has collapsed and failed. There is a sandy beach in front and a parking lot behind the structure. There is no visible sign of scour. There are many areas of erosion.

Conditions of structure/landform may warrant emergency stabilization as failure may result in potential loss of property and/or life. Landform eroded, loss of integrity. Structure exhibits critical levels of deterioration, section loss, cracking, spalling, undermining, and/or scour. Structure provides little or no protection from a major coastal storm. Actions taken to totally reconstruct structure to regain full capacity. Landform stability is severely compromised, rate of erosion/material loss may be increasing, and landform does not provide adequate protection from a major coastal storm. Actions taken to recreate landform to adequate limits for full protection from a major coastal storm.

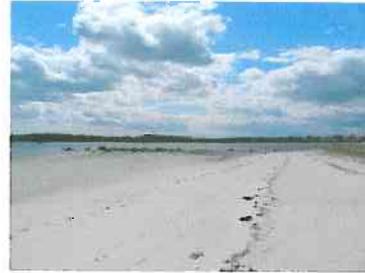
| Primary Type: Coastal Beach | Primary Material: Sand | Primary Height: Under 5 Feet |

| <i>Description</i> | Structure is sound but may exhibit minor deterioration, section loss, cracking, spalling, undermining, and/or scour. Structure adequate to withstand major coastal storm with little to moderate damage. Actions taken to reinforce structure to provide full protection from major coastal storm and for extending life of structure. Moderate wind or wave damage to landform exists. Landform may not be sufficient to fully protect shoreline during a major coastal storm. Actions taken to provide addition material for full protection and extended life. | <i>Description</i> | Inshore Structures with potential for Infrastructure Damage and/or Limited Residential Dwellings (<1 dwelling impacted / 100 feet of shoreline) |

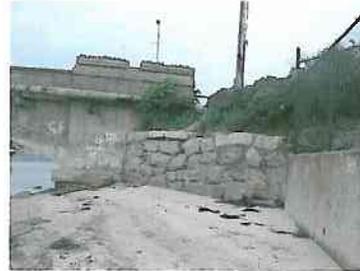
The stone block seawall has stones that are approximately 4 feet by 1 foot by 2 feet in size. The stones have been mortared together. Most of the mortar has fallen out. The stones have signs of rotation and settling. The riprap at the base of the wall is mostly buried or missing. The stones average 3 feet by 2 feet by 1 foot in size.

| <i>Description</i> | Structure is sound but may exhibit minor deterioration, section loss, cracking, spalling, undermining, and/or scour. Structure adequate to withstand major coastal storm with little to moderate damage. Actions taken to reinforce structure to provide full protection from major coastal storm and for extending life of structure. Moderate wind or wave damage to landform exists. Landform may not be sufficient to fully protect shoreline during a major coastal storm. Actions taken to provide addition material for full protection and extended life. | <i>Description</i> | Inshore Structures Present with Limited potential for Significant Infrastructure Damage |

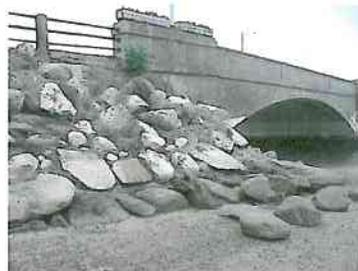
The revetment is made up of dumped riprap with concrete mortar. The stones average 4 feet by 2 feet by 1 foot in size and are at a 1 on 1 slope. There is visible scour and section loss. Mean low water extends out plus or minus 5 feet past the toe.

| <i>Condition</i> | C | <i>Priority</i> | II |

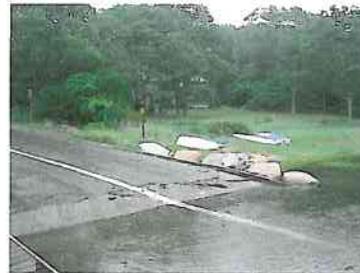
The revetment is made up of dumped riprap. The stones are approximately 3 feet by 2 feet by 2 feet placed along the side of the boat ramp.

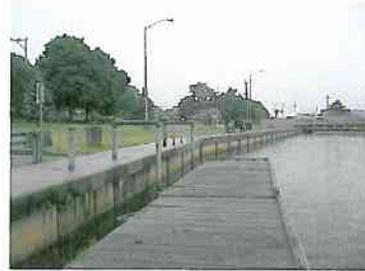
The bulkhead is made up of a concrete panel with steel frames and a precast walkway on the top. There are many areas of erosion behind the walkway which have been filled with crushed gravel. The walkway is heaving and collapsing. There is a parking lot behind the structure and floats in front.
