## HISTORIC STRUCTURE REPORT

# MAGAZINE BEACH POWDER MAGAZINE

CHARLES RIVER RESERVATION  
CAMBRIDGE, MASSACHUSETTS

JANUARY 20, 2016

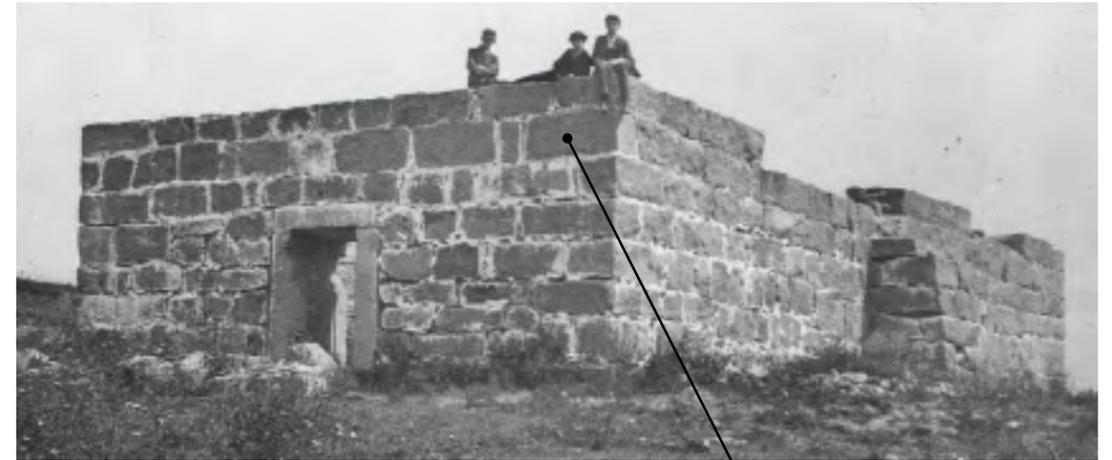
**6.2 (above):** Photograph of the west end and south side of the magazine from the 1890s showing its condition prior to being renovated in 1899 as a bathhouse. The slate roof, brick arch, and all doors are gone. The lower 8 courses (i.e., 11') of granite and the door openings remain intact, although portions of the eighth course are missing. The small chinking stones set in the joints also remain intact and are visible in this photograph. The top of the buttress is missing. There is no evidence of openings for ventilation (usually narrow slits) or windows in the remaining wall.

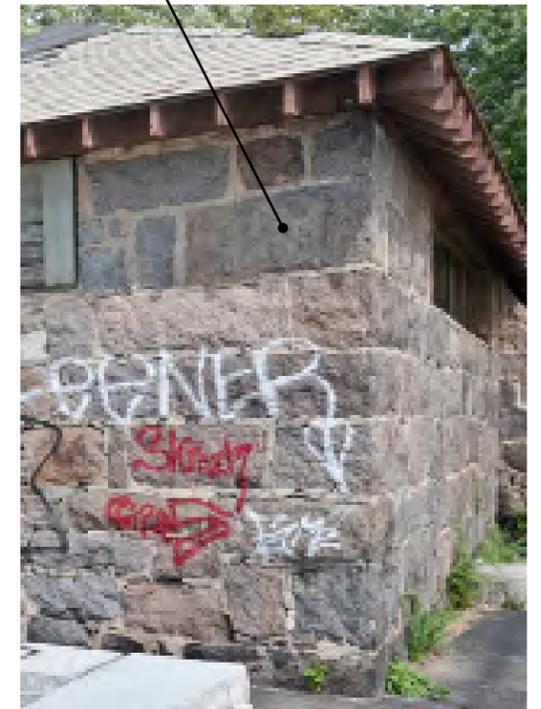
**6.3 (right):** 2013 photograph of the south corner west end wall. Detailed comparison of the individual stones in this photo with the 1890s photo above (5.2) shows that the eight courses present in the 1890s are still intact with most of the stones in the same position in both photographs.

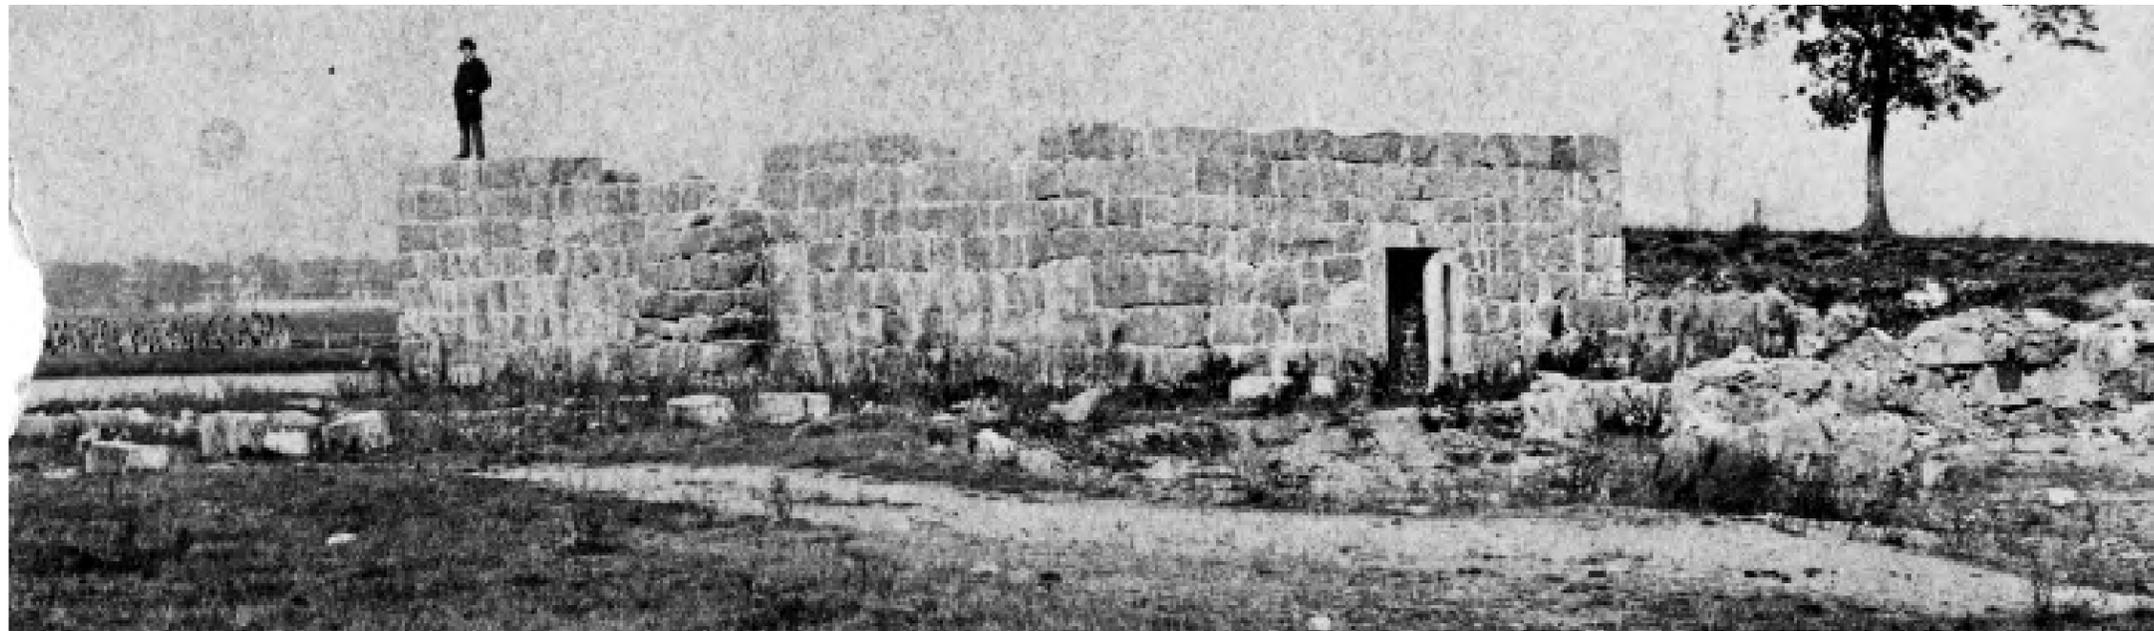
**6.4 (left):** C. 1892 photograph of the south side and east end wall of the magazine showing conditions similar to photo 5.2 with 8 courses of stone remaining in place along with the jamb stones for the east end entry. Again there is no evidence of former slits for ventilation or windows. The height of the 8 remaining courses is about 11' above grade. As the side walls were originally specified to be 14' high, the top 3' of the south wall is missing. More is missing from the end walls as these would have risen to about 21' at the peak of the gable roof. A considerable amount of masonry debris is visible on the ground including a number of dressed stones. The June 6, 1900 newspaper article describing the bath house conversion states that "there is plenty of available stone lying about ... to use for patching".

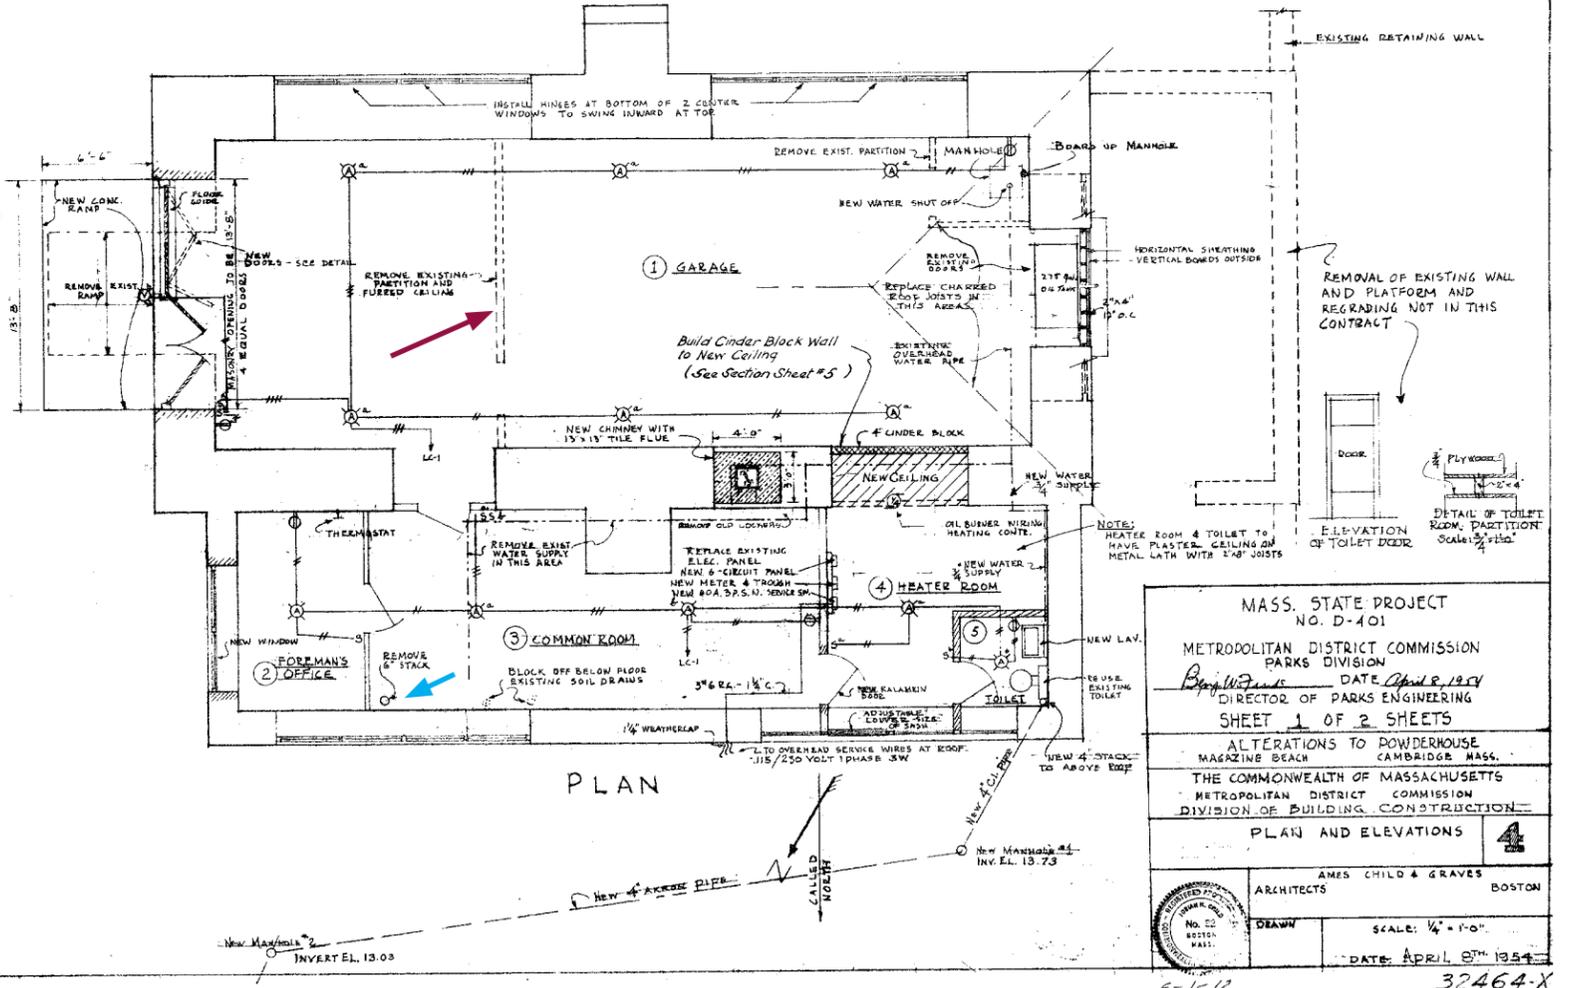
REPLACE CHARRED JOISTS ON THIS SIDE.

**ROOFING NOTES:**  
REMOVE ALL SLATE. REPLACE ANY DAMAGED OR ROTTEN BOARDS. COVER WITH FELT AND REPLACE SLATE IN ACCORDANCE WITH SPECIFICATIONS.

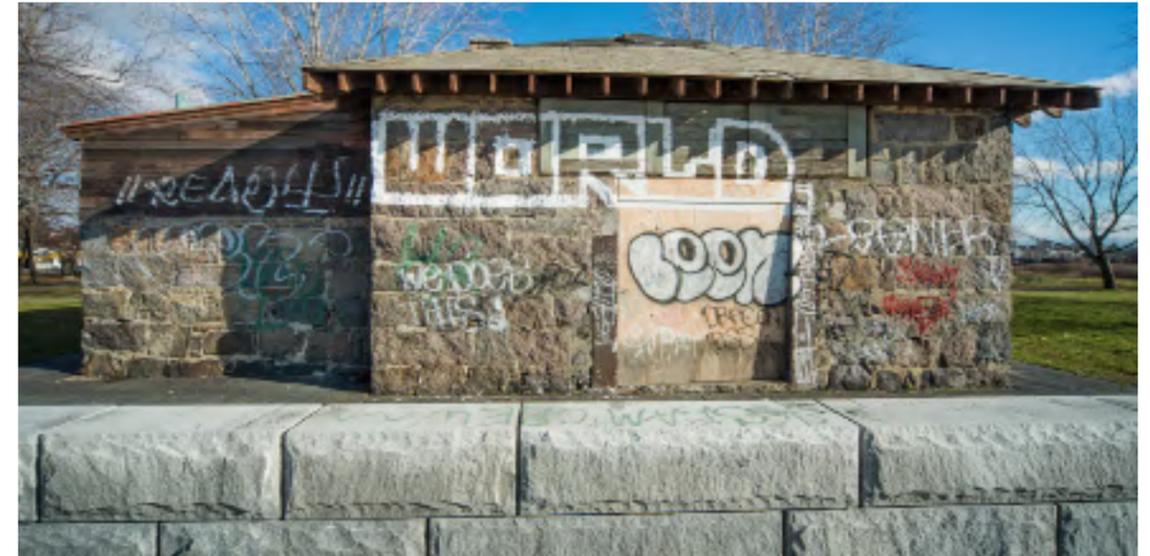
13.1: South elevation. The stone is laid in regular horizontal courses. Most stones have been dressed to roughly rectangular shapes. There is a considerable range in the color of the stones, which is typical of Quincy/Braintree granite quarried prior to c. 1825. There are numerous large patches in the slate roof.

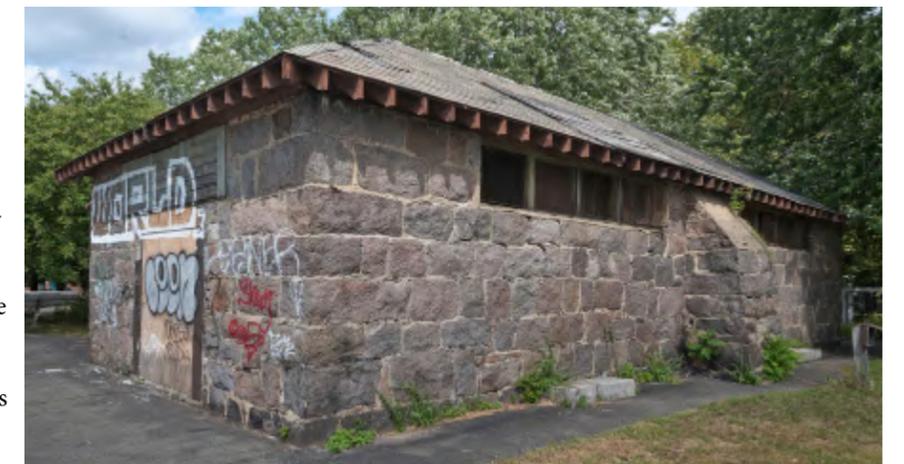
13.6: West and south elevations today for comparison with the c. 1890s photo at left (13.5). Note that the current site grade is about half way up the bottom course of stone. Historically the grade was at the bottom of the first course.

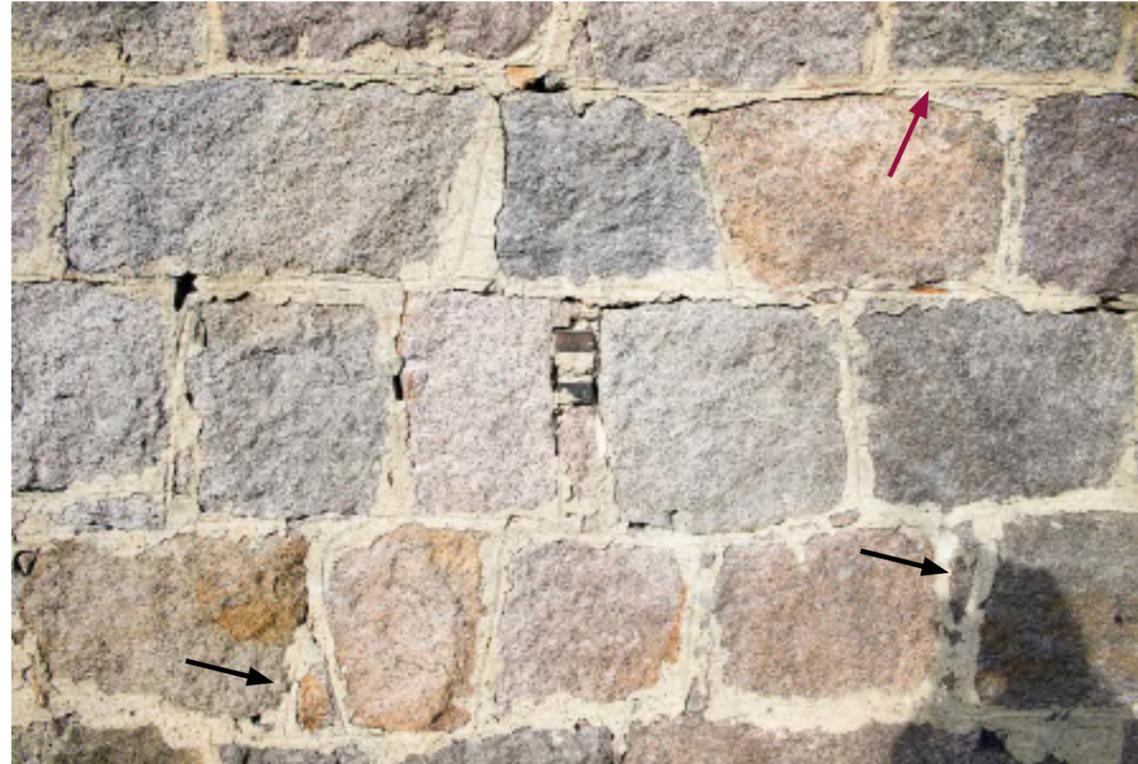
14.4: Open joint on east facade where the original lime mortar behind the 1900 cement pointing has been reduced to sand.

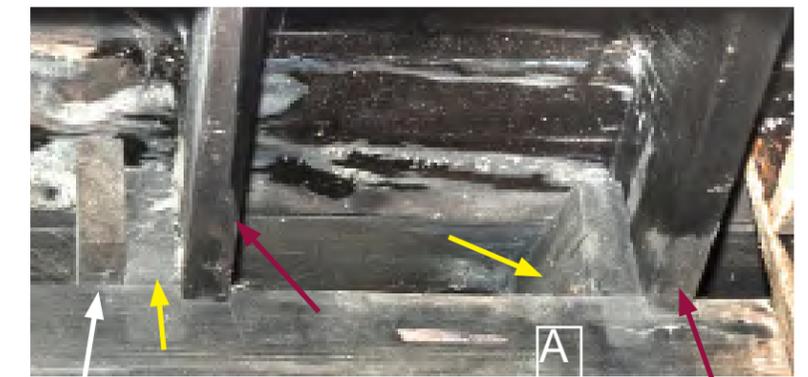
17.6: Interior of 1899 addition looking towards its junction with magazine north wall. The lower light colored framing was installed with the fiberboard ceiling. White spots on the ceiling are probably fungus from dampness.

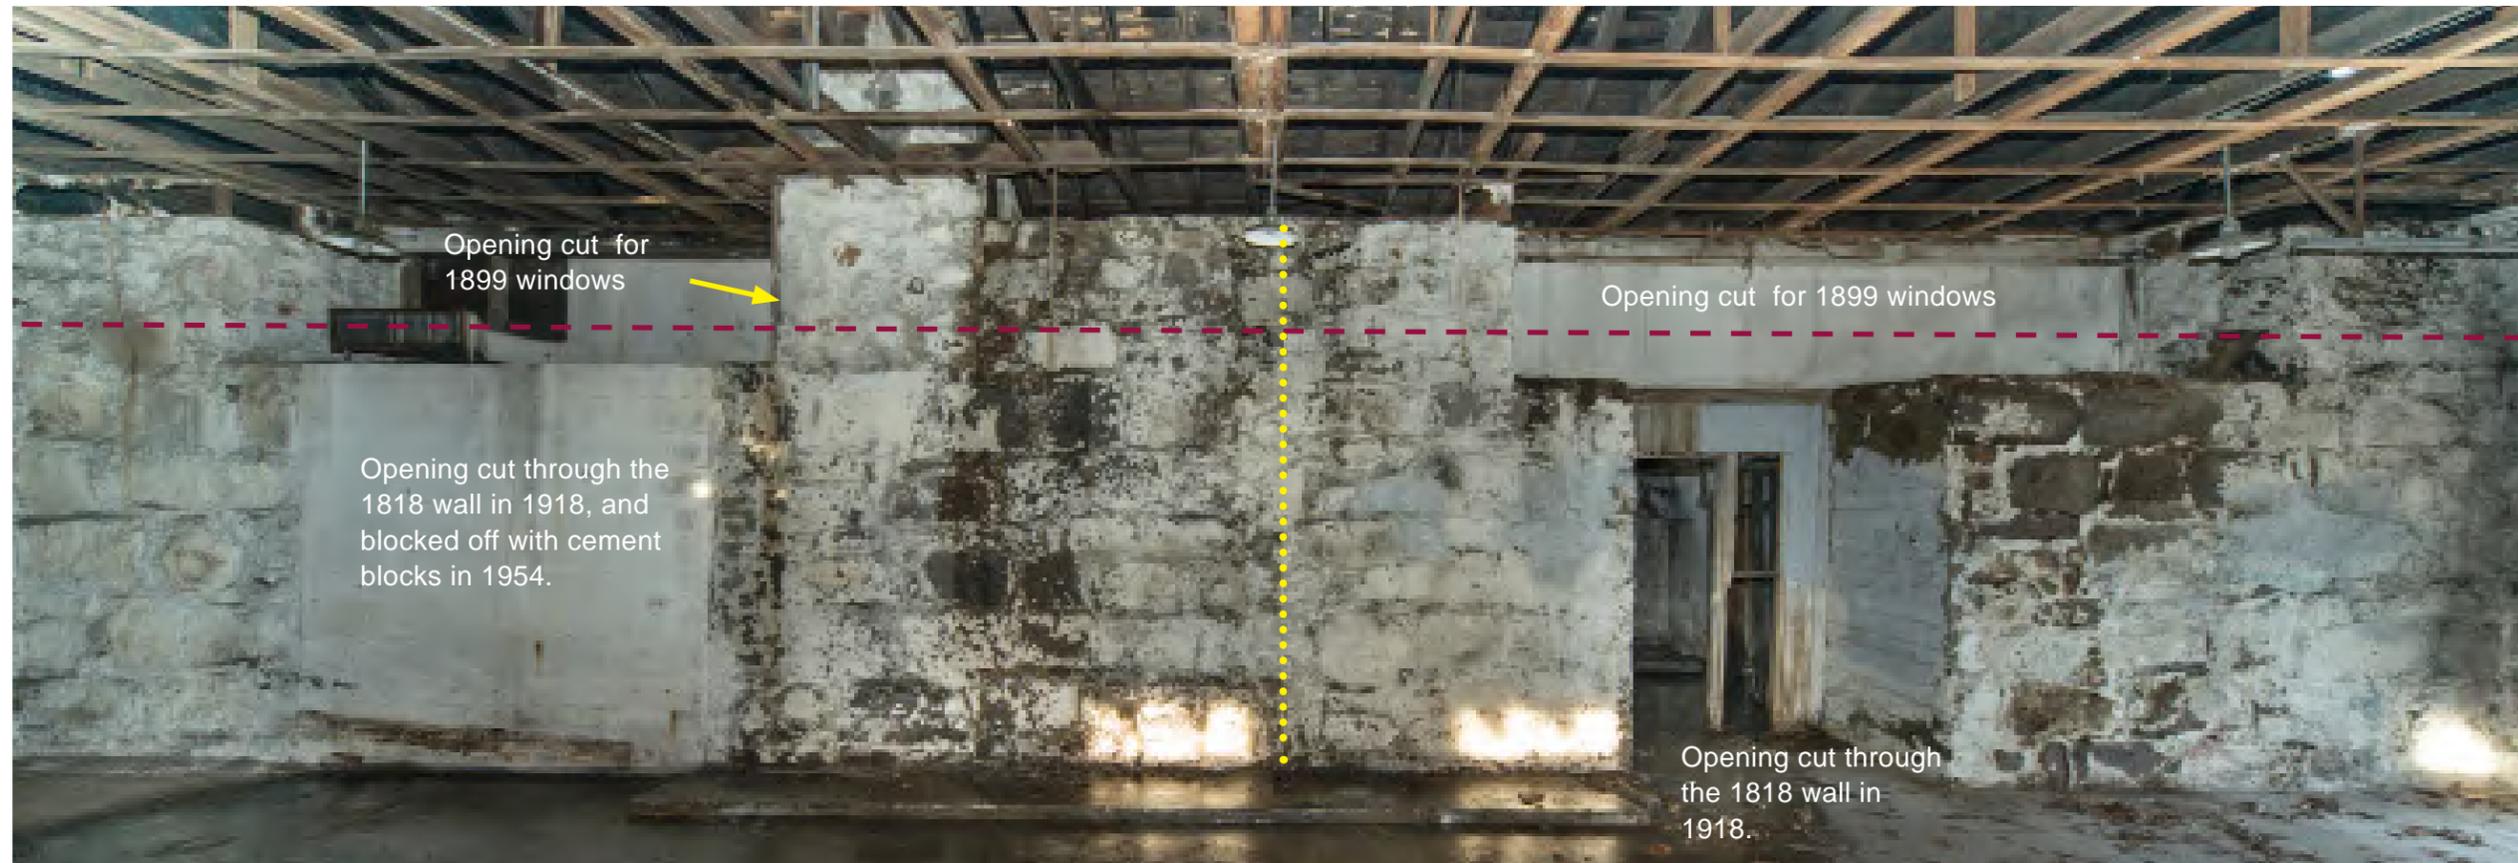
**18.1:** Overview of south wall in magazine. Dark joints are sloppily repointed using an inappropriately dark colored mortar. The crack discussed in the engineers's report is barely visible and is marked with the arrow (see 19.6 for a close up). The red line marks the approximate position for the spring of the 16" thick brick arch in the magazine as built in 1818. The stones above this line would have been missing for the 16" depth of the arch and would have been rebuilt in 1899.

**19.6:** Detail of south wall (18.1) showing the crack discussed in the engineers's report that extends through the full thickness of the wall.

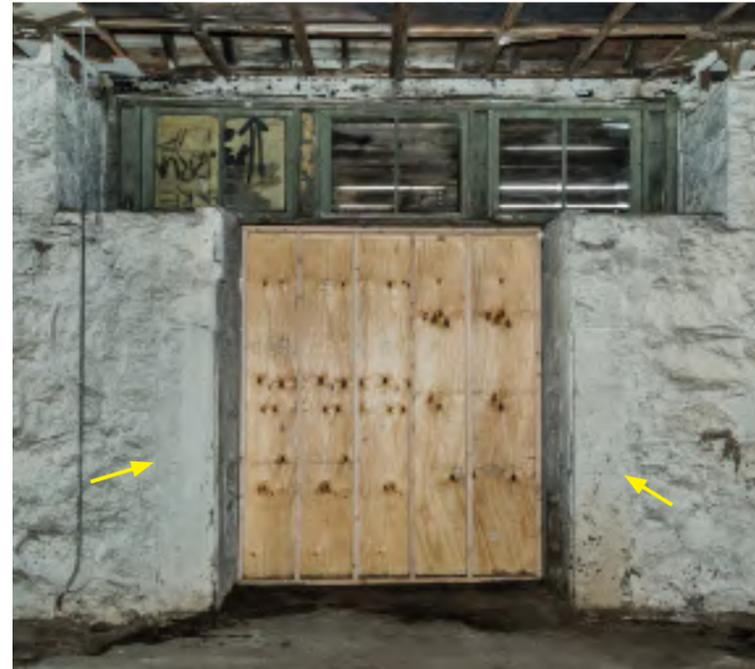
*The condition of the current concrete floor is serviceable with some minor patching needed.*

**19.1:** Overview of magazine interior looking towards east end entry. South wall is on the right. Yellow arrows point to raised platforms in the concrete floor that provided a base to raise the lockers above the floor. The concrete floor was installed in 1918. The previous floor was probably wood.

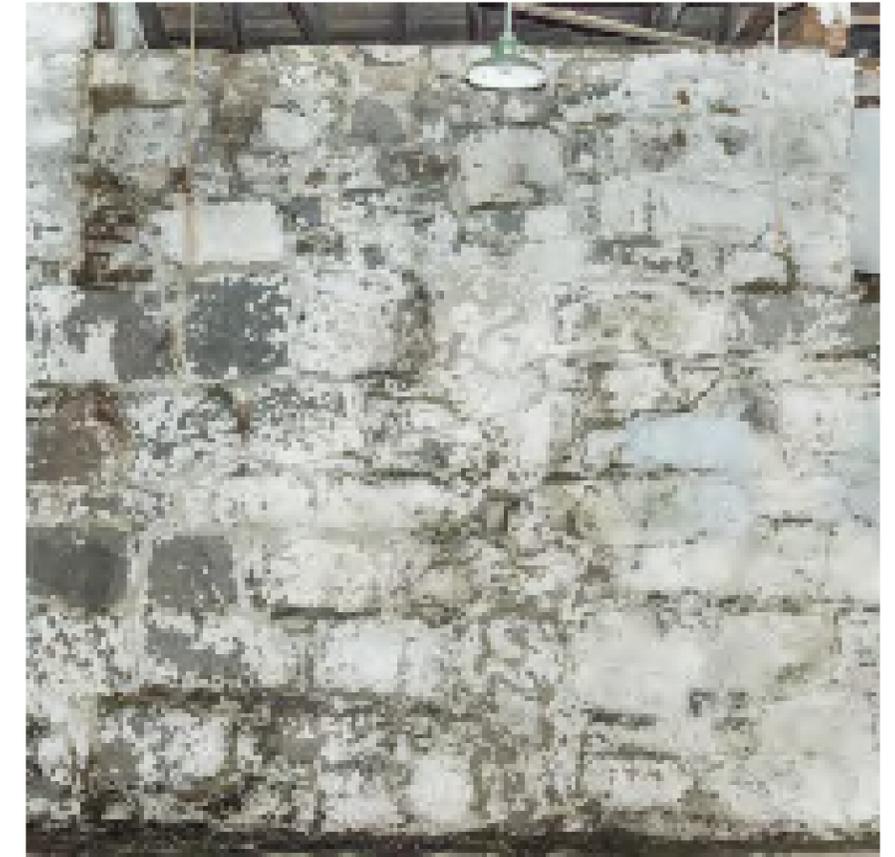
**19.3:** Detail of north wall (18.2 at the yellow dotted line) showing the smaller, irregular stones where the wall was rebuilt above the spring of the arch and where the central partition was removed.

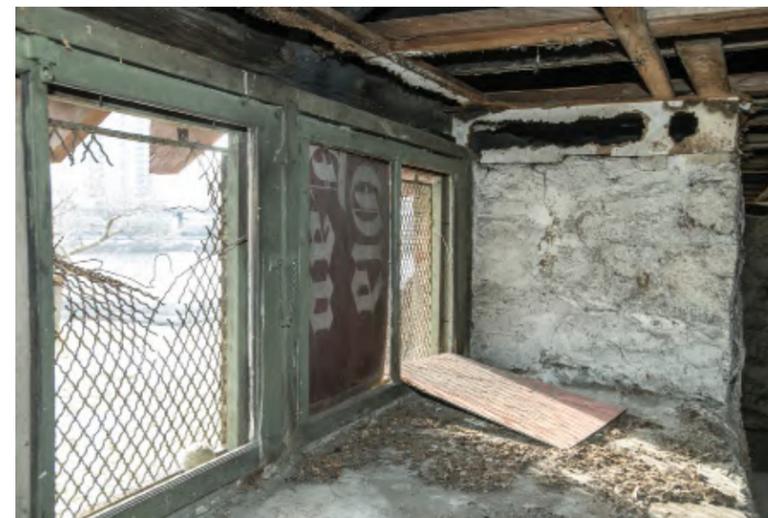
**19.5:** Detail of south wall (16.2) showing window set within the section of wall that was cut away in 1899 for the windows. The top of the wall has been parged with cement mortar to provide a level surface for installing the window frames.

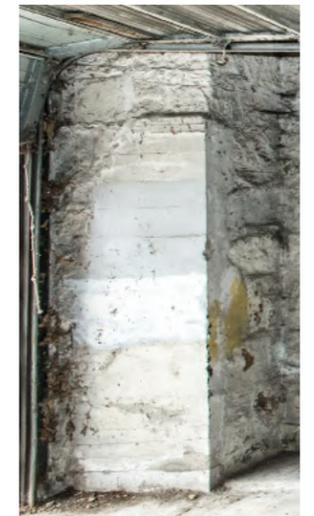
**19.7:** Jamb of east end entry with cast-in-place concrete installed in 1954 to make the cut-back wall smooth.

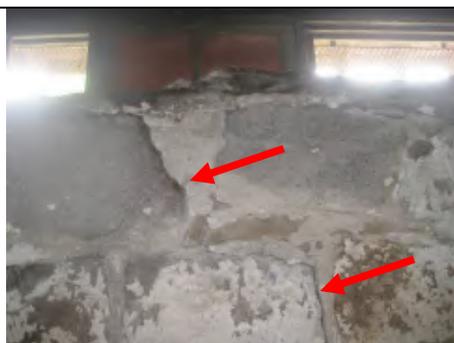
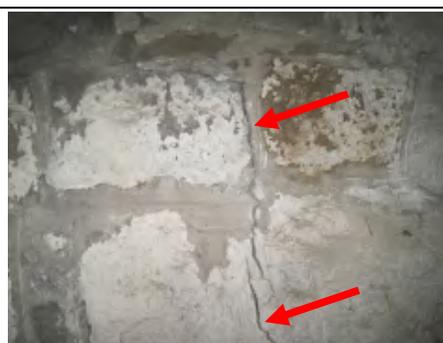
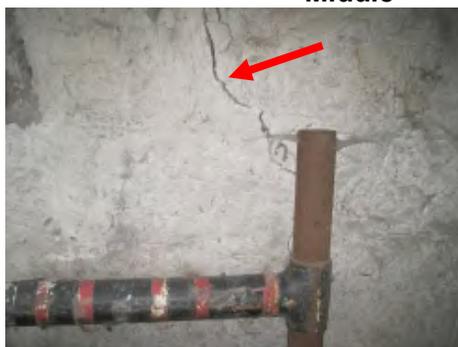
- 1) A diagonal crack in the west end of the main building's south wall. The approximate crack location is identified on the attached SKS-1 floor plan with the number "1". The crack is high at the east, low at the west. Please see photos 1 and 2 in the Photo Appendix. On the exterior face of the wall, the crack is reversed with the high end on the west, low end on the east, as shown in photo 8.

**Photo 2:** Diagonal Crack in interior face of main building's south wall at west end.  
(Three close-up photos)

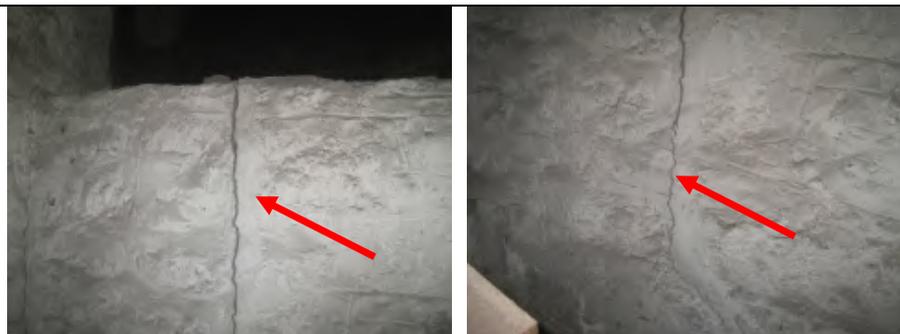
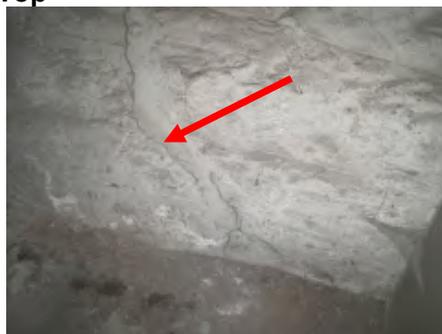
- 2) A nearly vertical crack in the south end of the north addition's west wall. The approximate crack location is identified on the attached SKS-1 floor plan with the number "2". Please see photos 3 and 4 in the Photo Appendix.

**Photo 4:** Crack in interior face of addition's west wall at south end.  
(Three close-up photos)

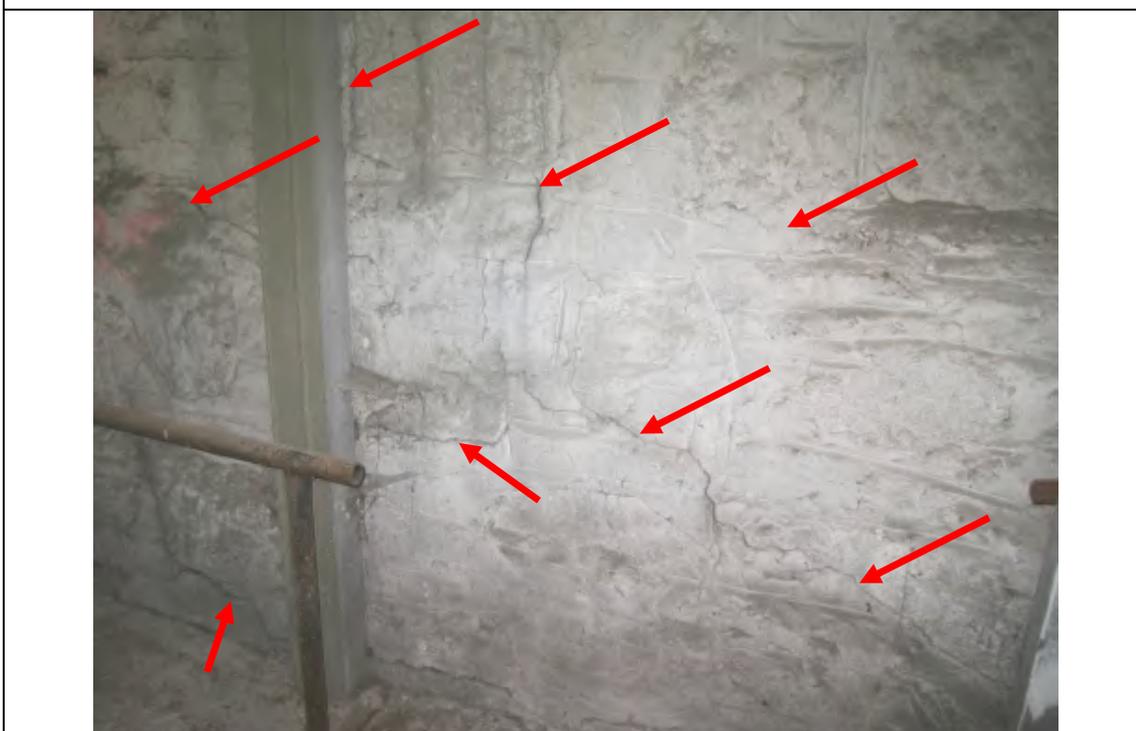
- At the west end of the addition's north wall there is some spider cracking in the mortar joints. The approximate location of this area of cracks is identified on the attached SKS-1 floor plan with the number "3". Please see photos 5 and 6 in the Photo Appendix. We suspect that this cracking is just in what appears to be a surface coat of parging.

**Photo 5:** Spider cracking in the mortar joints at the interior face at the west end of the addition's north wall.

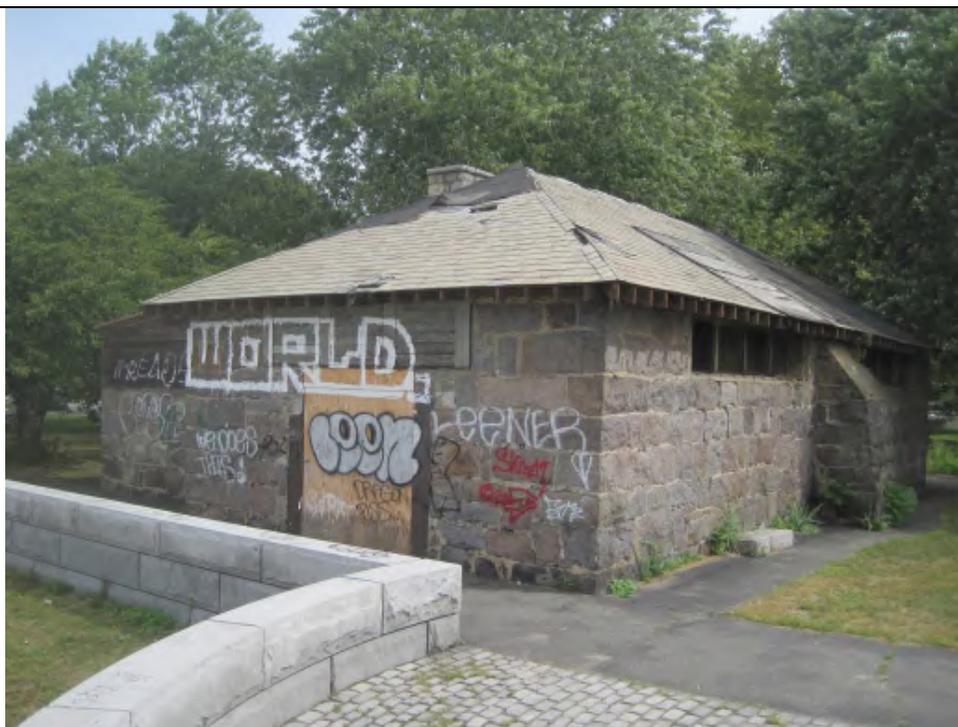
**Photo 6:** Spider cracking in the mortar joints at the interior face at the west end of the addition's north wall.

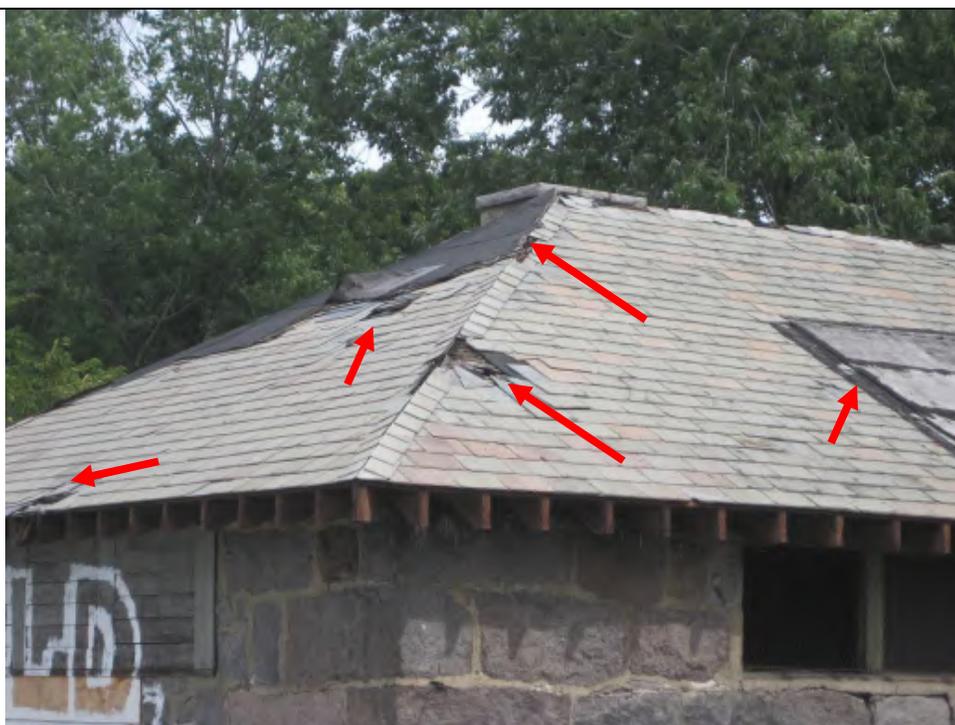
**Photo 11:** Typical exterior wall stone joint deterioration (west side of building)

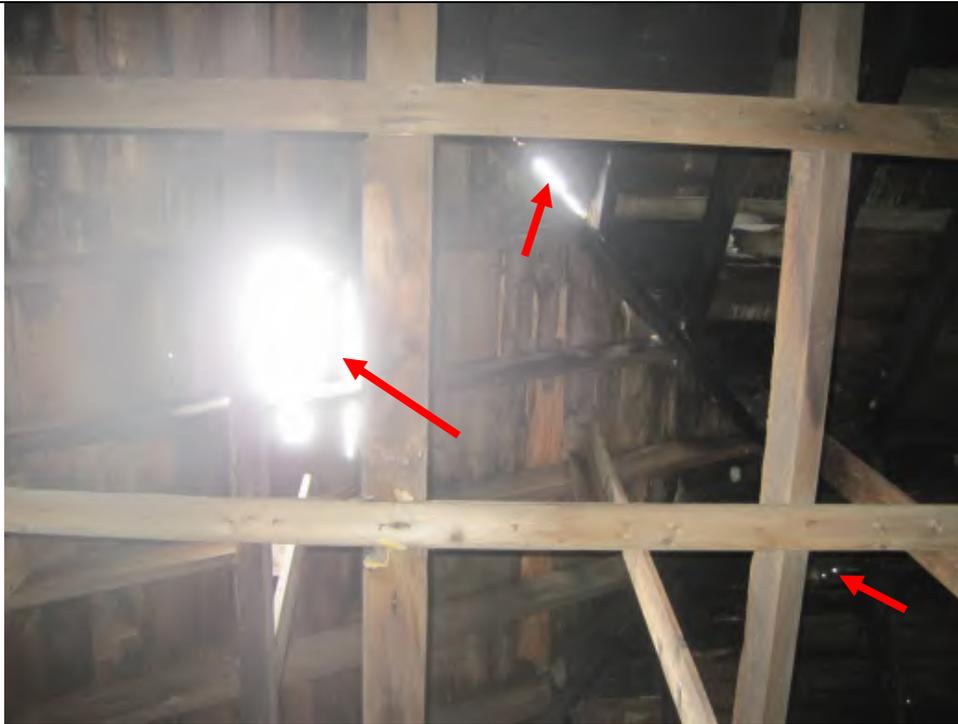
**Photo 12:** Roof damage from exterior

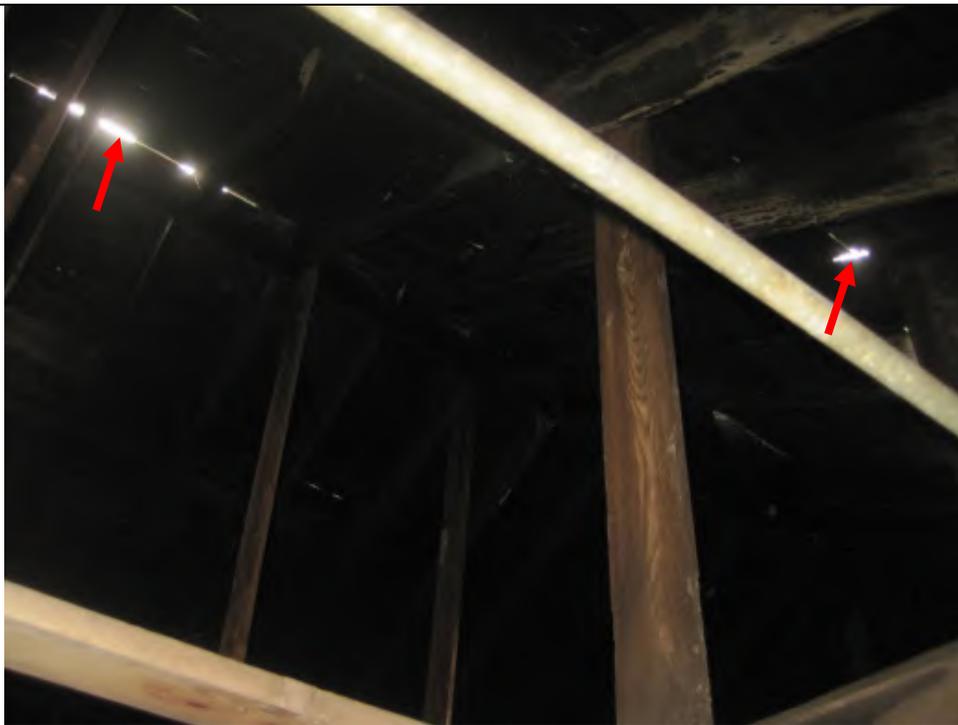
**Photo 13:** Roof damage from interior
