CASE STUDIES

SITE SPECIFIC ISSUES AND RECOMMENDATIONS

FIRST BURIAL GROUND

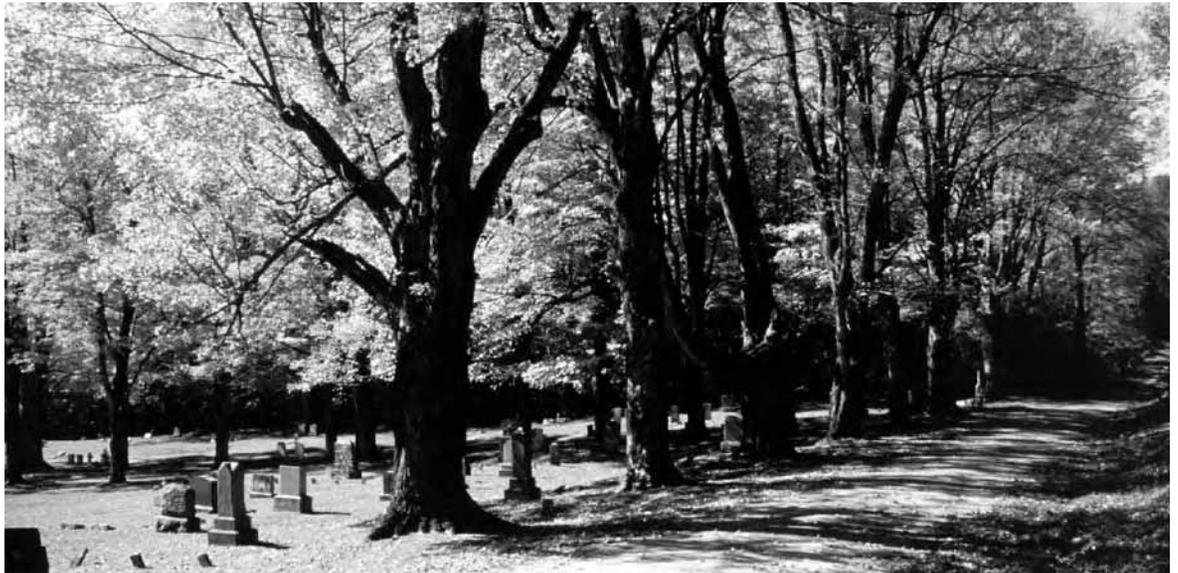
View west along Nillingdon Road

Lawns are in fair to poor condition with many small bare spots, moss and herbaceous weeds. Some slumping is evident on the steep south facing slopes. There are also mounds or small hummocks on these slopes that could be early burials.

Some erosion is also evident in relation to individual grave markers set parallel to steep slopes in the southern portion of the cemetery. Water flow has caused a build up of soils on the uphill sides of the grave markers and an erosion of soils on the downhill sides. This ultimately causes the grave markers to act as miniature retaining walls. Subject to the earth forces above, the markers ultimately lean downhill which creates a long term hazard for the resource. Areas of soil are exposed because a substantial vegetative ground cover has not been established due to the dense shade in this area.

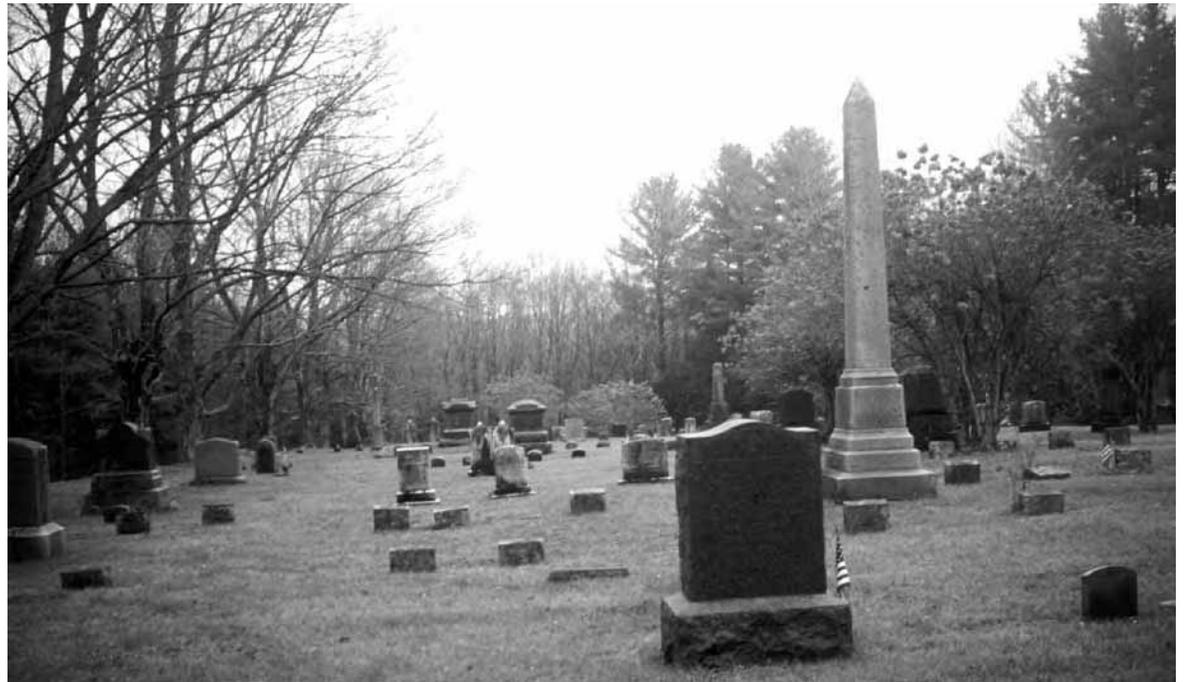
It appears that these trees have had some pruning in the past 5 years because of some old pruning wounds. However, large amounts of deadwood have accumulated since. A number of trees have codominant and multiple main stems like those in Center Cemetery. Ringville Cemetery does not have the same shade problems that Center Cemetery has.

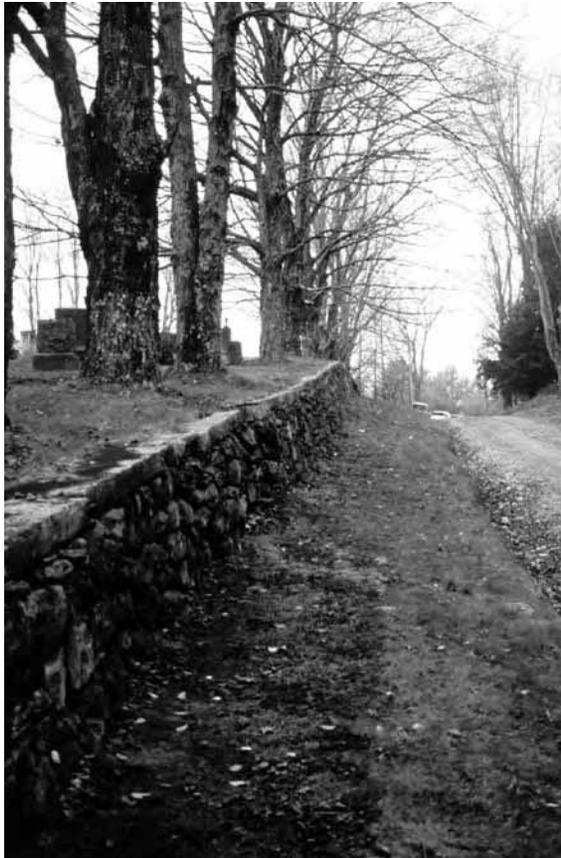
Stone wall along Witt Hill Road

The dry laid rubble stone retaining wall along Witt Hill Road at Ringville Cemetery was built about 1900 with stone hauled by oxen and wagons from West Chesterfield Gorge, 8 to 9 miles away. It appears to have been built in two stages with a slightly different character for each. The west end appears to be relatively level with a vertical face while the sloping east end has about a 6" batter on the face. Overall, the wall appears to be in stable condition with some slight shifting of the granite cap stones that are about 4" thick, 16 to 20" wide and very long, with one about 21' long.
