Chapter 3

PROPERTY INVENTORY AND ANALYSIS

Introduction

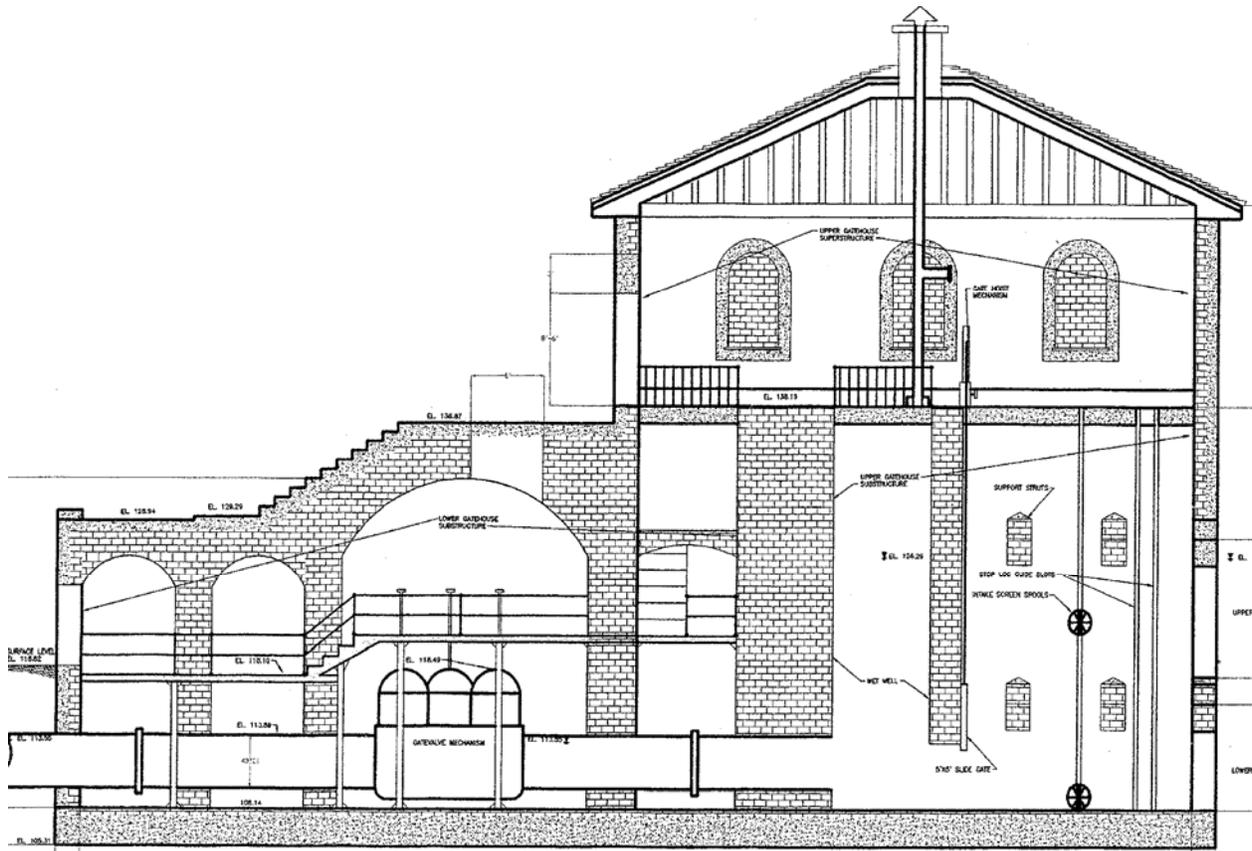
Figure 3.10: Section of Gatehouse #1 from GZA GeoEnvironmental, Inc. report

The 2005 field examination did not include the lower level; an attempt was made to reach the lower level but the wood platforms, catwalks and stairs were heavily damaged with rot and corrosion and access over the water-filled chambers was too dangerous to attempt. An extensive survey of the upper and lower interior levels was conducted by GZA GeoEnvironmental Inc in 1998 and their March 1998 report¹³ provides a complete description of the chambers and related elements.

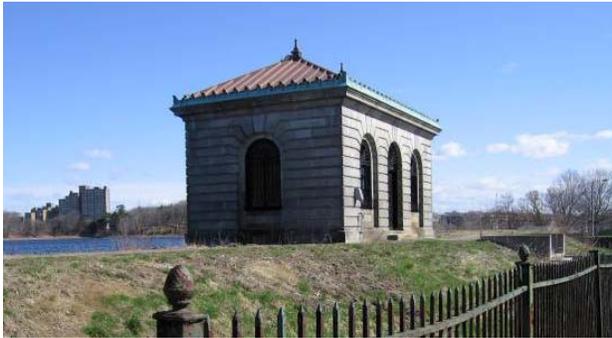
Figure 3.12: Gatehouse #2 (2005)

1898 when gravity was no longer sufficient to distribute water from Chestnut Hill) and took over the operations of the original Effluent Gatehouse #1. Built in the Renaissance Revival style, it is one-story in height, three window bays across and one window bay deep. The exterior is dressed granite ashlar and the windows are accented with iron grillwork. The roof has a shallow pitch and is clad with copper. Access to the structure is gained from the pedestrian path on top of the dam. There is a small flight of simple stone steps leading down to the Beacon Street sidewalk that are in fair condition.

A structural analysis for Gatehouse #2 was not conducted as a part of this Resource Management Plan. This gatehouse remains in operation and is under the control of the MWRA as the main outlet for discharge of the Reservoir's water to the water distribution system. It houses several five foot square gates used to maintain the water level. The MWRA has recently upgraded the equipment within the gatehouse and carried out repair and cleaning work to the inside and outside of the structure. Unlike Gatehouse #1, the windows are still glass and are covered with iron grille-work.

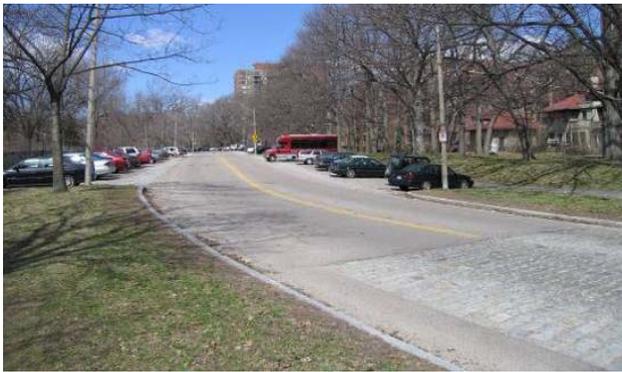
Figure 3.19: Chestnut Hill Driveway (2005)

Relative to the other roads in the area, traffic along the Chestnut Hill Driveway is low although higher traffic flows do occur during rush hour as this roadway is frequently used as a shortcut to bypass the traffic on Commonwealth Avenue and Beacon Street. The Driveway still provides a pleasant driving experience as it gently winds across the top of the slope north of the Reservoir, although views of the Reservoir are limited by the dense vegetation and the parking areas. While vehicular speed should be minimized along this road, the rumble strips have proved to be a constant maintenance issue for the DCR. The granite cobblestones routinely are displaced, particularly by snow plows, and are a hazard to bicyclists and pedestrians.

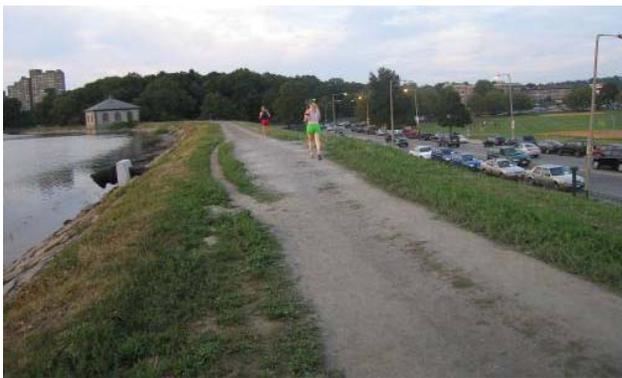
The original inner or perimeter path, now typically six to eight feet wide and surfaced in stone dust, still follows the shoreline of the Reservoir, with a section running along the top of the dam. This path is typically called the “inner” path, which is completely inside the perimeter steel picket fence, except in the southwest corner of the Reservation where the original stonedust path is located outside the fence and a narrow dirt path has been established inside the fence. This “inner” path is about 8,250 linear feet long (1.56 miles).

Figure 3.22: Stonedust path along top of Reservoir dam (2005)

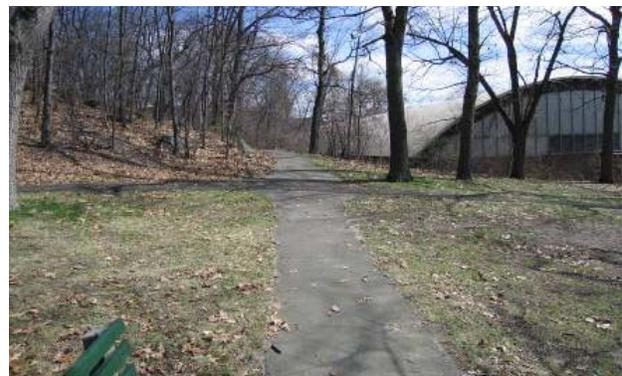
of the Reservation. These paths also connect to the old playground area and the Reilly Rink and Pool building. The paved portions of these paths were part of the 1977 MDC landscape improvements and are in varying conditions between fair to poor with the paved edges frequently crumbling. The typical paved path width is between four to five feet. Several “desire line” dirt paths also exist in this area. Some of these desire lines run straight up the slopes and are creating erosion problems. Since the Reservoir perimeter path system was re-opened, the paths on the hill parcel experience less pedestrian traffic. Given their poor condition and lack of use, these paths are candidates for reconfiguration, including enhancing access to some excellent views of the water.

Figure 3.24: Bituminous concrete path adjacent to 1977 playground (2005)

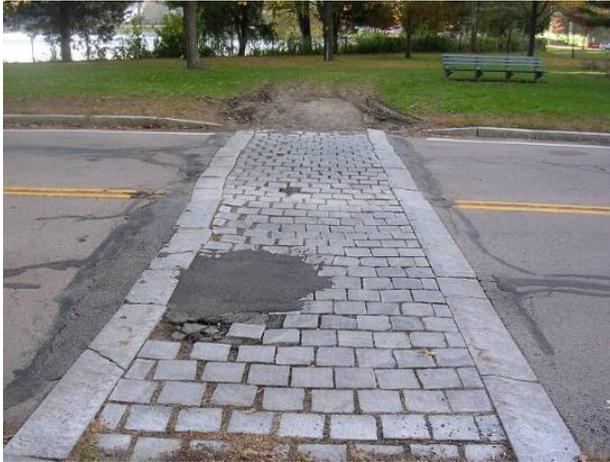
Painted crosswalks, outside the Reservation property, are provided at the intersections of all vehicular roads surrounding the Reservation. There are signalized crosswalks at Commonwealth Avenue and Chestnut Hill at Cleveland Circle. There are non-signalized, painted crosswalks within the Reservation at several points across Saint Thomas More Road and crosswalks paved with granite cobbles (rumble strips) at several points across the Chestnut Hill Driveway described above. These crosswalks serve to connect the outer pathway to a five foot wide bituminous concrete sidewalk running along the north side of the Driveway. The granite cobble crosswalks, part of the 1977 MDC improvements, are in fair to poor condition in many areas with loose and dislodged cobbles. Some areas of these crosswalks have been patched with bituminous concrete and may present tripping hazards to pedestrians.

Figure 3.26: Crosswalk across Chestnut Hill Driveway (2005)

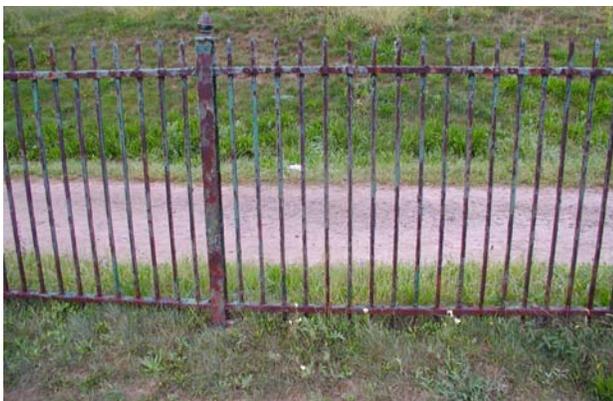
Figure 3.29: Typical intact 1928-29 panel (2005)

In total, the perimeter fence, as observed in 2005, consists of 814 panels: 443 panels of the 1928-1929 fence and 371 panels of fence replaced in 1977 (of which half a dozen are located randomly among the original fence panels and sixteen are in front of the community garden on the outer side of Chestnut Hill Driveway). There is also a short section of chain link fence between the 1928-29 panels just below Gatehouse #1.

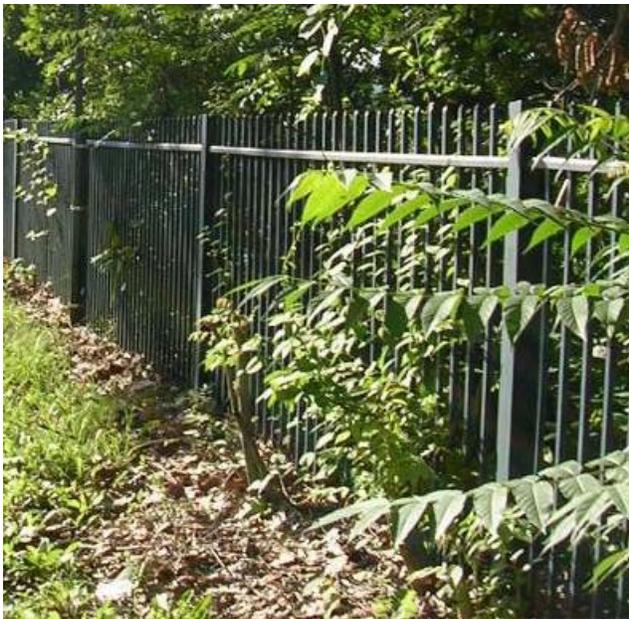
Figure 3.31: 1977 steel picket fence (2005)

The 1977 fencing panels are in fair to good condition except for some vine growth on certain sections, although preventative measures should be taken soon to ensure

they do not deteriorate. There is one panel near the 1977 overlook that appears to have had damage repaired by inserting a section of salvaged, unpainted 1928-1929 fencing.

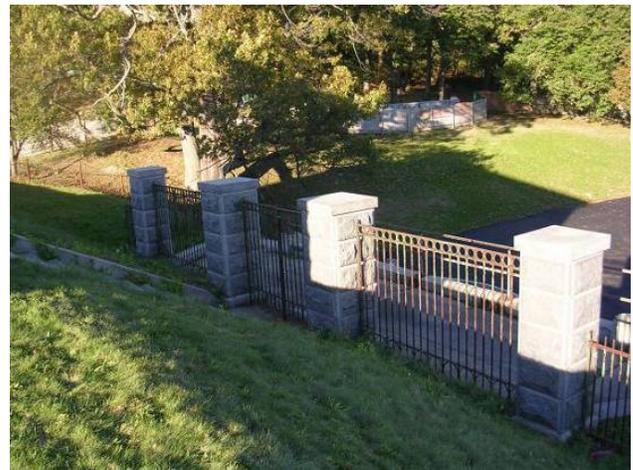
Two 1928-29 gates are located in front of the two gatehouses. The two forty-seven inch wide gate leaves and the ten foot six inch long fences on each side of the approach to Gatehouse #1 are about six feet high and are decorated more elaborately than the typical panel. Except for extensive paint loss and some corrosive pitting, they are in excellent condition. Most importantly, their hinges and anchors at the granite posts are intact and no spalling or deterioration was seen where the metal anchors are embedded in the stone. Similar gates without side fences are present at Gatehouse #2; some of the decorative circular elements are missing at these gates.

Figure 3.32: 1928-1929 entrance gate at Gatehouse #1 (2005)

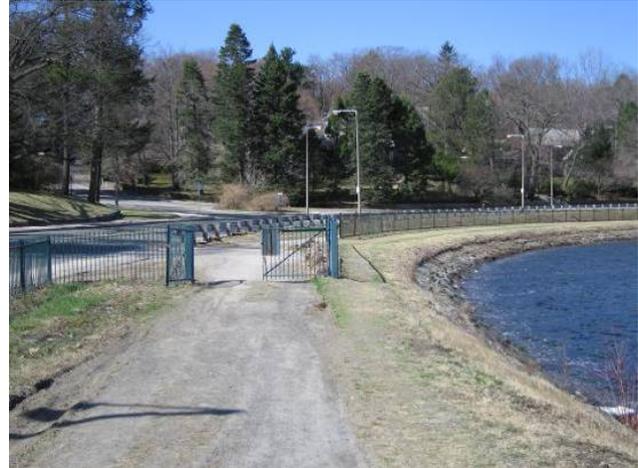
The MDC added two additional gates in 1977, one near the intersection of Saint Thomas More Road and Chestnut Hill Driveway, and the other near the intersection of Beacon Street and Reservoir Road. Both have double gates and are wide enough for vehicle access. In addition, as described in the section on circulation above, there are a total of seven openings in the fence where panels were removed in 2002 by the MDC to provide additional access points into the inner part of the Reservation.

Figure 3.34: Entrance gate along Beacon Street (2005)

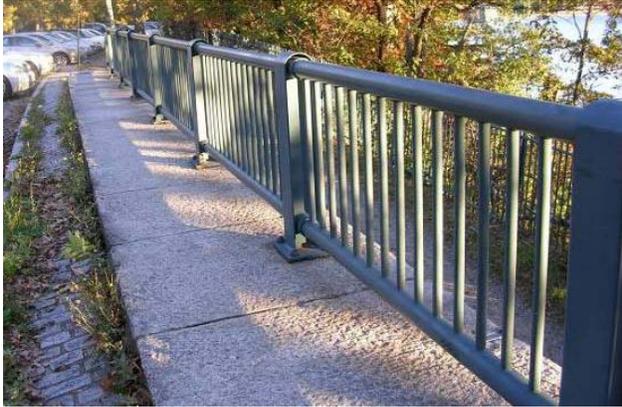
Figure 3.35: 1977 fence on top of Chestnut Hill Driveway retaining wall (2005)

A heavy-gauge pipe rail fence, installed in 1977, spans the top of the retaining wall along Chestnut Hill Driveway. Its design consists of panels of seventeen balusters attached to round horizontal bars at top and bottom between I-section posts with arched tops. It is painted green and remains in good condition.

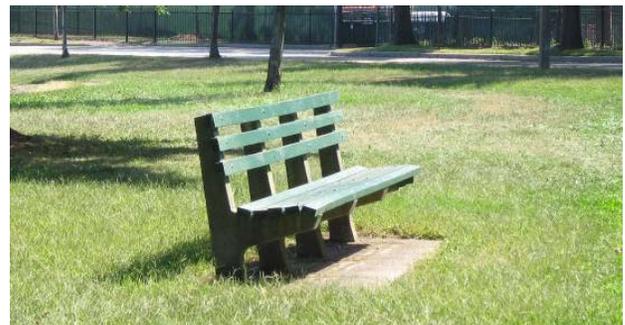
Figure 3.36: Type 1 bench (2005)

The first bench (Type 1) consists of wooden slats on a precast concrete frame. The concrete frame is attached to a below grade footer. The slats are painted green. These are a standard bench used by the former MDC throughout the metropolitan park system and thus are arguably the

These benches are generally in fair condition with mostly maintenance and small repairs needed such as painting the wood slats. The Type 1 benches are well-sited in the landscape and are directed toward views of the Reservoir, although a large grouping of benches is located in an unused area at the corner of Chestnut Hill Driveway and St. Thomas More Road.

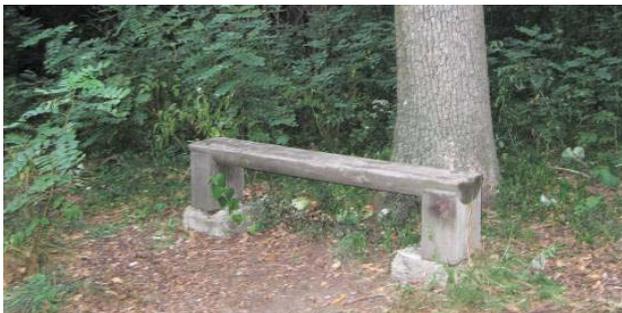
Figure 3.37: Type 2 bench (2005)

The second bench (Type 2) has a more rustic design and consists of a longitudinally cut log fixed on rectangular wooden legs. The legs are secured to concrete blocks, which are now exposed several inches above the grade of the soil. There are ten of these log benches in the Reservation:

Generally, the Type 2 benches are in poor to fair condition with some severely deteriorated and nearly falling over due to exposed footings. These benches are not visually attractive or appropriate for an urban park setting and are not sited to take advantage of the scenic views.

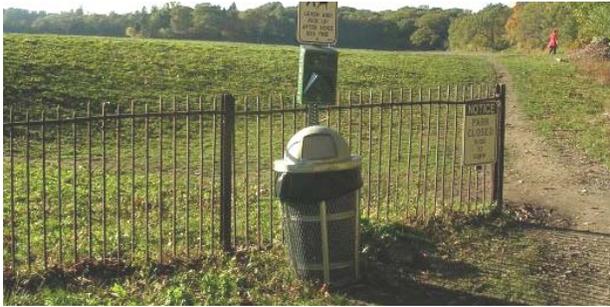
Two steel mesh trash receptacles are currently located at the entrance from the old playground and at the entrance near the intersection of Chestnut Hill Driveway and Saint Thomas More Road. Both are in relatively good condition. Adjacent to these two trash receptacles are dog scoop bag dispensers. A steel drum is located in front of the bituminous path to the Rink from Beacon Street that functions as a trash can. It may be that, for park users, a better location for trash receptacles would be at major entry or exit points to the Reservation. Certainly their current location means that DCR personnel must drive vehicles over pedestrian paths to access the receptacles for emptying: placing them at major gateways which are adjacent to roadways would result in less potential damage to pedestrian areas.

Figure 3.39: Trash receptacle and pet station (2005)

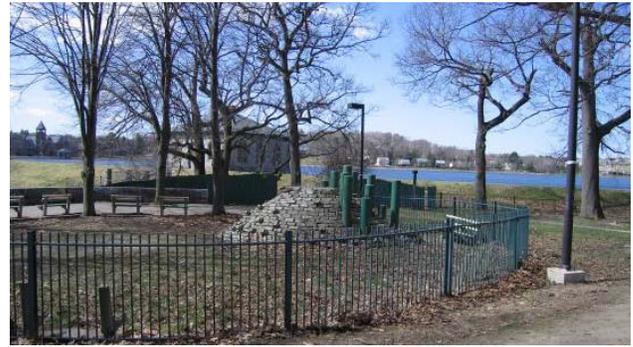
The 1977 MDC landscape improvements included the construction of a children's playground in the area between the Reilly Rink and the Reservoir. The play equipment has since been removed, although a stone mound remains that is a remnant of the slide play structure. The only remaining functioning feature is the semi-circular seating area with six benches facing the parking lot in front of Gatehouse #1. The stone retaining wall on the south side of the playground remains in good structural condition, although it is covered in graffiti. The original design of this playground does not meet current standards for children's play equipment and cannot safely be reused.¹⁶

The dilapidated playground and graffiti-covered retaining wall are prominent eyesores in the landscape. The stone mound is a safety hazard for children tempted to play on it. There are similar children's playgrounds provided in nearby parks such as Boyden, Shubow, Joyce and elsewhere. Given the limited amount of land available at

Figure 3.40: 1977 playground (2005)

Chestnut Hill Reservation and the historic significance of the landscape, DCR should carefully consider the need, siting and design of any proposed play equipment.
