VISUAL AND SCANNING ELECTRON MICROSCOPY INVESTIGATION AND TENSILE TESTING TO ESTIMATE RESIDUAL TENSILE STRENGTH OF A SELECTION OF LOBSTER LINES

**The Division of Marine Fisheries,
Commonwealth of Massachusetts**

Ref: TTI-JN-410-2007

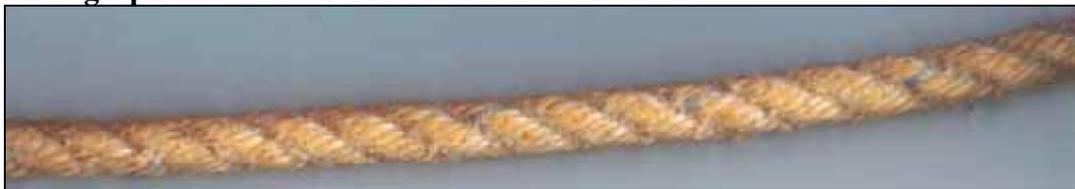
Photograph 22a Orion Orco field tested 28 hauls

It may be seen that the two cross-sections appear to be different in that the field sample has more polyester filaments of [probably] thicker cross-section than does the machine tested sample.

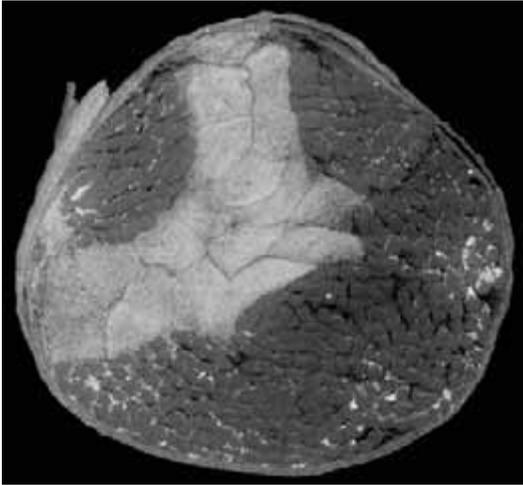
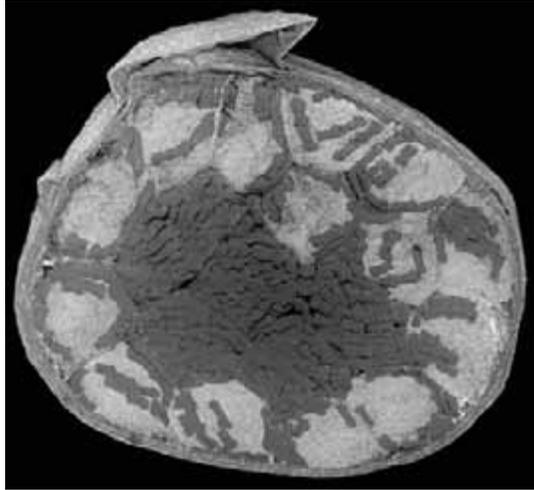
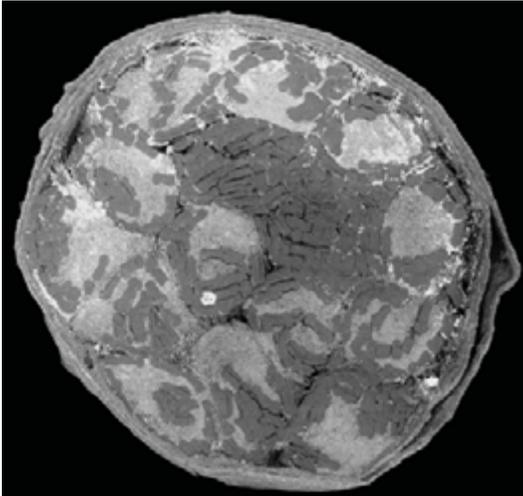
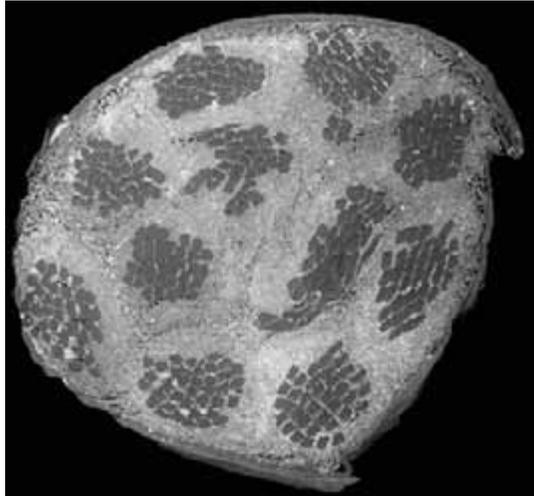
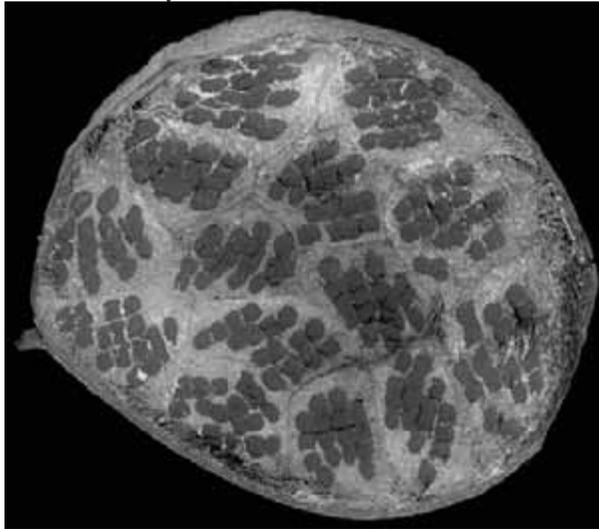
Photograph 27 shows a selection of cross-section views of all the ropes, to allow an overview of the differences in construction and the degree of particle penetration.

Whilst the number of hauls and the field conditions have varied between the rope types, there is good evidence to support the conclusion that where PP and polyester filaments are present in the outer face of the rope strands, then abrasion resistance is better and particle penetration is reduced.

The dominant fatigue mechanisms are external and internal abrasion with associated pressure damage particularly to the PP filaments. Whilst particle penetration has occurred in all the ropes to varying degrees, only a small amount of abrasion damage, as a result of this penetration, is seen.

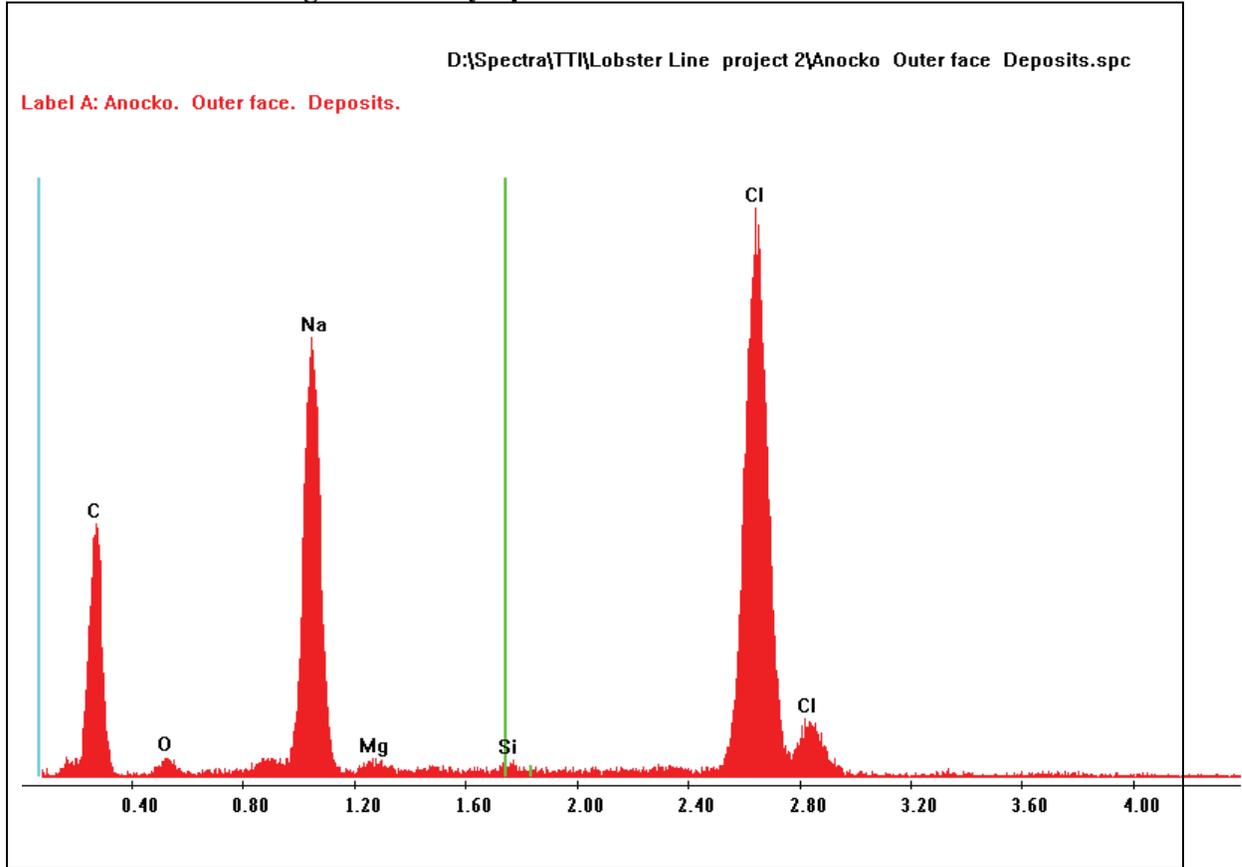
Figure 2 X-ray Spectrum of Anacko outer face

Figure 2 shows a similar spectrum but from the outer layer. In this case, salt appears to be the dominant contaminant.

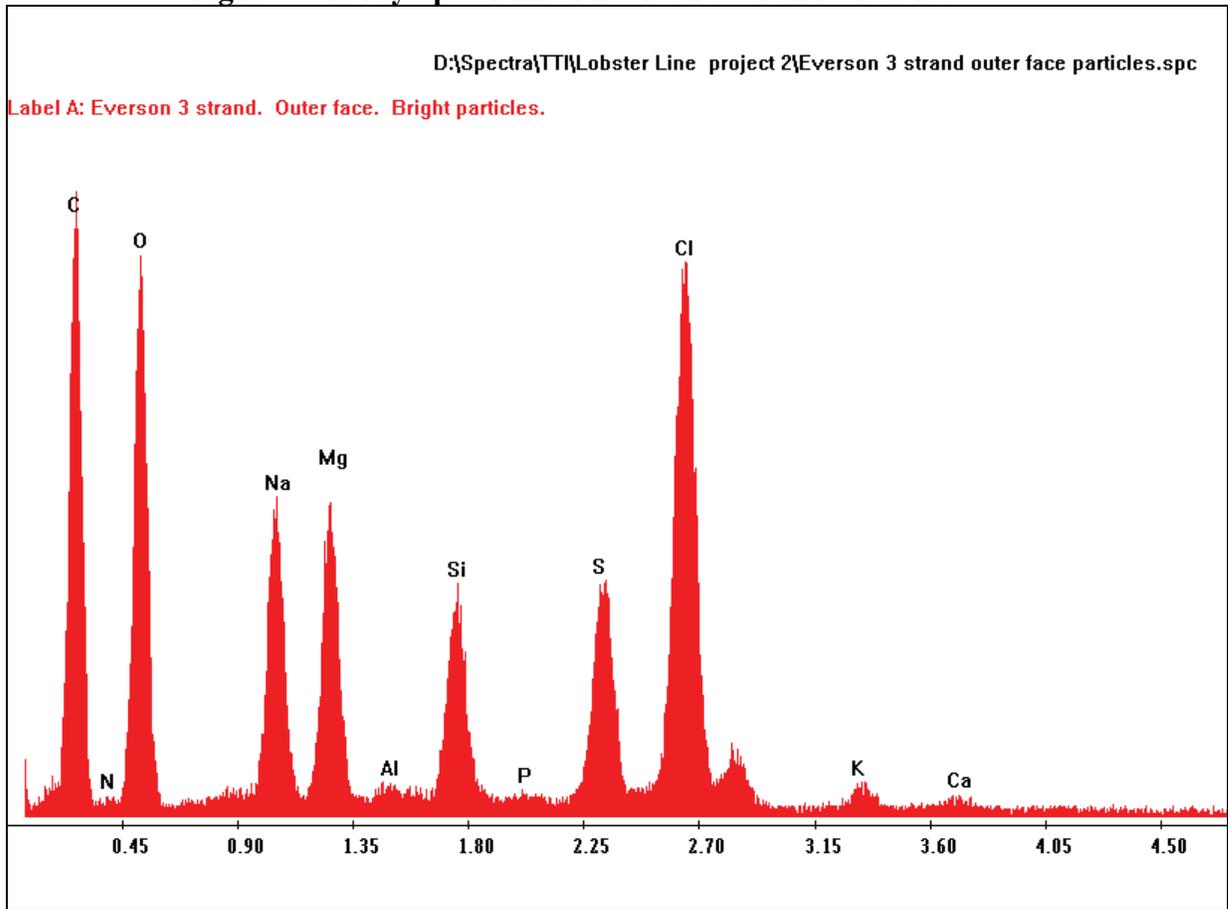
Figure 3 X-ray Spectrum of Everson 3-strand outer face

Figure 3 is an X-ray spectrum of the outer face of the strand. Both sand and salt appear to be contaminants.

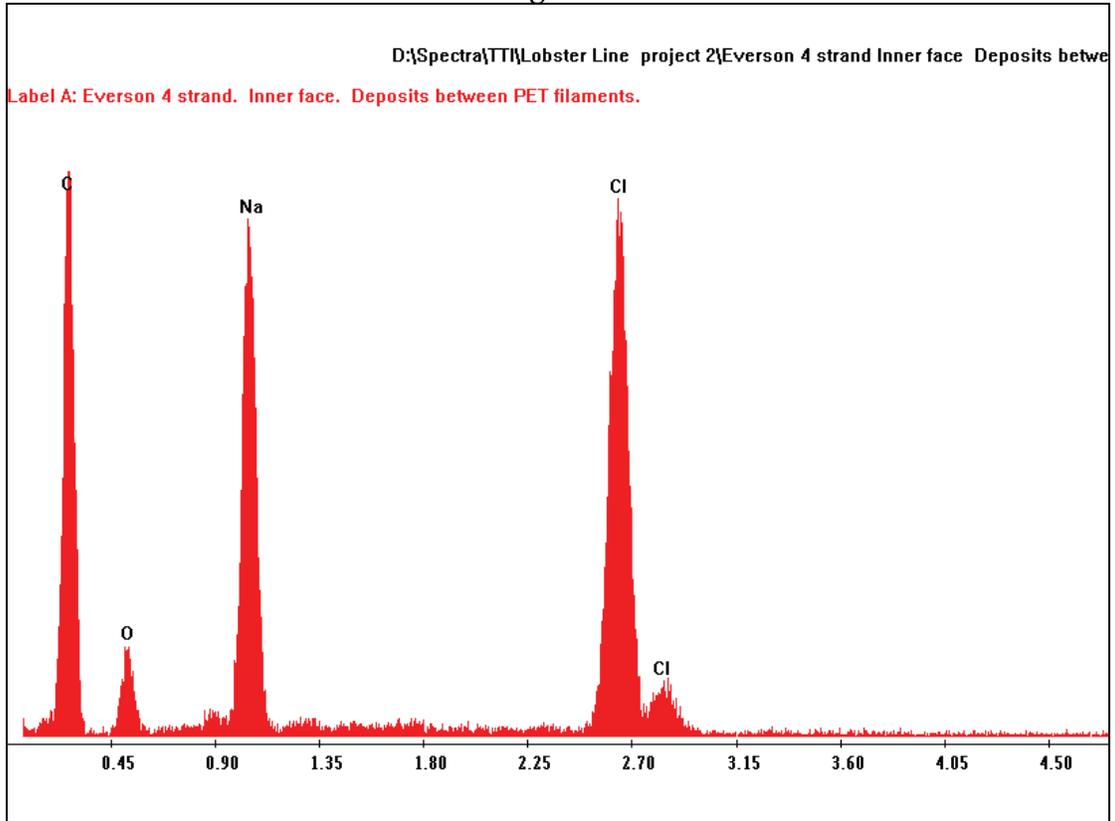
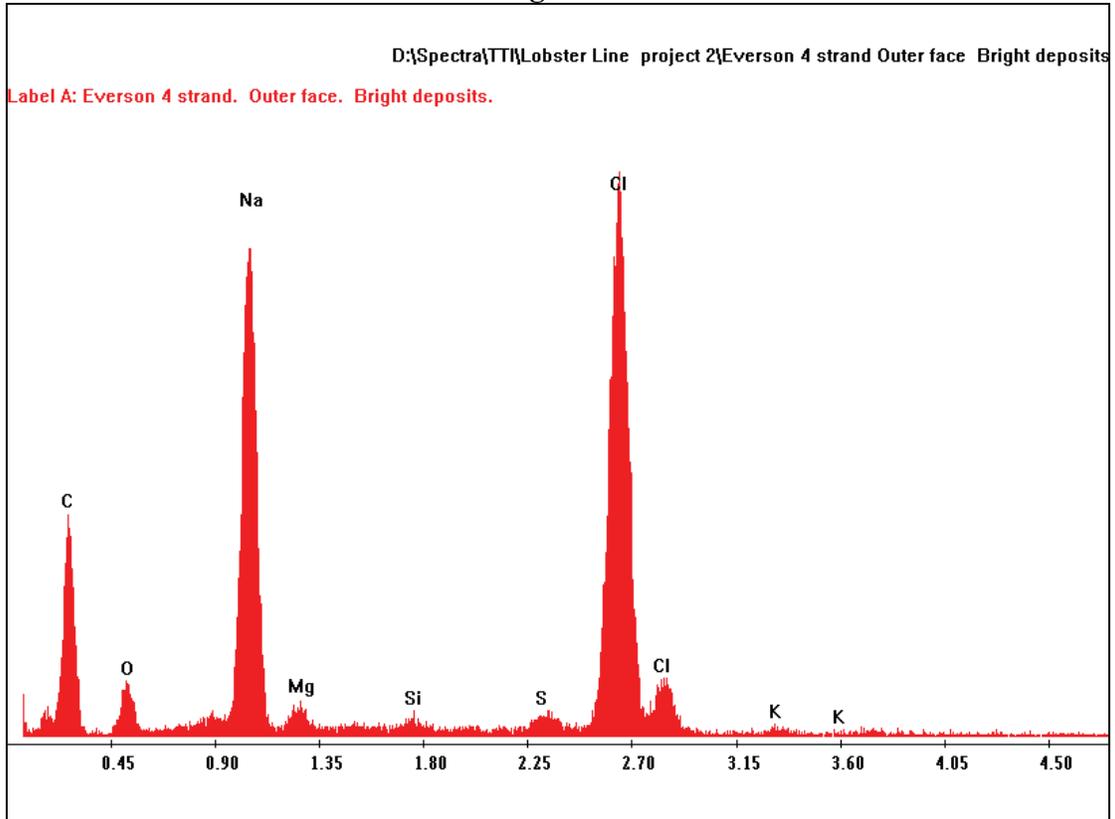
Figures 4 and 5 show X-ray spectra for the inner and outer faces. Salt appears to be the main particle contaminant.

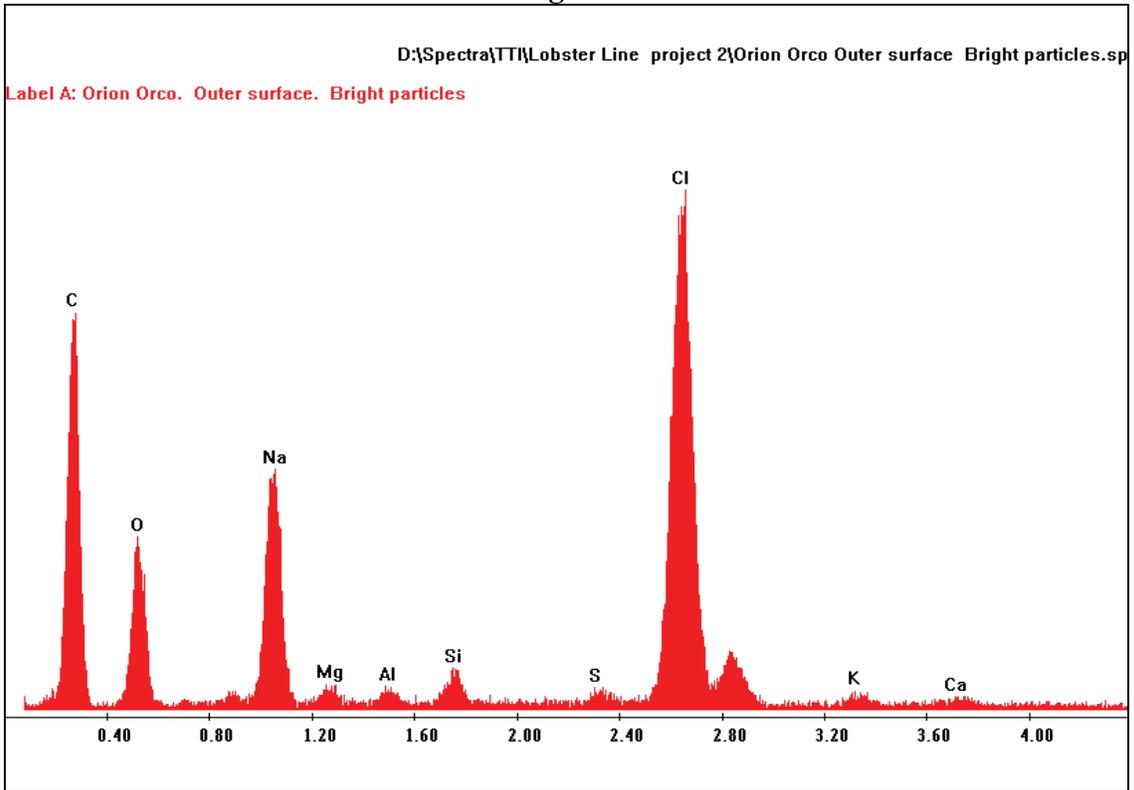
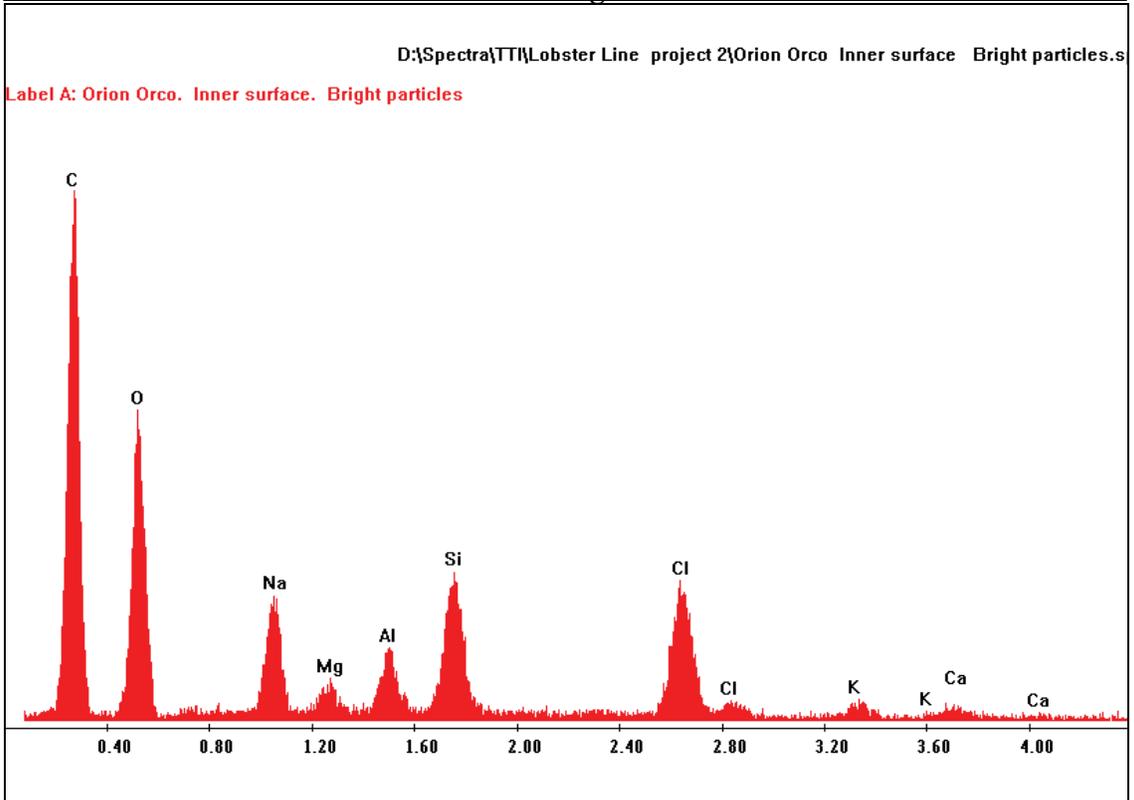
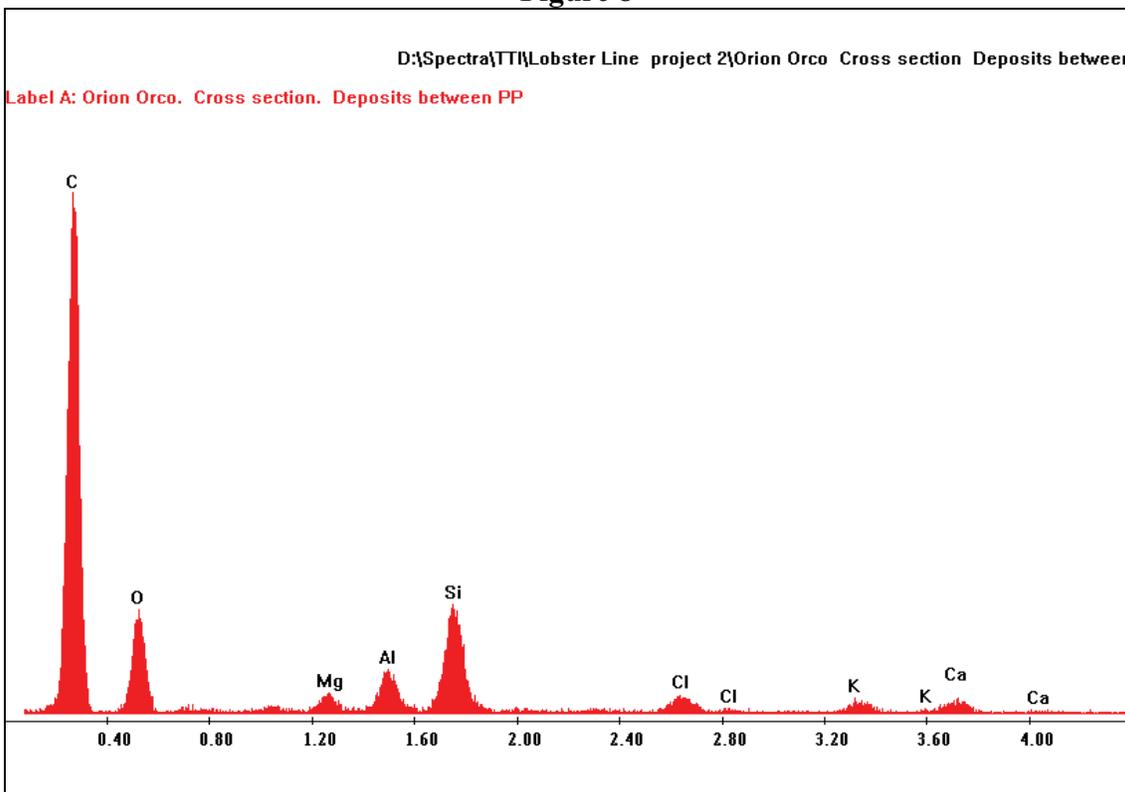
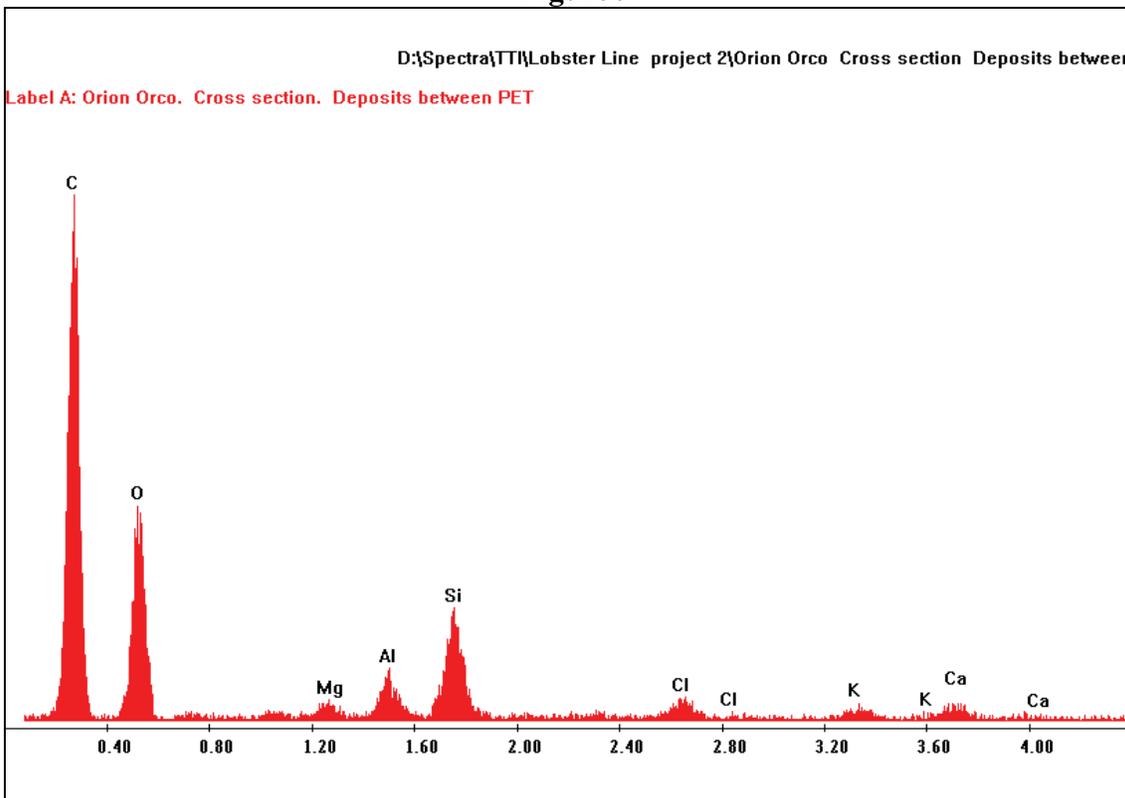
Figures 6 and 7 are X-ray spectra of sediment seen on the outer and inner surfaces, whilst Figures 8 and 9 are spectra of sediment seen in the cross-section, between the PP and polyester filaments respectively.

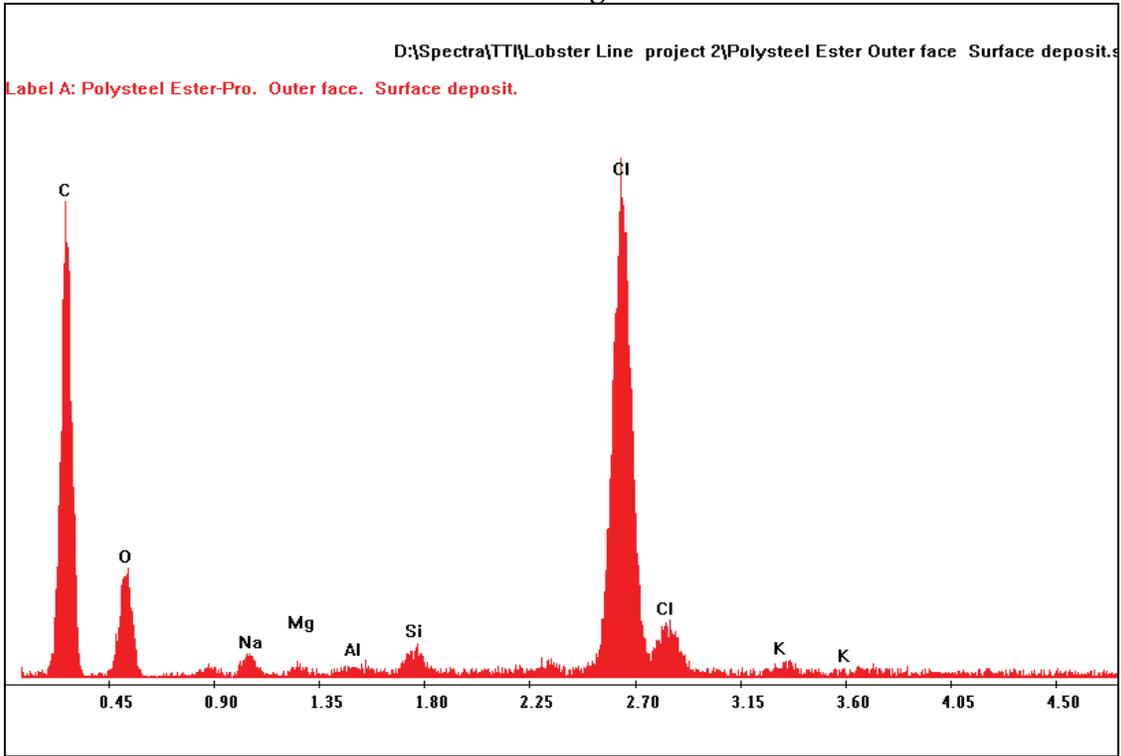
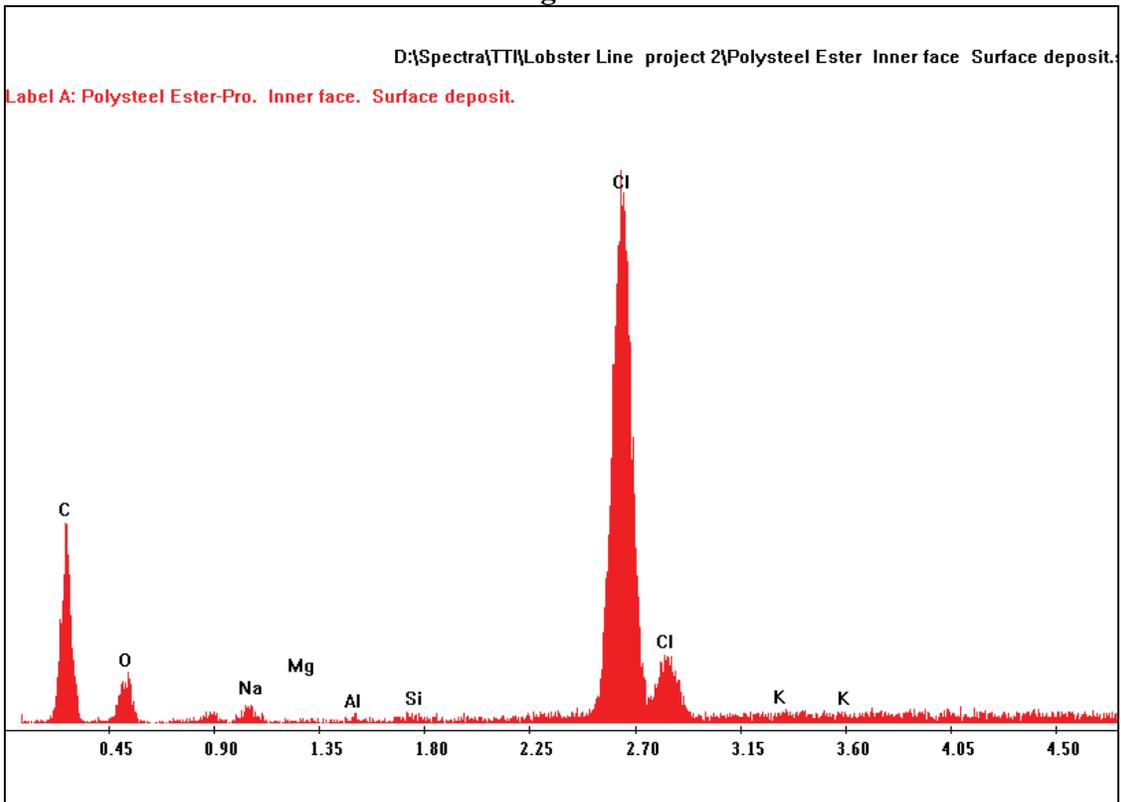
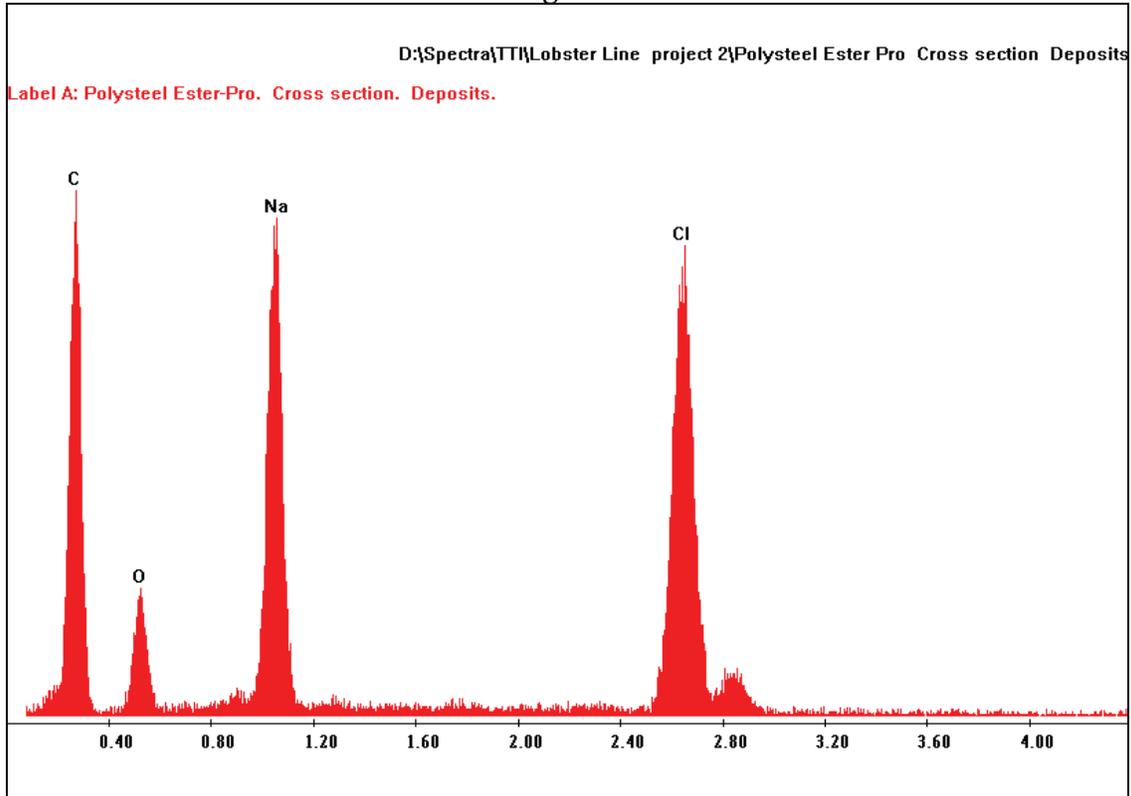
Figures 9,10 and 11 show X-ray spectra of deposits on the outer and inner faces and the cross-section.

Salt appears to be the main component of the sediment, though it can be seen that sodium, Na, was not strongly identified in the spectra of Figures 9 and 10.
