**DEPARTMENT OF
TELECOMMUNICATIONS & ENERGY**

PIPELINE ENGINEERING AND SAFETY DIVISION

INCIDENT REPORT

82 Marsh View Road, Chatham, Massachusetts
October 30, 2002

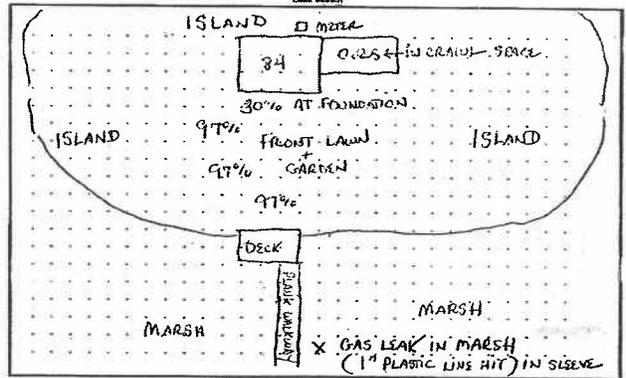
Exhibit 18: KeySpan Leak Investigation Report (1 of 3)

CGI TEST	
Positive	<u>97</u> % <input checked="" type="checkbox"/>
Negative	<input type="checkbox"/>

LEAK APPEARS TO BE ON	
Main	<input type="checkbox"/>
Service	<input checked="" type="checkbox"/>
Drp	<input type="checkbox"/>
Curb Valve	<input type="checkbox"/>
Main Valve	<input type="checkbox"/>
Other	<input type="checkbox"/>

COMMENTS:
 READINGS IN CRAWL SPACE 0.25 ON ARRIVAL / 30% AT FOUNDATION
 CALLED SUPERVISOR + STREET CREW
 SHUT GAS OFF AFTER LEAK WAS LOCATED
 GAS LEAK WAS MIGRATING THROUGH SLEEVE TO HOUSE FROM MARSH
