DEPARTMENT OF PUBLIC UTILITIES

PIPELINE ENGINEERING AND SAFETY DIVISION

INCIDENT REPORT

96 The Fenway, Boston, Massachusetts

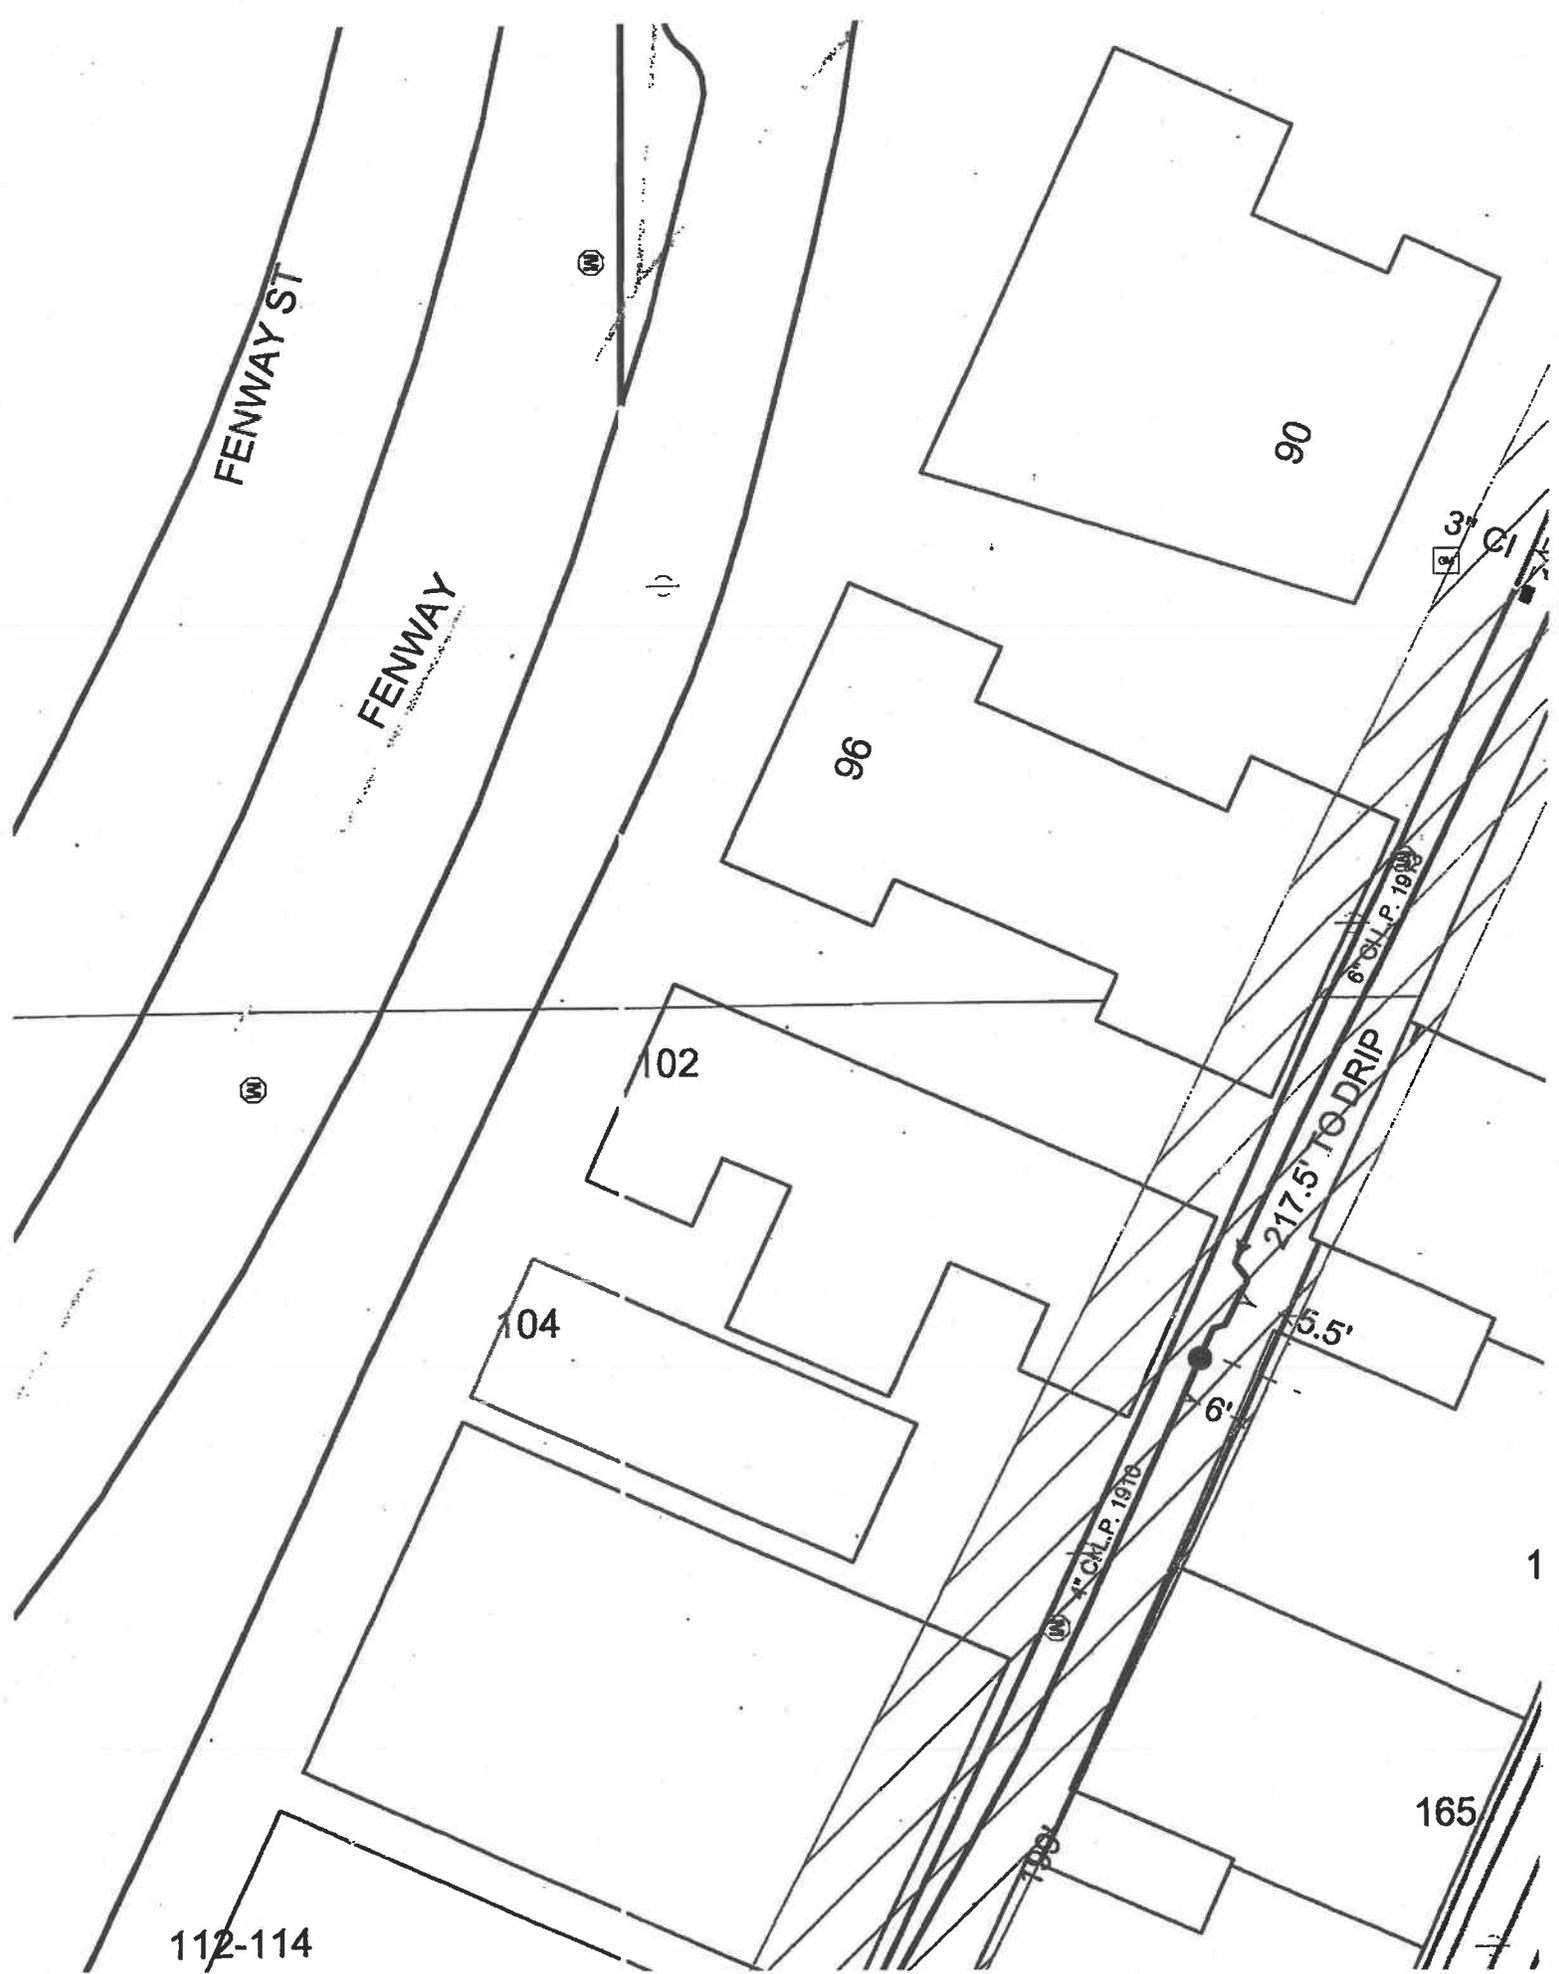
EXHIBIT 9

MAOP and History of Main Servicing 96 The Fenway

Response: The 6-inch cast iron main was installed in 1913. The MAOP for that main was 14 inches water column. The approximate operating pressure based on engineering models was 8.5 inches water column. Other than the main replacement work that was ongoing at the time of the incident, there is no record of any leaks, maintenance or replacement work performed on this main over the past year.
