INDOOR AIR QUALITY ASSESSMENT

**Duxbury Middle School
71 Alden Street
Duxbury, Massachusetts 02332**

Prepared by:
Massachusetts Department of Public Health
Bureau of Environmental Health
Indoor Air Quality Program
December 2009

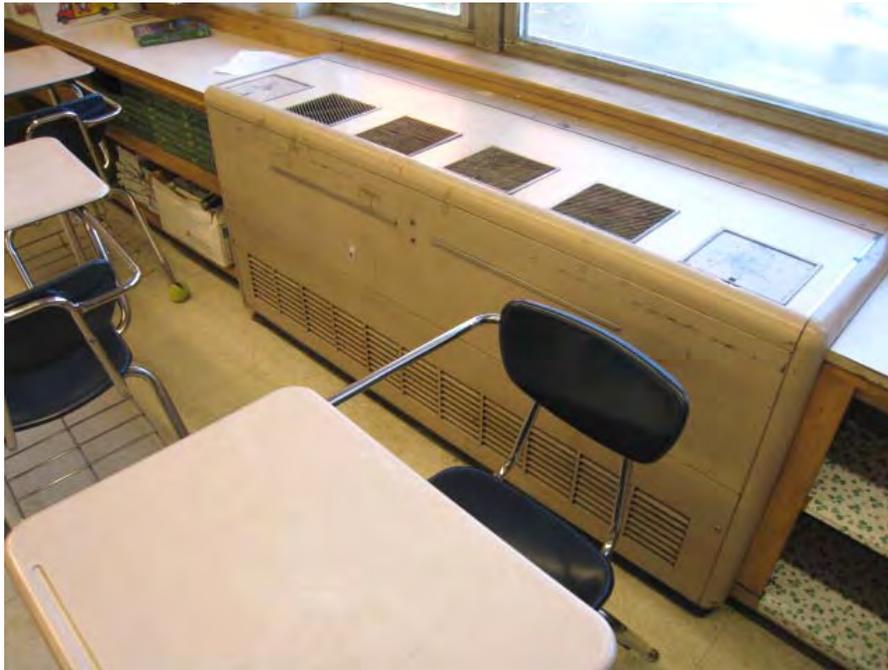
Picture 1

Fresh air is supplied to most classrooms by unit ventilators (univent) systems ([Pictures 1 through 3](#)). A univent draws air from the outdoors through a fresh air intake located on the exterior wall of the building or from rooftop vents ([Pictures 4 and 5](#)). Return air from the classroom is drawn through an air intake located at the base of the unit ([Figure 1](#)). Fresh and return air are mixed, filtered, heated and provided to classrooms through an air diffuser located in the top of the unit. A number of univents appeared to be original equipment, approximately 40 to 50 years old. Univents of this age are difficult to maintain because replacement parts are often unavailable.

1960's Vintage Univent

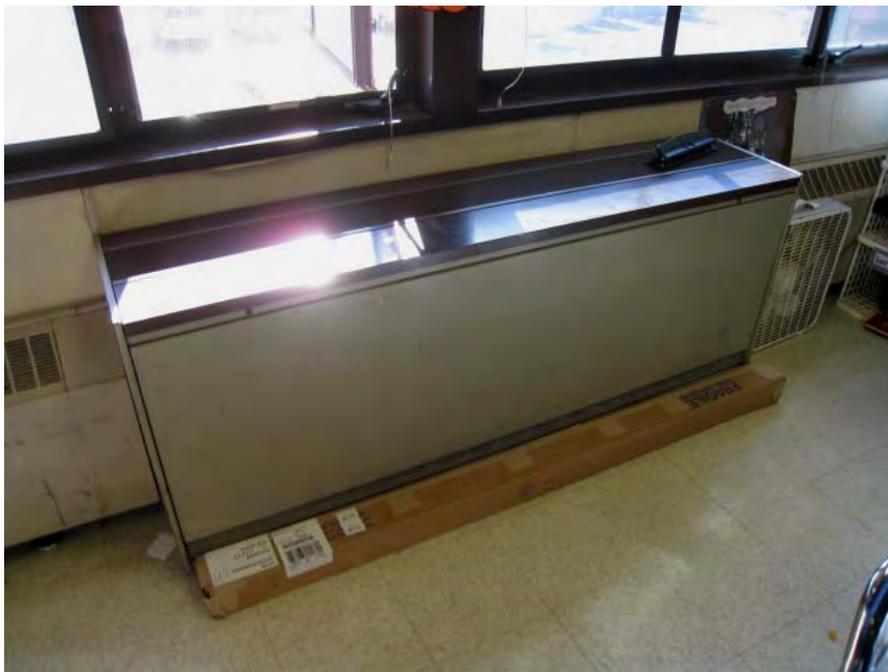
Picture 2

1970's Vintage Univent

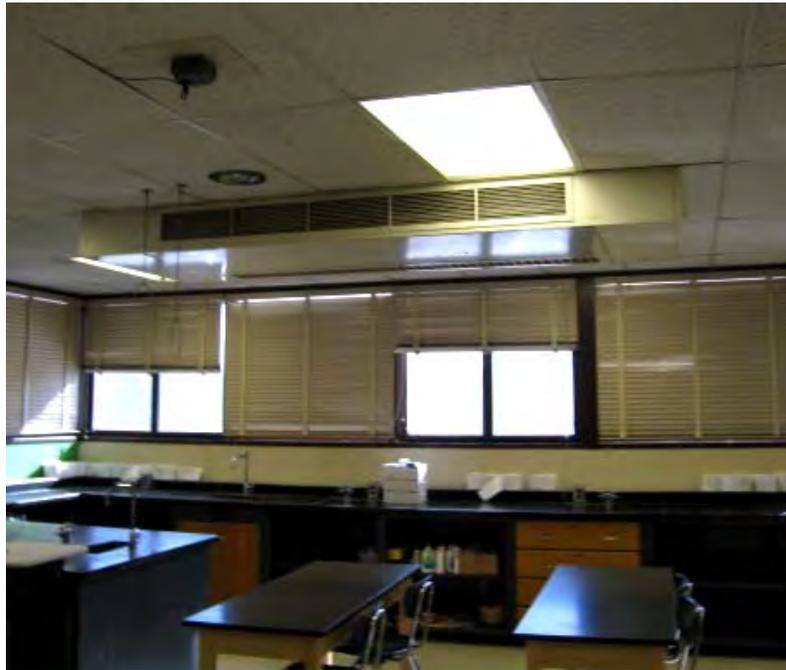
Picture 3

Ceiling-Mounted Univent

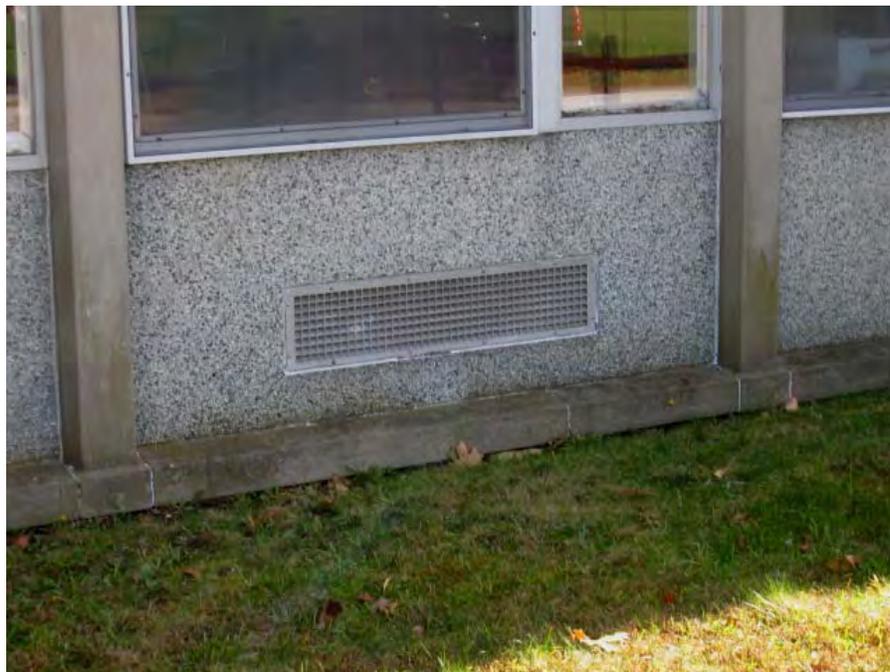
Picture 4

Univent Fresh Air Intake

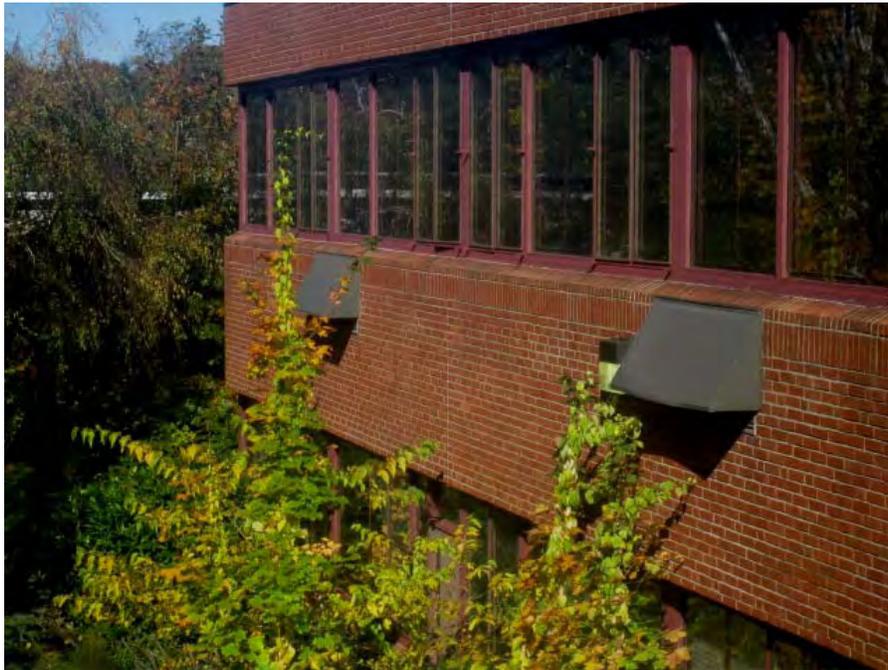
Picture 5

Univents have control settings of 'on or off' and 'low, medium or high' ([Picture 6](#)). Univents were found 'off' in many areas ([Table 1/Picture 6](#)); therefore, there was no means to provide mechanical ventilation to these classrooms at the time of the assessment. In several cases, univent fresh air intakes were sealed on the exterior of the building with plywood or cardboard and duct tape ([Pictures 7 and 8](#)). In order for univents to provide fresh air as designed, intakes/returns must remain free of obstructions. Importantly, these units must remain 'on' and be allowed to operate while rooms are occupied.

Univent Fresh Air Intakes Covered with Metal Hoods

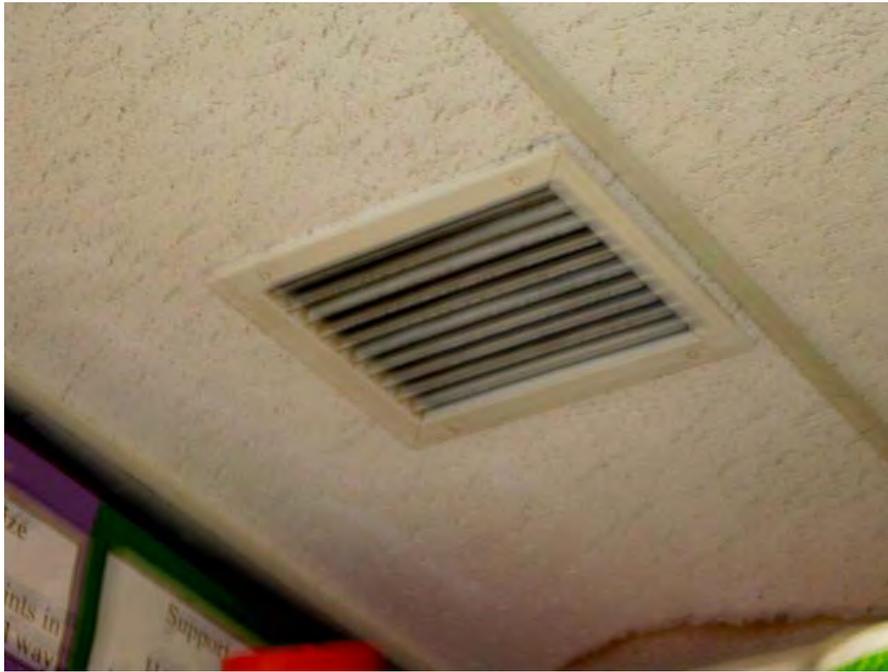
Picture 9

Exhaust ventilation in classrooms is provided by wall or ceiling vents ducted to rooftop motors ([Pictures 9 and 10](#)). Many exhaust vents were obstructed ([Picture 11](#)) and/or deactivated at the time of the assessment. As with univents, in order to function properly, exhaust vents must be activated and allowed to operate while rooms are occupied. Without adequate supply and exhaust ventilation, excess heat and environmental pollutants can build up and lead to indoor air/comfort complaints.

Ceiling-Mounted Exhaust Vent

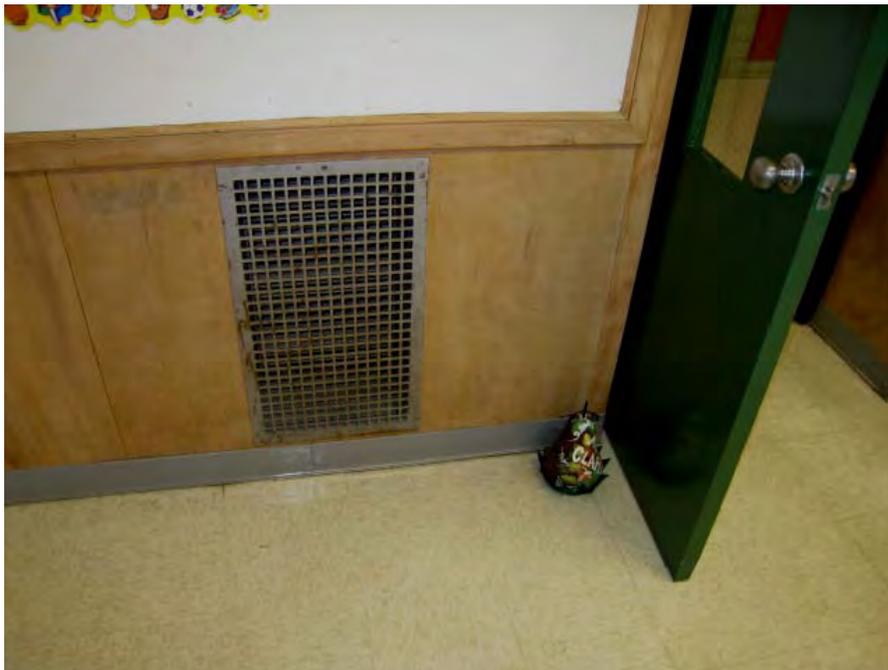
Picture 10

Wall-Mounted Exhaust Vent

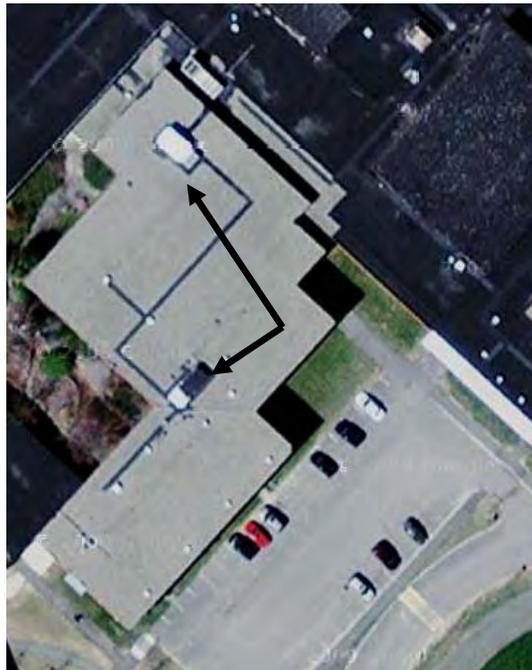
Picture 12

mounted air-handling units (AHUs) ([Pictures 12](#) and 13). Fresh air is distributed via ceiling-mounted air diffusers ([Picture 14](#)) and ducted back to AHUs via ceiling or wall-mounted return vents ([Pictures 15](#) and 16). Several of these units had been deactivated or were inoperable at the time of the assessment; therefore, there was no means of mechanical air exchange in these areas, which was evidenced by the elevated carbon dioxide levels. Of particular note was the lack of mechanical ventilation in interior rooms without windows (e.g., guidance suite, 418, 522, 518). Since these areas cannot open windows they are entirely dependant on mechanical ventilation for air exchange. At the time of the assessment, Mr. Burgess reported that he believed a fuse was out that controlled the unit. In subsequent correspondence with Mr. Burgess, he reported that the fuse had been replaced and the AHU reactivated.

Rooftop AHUs

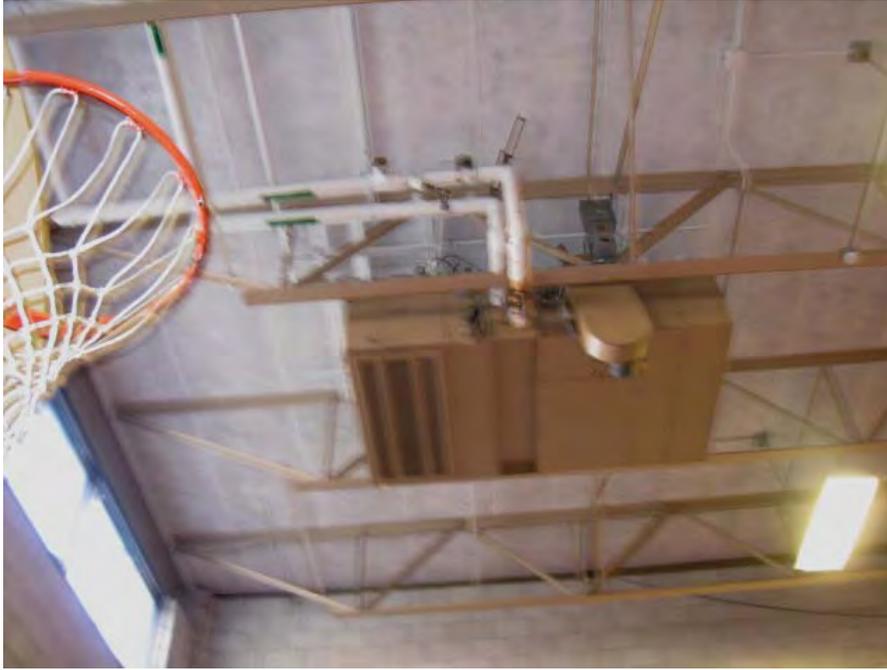
Picture 13

Ceiling-Mounted AHU in Gym

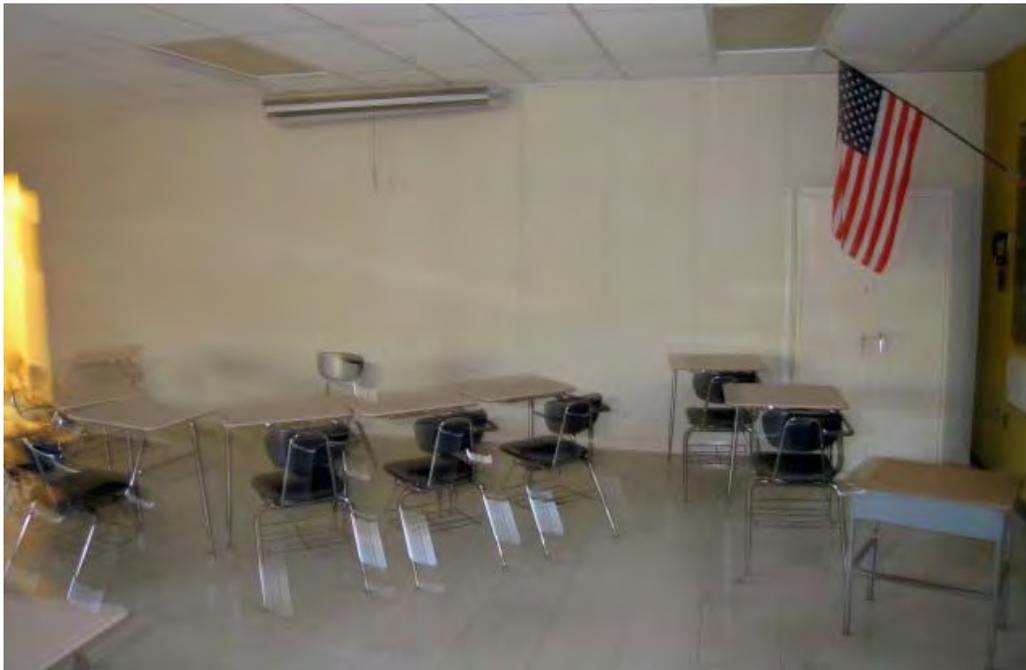
Picture 22

During the assessment, Mr. Burgess reported that several weeks previous to the assessment, mold growth was observed on a flexible cloth covered wall in room 212. At the time of the assessment, the flexible wall had been removed and replaced with a solid, floor to ceiling, paneled wall ([Pictures 22](#) and [23](#)). No current evidence of water damage or mold was observed during the MDPH assessment.

“New” Floor to Ceiling Paneled Wall in Classroom 212

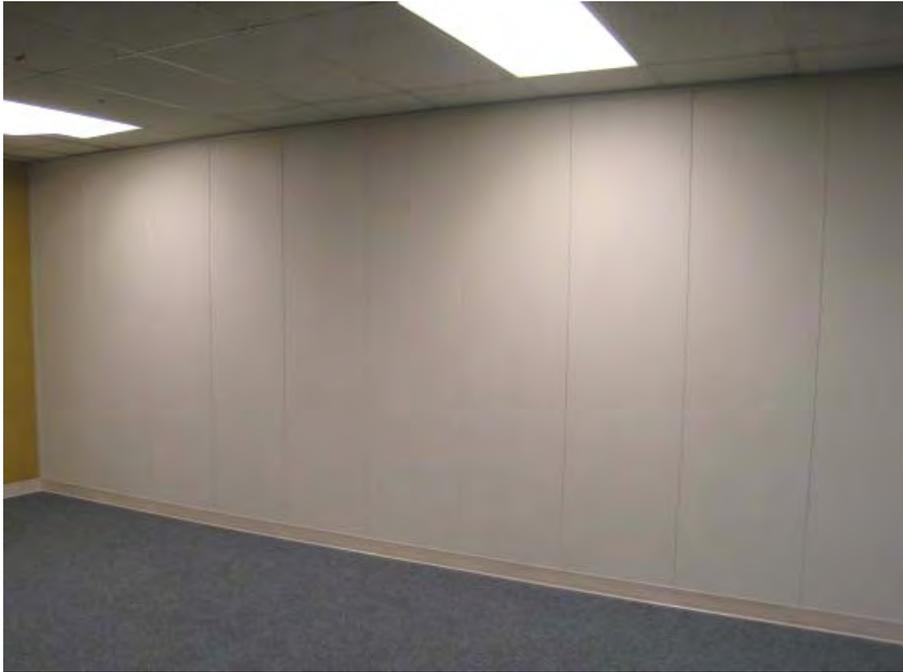
Picture 23

“New” Floor to Ceiling Paneled Wall in Classroom 212

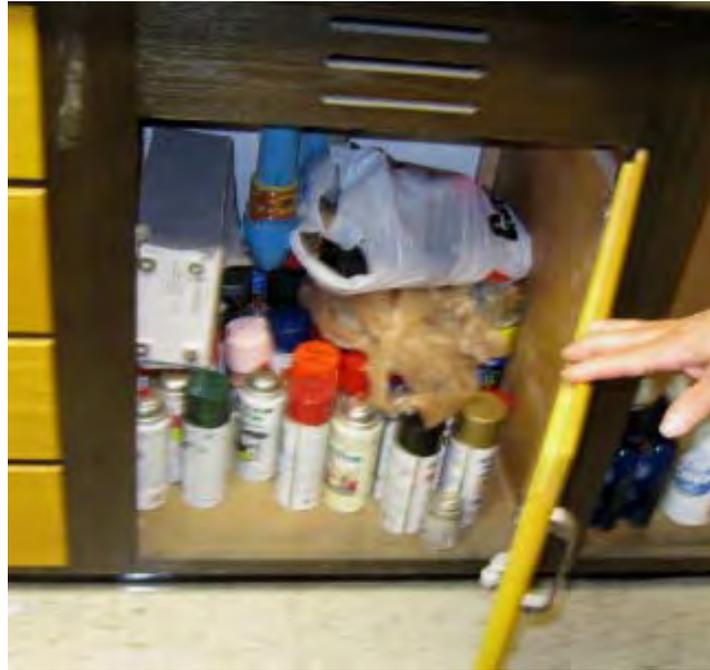
Picture 39

Multiple Cans of Spray Paint in Classroom Cabinet under Sink

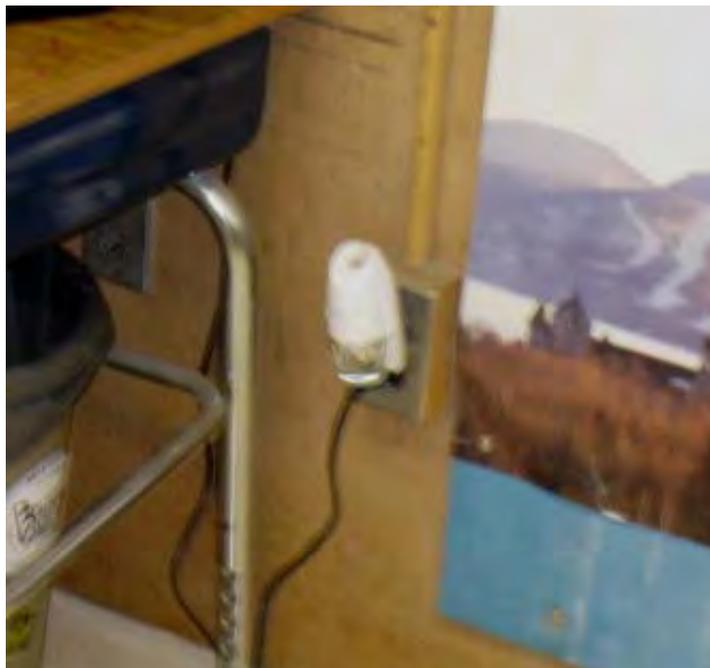
Picture 40

Plug in air deodorizers and other scented materials (i.e., reed/oil diffusers) were observed in some areas ([Table 1/Pictures 40](#) and 41). Air deodorizers can contain chemicals that can be irritating to the eyes, nose and throat of sensitive individuals. Furthermore, deodorizing agents do not remove materials causing odors, but rather mask odors that may be present in the area.

Plug-in Air Deodorizer

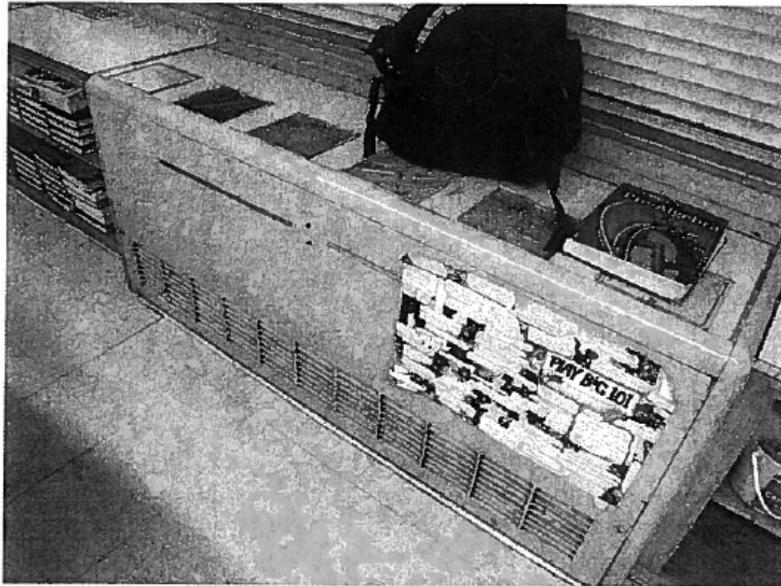
Picture 3

At the rear of classroom 109, BEH staff observed damaged/exposed insulation that may contain asbestos around hot water pipes that feed the unit ventilator (univent; Pictures 1 and 2). It appears that the original univent in room 109 (Picture 3) was replaced with a more modern unit (Picture 4). Installation of this new univent required the destruction of the adjacent cabinet for access to hot water pipes feeding the univent. It was unknown at the time of the assessment when this work had occurred. In subsequent conversation with Mr. Burgess, it was reported that this work was conducted approximately 6 years ago as a result of a frozen pipe.

Original 1060's Vintage Univent

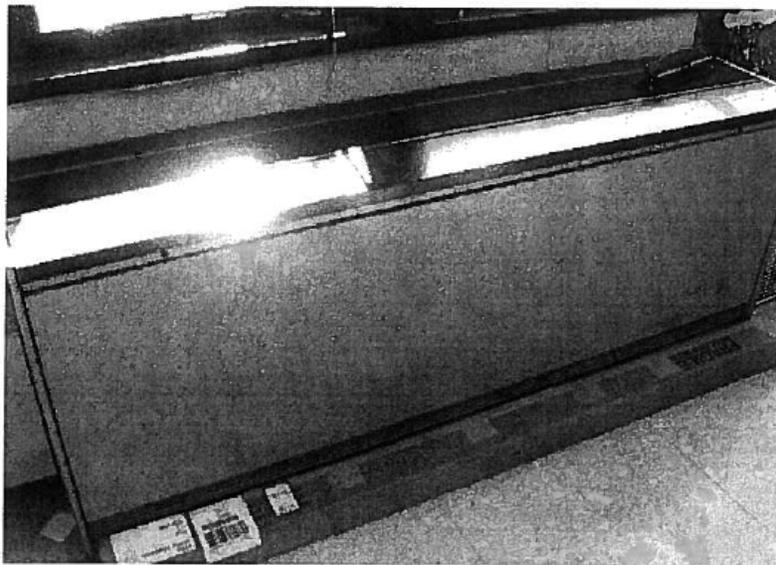
Picture 4

Modern Univent as Seen in Classroom 109

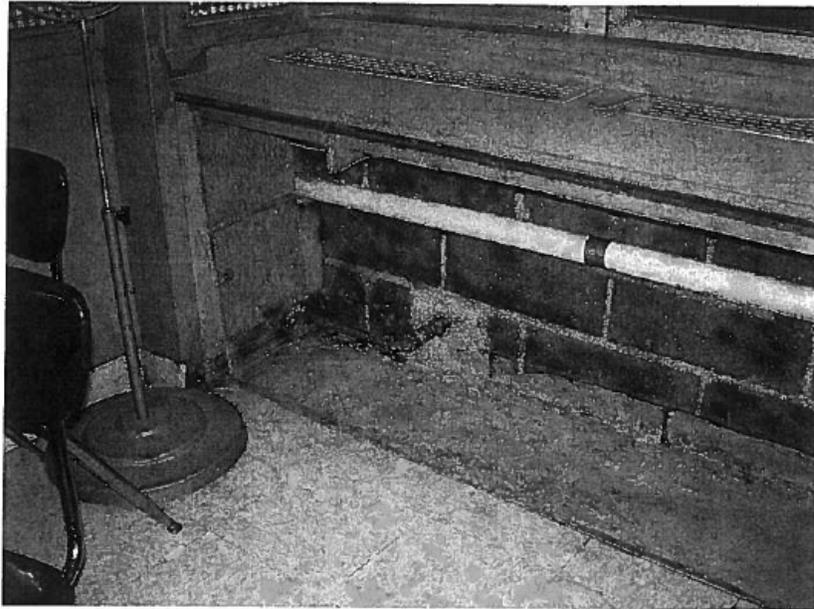
Picture 5

**Post-Remediation Picture of Univent Pipes in Classroom 109
(Picture Provided by Don Burgess, Duxbury Public Schools)**

On November 2nd, Mr. Burgess again contacted Mr. Holmes to report that the pipes were fully remediated (Pictures 5 and 6). Mr. Holmes asked that reports related to the asbestos remediation be provided to MDPH for its files.

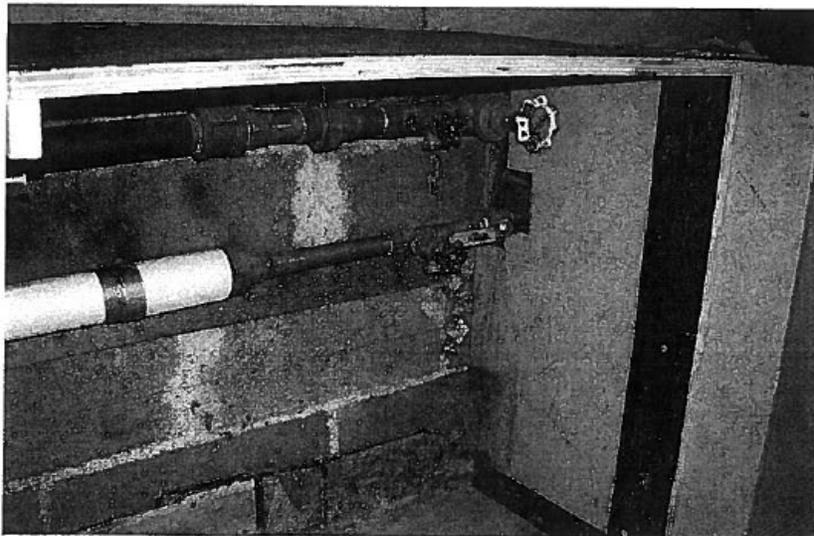
Picture 6

**Post-Remediation Picture of Univent Pipes in Classroom 109
(Picture Provided by Don Burgess, Duxbury Public Schools)**
