# **INDOOR AIR QUALITY ASSESSMENT**

**Galvin Middle School  
525 Main St  
Wakefield, MA**

Prepared by:  
The Massachusetts Department of Public Health  
Bureau of Environmental Health  
August 2010

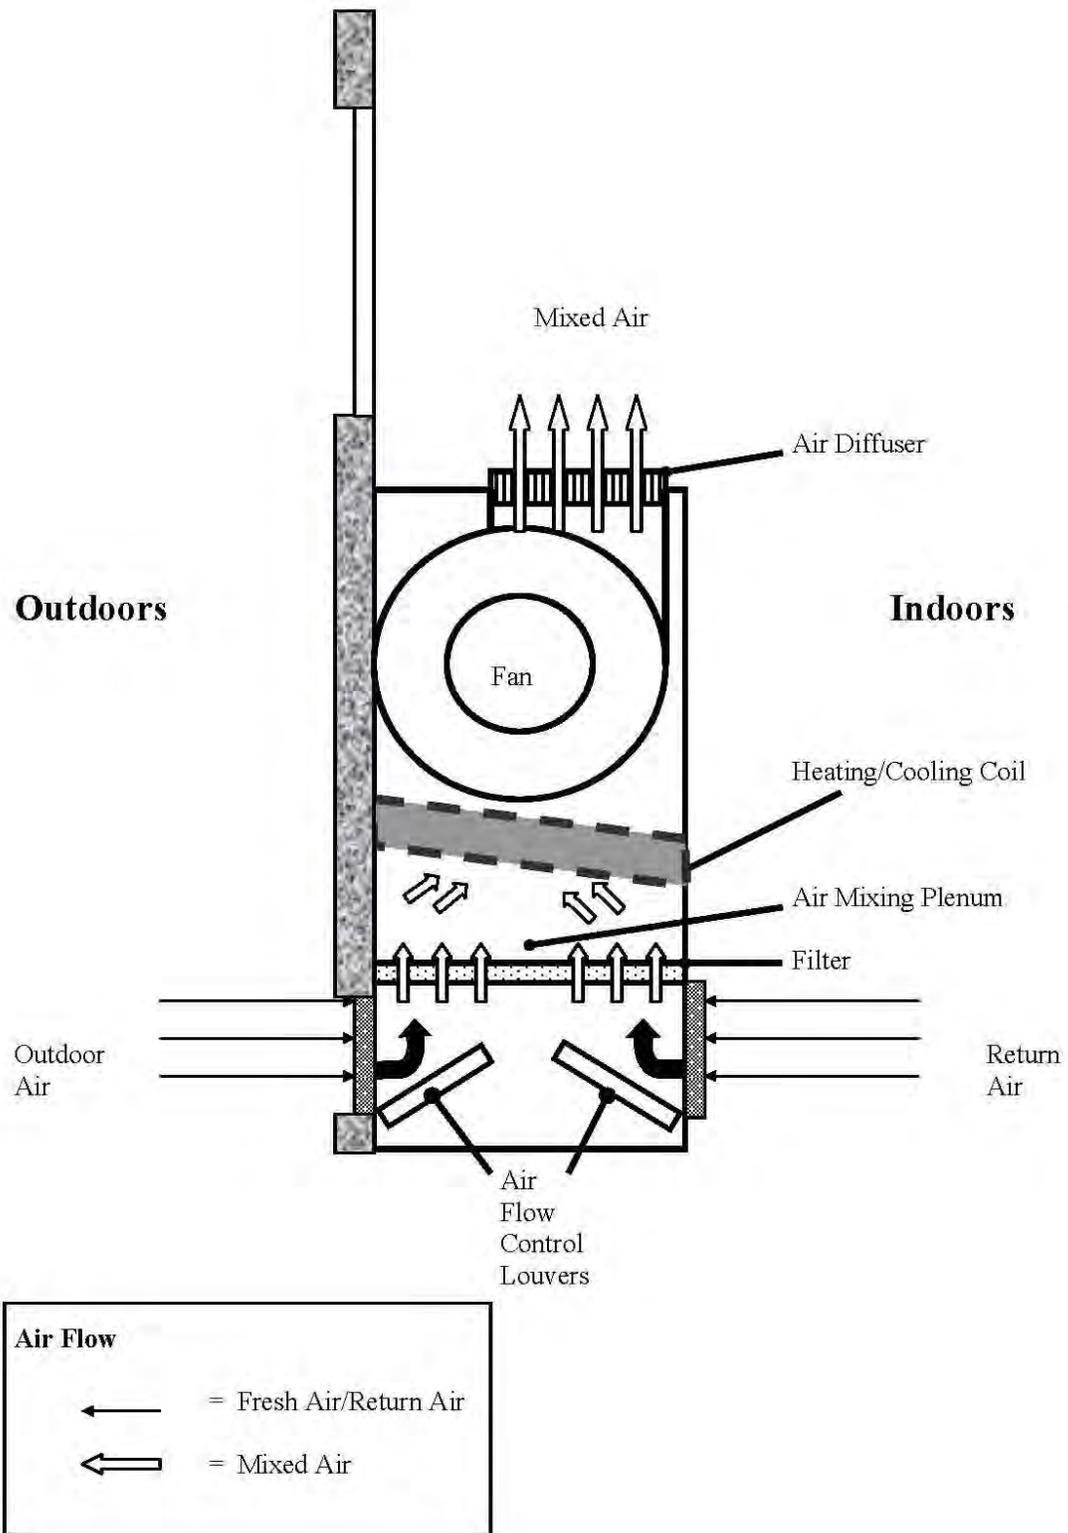
Figure 4

Fresh air in classrooms throughout the school is supplied by unit ventilator (univent) systems. A univent draws outdoor air through an air intake located on the exterior wall of the building and returns air from the room through an air intake located at the base of the unit ([Figure 4](#); Picture 1). Fresh and return air are mixed, filtered, heated, and delivered to the room through an air diffuser located in the top of the unit. Univents were deactivated in a number of areas during both days of assessment. Univents were obstructed by items such as chairs, tables, desks, and books in many classrooms (Pictures 1 and 2). In order to function as designed, univents must be activated and allowed to operate free of obstructions and blockages. Lastly, a container of sand was observed on the univent in classroom 248. Over time, sand and other particles that fall into the univent can result in damage to the unit.

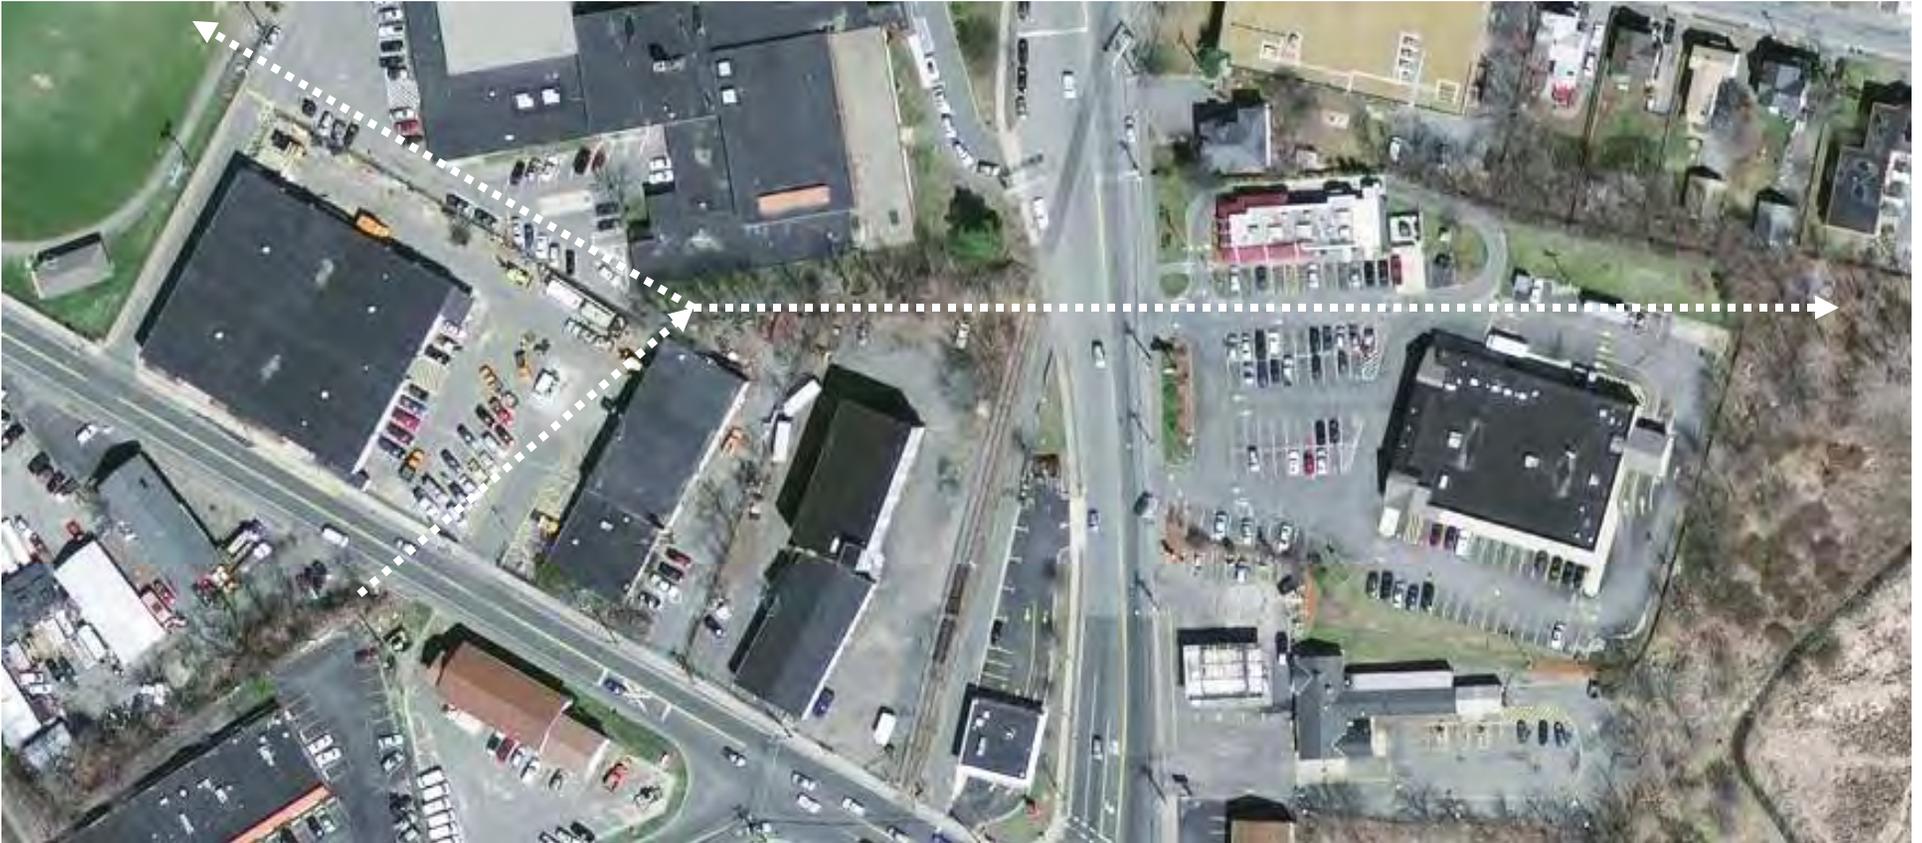
Figure 5

Several staff members reported concerns about potential contamination of school property from Kytron Circuits Corp., a former circuit board manufacturing company which abuts the GMS property. Staff were concerned about contamination of the school through flooding and groundwater. As reported by building staff, the area located to the south of the GMS was flooded in the spring of 2006. Building occupants also reported that the school was not affected by the flooding, but North Avenue (south of the GMS) had flooded, likely from overflow of Crystal Lake. The source of the flood was likely a stream that passes under North Street (Picture 22) and appears to pass under the Wakefield Public Works Yard. The stream then splits to run roughly parallel to the school to the east where it joins with the Mill River (Figure 5). Concerns were raised that flooding of the areas surrounding the school may have resulted in hazardous

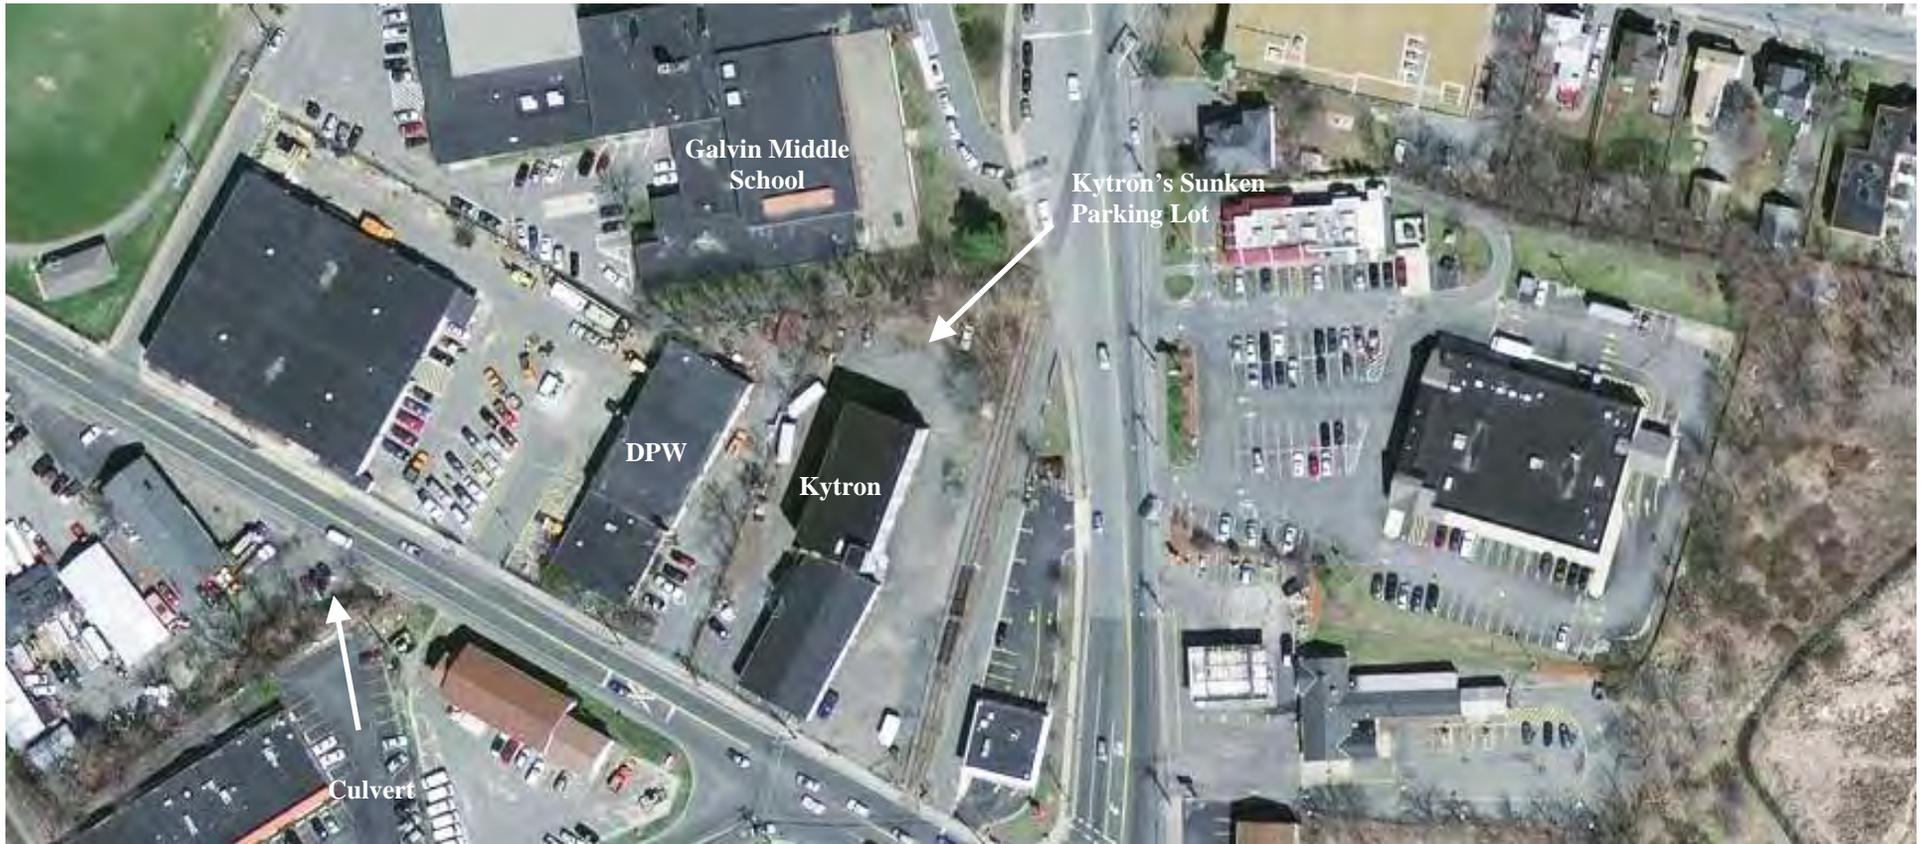
Figure 6

materials from the Kytron Circuits Corporation impacting the indoor environment of the GMS. The Kytron site is situated in a lot to the south of the GMS (Figure 6).

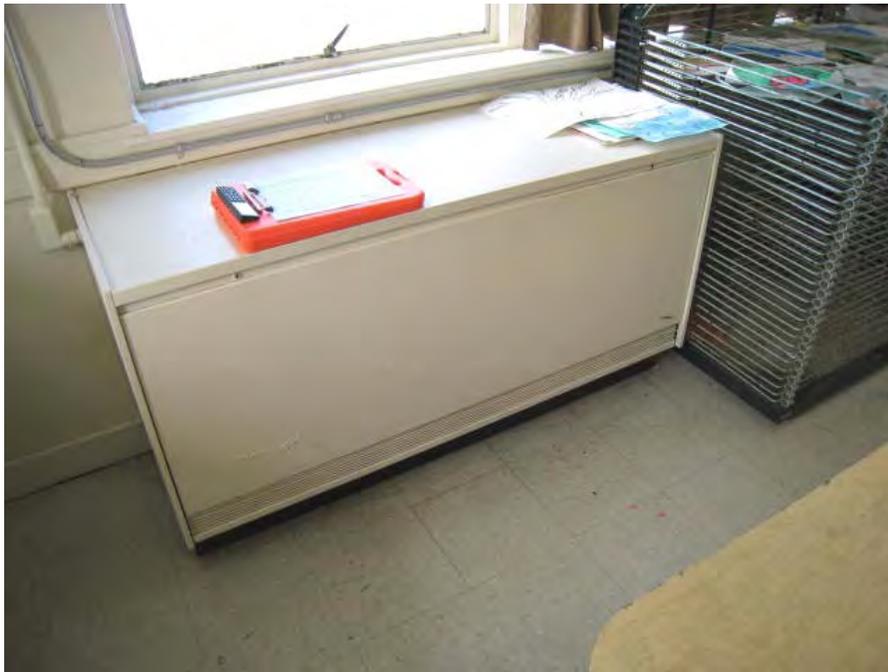
**Picture 4**

The 1974 classroom wing employs unit exhaust ventilators (Picture 4). They are controlled by an internal thermostat, which activates the unit at a set temperature. Several of these units were not functioning at the time of assessment, despite high occupancy.

**Unit exhaust ventilator**

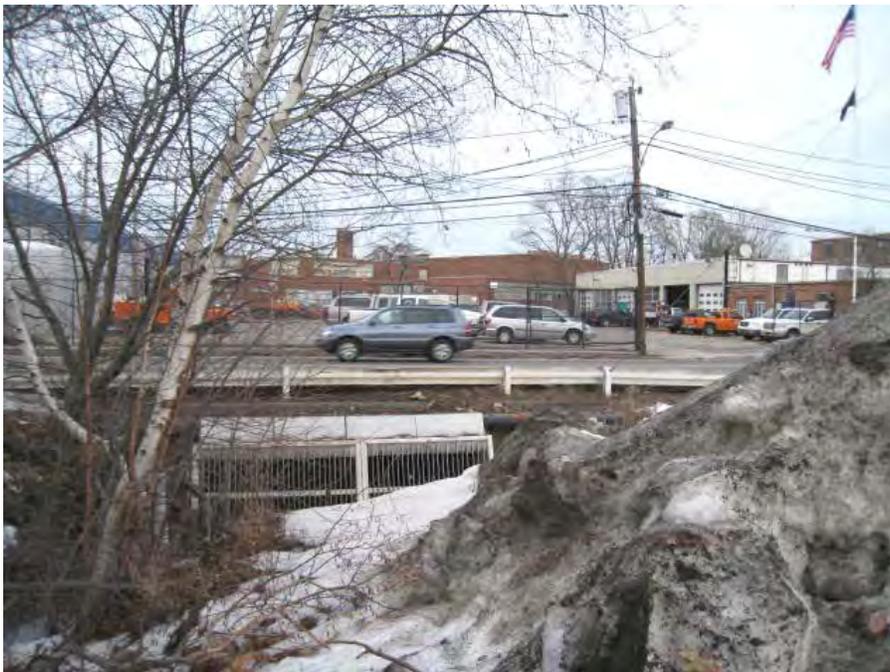
**Picture 22**

**Culvert to stream passing beneath North Avenue**
