# **Mold/Water Damage Investigation**

**Winchester High School  
80 Skillings Road  
Winchester, Massachusetts**

Prepared by:  
Massachusetts Department of Public Health  
Bureau of Environmental Health  
Indoor Air Quality Program  
August 2010

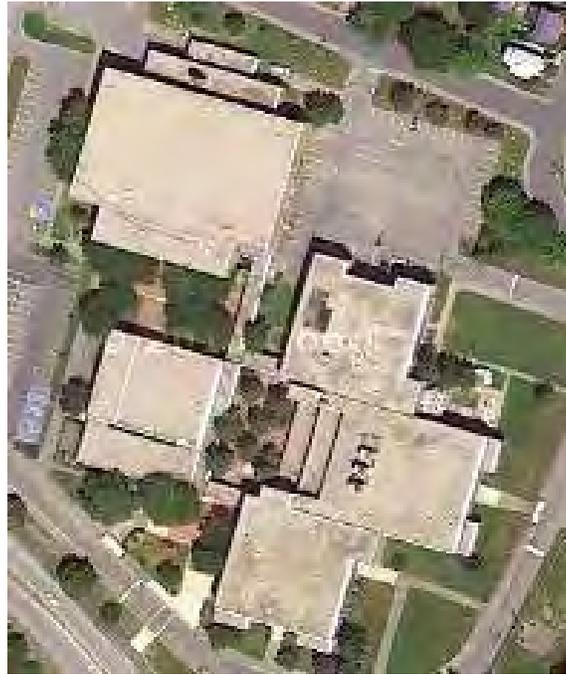
**Picture 1**

The WHS is a three-story brick building constructed in the early 1970s. The school consists of 5 building blocks structured around a courtyard (Picture 1). Windows in the building are not openable.

**The Five Buildings of Winchester High School**
