# **INDOOR AIR QUALITY ASSESSMENT**

**Salemwood School  
529 Salem Street  
Malden, Massachusetts**

Prepared by:  
Massachusetts Department of Public Health  
Bureau of Environmental Health  
Indoor Air Quality Program  
September 2011

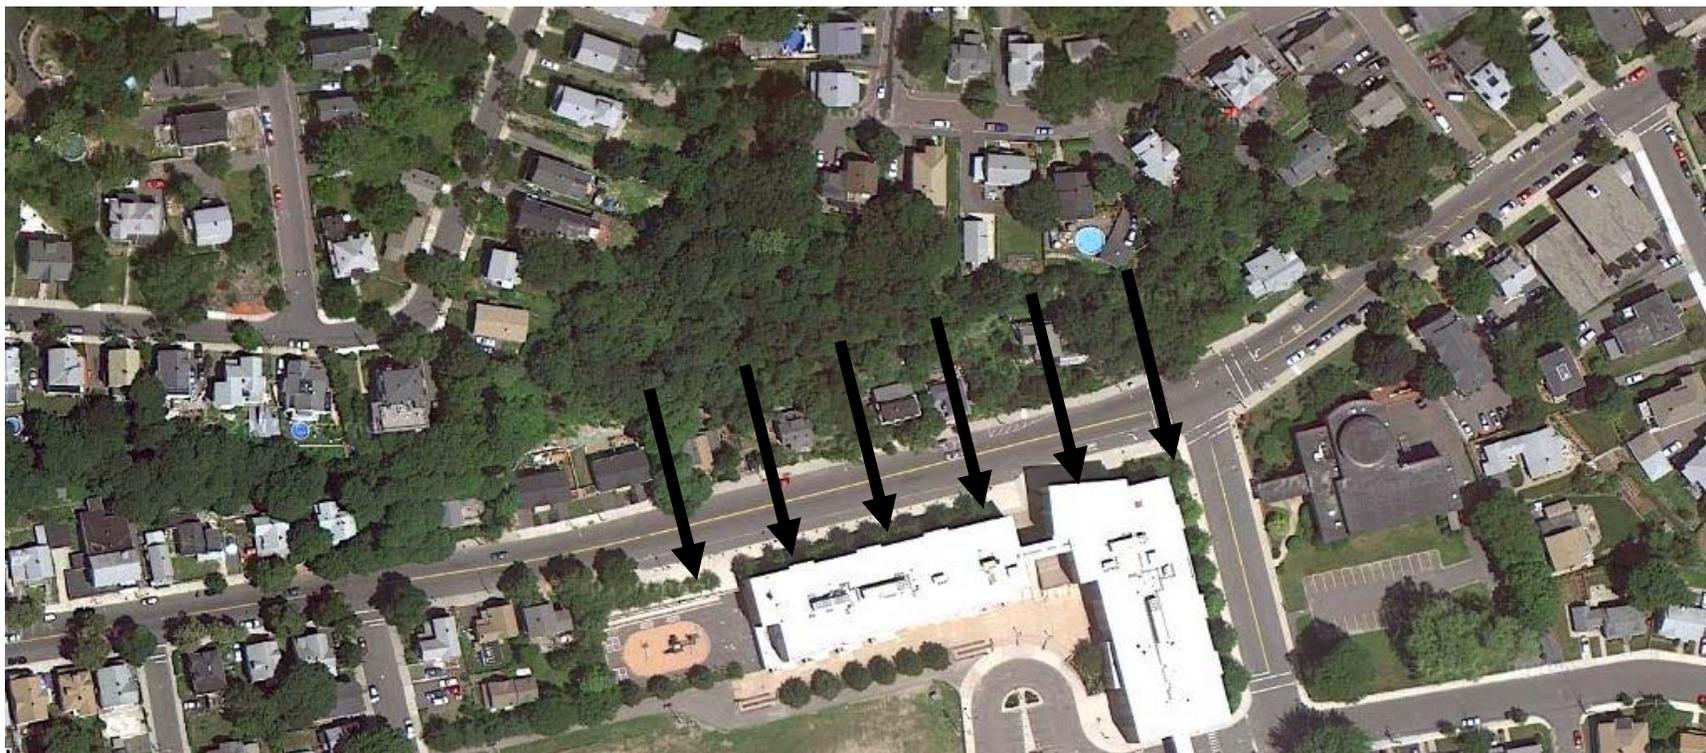
**Figure 2: Direction of Groundwater around the SES**

BEH staff conducted a perimeter inspection of the building's exterior to identify potential sources of water penetration. The administrative area has sustained water damage on repeated occasions, wetting the gypsum wallboard (GW) and wall-to-wall carpeting. The GW was replaced with cement board. Although the carpeting has been cleaned, it has not been replaced. The administrative area offices are located on the ground floor, which has a below grade exterior foundation wall along the Salem Street sidewalk. Salem Street is below a steep hill, which directs groundwater towards the building (Figure 2). Seams between the sidewalk and building as well as the building and slab appeared damaged (Pictures 6 through 8) allowing water to penetrate under the sidewalk and contact the exterior wall of the SES foundation.

**Black arrows show the expected major direction of groundwater flow in the vicinity**
