INDOOR AIR QUALITY ASSESSMENT

**Pembroke Community Center
128 Center Street
Pembroke, Massachusetts**

Prepared by:
Massachusetts Department of Public Health
Bureau of Environmental Health
Indoor Air Quality Program
June 2012

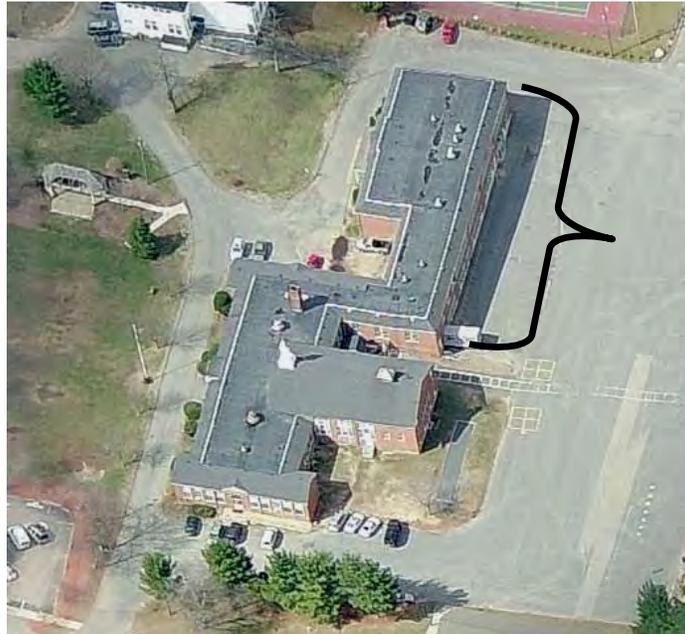
Picture 1

The PCC was originally constructed as a single-story red brick elementary school in the 1930s. A two-story red brick addition was built in the 1950s (Picture 1). A dirt crawlspace exists under the original 1930s portion of the building for utilities. It was reported that the building had been left vacant for some time in the 1970s before it was reopened as a bingo hall and community center in the late 1970s or early 1980s. No renovations or improvements have been made with the exception of window replacement in portions of the 1930s building and the creation of the TV studio in the 1950s wing. The original 1930s wing contains a daycare center, game room for afterschool programs, a sewing room, and office space. The 1950s wing contains two large bingo halls on the first and second floors (the lower bingo hall and the upper bingo hall respectively), a food pantry and the TV studio. Windows are openable throughout the building.

Aerial View of Pembroke Community Center Showing 1930s Original Building (South) Containing the Day Care Center, and 1950s Addition Containing Bingo Halls (North, Bracket)
