# **INDOOR AIR QUALITY ASSESSMENT**

**Advanced Math and Science Academy Charter School  
165, 199, and 201 Forest Street  
Marlborough, MA**

Prepared by:  
Massachusetts Department of Public Health  
Bureau of Environmental Health  
Indoor Air Quality Program  
December 2013

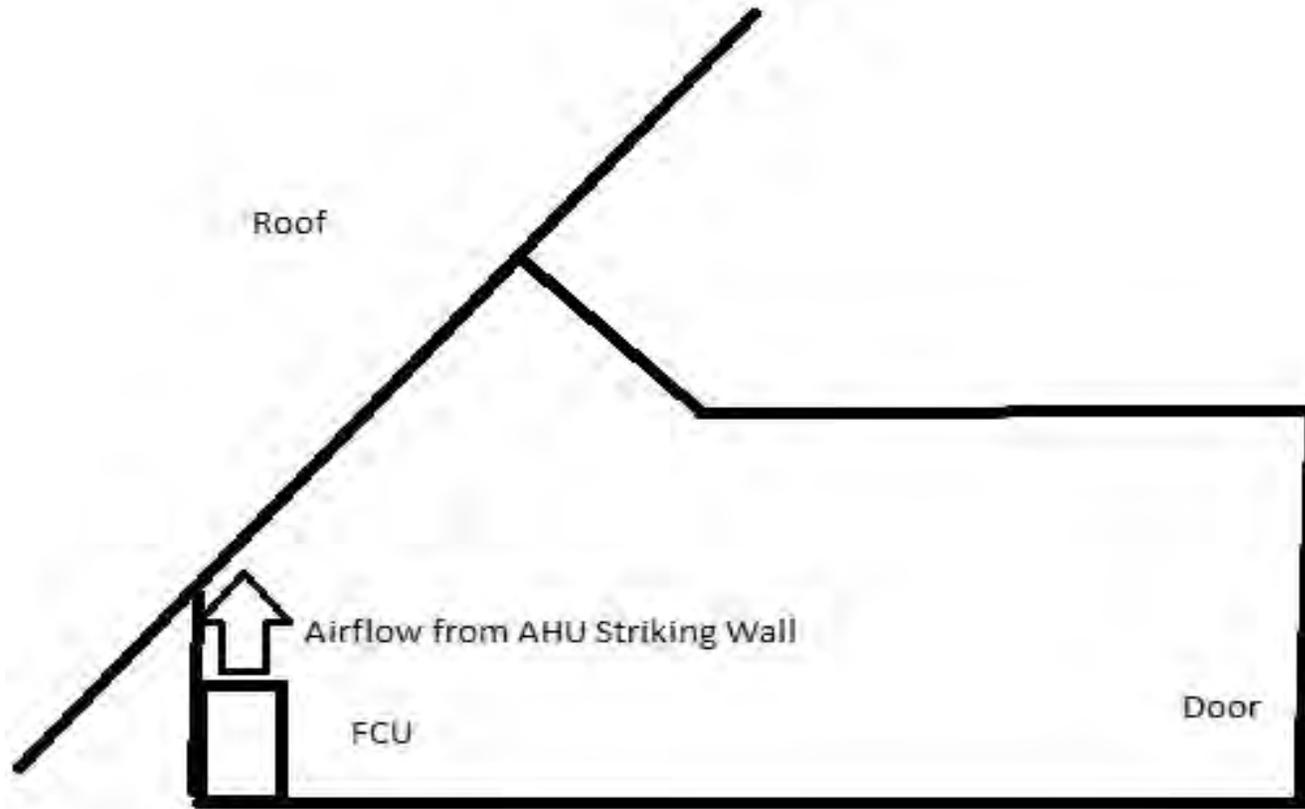
**Figure 2**  
**Configuration of Building 201 Classrooms Built into Underside of Roof**

Building 201 has unusual construction and building component details that make it particularly prone to water damage and mold growth. The roof of the building is deeply sloped and reaches from the peak down to the first story of the building (Picture 1). Many classrooms have walls that follow the slope of the roof (Figure 2). In the experience of BEH/IAQ staff, FCUs are usually installed so that airflow from the diffuser does not directly impinge upon building components. In Building 201, the FCUs in most classrooms are located against the exterior wall/roof, with a section of the wood clad roof directly above the air diffuser (Picture 8). This is a poor design for the following reasons:

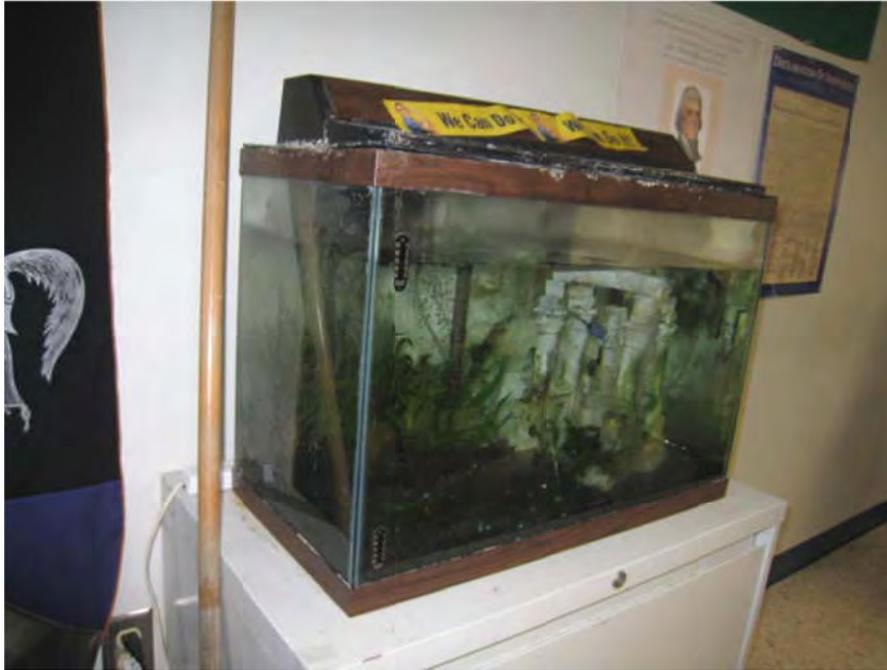
**Picture 26**

sources of mold growth. Plants should be properly maintained, over-watering of plants should be avoided and drip pans should be inspected periodically for mold growth. Plants should also be located away from ventilation sources to prevent aerosolization of dirt, pollen or mold. Aquariums and animal cages were also observed in several classrooms (Table 1; Pictures 25 and 26). Aquariums and animal cages can be a source of moisture or spills and, if not cleaned regularly, can emit unpleasant odors.

**Aquarium in hallway**

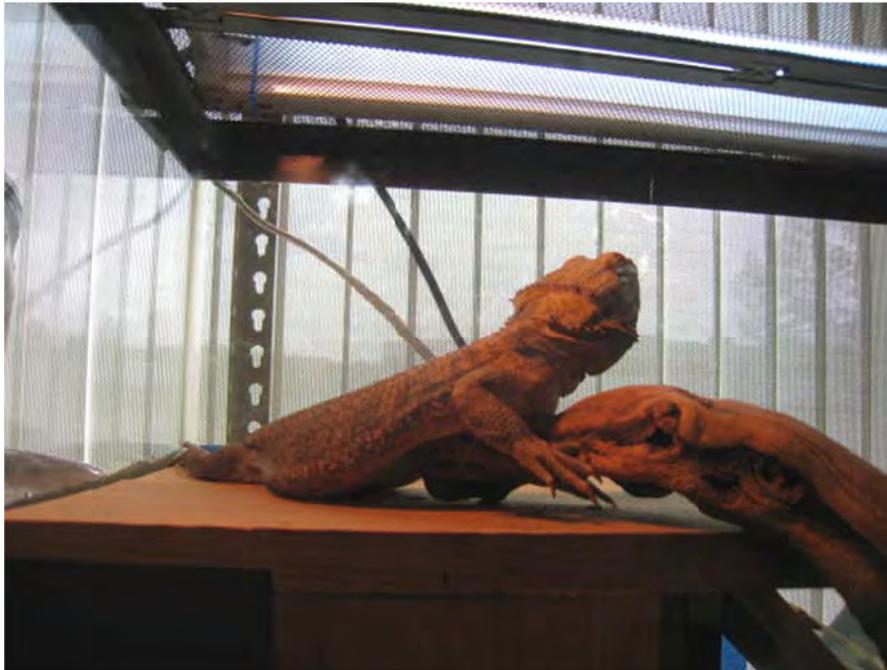
**Picture 27**

**Reptile in cage in classroom**
