INDOOR AIR QUALITY ASSESSMENT

**Methuen City Hall
41 Pleasant Street
Methuen, MA**

Prepared by:
Massachusetts Department of Public Health
Bureau of Environmental Health
Indoor Air Quality Program
June 2016

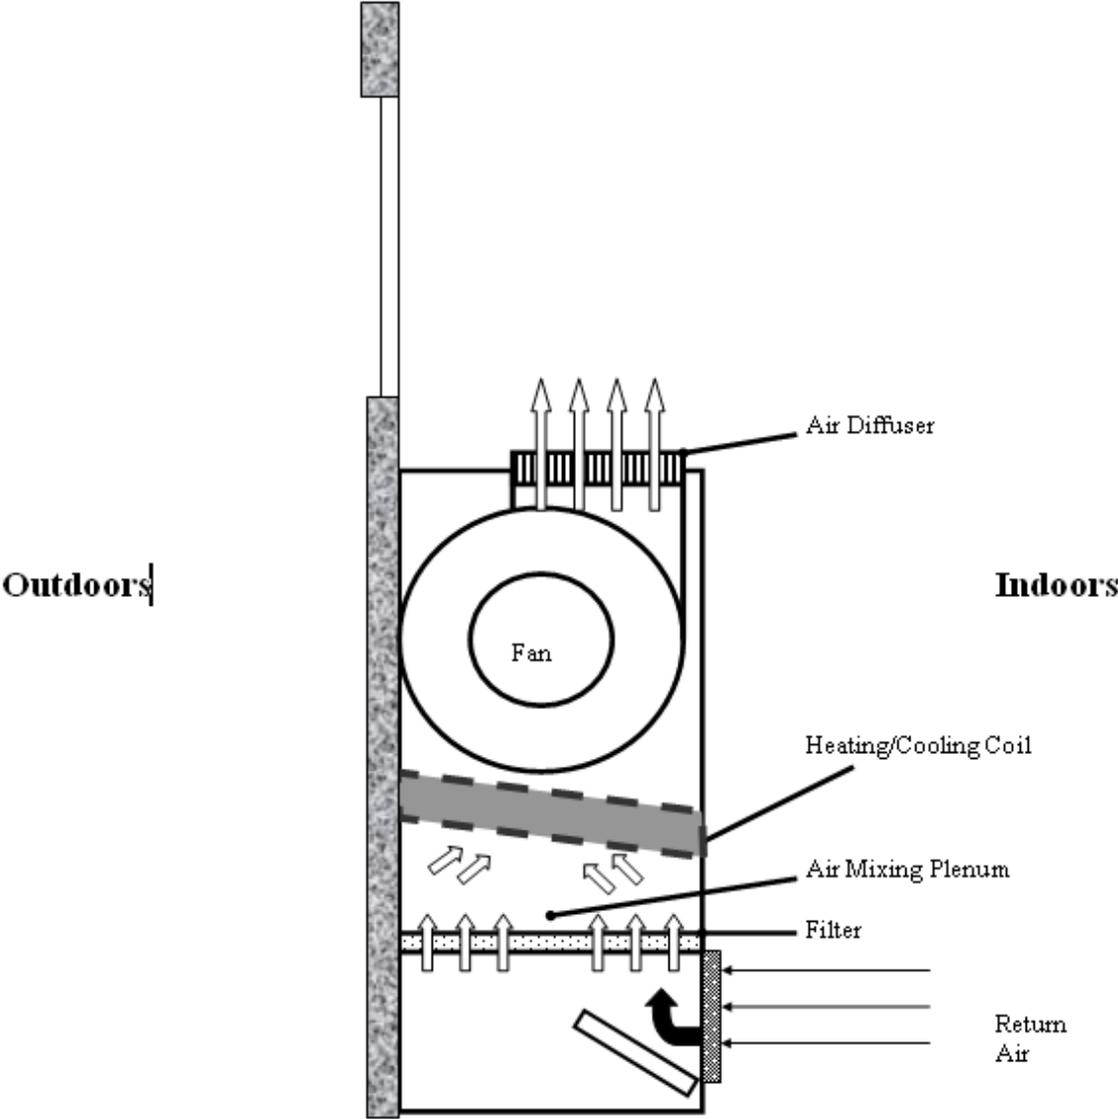
Picture 5

When the building was converted to offices for year-round occupancy, it was renovated and fan coil units (FCU) were installed along exterior walls within the building (Picture 4). The FCUs are designed to provide both heat and cooling. Depending on the setting, heated or chilled water is pumped through a finned tube (i.e., a coil) that is connected to the furnace/chiller by copper pipes that are installed in the pipe chase. Water runs through the copper pipe into the coils, which heat/cool the air forced over the coils by the FCU fans. It is important to note that FCUs are designed to provide either heating or cooling, but do not have a fresh air supply. FCU units can only *recirculate* air (Picture 5).

Fan coil unit rendering
