INDOOR AIR QUALITY ASSESSMENT

**Webster Town Hall
350 Main Street
Webster, MA**

Prepared by:
Massachusetts Department of Public Health
Bureau of Environmental Health
Indoor Air Quality Program
June 2016

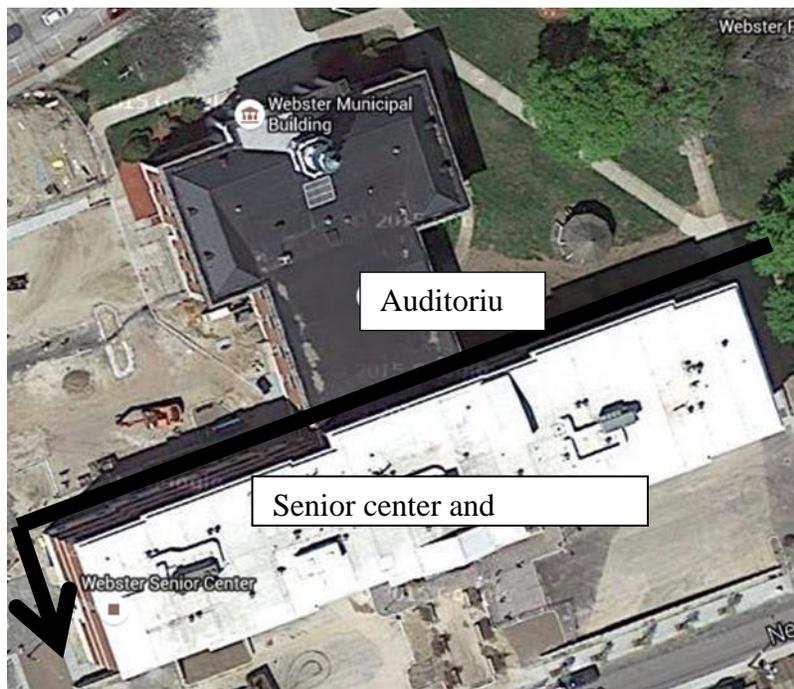
Picture 4

The auditorium is a large two-floor open area which is between the main part of the WTH and the attached building, which contains the Webster senior center and residential units (Picture 4). It appears that the two buildings had previously shared a ventilation system. The vents for this system have been blocked off with plastic and tape from the auditorium side (Picture 5).

Aerial view of Webster Town Hall and attached residential/senior center building
